HIGHWAY POST SURVEY

A 1960 Progress Report

A. R. Olson

Circular 217
March 1961

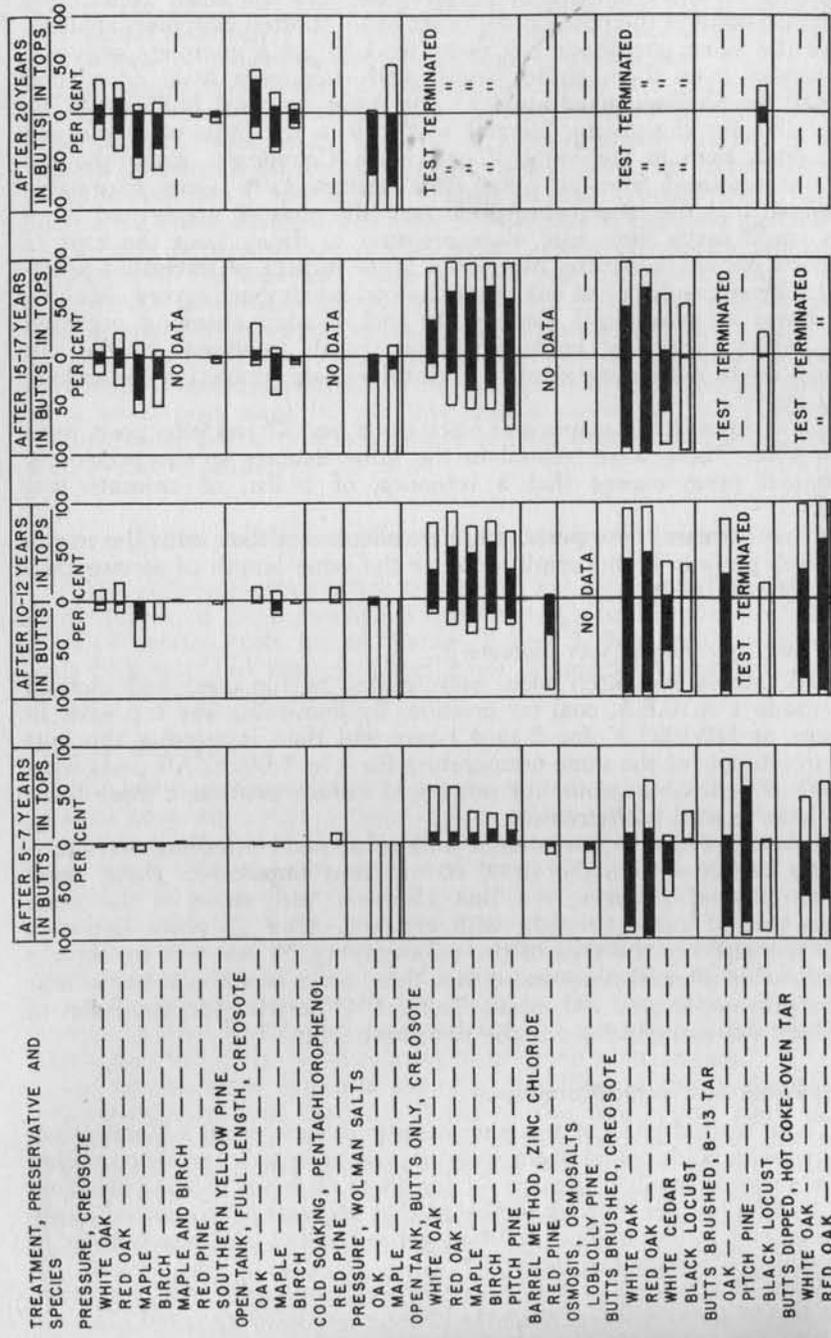
The condition of the butts and tops is shown separately in Figure 1 and Table 1 which indicate where the preservative treatment failed to provide adequate protection against decay. The percentages under the several headings are based on the number of posts actually in service at the time of inspection, not the number originally set.

FIGURE 1. Per cent of butts and tops of posts partially decayed but still serviceable (□) and decayed, unserviceable (■).

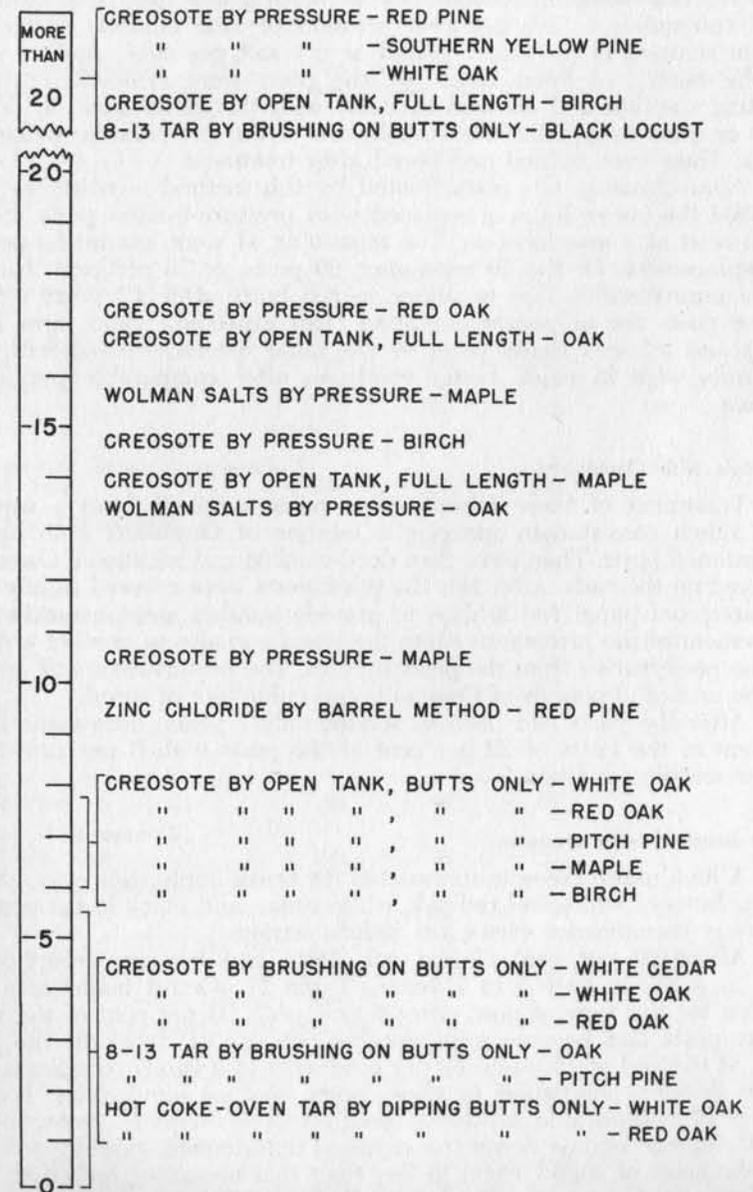
Figure 2 and Table 2 show the percentages of posts found in a serviceable condition without separate consideration of butts and tops. The data are based on the number of posts originally set less those removed for reasons other than decay (relocation of the highway, broken in accidents, etc.). Consequently they present a better basis for estimating all losses due to decay than do the data in Figure 1 and Table 1.

FIGURE 2. "Yardstick" of effectiveness of the preservative treatments to provide protection against decay in the posts as determined by number of years 80 per cent of the posts remained in serviceable condition. Treatment with pentachlorophenol and Osmosalts not shown because of insufficient length of service.
