Docket No. 217 – Development and Management Plan Inspection

Northeast Utilities Service Company Certificate of Environmental Compatibility and Public Need for the construction of a 345-kV electric transmission line and reconstruction of an existing 115-kV electric transmission line between Connecticut Light and Power Company's Plumtree Substation in Bethel, through the towns of Redding, Weston, and Wilton, and to the Norwalk Substation in Norwalk, Connecticut.

Date: January 26, 2006

Location: 115 kV Underground Route

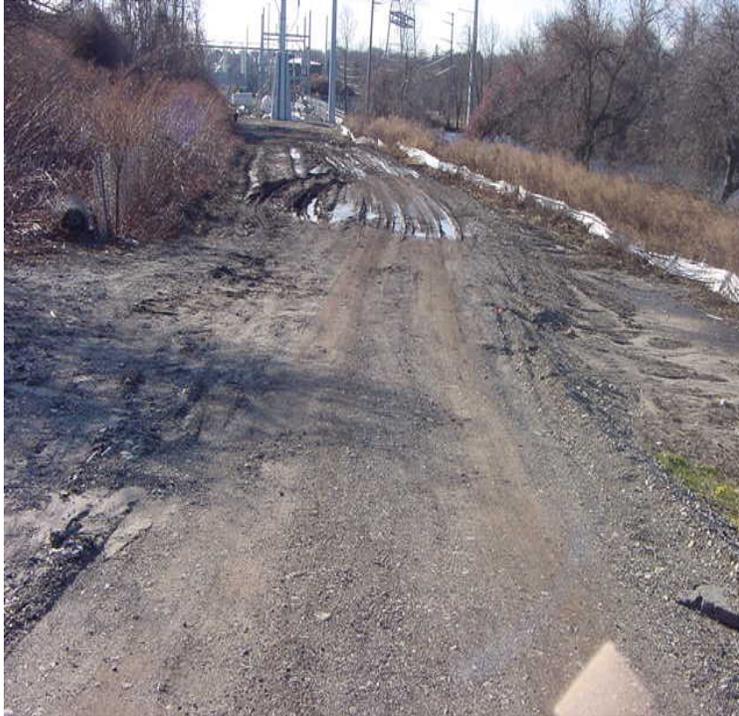
<p>Broad Street, ROW, and Rt. 7 Norwalk</p>	<p>- A disturbed area near the cemetery could use some mulch if feasible. 12/8-1/26/06</p> <p>- The ROW was muddy and heavily rutted due to equipment access. 1/26/06</p>	<p>- Any leftover materials should also be picked up here as well as at Norwalk Junction1/26/06</p> <p>- Keep silt fence in good repair until the area is stabilized and the bike path constructed. 1/26/06</p>
<p>Soils</p>	<p>-Clean process remains in one pile at the Putnam Park storage area. 12/22-1/26/06</p>	<p>- All soils appear to be handled appropriately. 12/22-1/26/06</p>

115kV (ROW and Putnam Park): Photo on the left shows a view of the ROW adjacent to the Norwalk substation where ruts will need to be restored in the spring. Photo on the right shows a view of the extended erosion controls at the Putnam Park storage area. 1/26/06

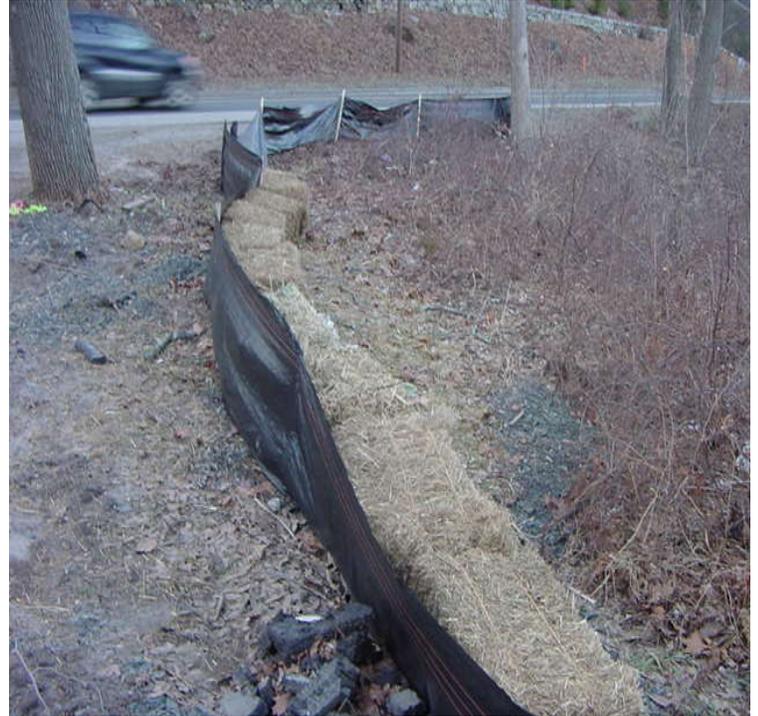
<p>Route 58</p>	<p>- A few areas of bare soil had remained around some of the recently accessed vaults.1/4-1/26/06</p> <p>- Controls at the Putnam Park storage area are in good shape and were extended along the roadway edge for more complete coverage. 1/26/06</p> <p>-Erosion controls were installed along the Sunset Hill Rd. storage area and they are working on removing sediment from the swale. 1/26/06</p>	<p>-Plan to return and restore the edge of roadway in the spring as necessary. 1/4-1/26/06</p> <p>- None at this time. Controls should remain at this site until the growing season. 1/26/06</p> <p>-The conditions here are greatly improved. Continue to finish the work and place mulch on the surface of the yard. 1/26/06</p>
<p>Gallows Hill Road</p>	<p>-The area is well stabilized. 1/26/06</p>	<p>- None at this time 1/26/06</p>
<p>Rt. 107 (Lonetown Rd)</p>	<p>- Erosion controls were also well installed at the 90 degree turn on Rt. 107. 1/26/06</p>	<p>- Conditions here are greatly improved. Continue to mulch the yard with straw. 1/26/06</p>

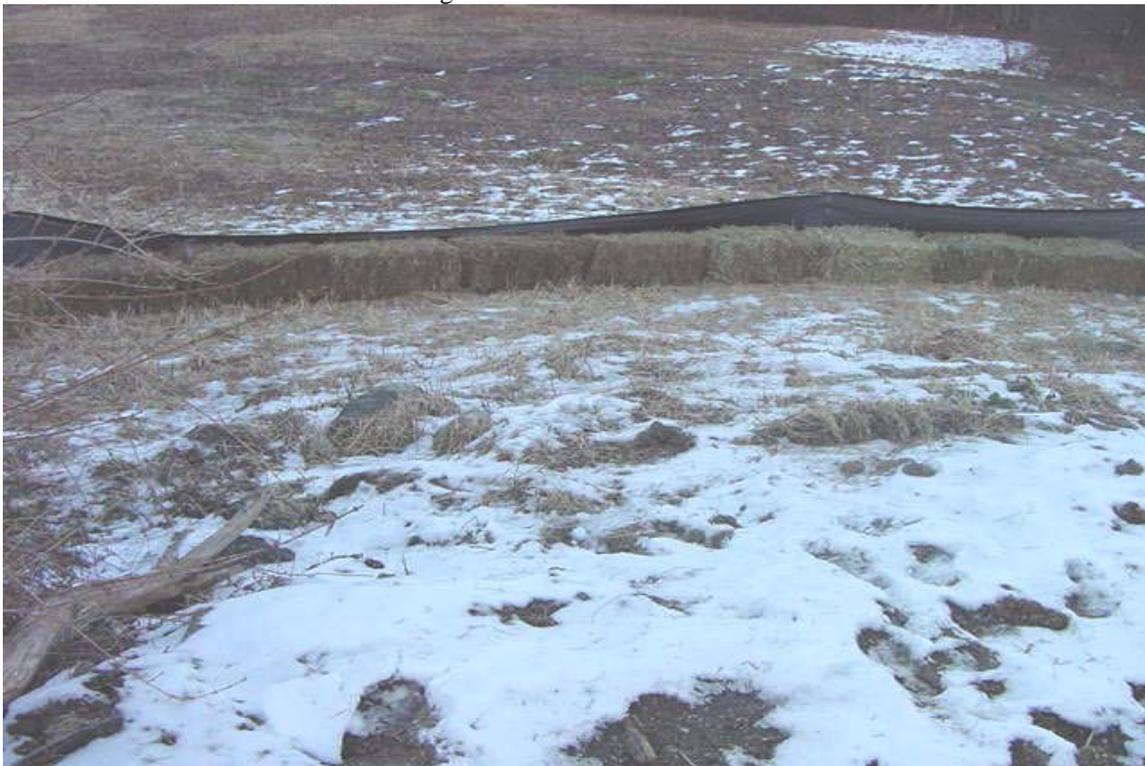
115kV (Rt. 107): Photo shows the "Rt. 107 turn" storage area where erosion controls were installed near the base of the disturbed area as recommended. 1/26/06

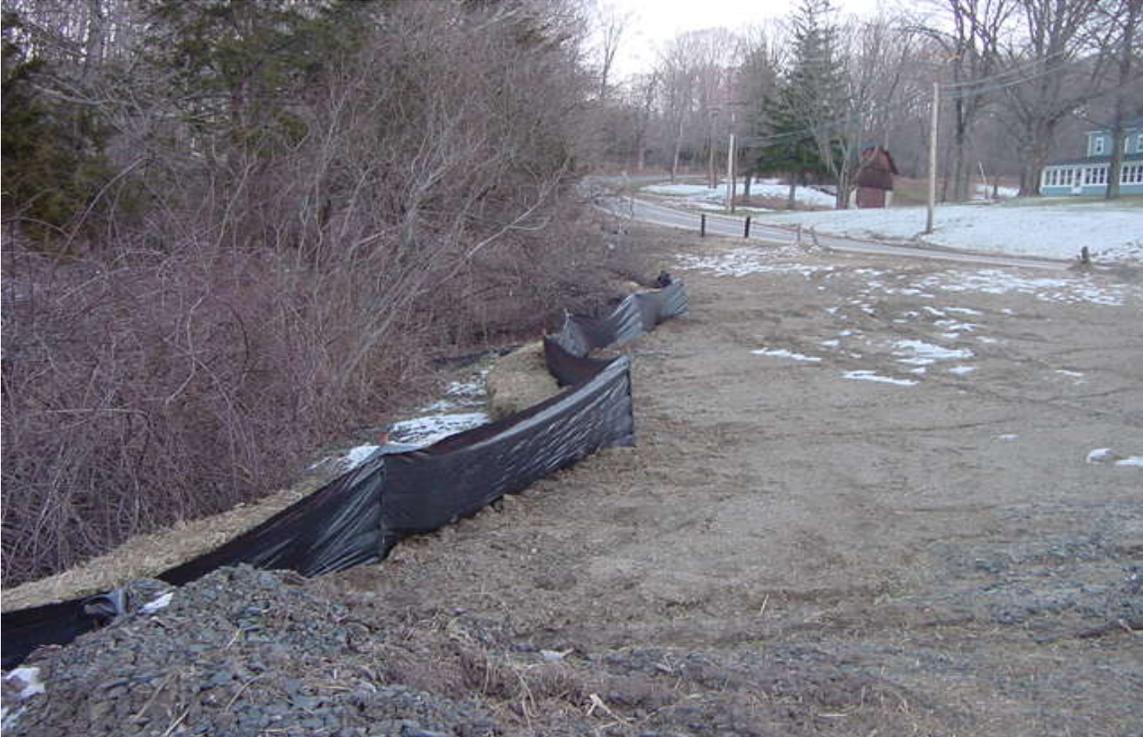
115kV (Rt.58). Photo shows a view of the Sunset Hill Rd. storage area. Erosion controls were installed as recommended here and some of the sediment was removed from the wet swale at the edge of the yard.
1/26/06

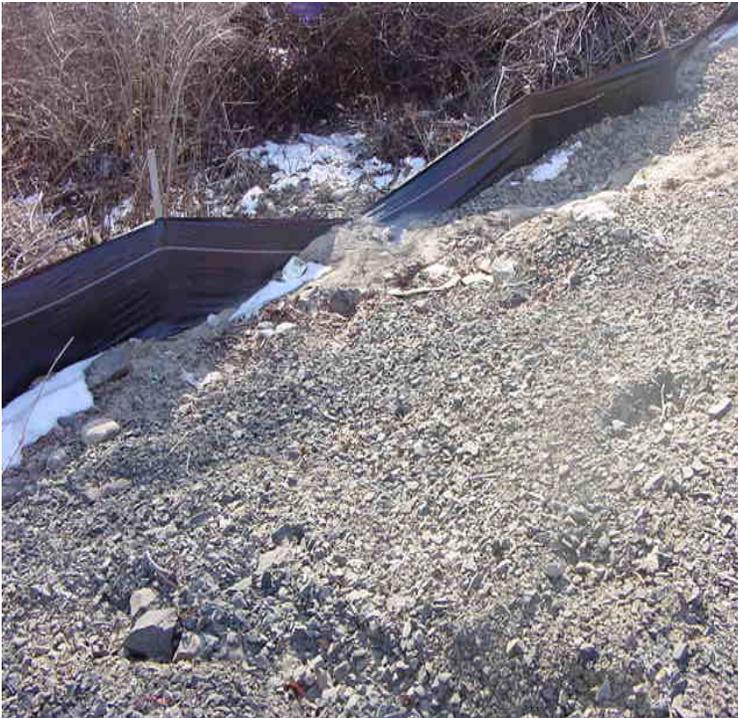
115kV (Bethel Ed) Work is inactive but recent storms have created some issues. Photo on the left shows an area along the access road to the south tower where sediment washed over the fence. Photo on the right shows a gully and washout at the south tower. These areas should be repaired sooner than later. 1/26/06

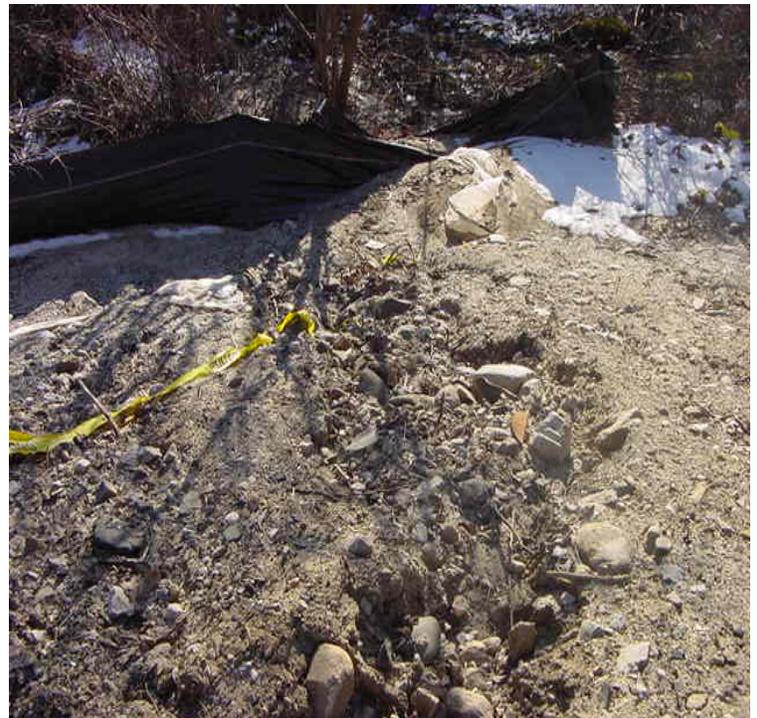
Areas of Inspection	Observation	Recommended Action
<p>Erosion and Sediment Controls (includes inspection within 24 hours of a storm event)</p> <p>Bethel Educational Park</p>	<p>- The gully along the northern ROW continues to washout, leaving a trail of sediment into the woods. 12/8-1/26/06</p> <p>-Several washouts along the southern ROW and at the tower were worsening with sediment over the silt fence here.1/26/06</p>	<p>-This gully has been placed with stone several times but continues to washout. Try larger stone or develop alternative solutions. 1/26/06</p> <p>- Repair the washouts and determine solutions for stabilizing the slope by the tower. 1/26/06</p>
<p>Hoyts Hill Riser Transition Structure (Off Rt. 58)</p>	<p>- Equipment access had created additional ruts along the sides of the drive in the mud. 11/23-1/26/06</p> <p>-Litter and materials left behind from the scaffolding were present.</p>	<p>-Check status in the spring. Provide repair and straw mulch/seed if necessary. 1/26/06</p> <p>- Provide good housekeeping. 1/26/06</p>
