**Docket No. 217 – Development and Management Plan Inspection**

**Date:** May 26, 2005

**Inspector:** Diana Walden

**Location:** 115 kV Underground Route

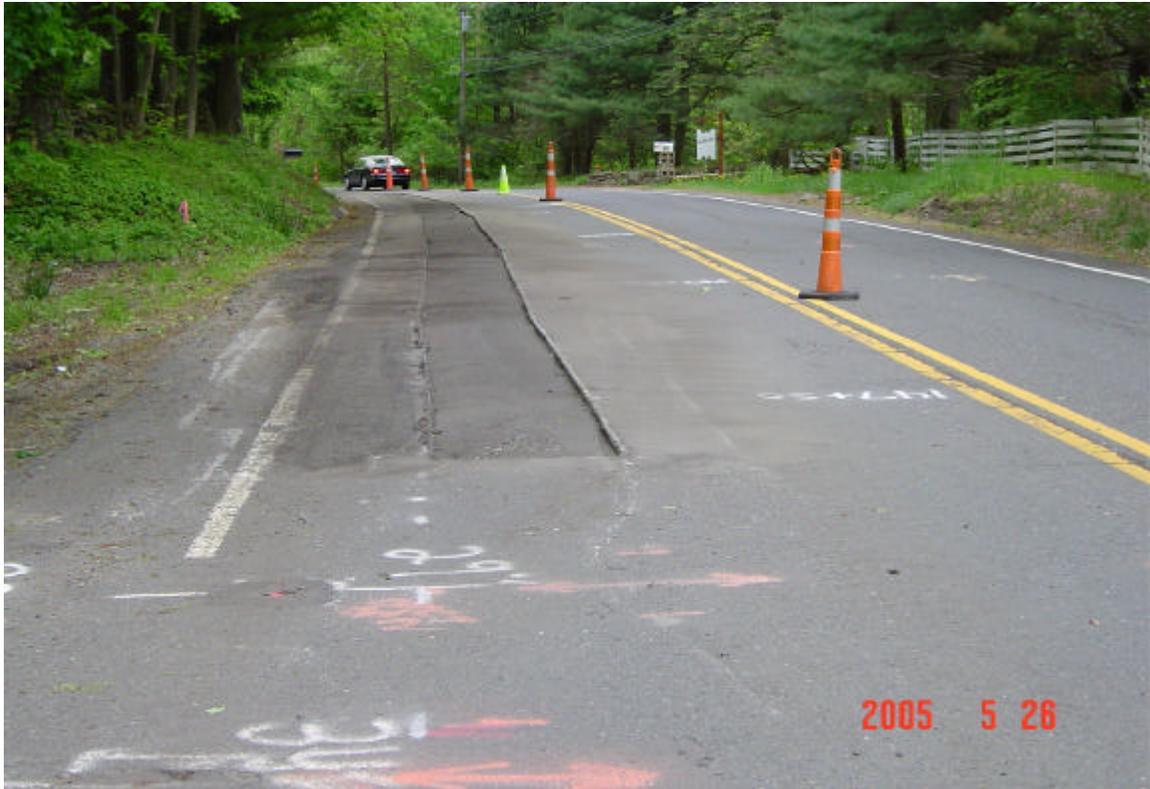
115 kV- Preparation trenching has been occurring along Rt. 107 and silt fence is in place. (5/26/05)

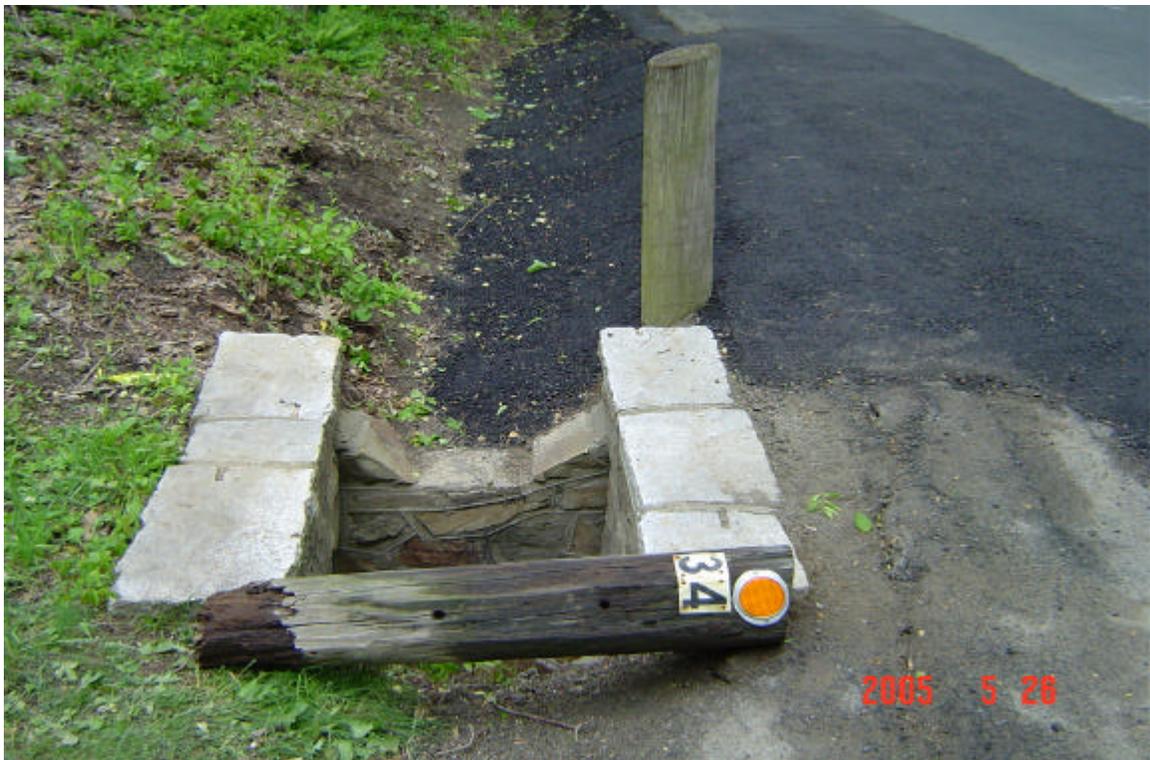
A drain inlet at 34 Gallows Hill Road should be protected with a haybale when activities resume here. (5/26/05)

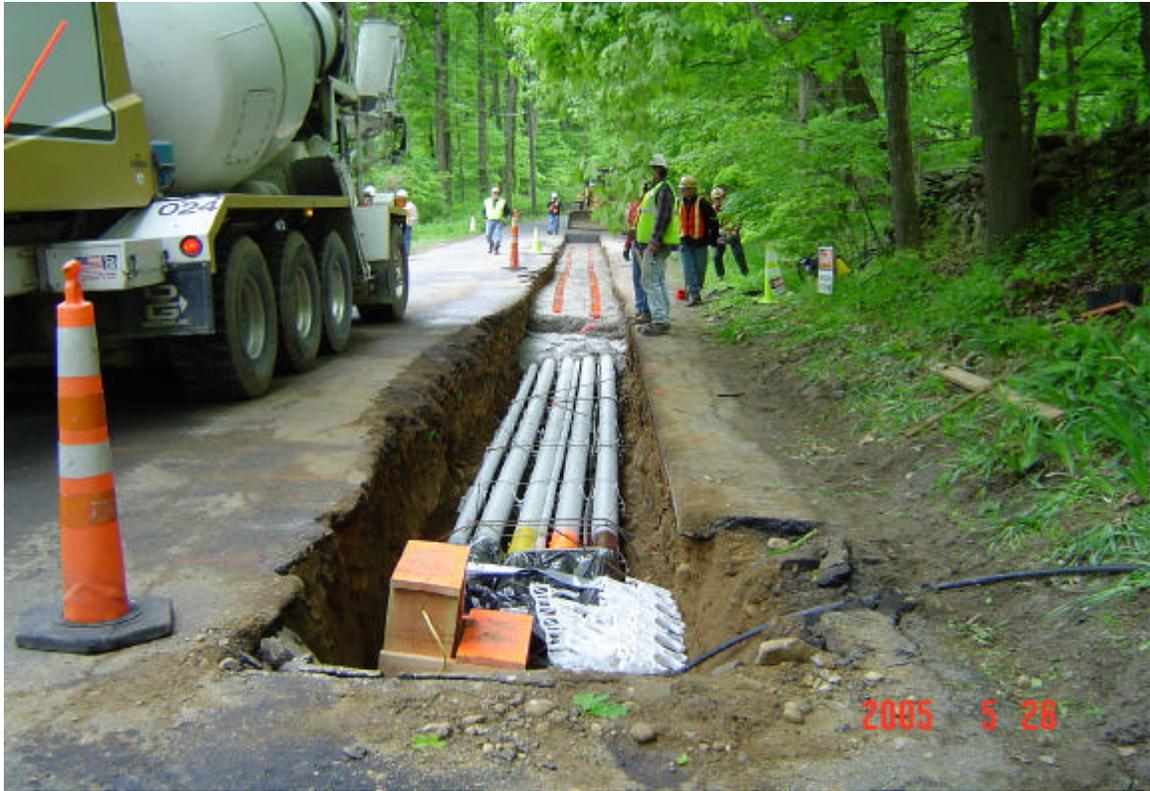
View of the first portion of the cable/conduit installation along Gallows Hill Rd. (5/26/05)

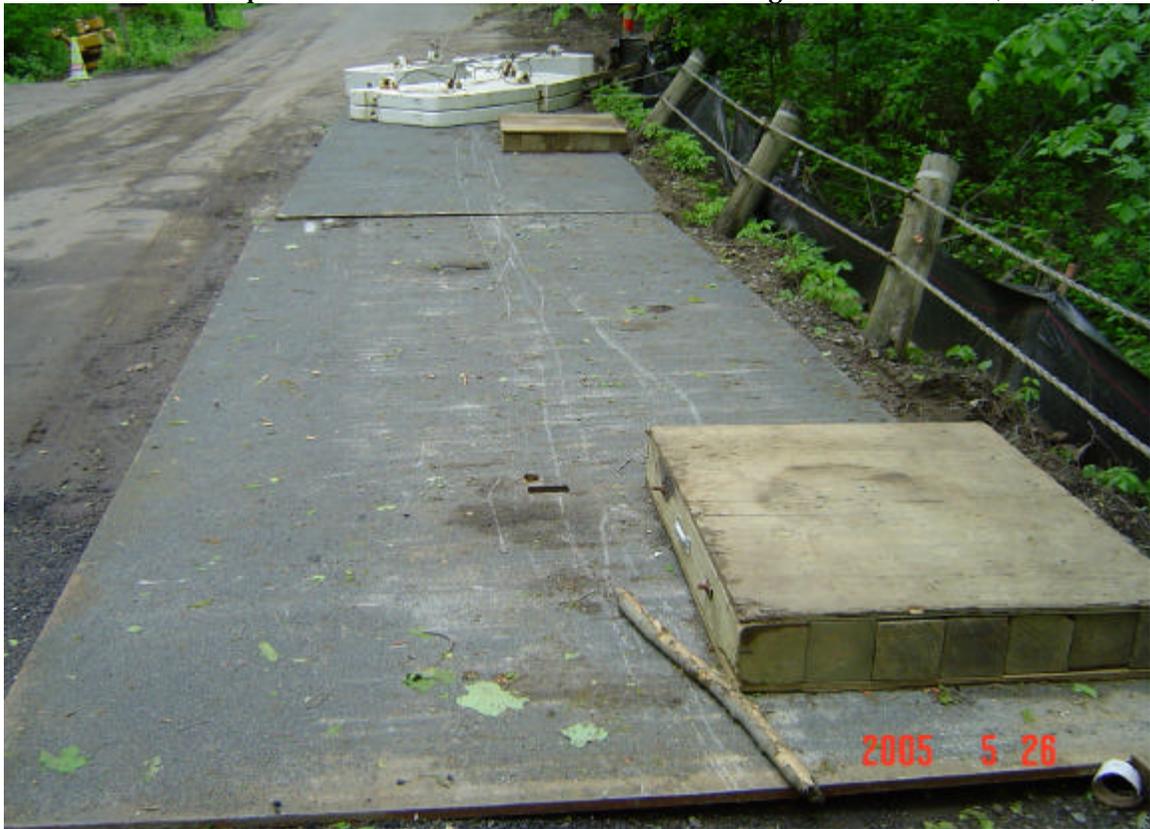
The first vault has been installed along Gallows Hill Rd. and was covered for the night. (5/26/05)

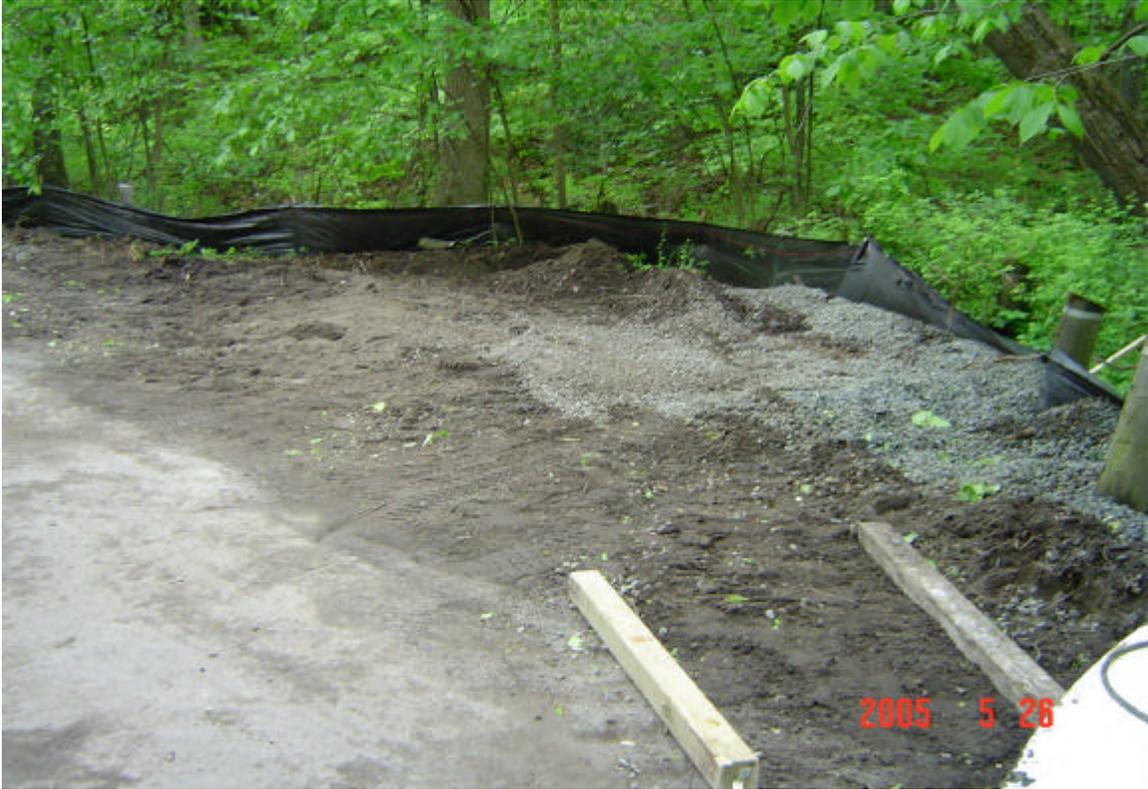
Silt fence along Gallows Hill in the vicinity of the vault had been strained in one area due to a small gravel pile. (5/26/05)

Areas of Inspection	Observation	Recommended Action
Erosion and Sediment Controls (includes inspection within 24 hours of a storm event)	<ul style="list-style-type: none"> <li>- Silt fence has been well installed where the work is located adjacent to wetlands off the roadway. Due to curbing or natural berms some of the areas of installation seem unnecessary. 5/26/05</li> <li>- Several silt fence check dams have been placed in the existing country drainage swales along the roadway to protect the inlets from sedimentation. 5/13-5/26/05</li> </ul>	<ul style="list-style-type: none"> <li>- None at this time. Continue to monitor and maintain and repair the fence as necessary. 5/13-5/26/05</li> </ul>
Erosion and Sediment Controls continued	<ul style="list-style-type: none"> <li>- The swale to the drain inlet near #34 Gallows Hill Road was paved to prevent erosion to the inlet. 5/26/05</li> <li>- A small pile of gravel and sediment was pushed against the silt fence at the vault installation (#129 Gallows Hill) and pulled a portion of the fence from a stake. 5/26/05</li> </ul>	<ul style="list-style-type: none"> <li>- A haybale should be placed in the swale when the adjacent trench is reopened. 5/26/05</li> <li>- The fence should be repaired in this location and the gravel pulled back from the erosion controls. 5/26/05</li> </ul>

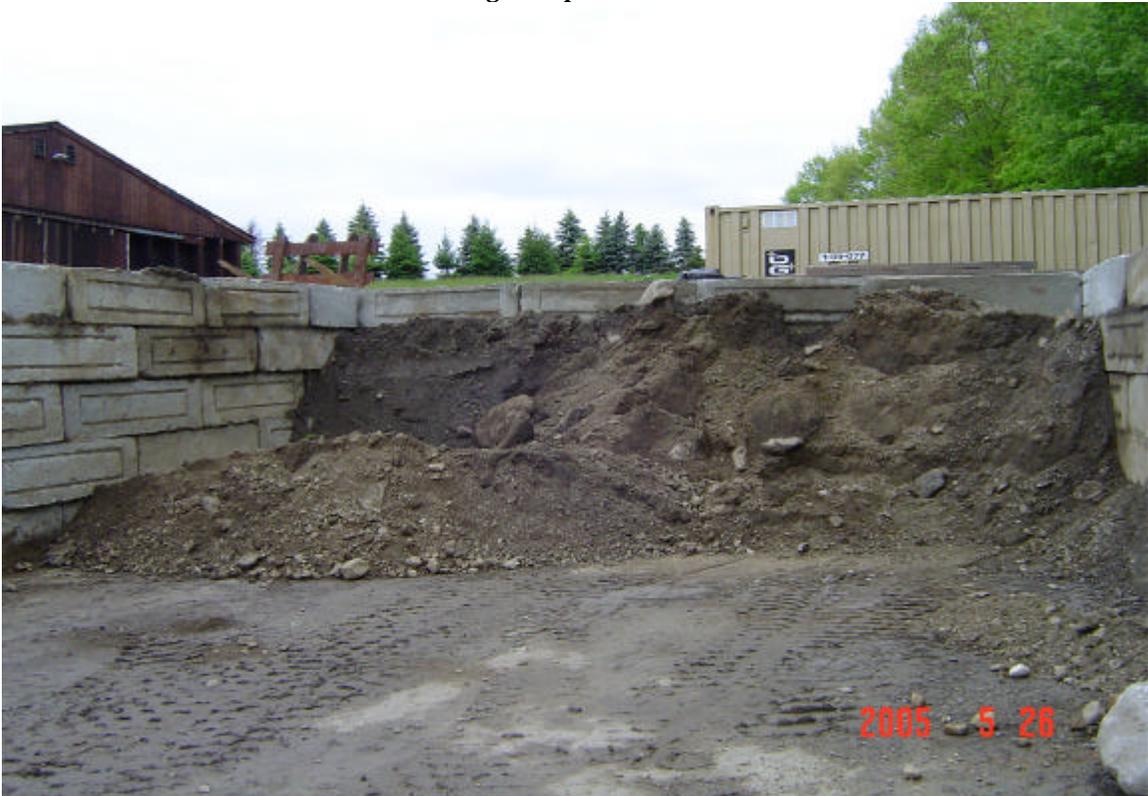
View of the Redding Town yard where clean excavate from the roadwork is being temporarily stored. (5/26/05)
