Docket No. 217 – Development and Management Plan Inspection

Northeast Utilities Service Company Certificate of Environmental Compatibility and Public Need for the construction of a 345-kV electric transmission line and reconstruction of an existing 115-kV electric transmission line between Connecticut Light and Power Company's Plumtree Substation in Bethel, through the towns of Redding, Weston, and Wilton, and to the Norwalk Substation in Norwalk, Connecticut.

Date: June 9, 2005

Location: 115 kV Underground Route

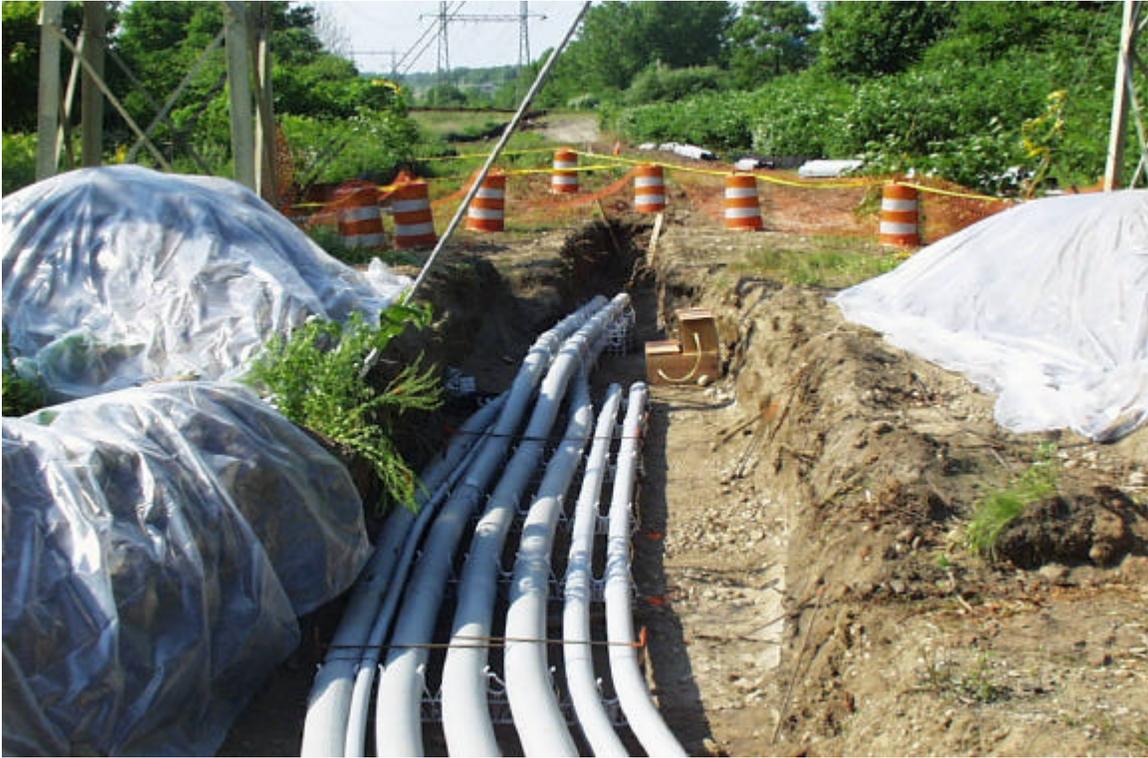
115 kV (Broad Street-Norwalk)-Conduit installation is underway from the north of Norwalk substation in the ROW. 6/9/05

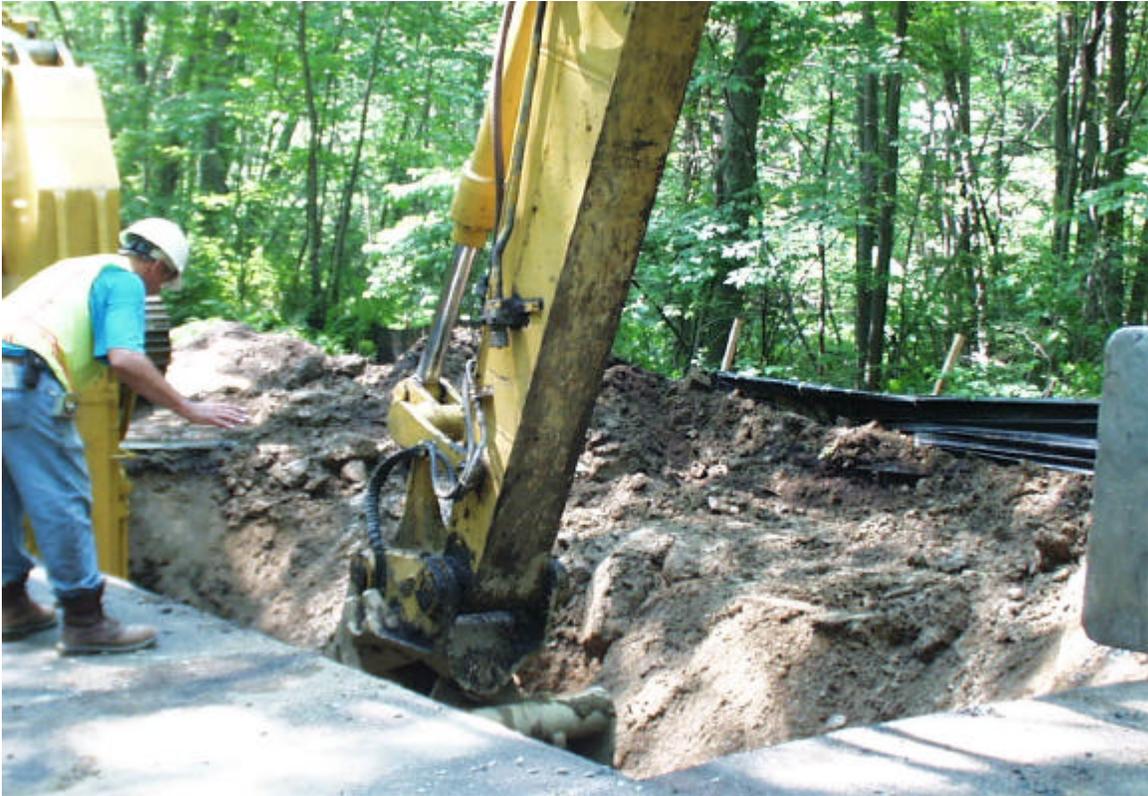
115 kV (Gallows Hill Road, Redding) Vault #13 installation on Gallows Hill Road. 6/9/05

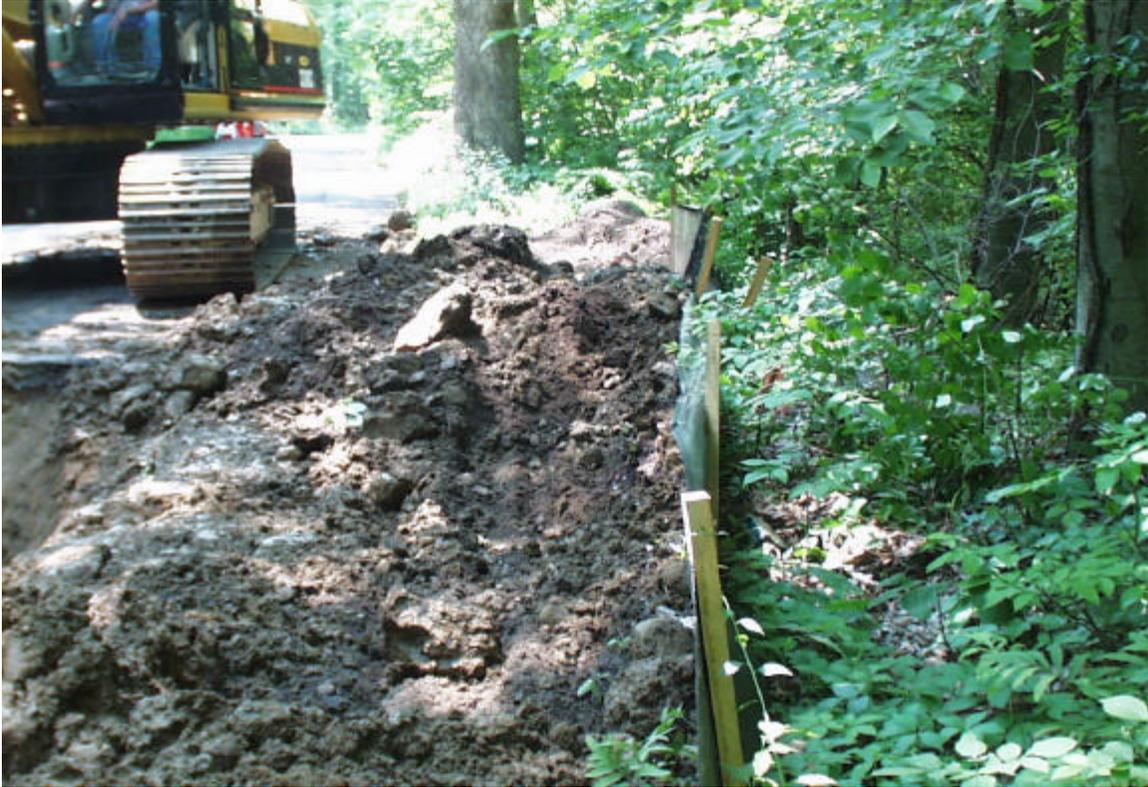
Silt fence adjacent to the vault installation is strained slightly due to the sediment pile. Soil has not crossed the barrier but the fence should be repaired if necessary following the work. 6/9/05

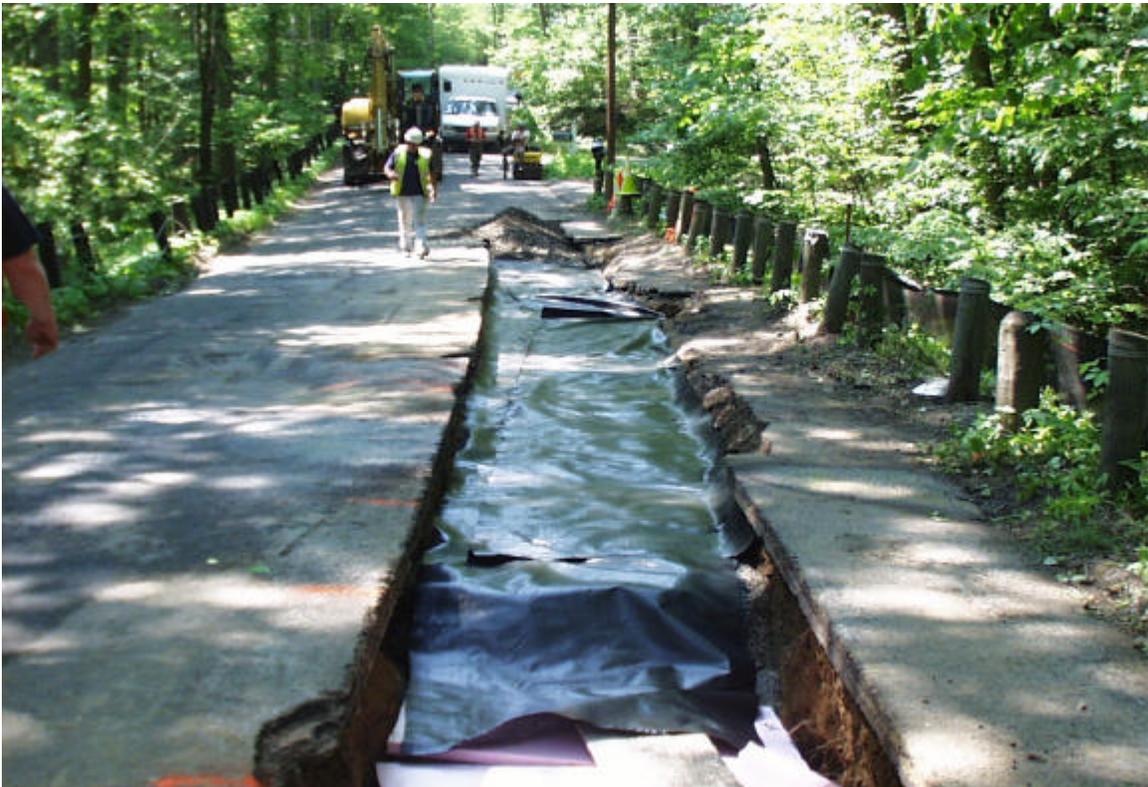
View of more conduit installation on Gallows Hill Road. 6/9/05

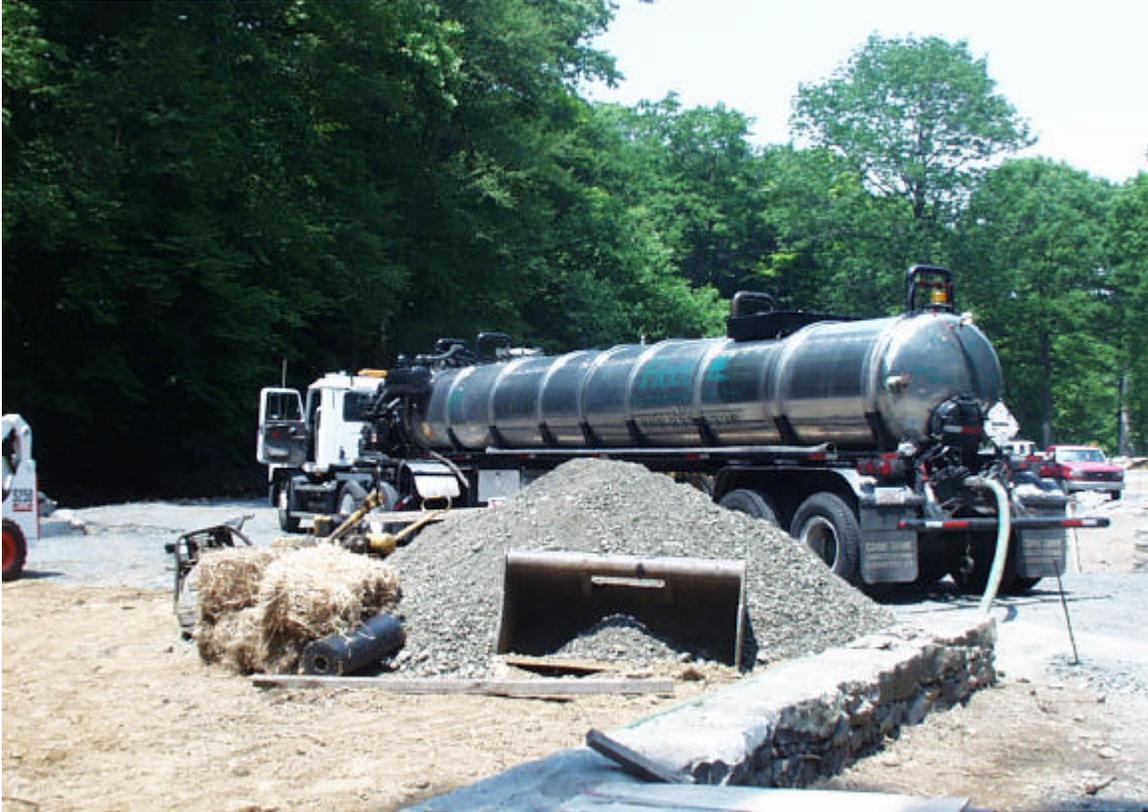
115 kV (Rt 58 Putnam Park, Redding). Dewatering discharge water is being directed to a tank truck and removed from site. 6/9/05

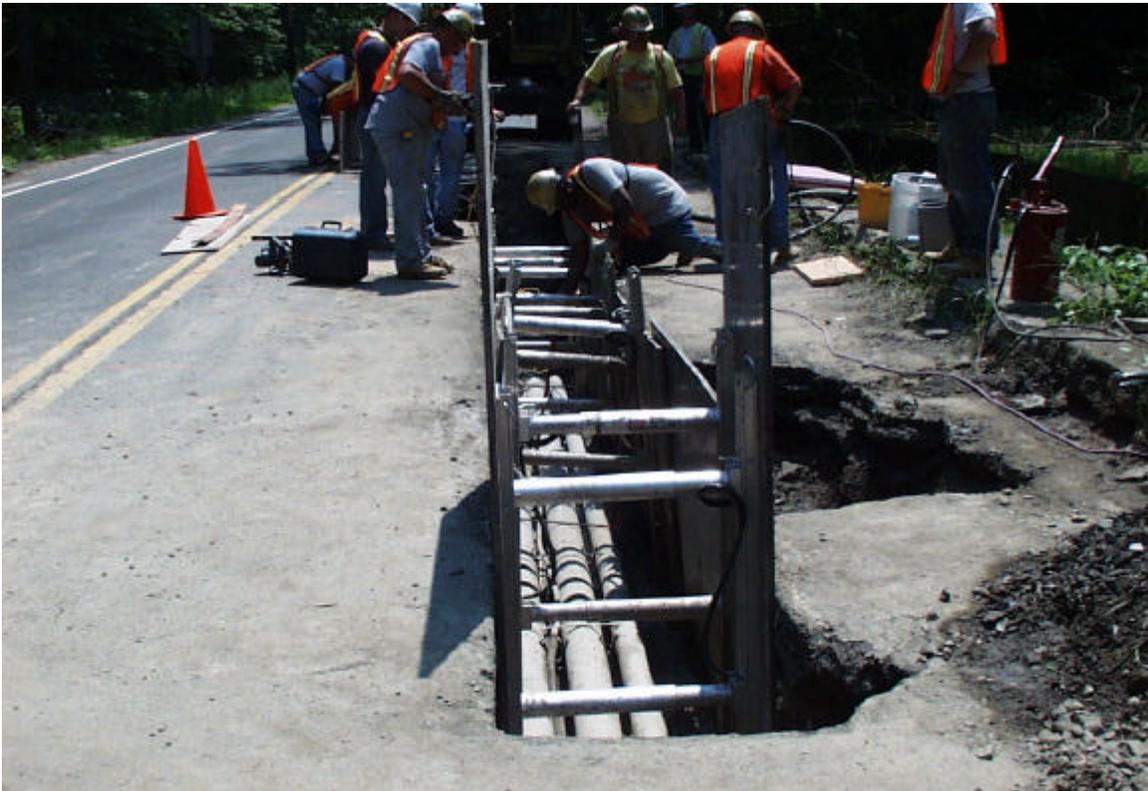
Conduit installation work along Rt. 107 near intersection with Rt. 58. 6/9/05

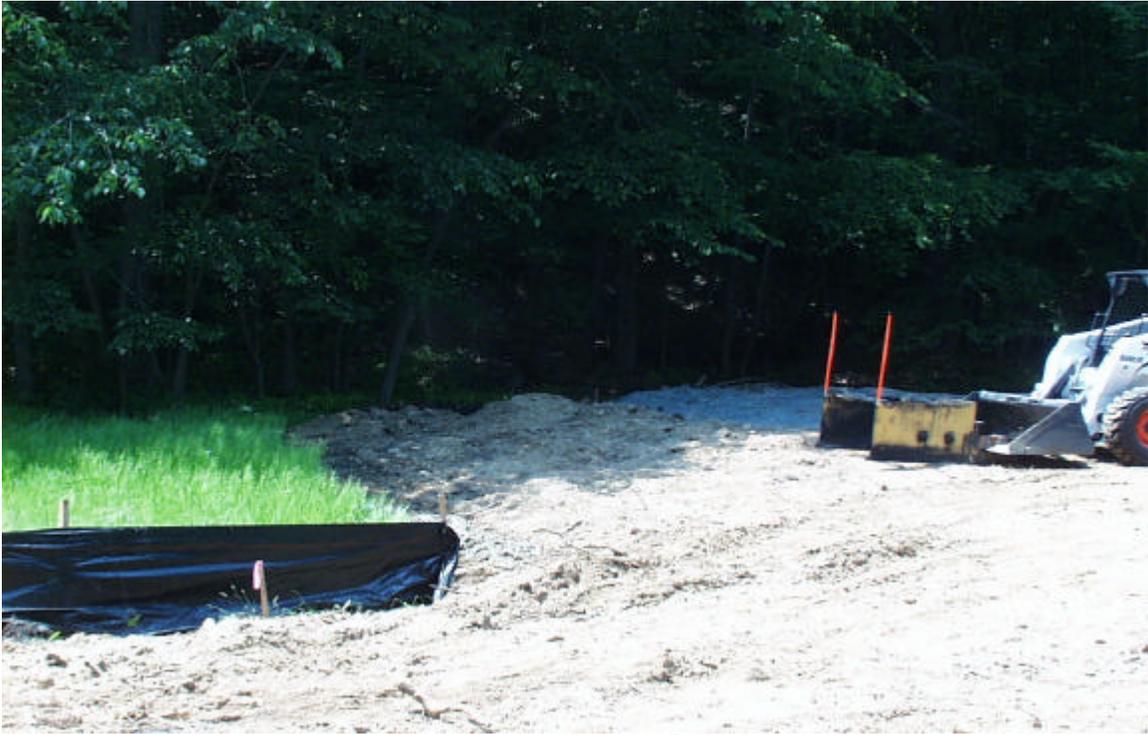
Temporary storage area in parking area near Putnam Park. Separate project construction is ongoing on the lot and grounds here resulting in the soil disturbance, but additional silt fence should be added to the corner here. 6/9/05

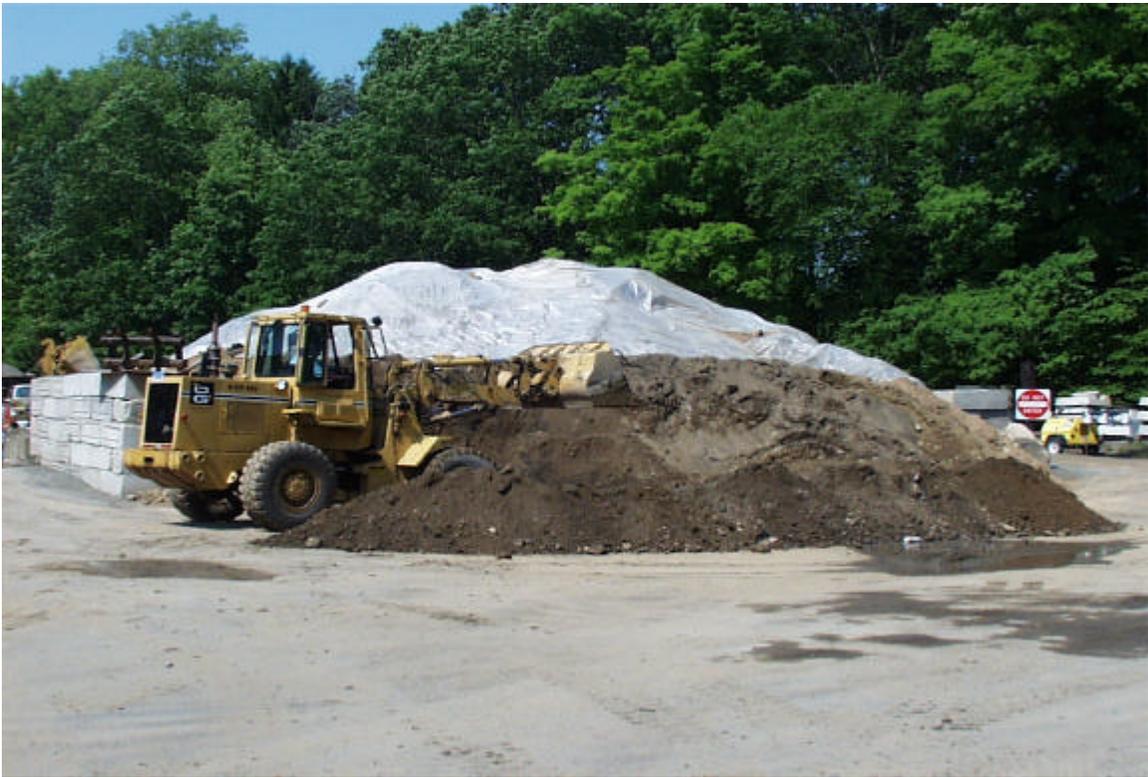
115kV (Redding Town Yard) Storage area for excavate from the roadway work. Haybales should be considered at the downgradient side of the pile. 6/9/05

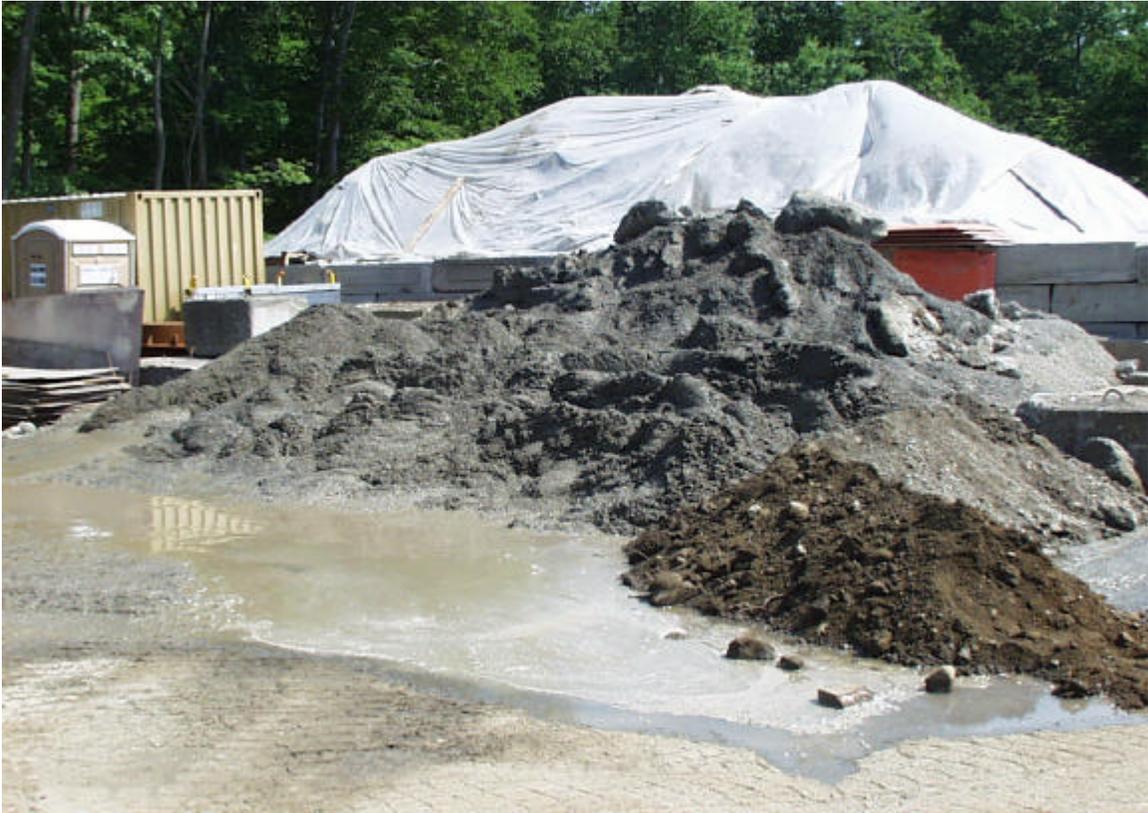
Concrete washout area. Additional containment or filter barrier should be considered as some water appeared to be reaching a catch basin on site. This water appeared to be cleaner than the immediate washout and may be coming off the trucks. 6/9/05
