**Docket No. 217 – Development and Management Plan Inspection**

Northeast Utilities Service Company Certificate of Environmental Compatibility and Public Need for the construction of a 345-kV electric transmission line and reconstruction of an existing 115-kV electric transmission line between Connecticut Light and Power Company’s Plumtree Substation in Bethel, through the towns of Redding, Weston, and Wilton, and to the Norwalk Substation in Norwalk, Connecticut.

**Date:** June 15, 2005

**Location:** 115 kV Underground Route

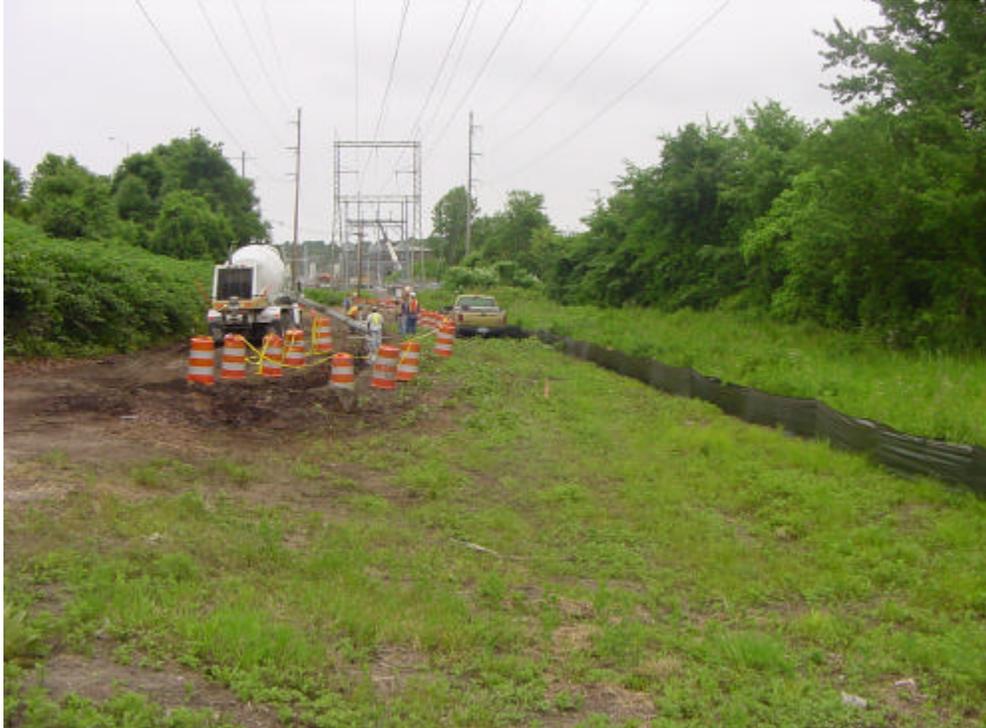
**Broad Street, Norwalk 115kV: Pouring concrete within the conduit trench between Norwalk Substation and Broad Street. (6/15/05)**

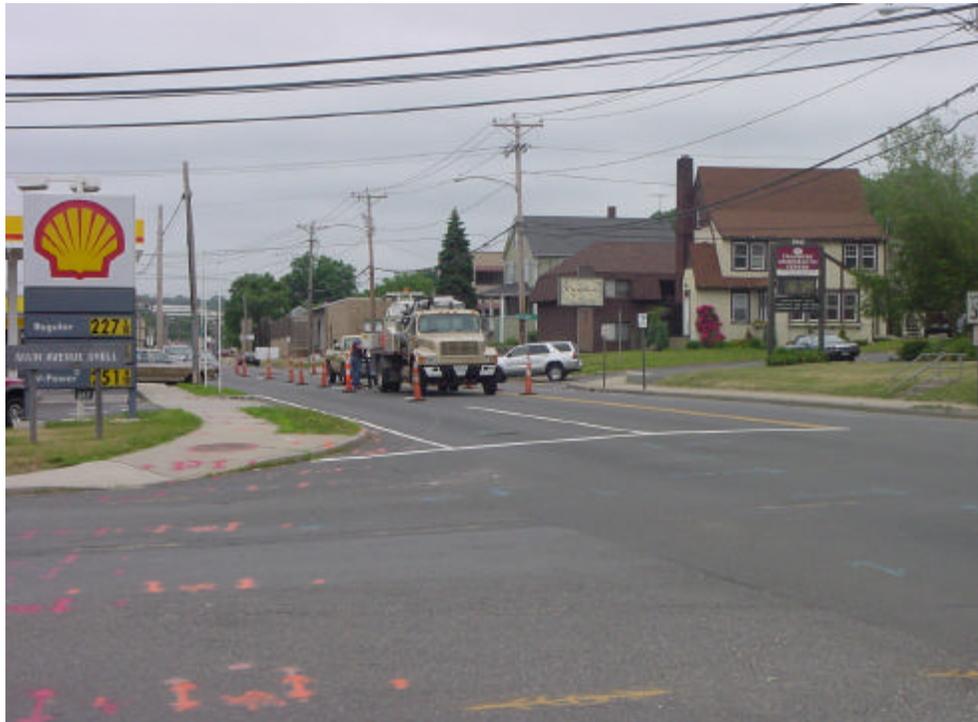
**Trenching work underway just before the intersection of Route 7 and Broad Street in Norwalk. (6/15/05)**

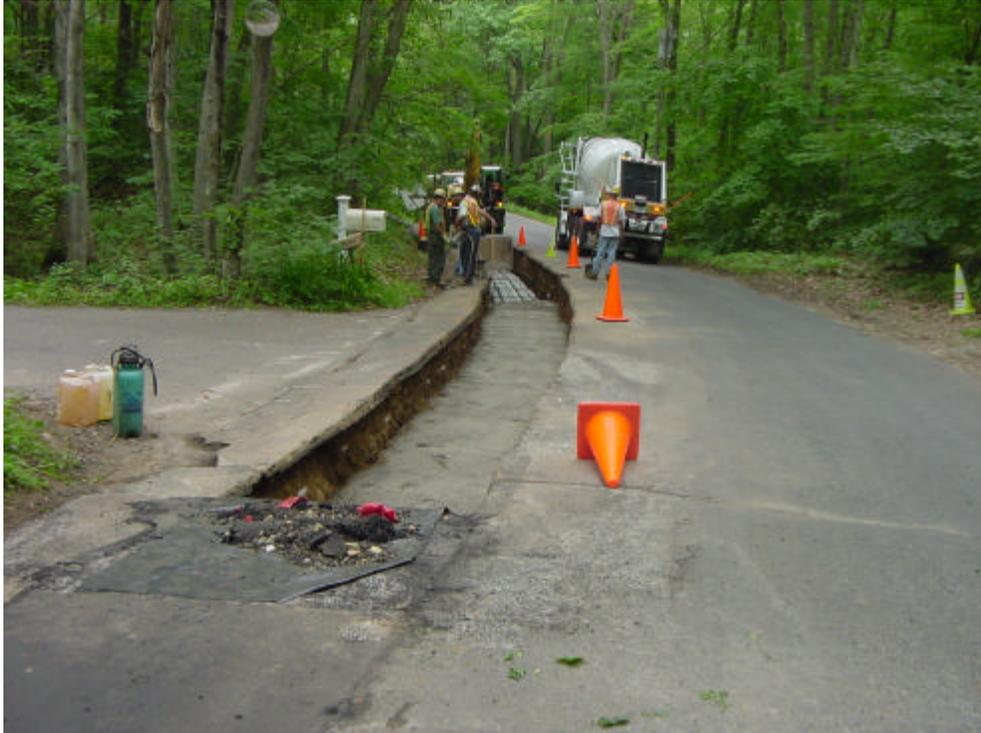
Gallows Hill Road, Redding 1155kV: Pouring of concrete in conduit trench along Gallows Hill Road. (6/15/05)

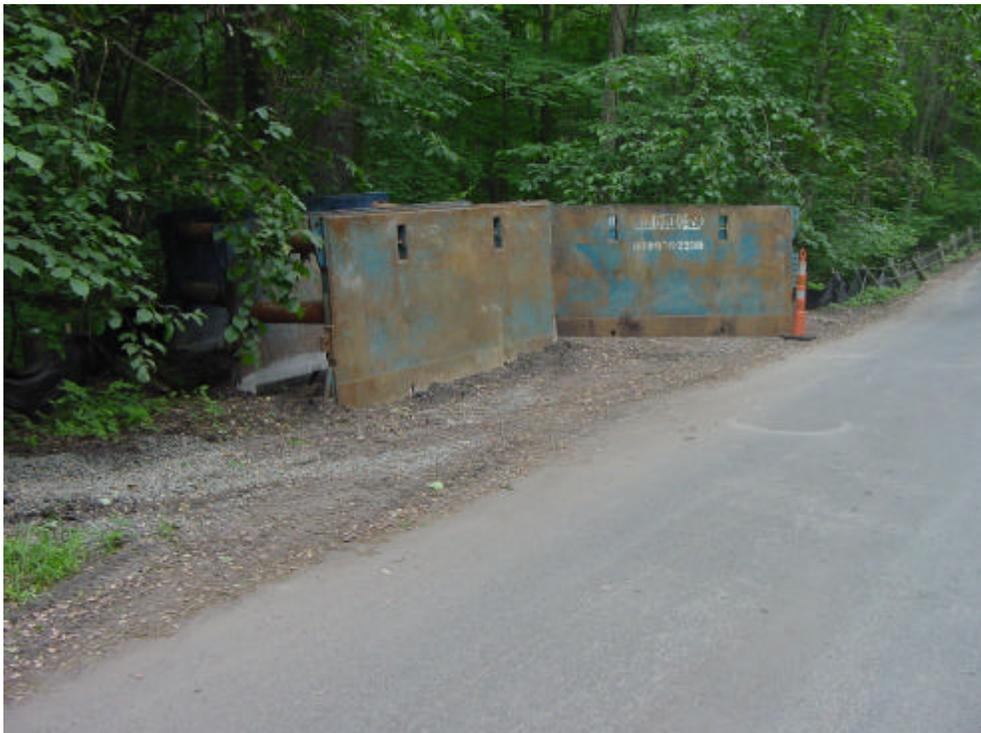
Areas of Inspection	Observation	Recommended Action
Adjacent Wetlands and Waterways	areas adjacent to the roadway work were affected by the activities in any of the locations. No sedimentation or turbidity was noted. 6/15/05	monitor.
Staging, Storage, and Parking Areas	<p>- The <b>pull-off</b> on the side of <b>Gallows Hill Rd</b> that has been designated as a machinery parking area also contained some loose soil but it was being used at the time of inspection. 6/15/05</p> <p>- A second <b>Gallows Hill pull-off</b> near the completed vault #15 installation has some stone and trench components stored here. 6/15/05</p> <p>- In <b>Redding Town Yard</b>, almost all excavate from Gallows Hill Road has been removed for disposal in the O&amp;G facility in Bridgeport. A second bin has been started for the excavate from Rt. 107. 6/15/05</p> <p>- Concrete washouts are also taking place within the yard in a specified location. It may be necessary to add an additional form of containment here as water was noted entering a catch basin on site. 6/09-6/15/05</p> <p>- The <b>Putnam Park parking lot</b> is also being used for temporary equipment storage and includes a stone pile and some machinery. 6/09-6/15/05</p>	<p>- There are no impending issues here at this time. 6/15/05</p> <p>- There are no impending issues here at this time but the area should be cleaned up when feasible. 6/15/05</p> <p>- If the piles progress beyond the bins, haybales should be placed downgradient of the pile unless this is in the way of active equipment movement. 6/15/05</p> <p>- The water did appear to be cleaner than the direct washout water so it may have come from the truck surface. It should be determined however, if and how the area could be contained. 6/09-6/15/05</p> <p>- Although the area has disturbed soil due to a separate project at the park, it should be monitored since it is being used for the 115kV project. 6/15/05</p>

The 2<sup>nd</sup> pull-off area along Gallows Hill Road near the completed vault #15 installation. Some stone and trench components remain stored here. (6/15/05)

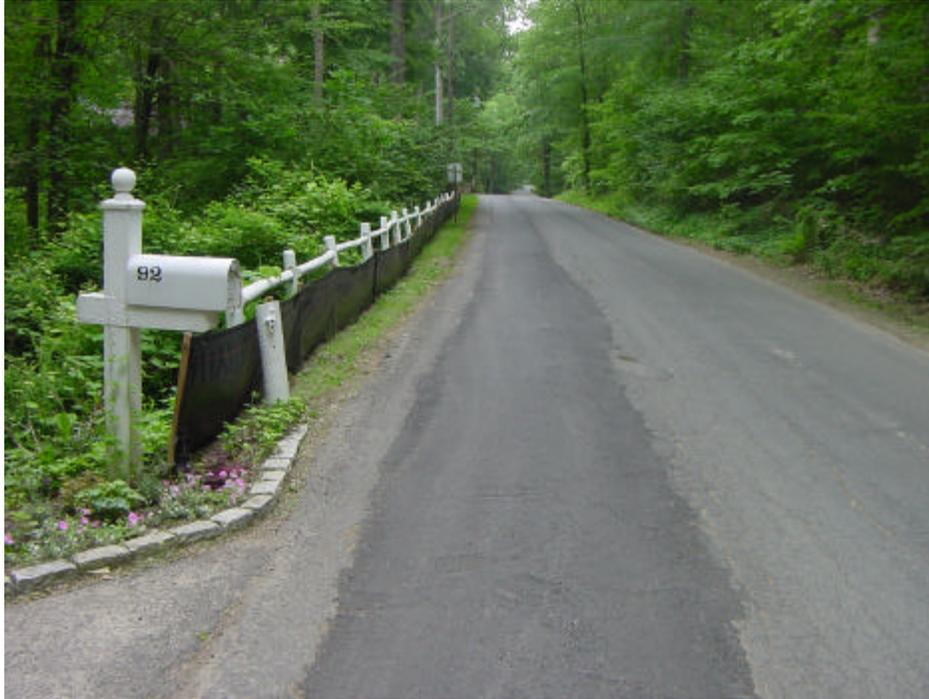
Example of silt Fence along Gallows Hill Road. (6/15/05)

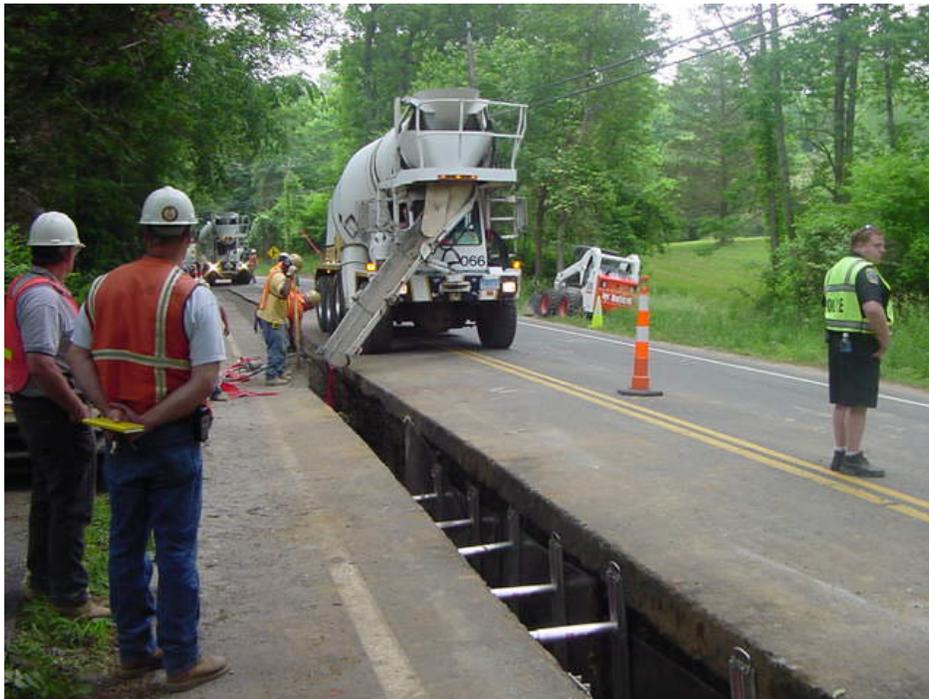
Route #107, Redding 115kV: Trench work and conduit installation along Route 107. (6/15/05)
