Docket No. 217 – Development and Management Plan Inspection

Northeast Utilities Service Company Certificate of Environmental Compatibility and Public Need for the construction of a 345-kV electric transmission line and reconstruction of an existing 115-kV electric transmission line between Connecticut Light and Power Company’s Plumtree Substation in Bethel, through the towns of Redding, Weston, and Wilton, and to the Norwalk Substation in Norwalk, Connecticut.

Date: July 21-22, 2005

Location: 115 kV Underground Route

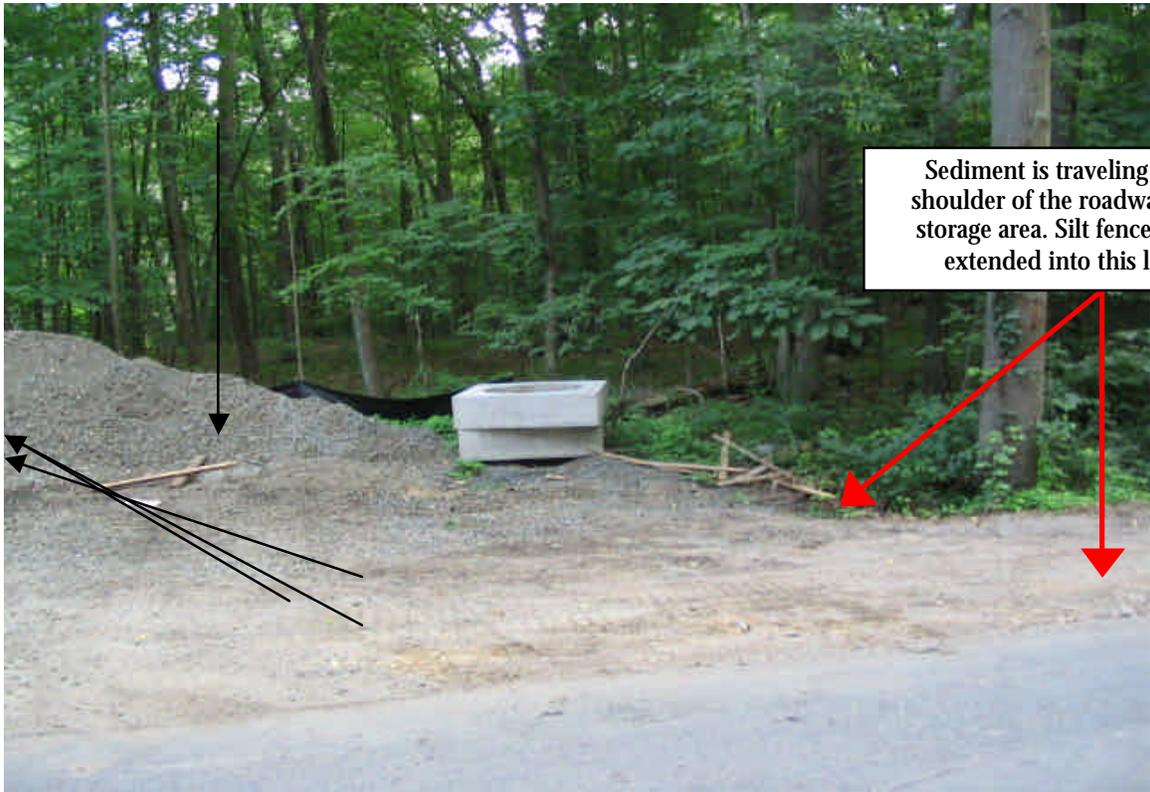
115 kV (Gallows Hill Road, Redding): The storage area at Gallows Hill should have additional silt fence placed up to the roadway edge to prevent sedimentation along the shoulder. 7/21/05

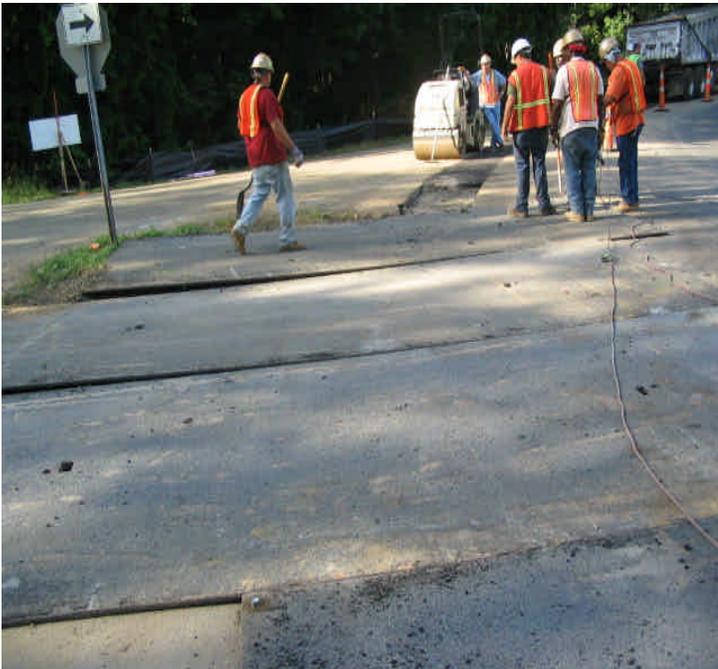
115 kV (Rt. 107, Redding): View of the trenching and conduit installation at the corner of Rt. 107 where it turns to Lonetown Rd. 7/21/05

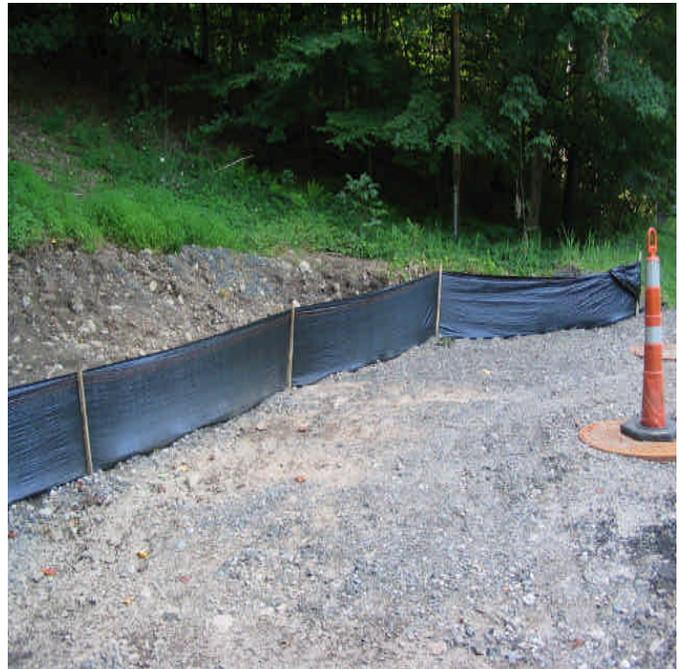
115 kV (Rt. 58, Bethel): Silt fence has been installed at the base of the steep grade by the vault installation. Mulch should be applied. 7/21/05

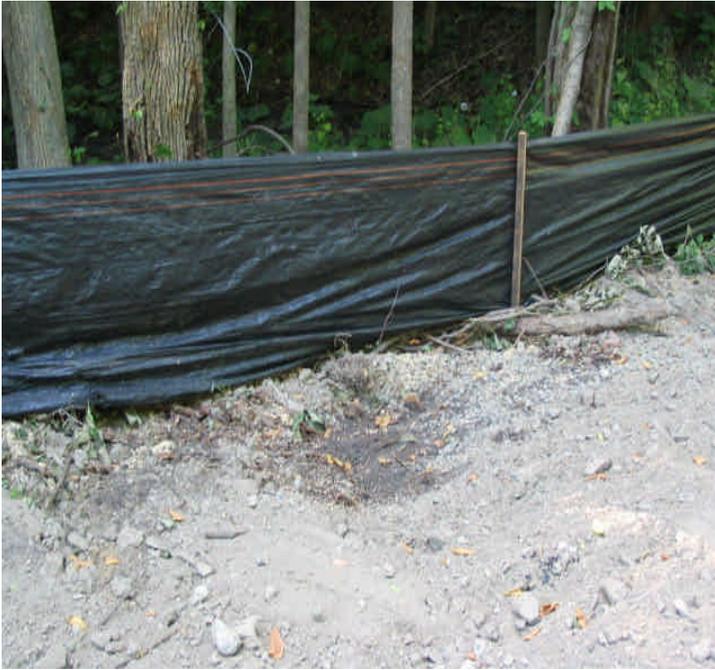
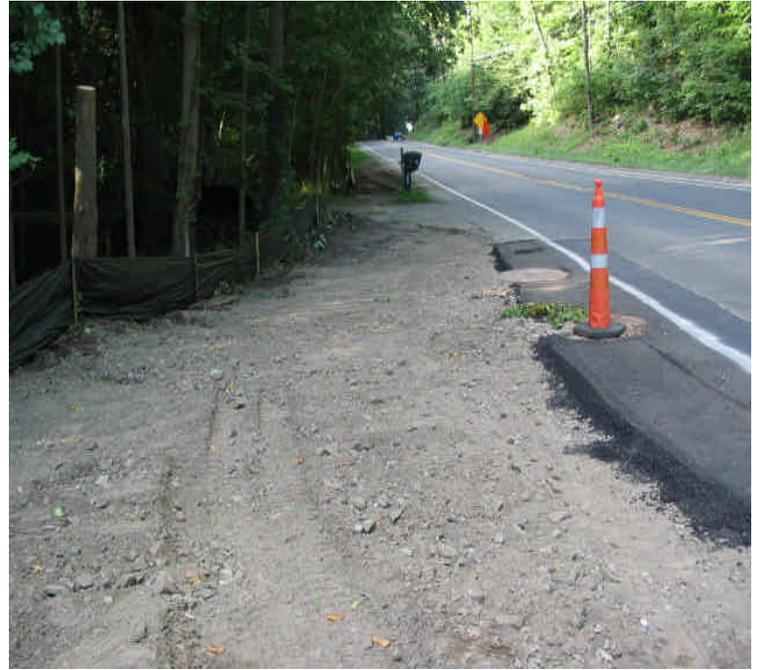
115 kV (Rt. 58, Bethel): View of recent handhole installation near the Sunoco and station 70+14. Bare soil remains and the silt fence is un-toed in several locations. The fence should be repaired until the area is stable. 7/21/05

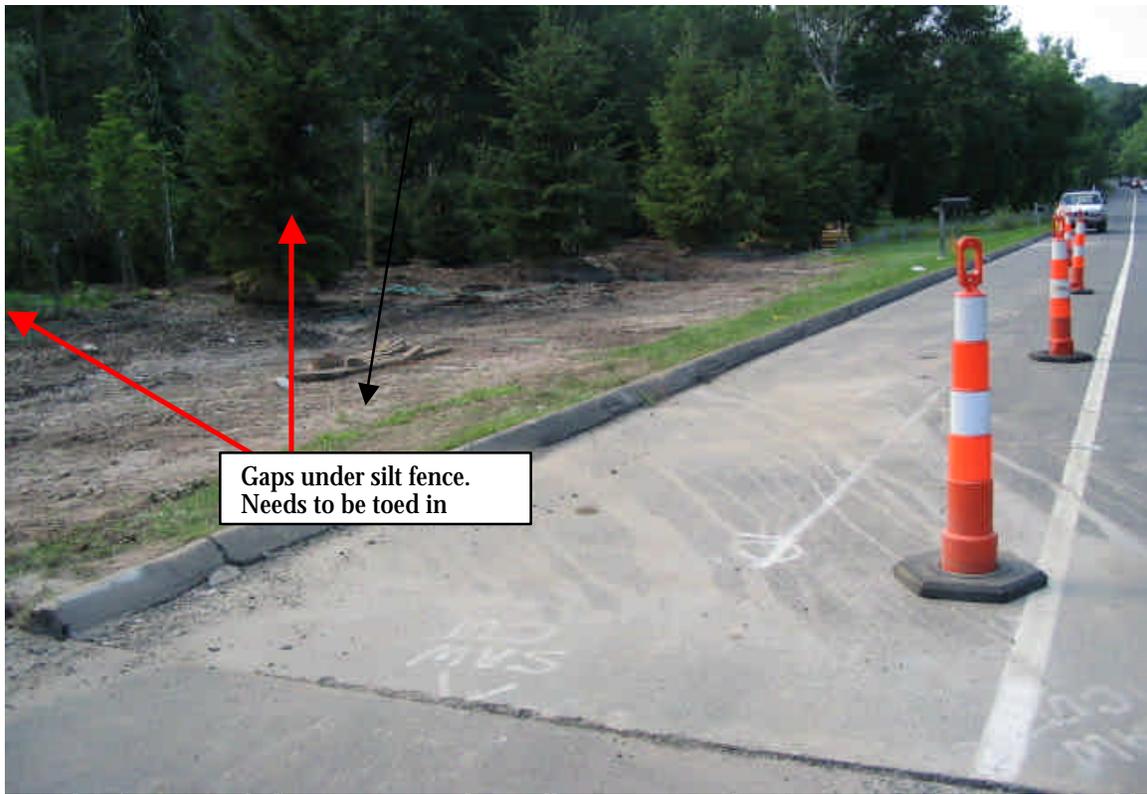
115 kV (Rt. 58, Bethel): Ongoing vault installation near Steck's Nurseries. A check dam should be placed down gradient of the work area to prevent sedimentation. 7/21/05

Areas of Inspection	Observation	Recommended Action
Route 58	<p>- Bare soil at the vault installation near Steck's is well contained for the most part but due to a slight slope here, a check dam installed here would help prevent sedimentation downgradient. 7/21/05</p> <p>- Bare soil and clearing of vegetation was noted at the handhole installation on either side of the driveway at #123. The silt fence here had several areas with gaps underneath. 7/21/05</p> <p>- The completed vault installation by Jacob's Lane had silt fence well installed at the base of the steep grade. 7/21/05</p>	<p>- Place a silt fence or haybale check dam downgradient from any exposed soil if sedimentation becomes an issue. 7/21/05</p> <p>- The silt fence should be toed in ASAP due to wetlands immediately on the other side of the fence. 7/21/05</p> <p>- Mulch could be placed on the bare soil here to provide further stabilization. 7/21/05</p>

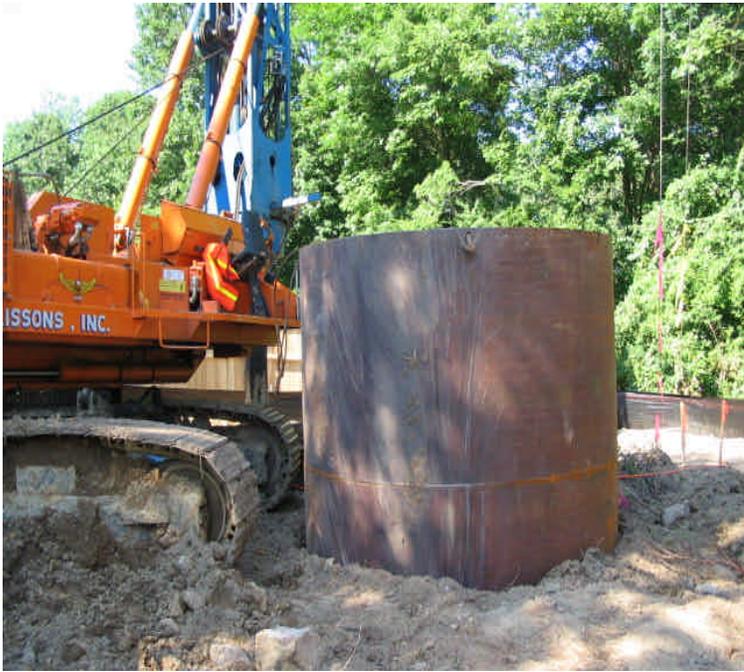
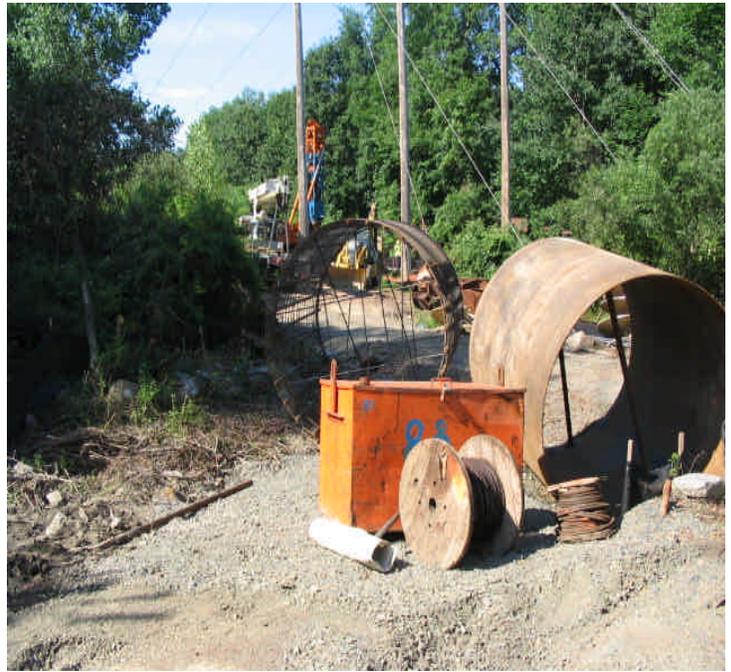
115 kV (Route 58, near Hoyts Hill- Transition Pole): View of the caisson being drilled for placement of the structures and various materials in the work area. 7/21/05

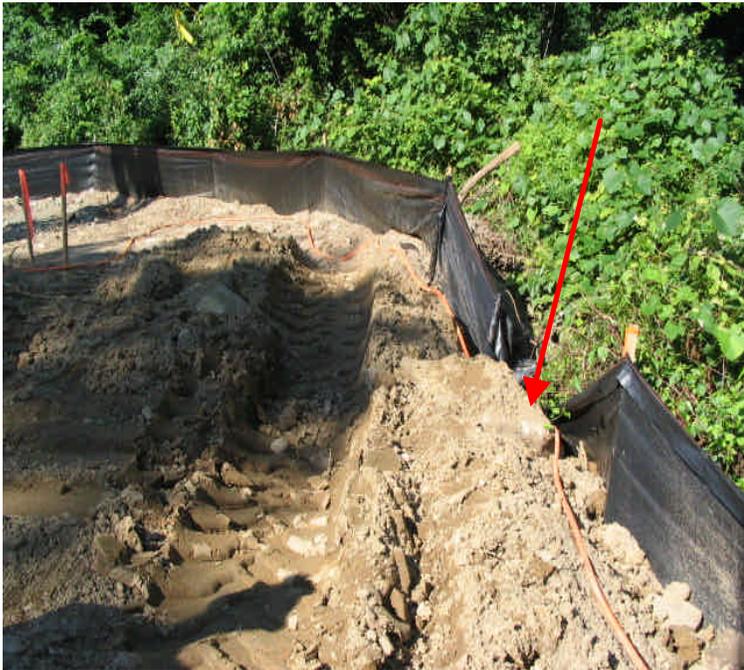
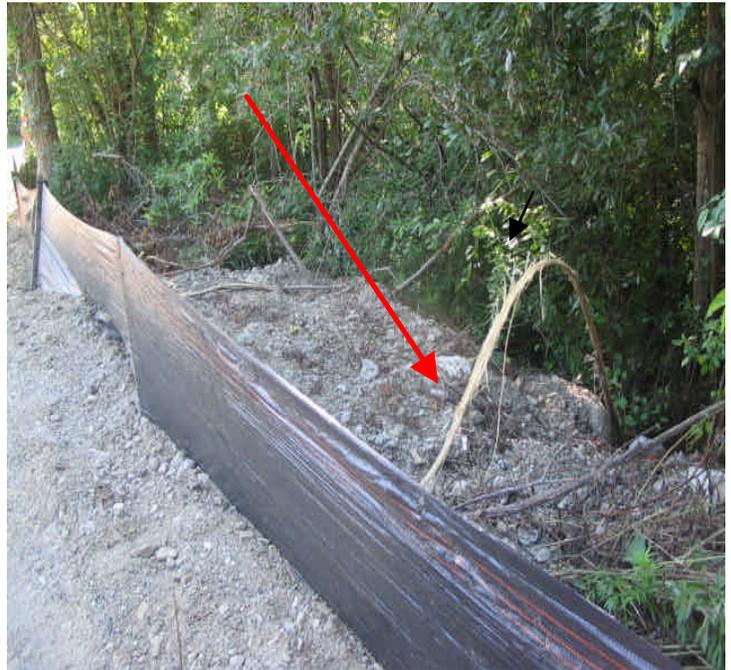
Silt fence along the access road to the transition pole is in need of repair and toeing-in in various locations. The left hand photo shows fence overtopped near the caisson and the right hand picture shows sediment placed beyond the fence. 7/21/05

<p>Hoyts Hill Transition Structure (Off Rt. 58)</p>	<p>- Silt fence requires repair/toeing-in at several locations along the access road. A piece of silt fence was placed appropriately at a stormwater inlet. 7/21/05</p> <p>A small amount of sand/gravel is beyond the fence in several locations along the road.7/21/05</p> <p>- The caisson is being drilled and materials are being stored in the vicinity. Silt fence was also overtopped here in one spot. 7/21/05</p> <p>- The mulch/wood chips were not removed completely from the wetland area off the access road and brush was also observed here. 7/21/05</p>	<p>- Maintain silt fence where necessary. 7/21/05</p> <p>-Either pull sediment back or extend the fence where material is placed beyond. 7/21/05</p> <p>- Maintain silt fence near the drilling. 7/21/05</p> <p>- The D&M plan states that brush and clearing materials should not be placed in wetland areas. The chips and brush should be removed by hand. 7/21/05</p>

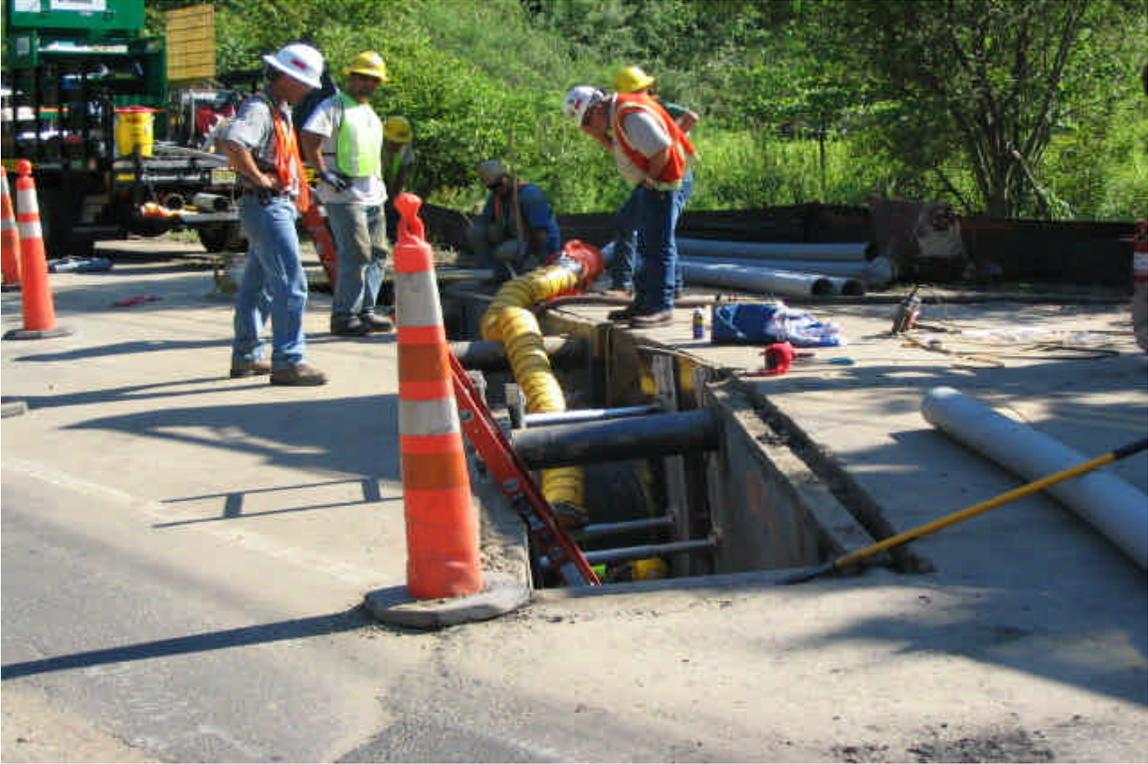
115kV (Route 58, Bethel near Hoyts Hill) View of trenching and conduit installation across Rt. 58 leading to the transition structure from the transition station. 7/21/05

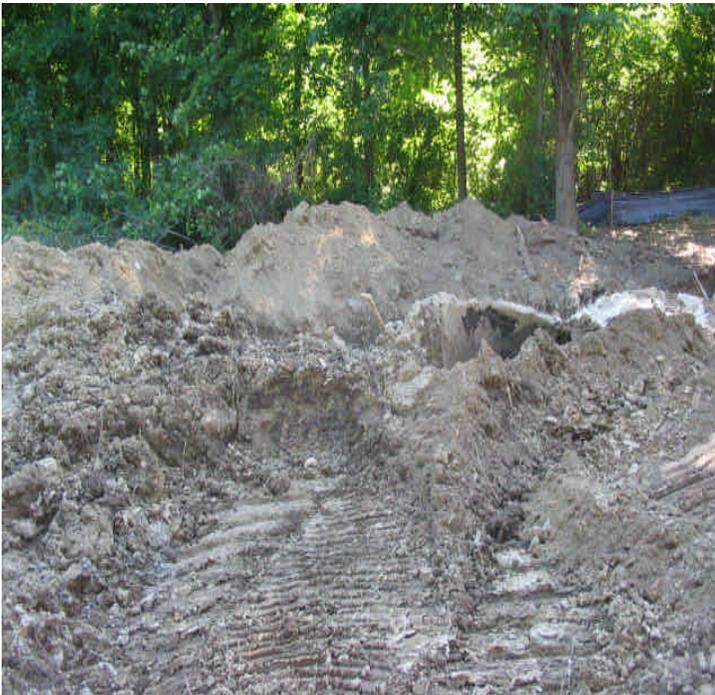
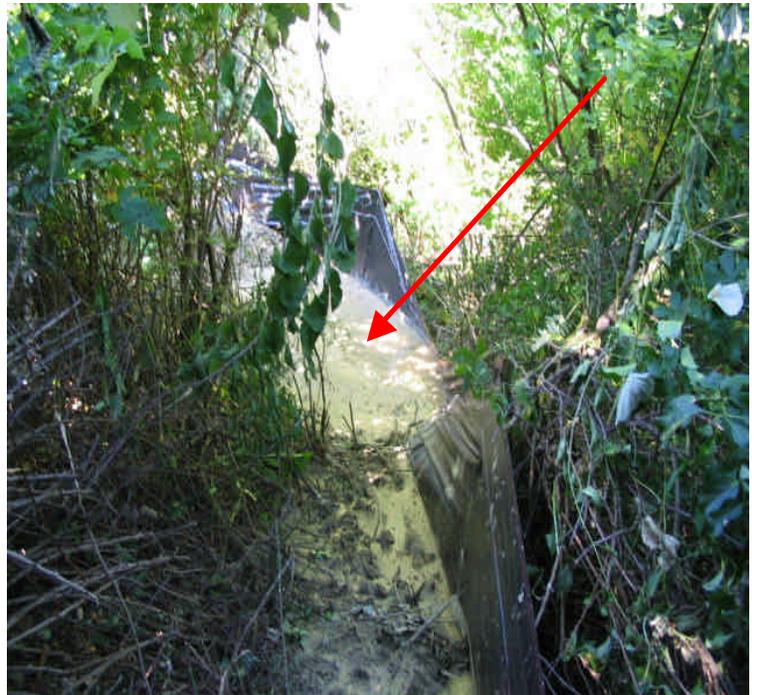
115kV (Bethel Education Park) Excavation area for the transition structure at the end of the ROW. A large amount of soil is exposed here and sediment has run and almost overtopped the silt fence below. It should be repaired ASAP and reinforced with haybales. 7/21/05

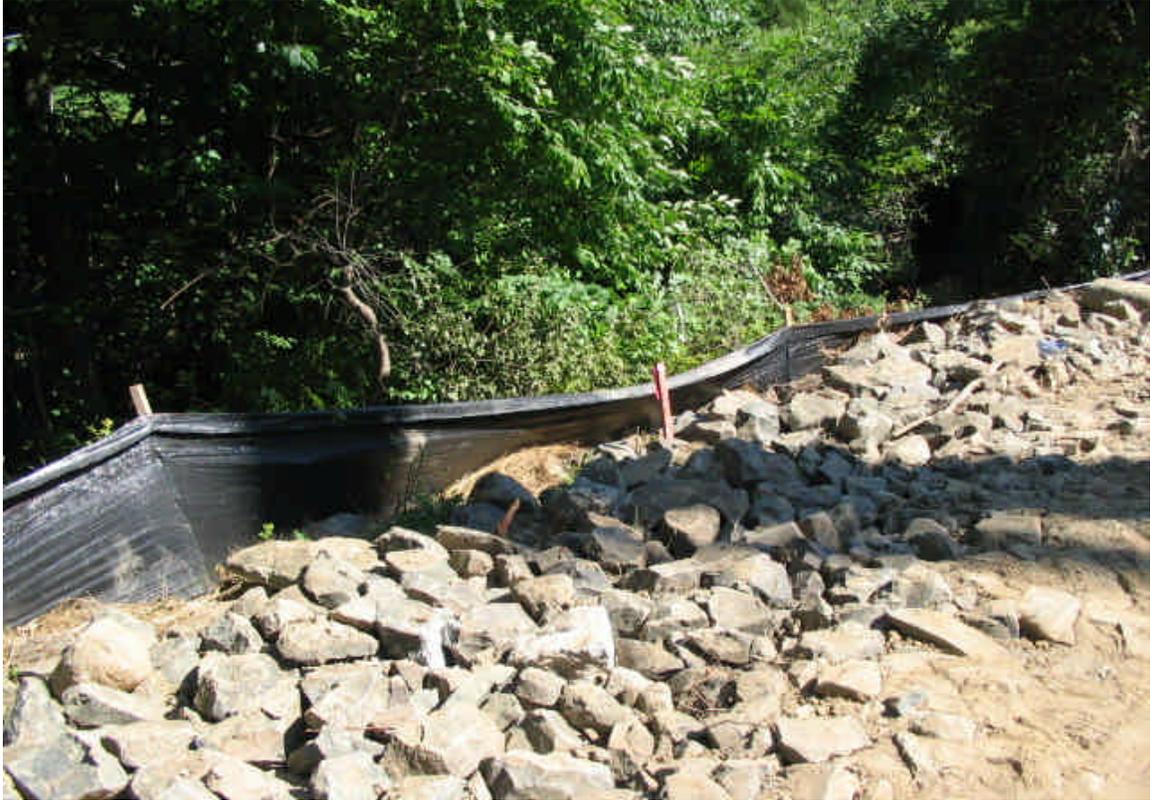
The fence beyond the riprap area has not been toed-in and a steep slope and wetland is located beyond the ROW. A large amount of run-off appears to flow here during storms so the fence should be reinforced. 7/21/05

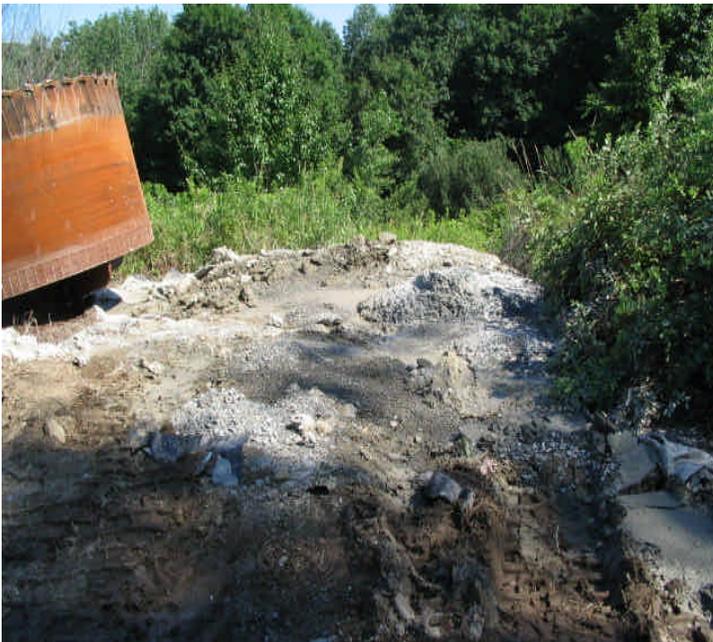
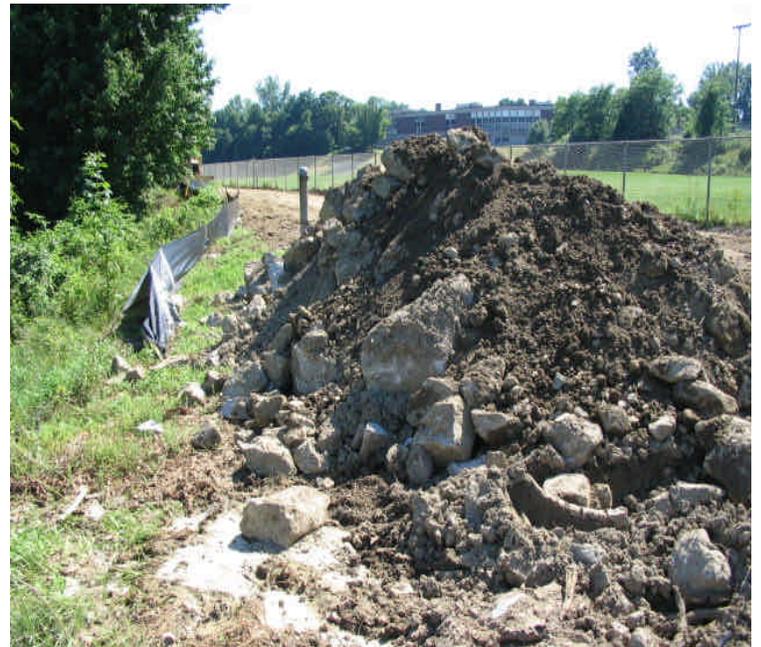
View of a concrete washout on the left and a soil stockpile on the right. The pile is not located within the silt fence at the edge of the ROW near Bethel Middle School. The concrete should not have been placed here. 7/21/05

Blasting	<p>- No blasting is occurring in any areas at this time.</p>	<p>- None at this time.</p>
Spills and Material Storage	<p>- Two areas of concrete washouts were noted on the ROW at the Bethel Ed. Park. One at the edge of the ROW near the Middle School. Some water had apparently washed partially downhill here. The second was near the far caisson/structure installation. 7/21/05</p> <p>-Leaks were not noted from the machinery during this inspection. A report of any leaks or spills that reach the ground and occur during the week will be provided to BSC from internal project inspectors 6/15-7/21/05</p> <p>- Catch basins should also be protected with fabric especially in</p>	<p>-So far, concrete washouts have been restricted to designated areas. This should be sure to continue. 7/21/05</p> <p>- Equipment and materials should not be stored in wooded areas unless it is designated for storage. 7/21/05</p> <p>- The contractors should remain vigilant about securing and handling fuel containers. Continue to keep all vehicles maintained well (i.e. no apparent fluid leaks) if they will be used or stored on site. Check equipment status on a regular basis and keep spill</p>

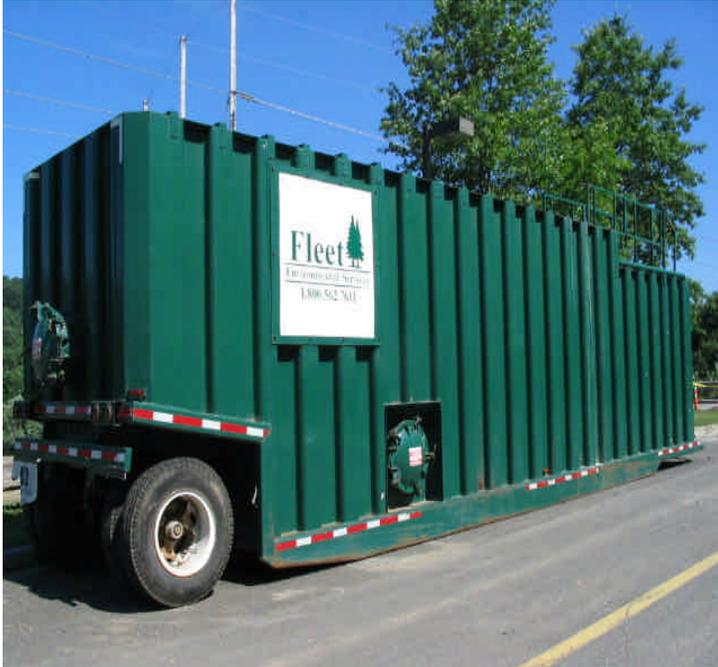
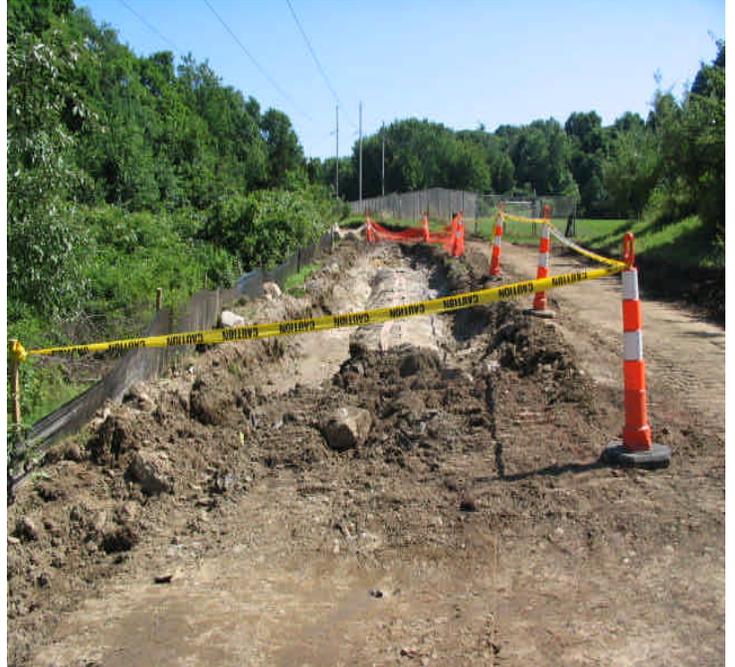
View of the frac tank for holding dewatering discharge on the left and a view of the ROW and conduit installation near Bethel Middle School on the right. 7/21/05

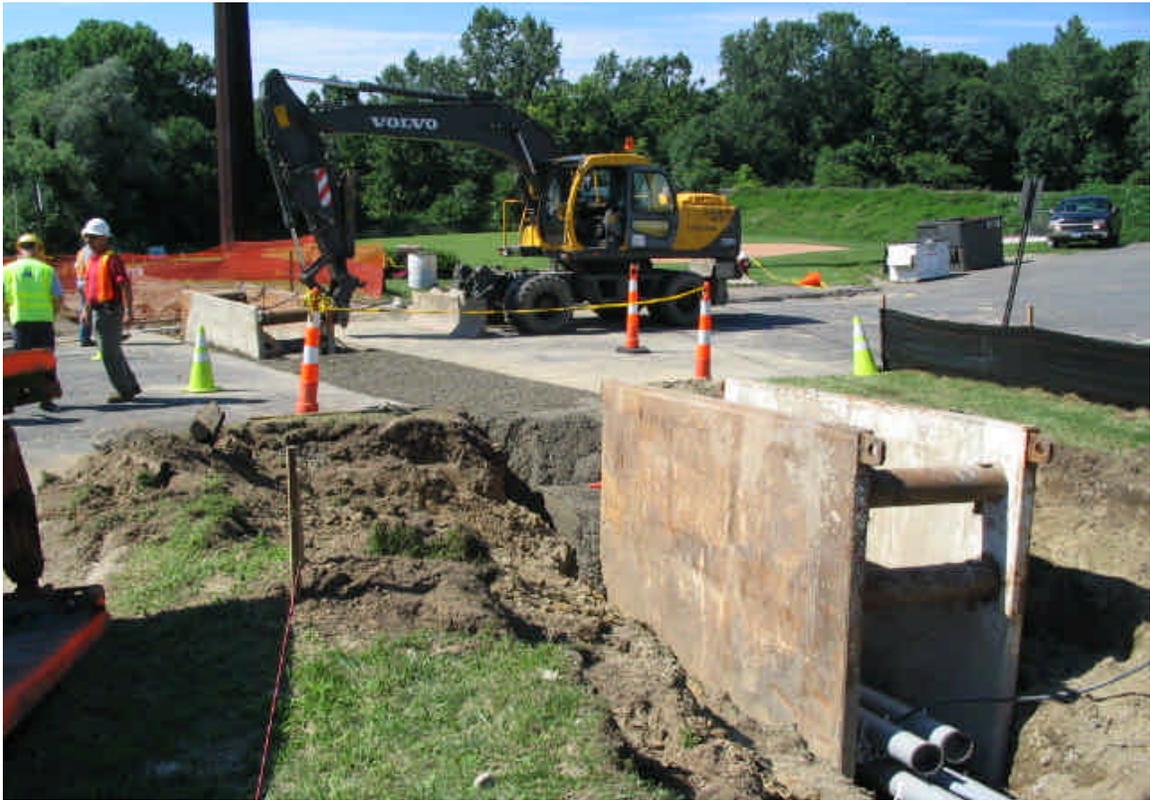
View of the conduit installation crossing the drive and into the lawn in front of the RT Johnson school.

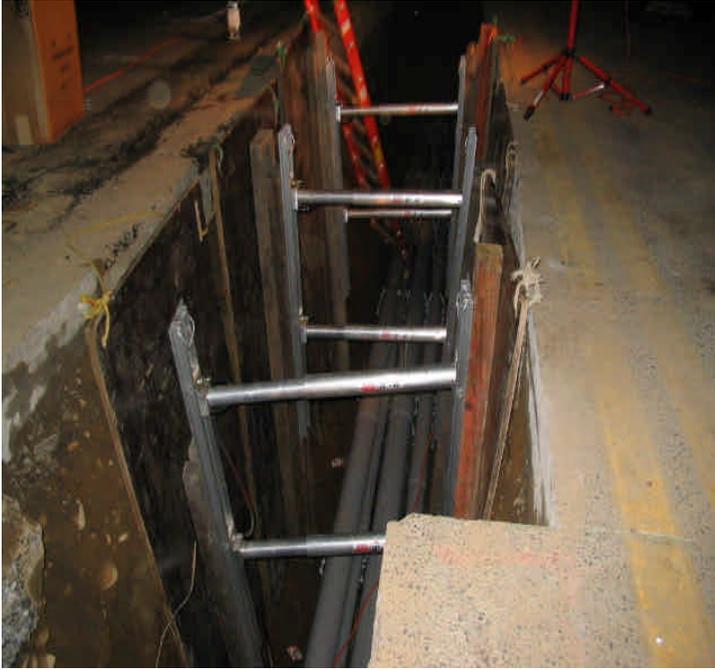
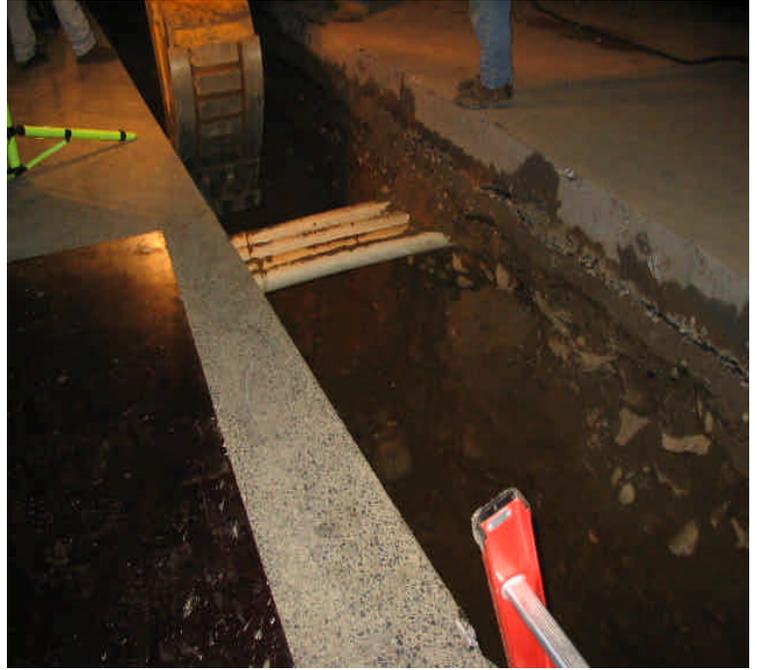
115kV (Route 7, Norwalk): View of the trenching and conduit installation during the night work on Rt. 7. 7/22/05

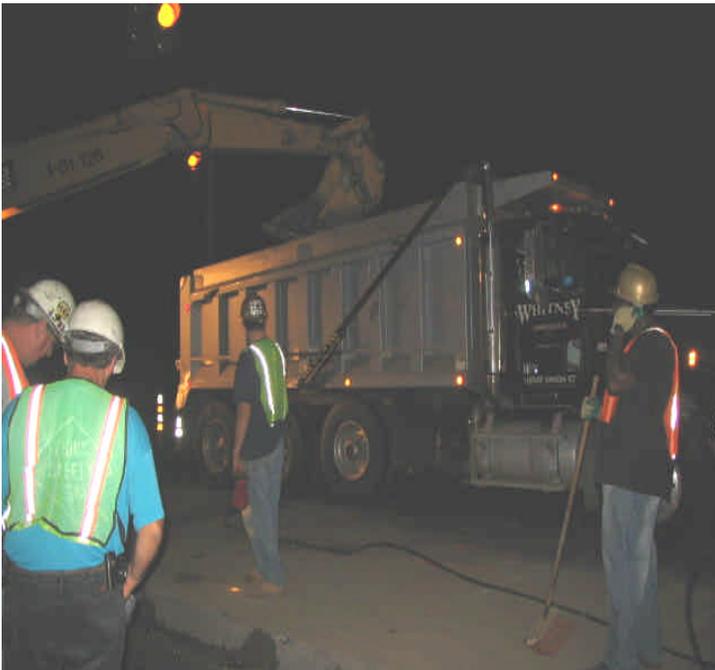
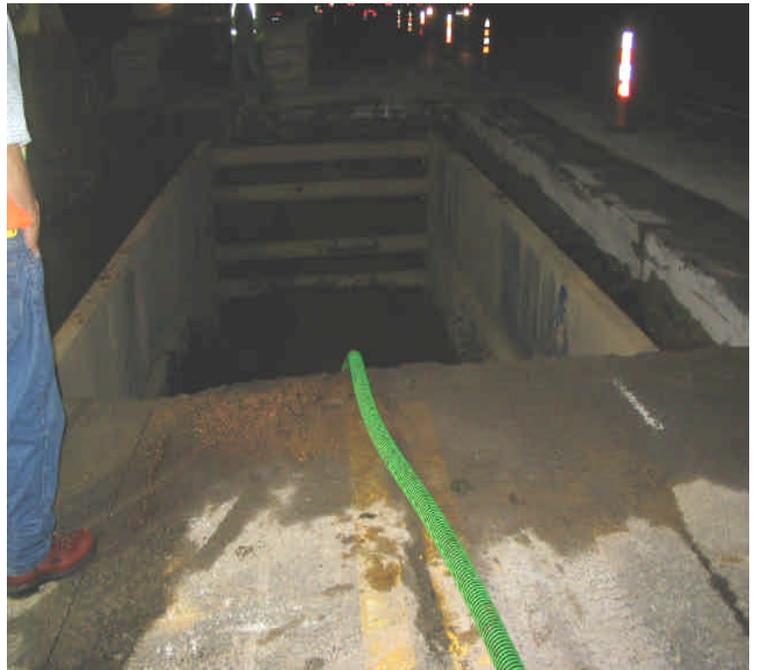
View of excavate from the trench being loaded and trucked away on the left and an ongoing vault installation on the left. Dewatering from the vault was being directed to a frac truck. 7/22/05

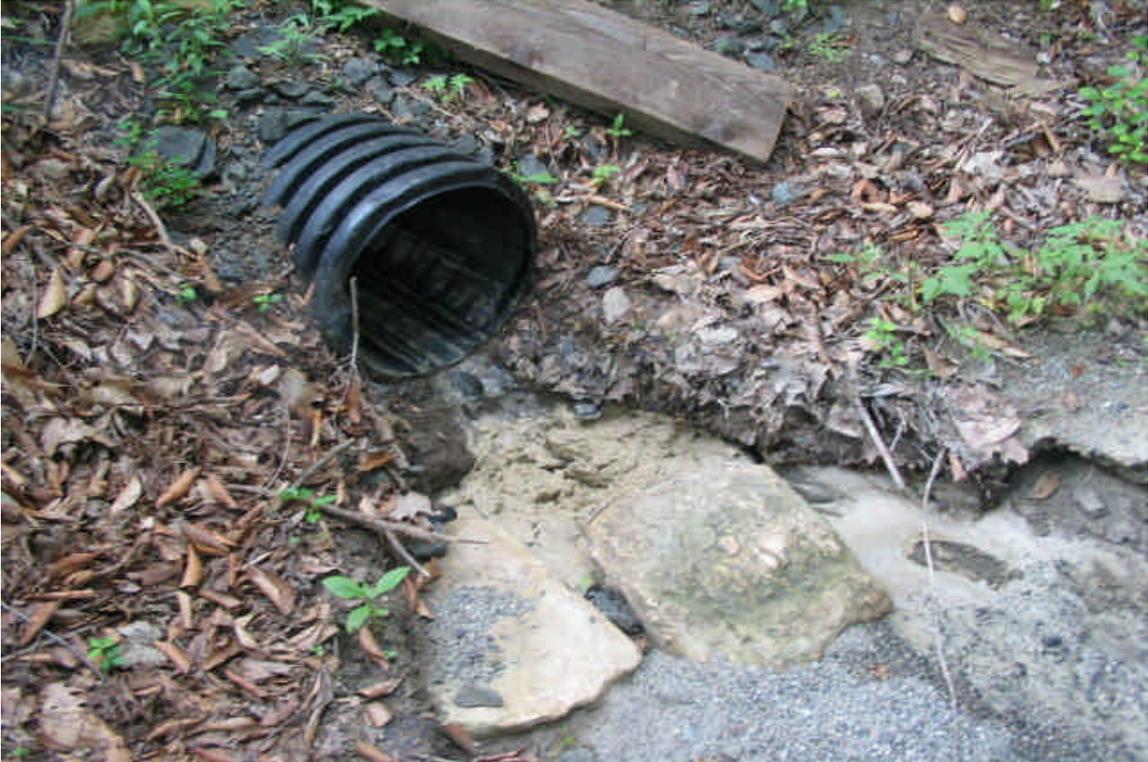
Areas of Inspection	Observation	Recommended Action
	<p>for disposal in the O&G facility in Bridgeport or the Redding landfill. 7/22/05</p> <p>- Concrete washouts are also taking place within the Redding yard in a specified location but daily amounts of concrete appear to be overwhelming the area once again. Water from the bin was again noted entering a catch basin in the yard. A discharge pipe was located in the woods several feet from wetlands and a stream. It appeared that some sediment had already entered the stream over time. 7/21/05</p> <p>Concrete washouts for Rt. 7 are directed to a corral placed near the Merritt Parkway ramps at an O&G work area. 7/21/05</p> <p>- An equipment storage area for the Putnam Park area materials is located at a pull-off on Route 58 just north of the Rt. 107 intersection. 7/14/05</p> <p>- A storage area for materials, conduit and equipment is in use at the Bethel Educational Park near the RTJ School. 7/6-7/21/05</p>	<p>should be placed down-gradient of the pile unless this is in the way of active equipment movement. 7/21/05</p> <p>- O&G was consulted and they will be extending the berm and placing signage to reduce excessive water use here. They will also install a corral within the woods below the discharge pipe as an accidental overflow area. The bin should be continue to be emptied regularly to prevent escape of the wash water. 7/21/05</p> <p>- None at this time 7/21/05</p> <p>- None at this time 7/21/05</p> <p>- None at this time- well contained. 7/21/05</p>

115kV (Redding Town Yard). Concrete washout water was escaping past the berm and entering a catch basin in the yard. A discharge pipe was identified in the adjacent woods. 7/21/05

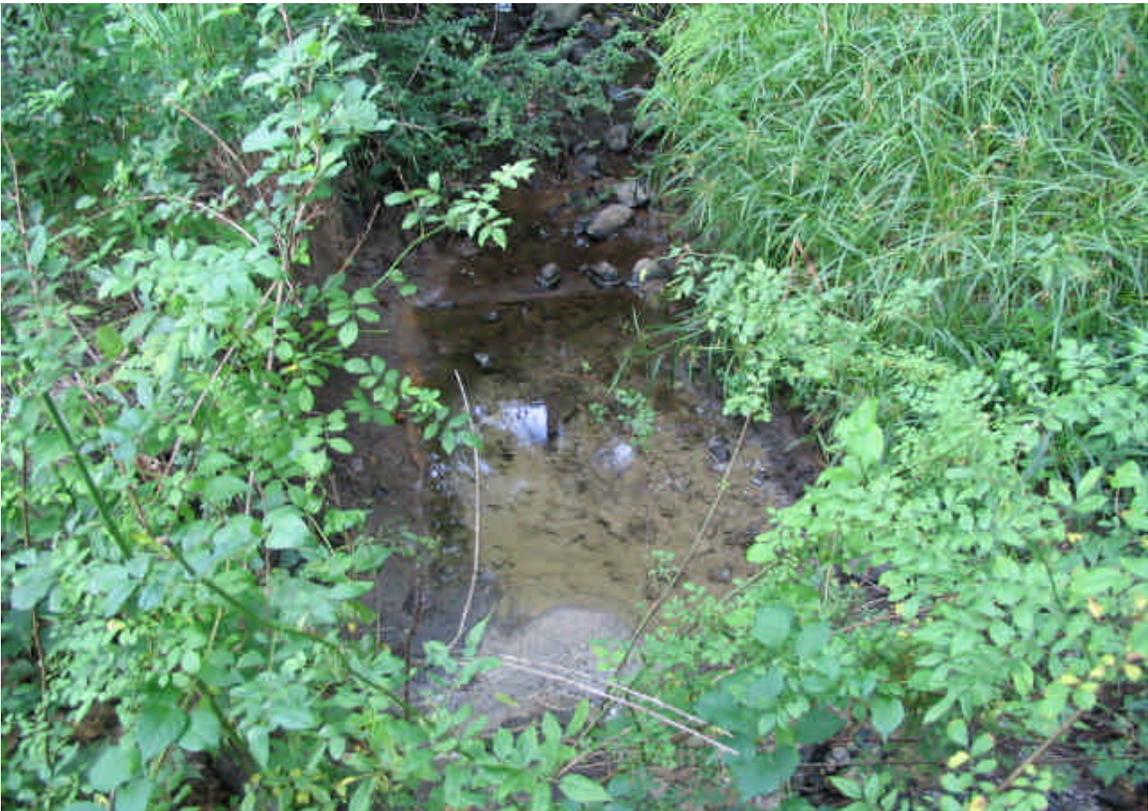
Some fine sedimentation was noticeable in the adjacent stream bed for several feet downstream. 7/21/05
