Docket No. 217 – Development and Management Plan Inspection

Northeast Utilities Service Company Certificate of Environmental Compatibility and Public Need for the construction of a 345-kV electric transmission line and reconstruction of an existing 115-kV electric transmission line between Connecticut Light and Power Company's Plumtree Substation in Bethel, through the towns of Redding, Weston, and Wilton, and to the Norwalk Substation in Norwalk, Connecticut.

Date: August 4, 2005

Location: 115 kV Underground Route

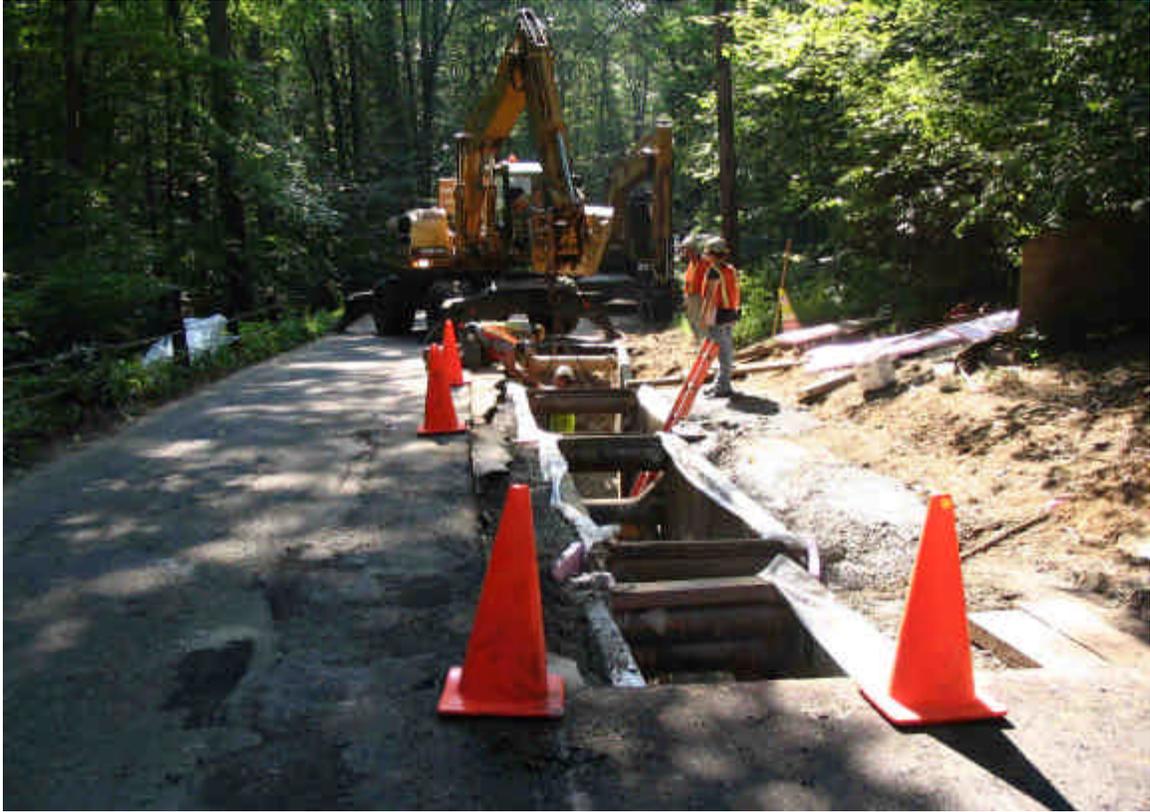
115 kV (Gallows Hill Rd): View of the trench work up near #116 Gallows Hill. 8/4/05

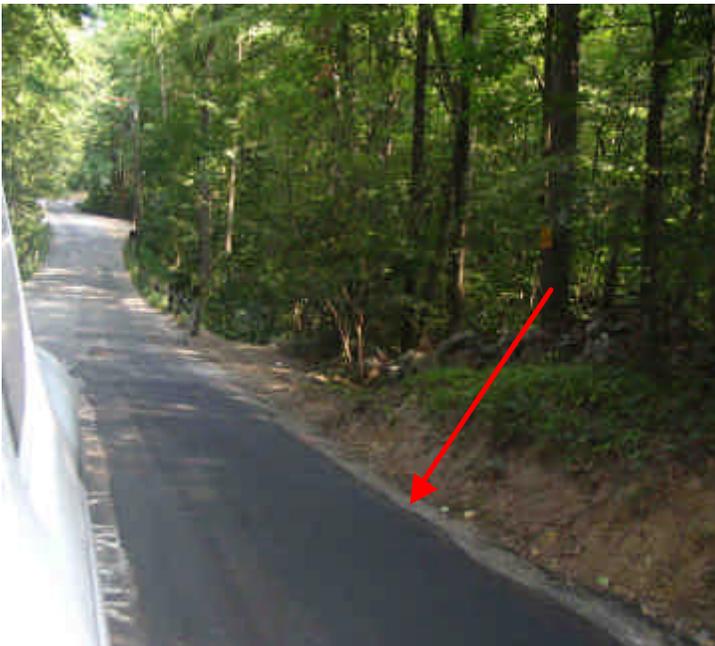
Photo on the left: View of dried sediment tracking from a recent work area down the slope of the road. Crews on all parts of the job need to be aware of controlling these sediments. Photo on the right shows the recommended silt fence extension has been made near the storage area. 8/4/05

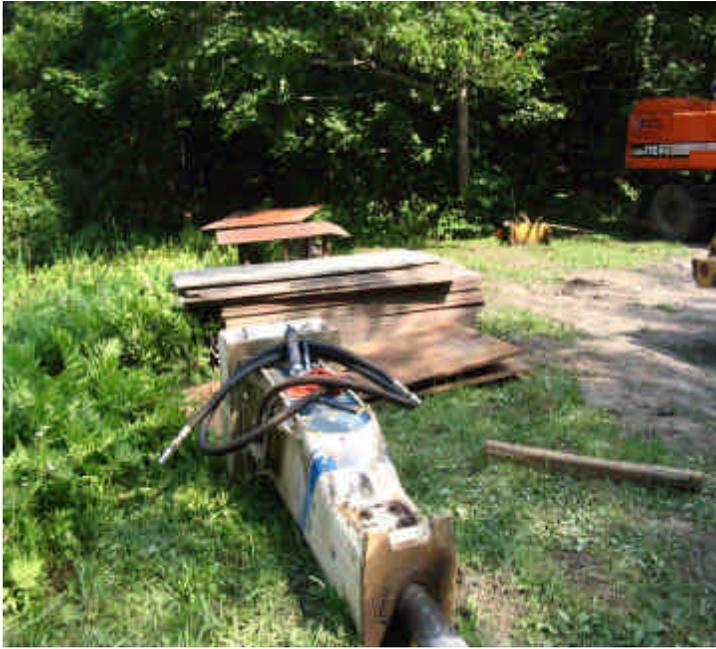
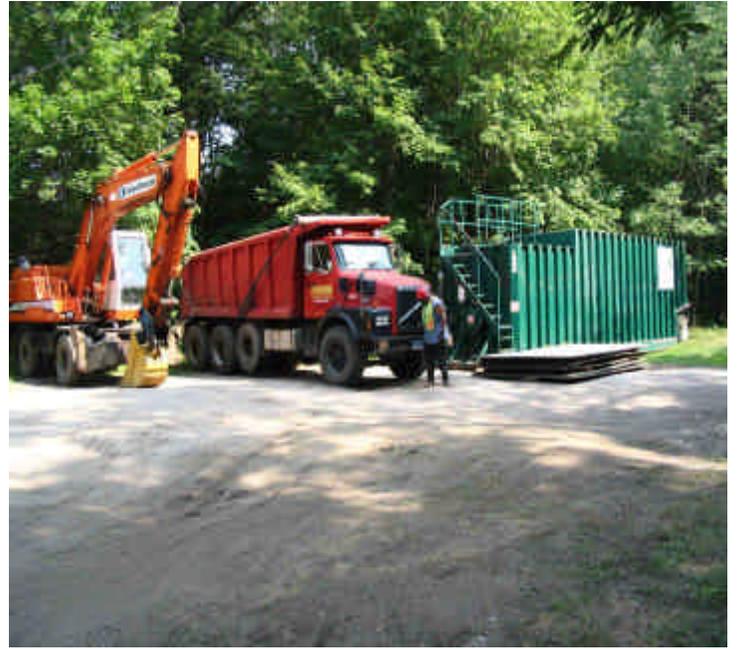
115 kV (Route 58 near Putnam Park): Another parking storage area was noted and is being utilized by Mather (subcontractor). Materials are being stored too close to the wetland with no silt fence in place as a limit of work 8/4/05

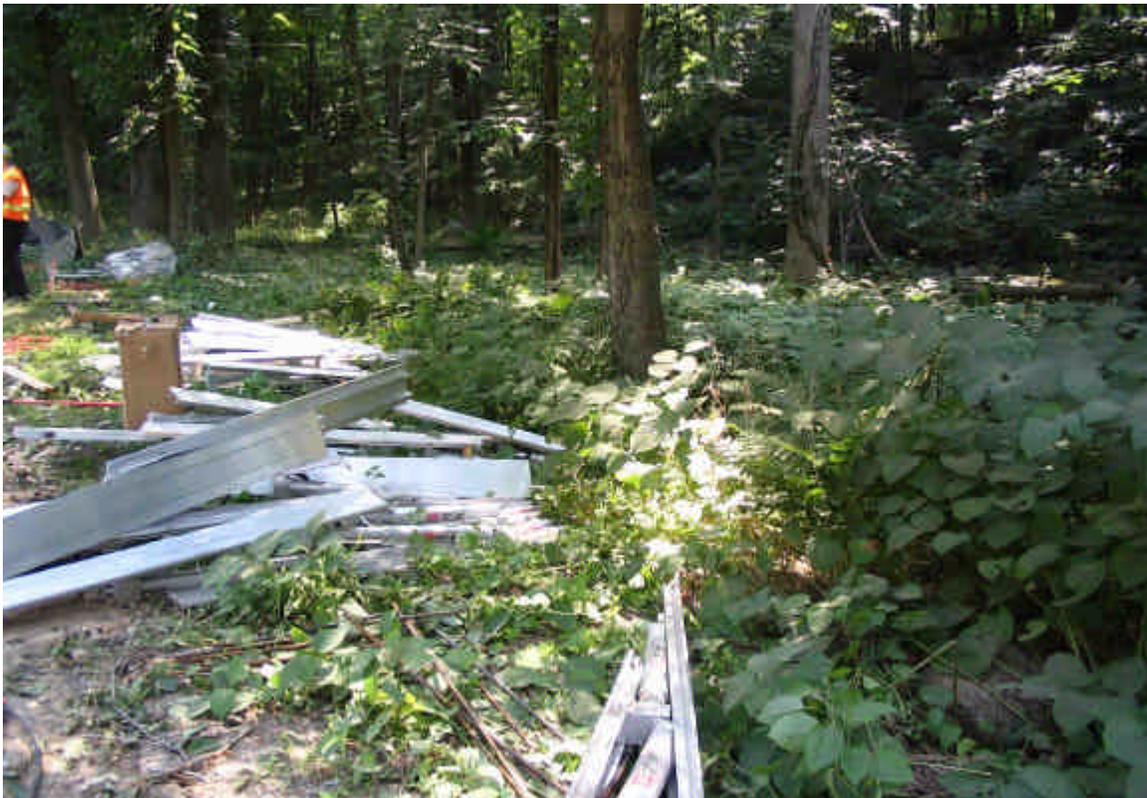
115 kV (Route 58 north of Handhole 4): Silt fence along this stretch of active work needs repair or toeing-in in several locations. Silt fence needs to be extended here as the wetland continues beyond. 8/4/05

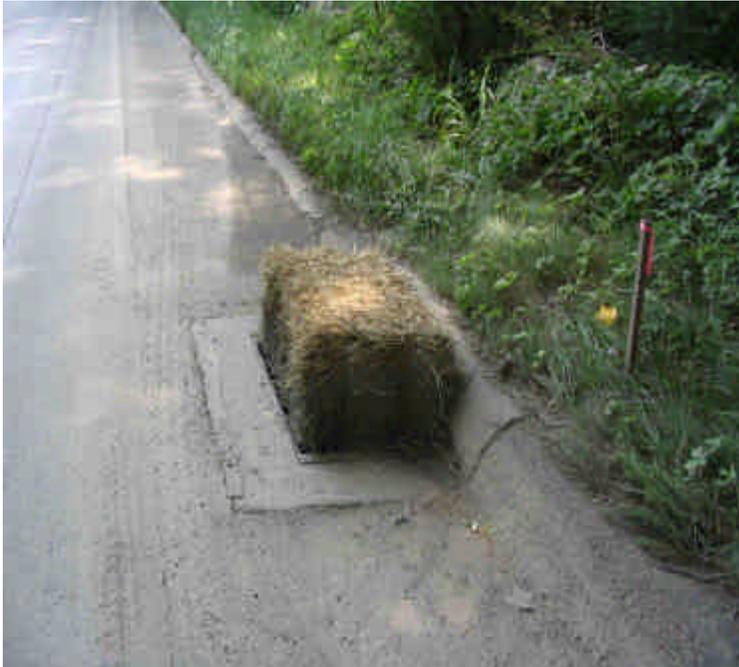
115 kV (Route 58): Efforts have been made to protect some catch basins but it would be best with either a “frame” of haybales or filter fabric. In the photo on right, dried sediment tracks were heading to an unprotected catch basin north of Steck’s. 8/4/05

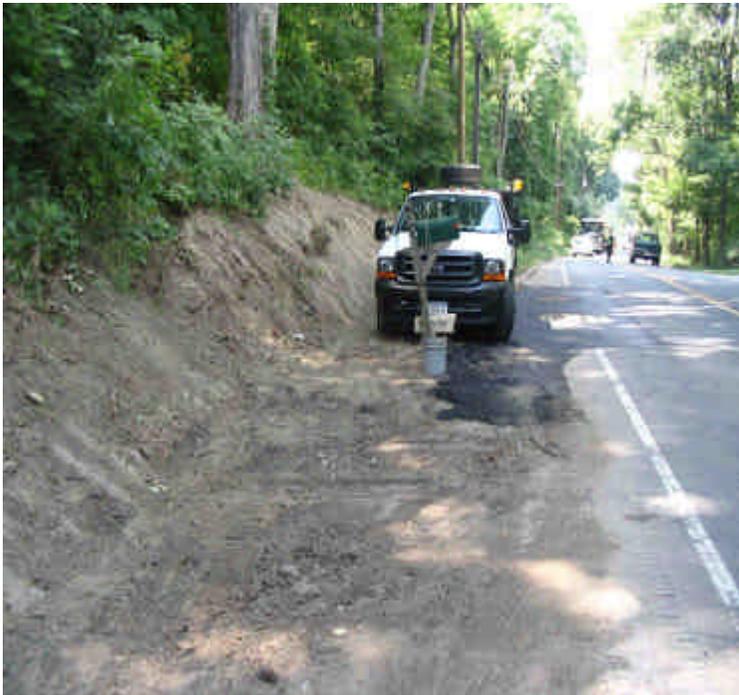
115kV (Route 58) A bank cut and clearing were necessary for a handhole installation near Sunset Hill Rd. (photo on left). The foundation for the transition structure at Hoyts Hill Rd. still has downed silt fence adjacent. (photo on right). 8/4/05

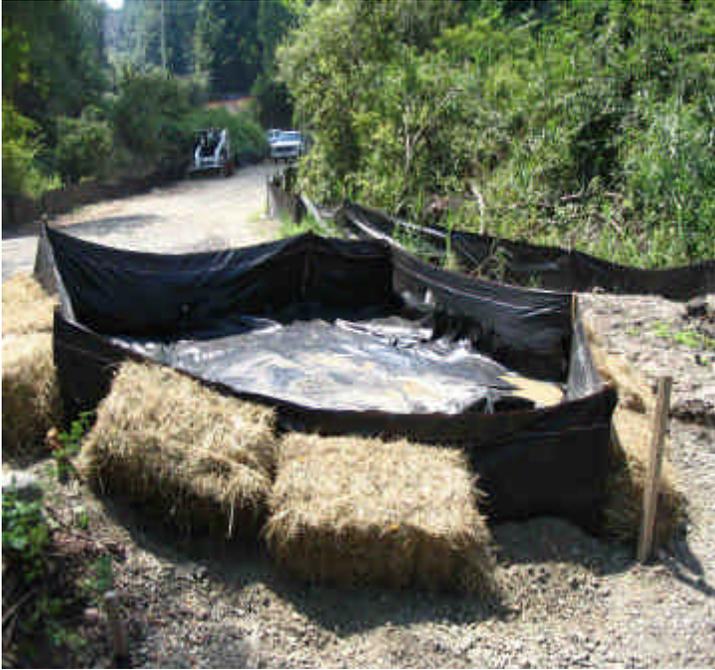
115 kV (Route 58, near Hoyts Hill- Transition Pole): A new concrete washout station was constructed here and concrete trucks were actively using it. (photo on left). A concrete washout appeared to have taken place which likely led to the construction of the corral (photo on right). 8/4/05

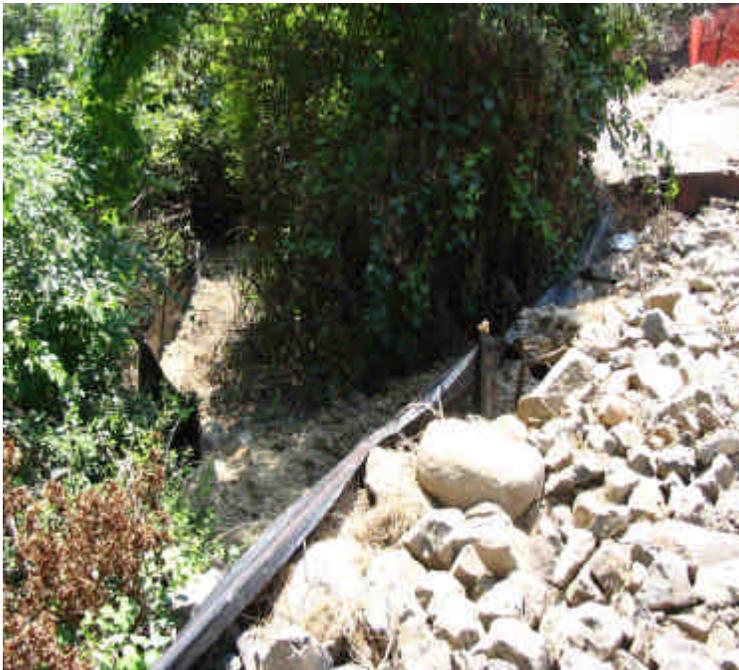
115kV (Bethel Education Park) View of area near the southern caisson drilling that needs extension of the silt fence. Sediment needs to be pulled back from the fence here. (photo on left) View of active work along the ROW with a portion of silt fence down (photo on right). 8/4/05

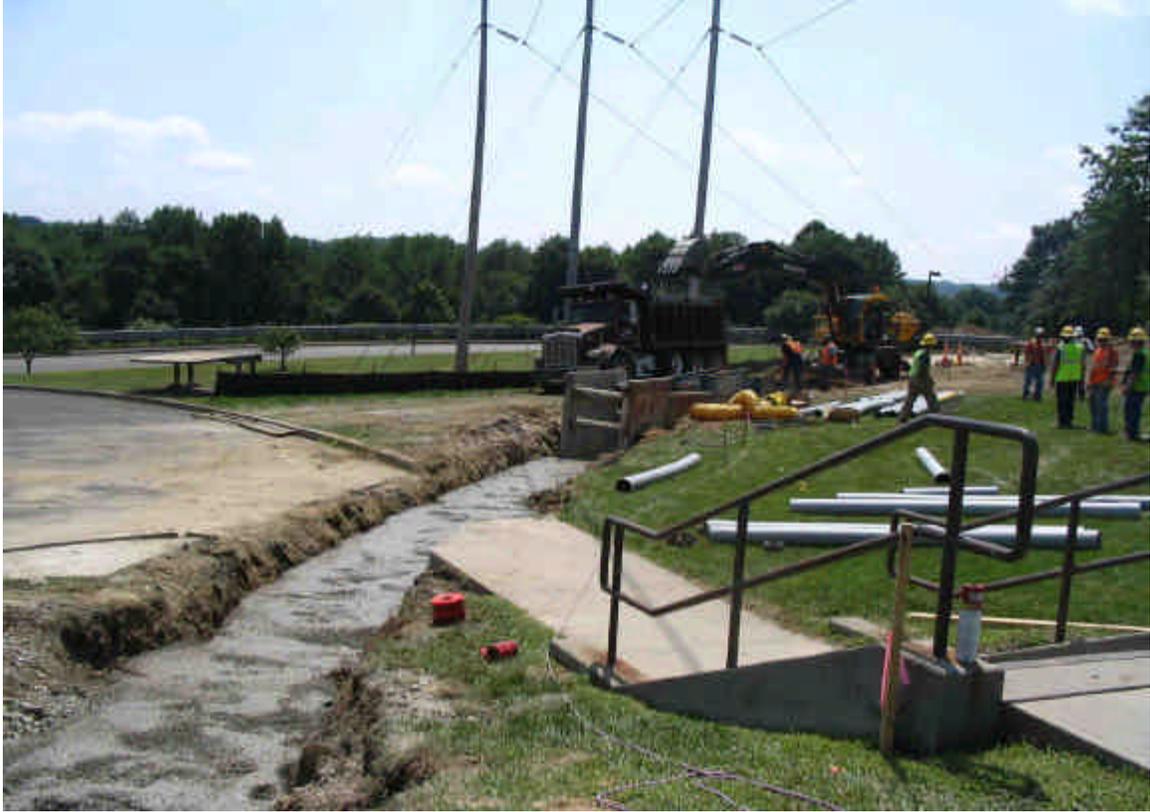
View of the work crossing the school yard out in front of Bethel Middle School. 8/4/05

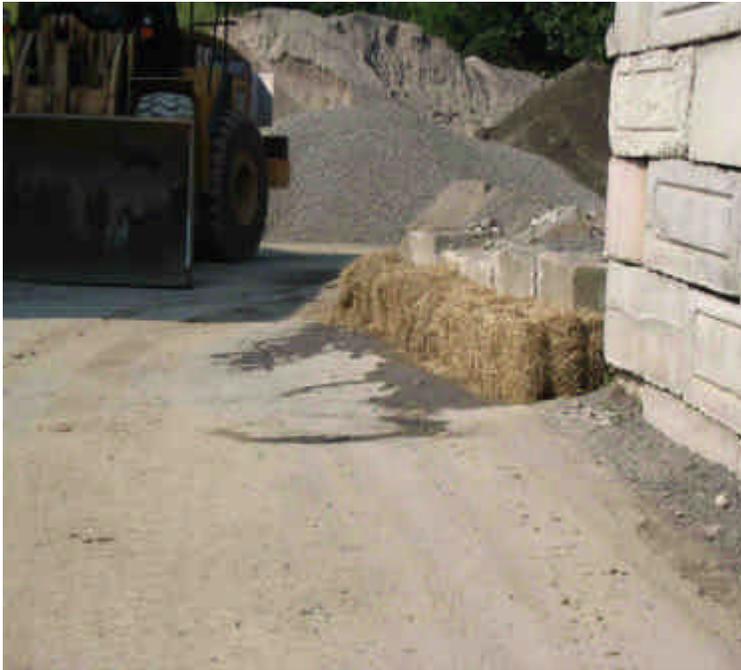
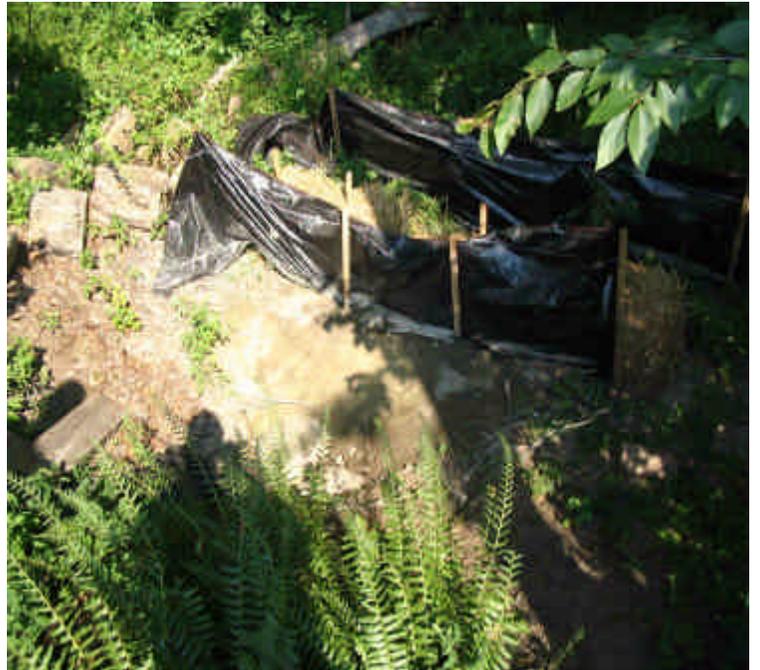
115kV (Redding Town Yard): Attempts have been made to control the concrete washout station. Haybales were placed along the outside of the berm and check dams were placed at the catch basin outlet. 8/4/05
