Docket No. 217 – Development and Management Plan Inspection

Northeast Utilities Service Company Certificate of Environmental Compatibility and Public Need for the construction of a 345-kV electric transmission line and reconstruction of an existing 115-kV electric transmission line between Connecticut Light and Power Company’s Plumtree Substation in Bethel, through the towns of Redding, Weston, and Wilton, and to the Norwalk Substation in Norwalk, Connecticut.

Date: August 18 and 19, 2005

Location: 115 kV Underground Route

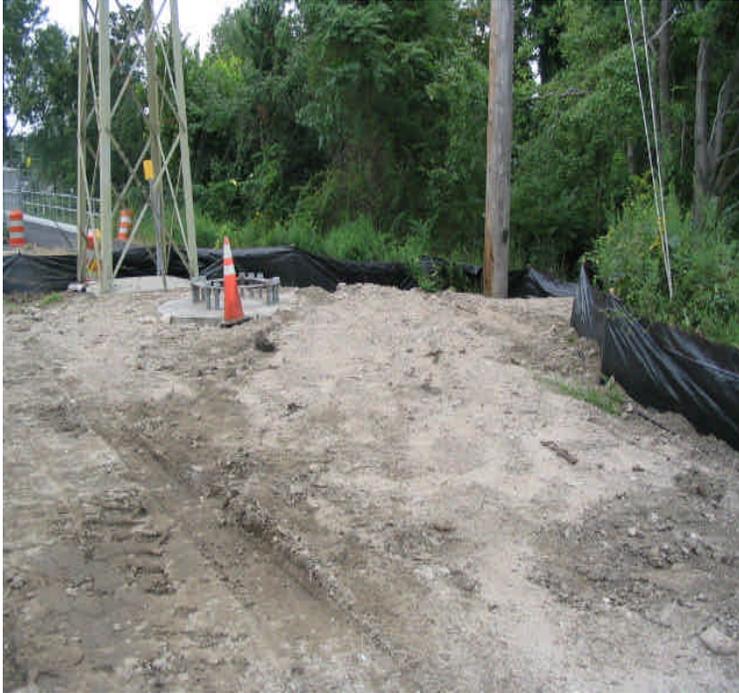
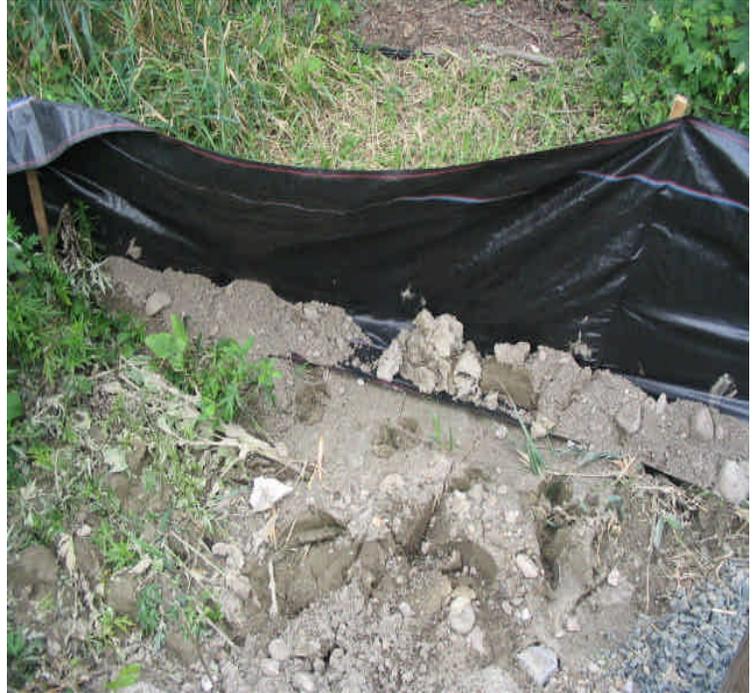
115 kV (Broad Street and ROW): The silt fence was repaired near the Norwalk Substation on the ROW as recommended but some areas were not appropriately toed in. 8/19/05

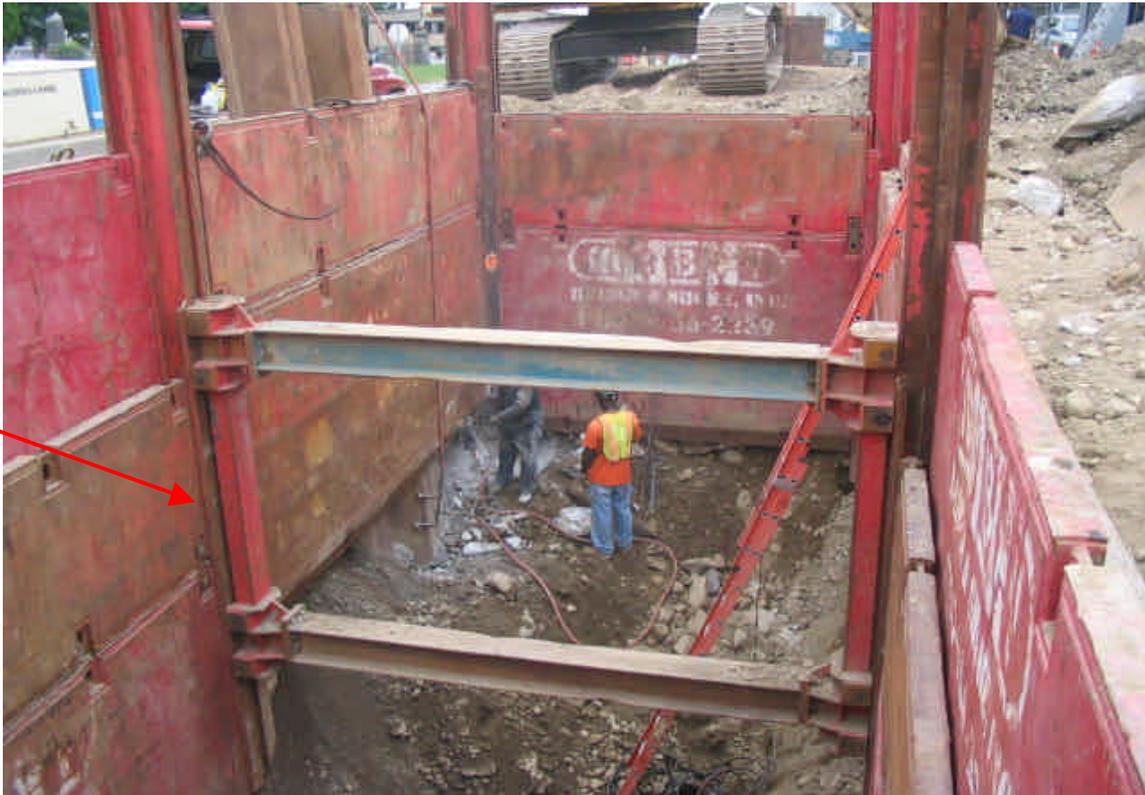
View of the jacking pit in preparation for the jack and bore under the railroad on Broad Street. All excavate has been trucked away and the pit is well shored. 8/19/05

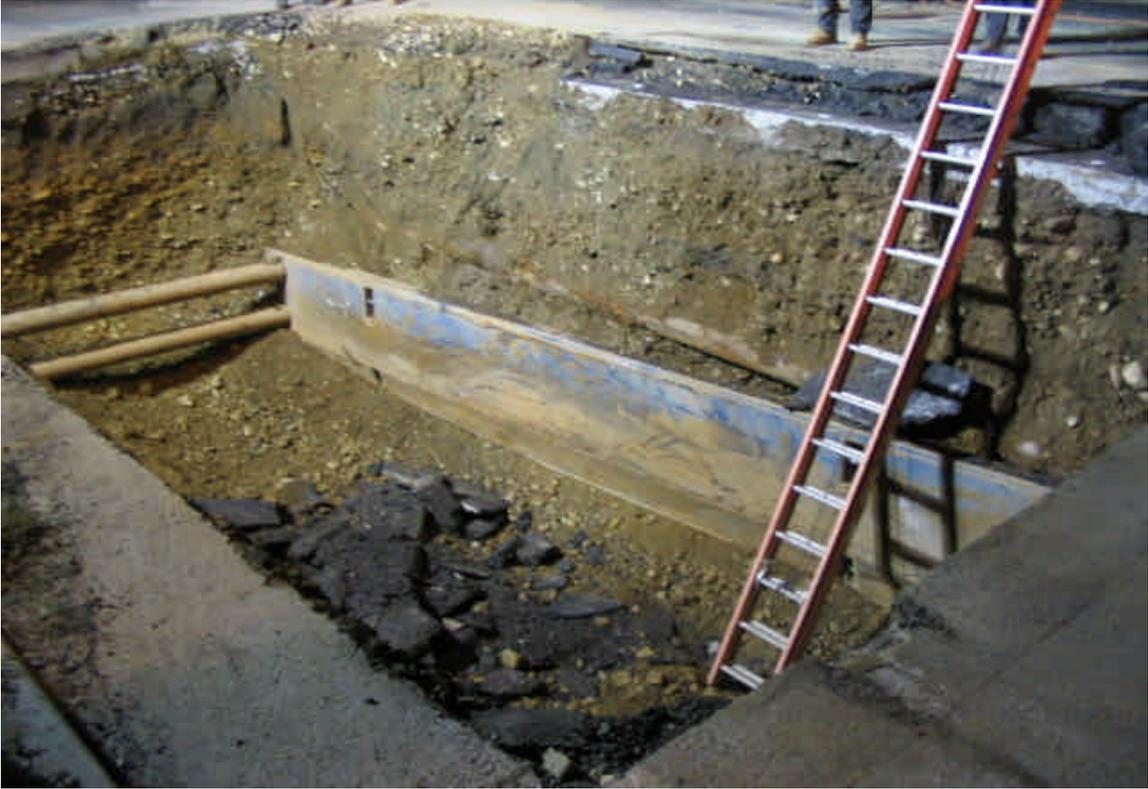
115 kV (Rt. 7 Nightwork): View of vault installation along Rt. 7. A partially exposed water main had to be supported before work could continue. 8/19/05

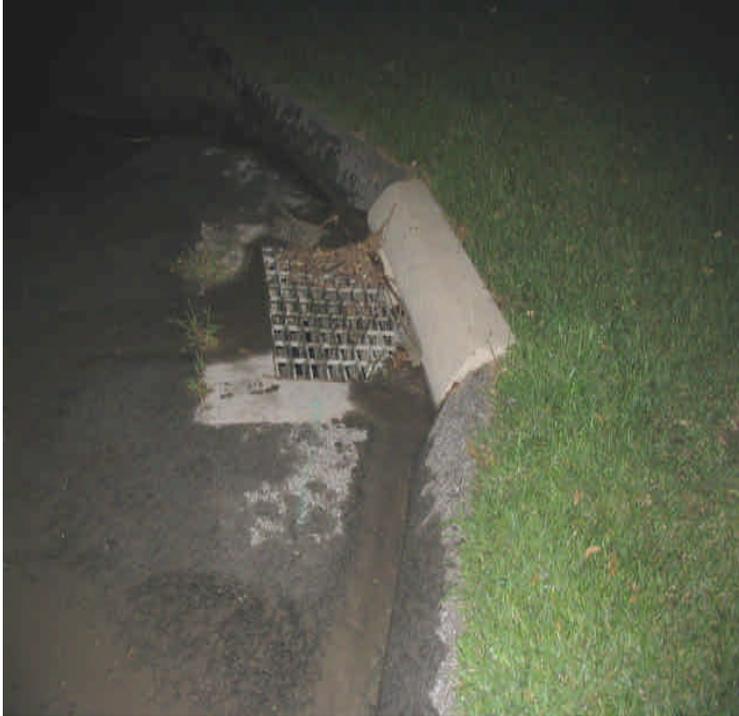
Photo on the left shows some slurry mud running to an unprotected catch basin near Wilton Corporate Park Work on Rt. 7 usually involves a vac truck to remove mud as it is created. This was the first observed problem. Photo on the right shows a view of the trench work. 8/19/05

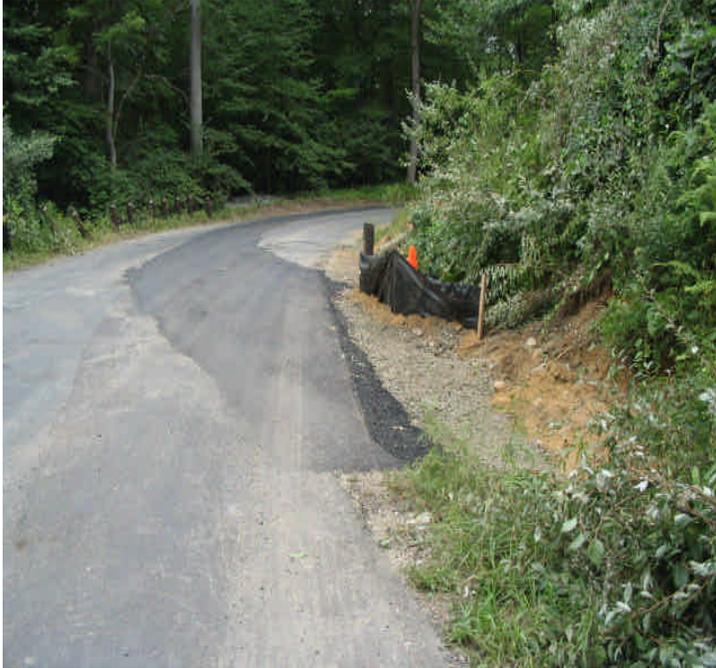
115 kV (Gallows Hill Road): Photo on the left shows the initial trench work turning the corner to the overhead ROW with an inlet well protected. Photo on the right shows the installation of a caisson in the ROW. 8/19/05

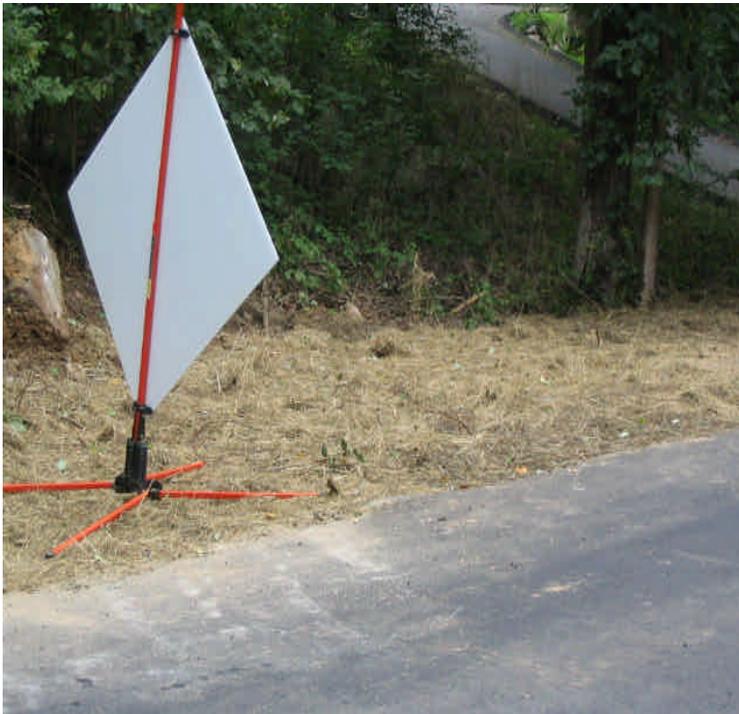
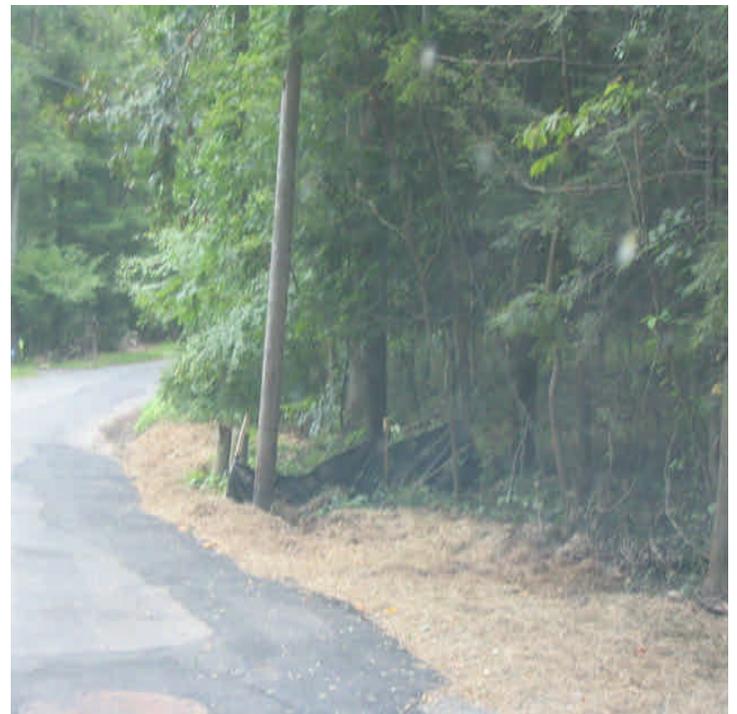
Both photos show various areas along Gallows Hill where the area has been temporarily restored with straw mulch until they can be revegetated. 8/19/05

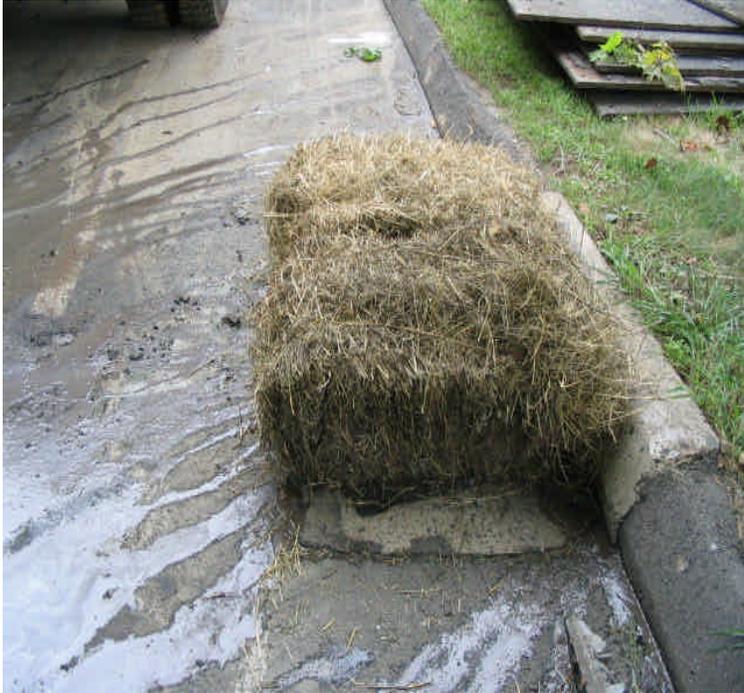
115kV (Rt. 107, Redding) Photo on the left: A well protected catch basin including filter fabric in the vicinity of slurry muds. Photo on the right: A general view of the trench work. 8/19/05

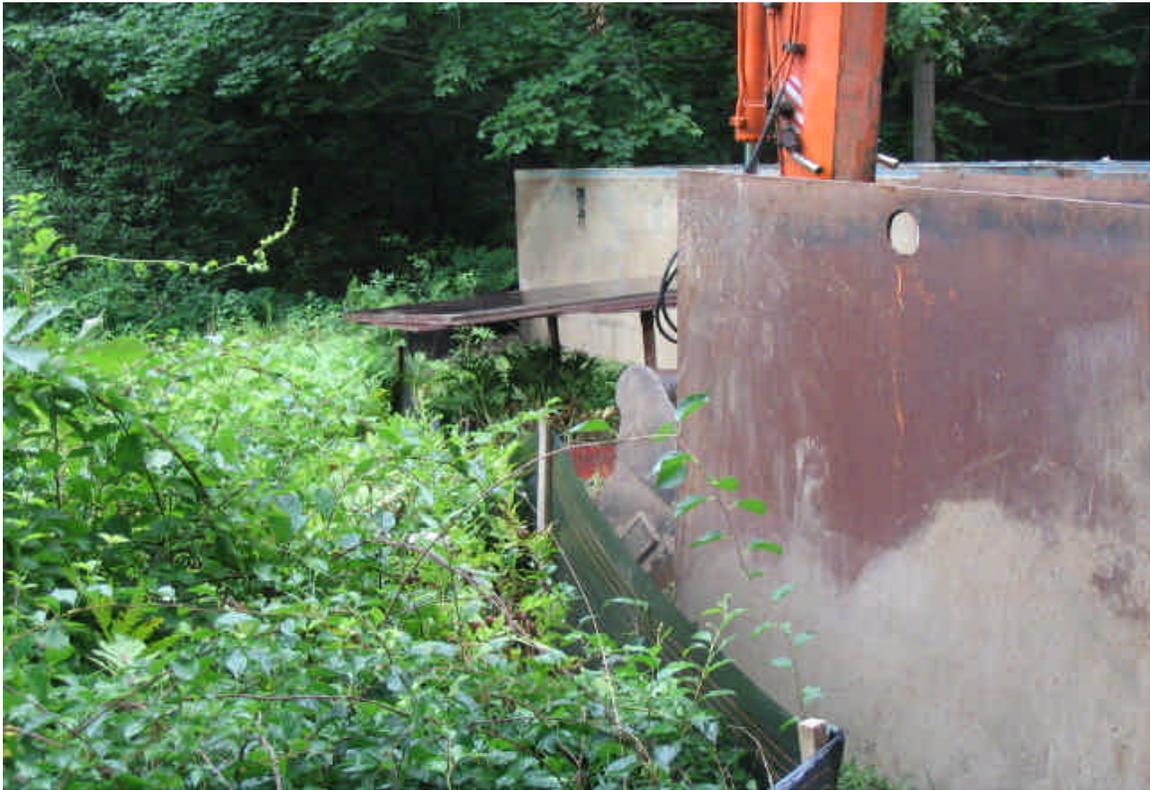
115 kV (Route 58 near Putnam Park): The storage area near the pond has silt fence installed and toed in but this particular portion encroaches on the wetland and needs to be pulled back. 8/19/05

Areas of Inspection	Observation	Recommended Action
	<ul style="list-style-type: none"> - Silt fence was toed in at the storage area off Rt. 58 but one section is still encroaching on the wetland vegetation. 8/19/05 - Repairs were made to the silt fence as recommended but it still needs to be toed in. 8/19/05 	<ul style="list-style-type: none"> - The fence here will be pulled back to provide a limit of work back from the wetland. 8/19/05 -Toe-in the fence and continue to monitor. 8/19/05
<p>Staging, Storage, and Parking Areas</p>	<ul style="list-style-type: none"> - The concrete storage area for Rt. 7 work near the Merritt Parkway cloverleaf needs some attention. Evidence of concrete discharge was seen in the soil and leading to an inlet on Rt. 7. 8/19/05 - In Redding Town Yard, soil excavate is only temporarily stored here until it can be trucked for disposal in the O&G facility in Bridgeport or the Redding landfill. - The concrete washout here has been reinforced both at the bin and near the outlet. Controls are working well to protect the wetland but discharge still reaches the outlet. 8/19/05 - The storage area for materials, conduit and equipment at the Bethel Educational Park near the RTJ School is being dismantled as work leaves the school yard. 8/19/05 - The Mathers storage area was identified off Rt. 58 had silt fence in place as recommended but a small portion still encroaches on wetland vegetation. 8/19/05 	<ul style="list-style-type: none"> - This area is used for 115kV and other O&G projects in the area. It needs to be reinforced and controlled. 8/19/05 - There are no current issues as little soil is stored here at any one time. 8/19/05 - The bin should continue to be emptied regularly to prevent overflow. The recent additional measures seem effective but are still discharging. 8/19/05 - None at this time. 8/19/05 - Silt fence should be moved back from the wetland edge to provide an effective limit of work. 8/19/05

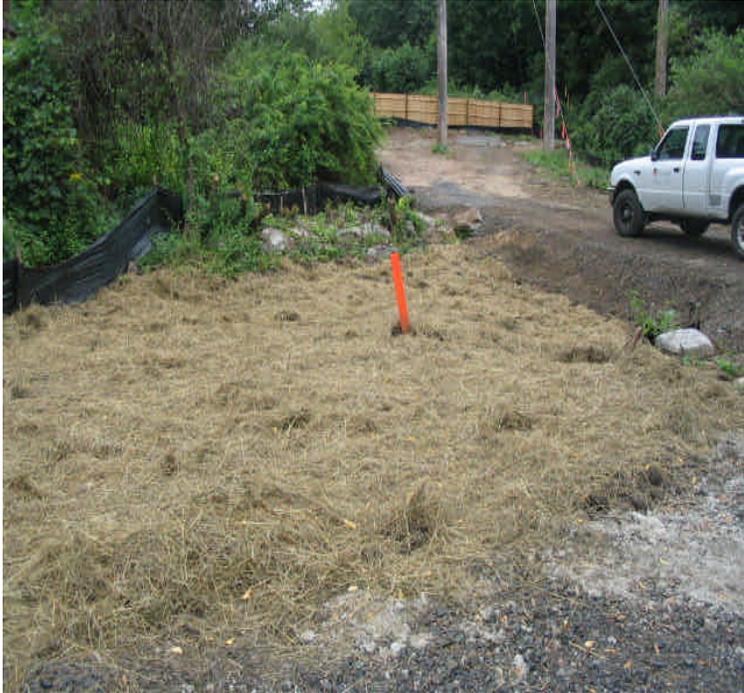
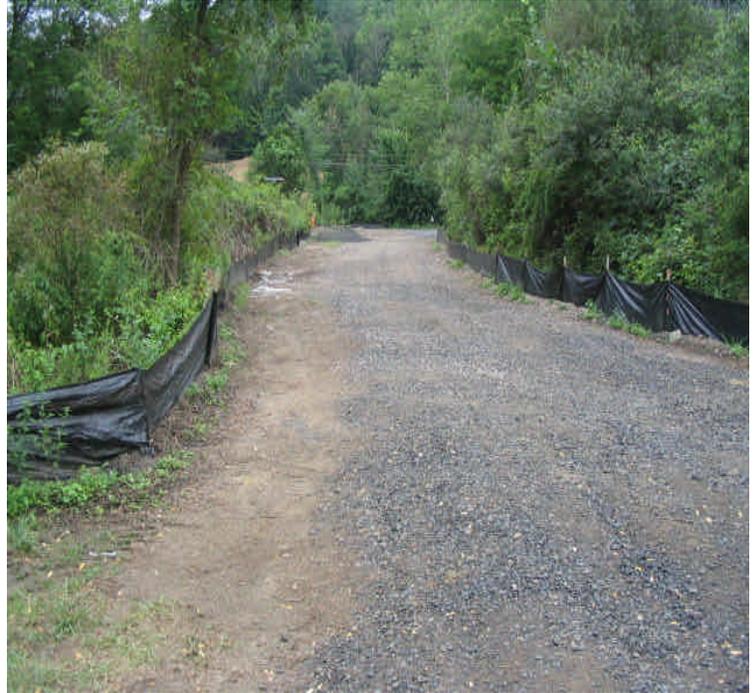
115kV (Route 58, near Hoyts Hill- Transition Pole): The access road in to the site has been cleaned up and disturbed areas placed with mulch. Most repairs were made with a few materials left to remove. 8/19/05

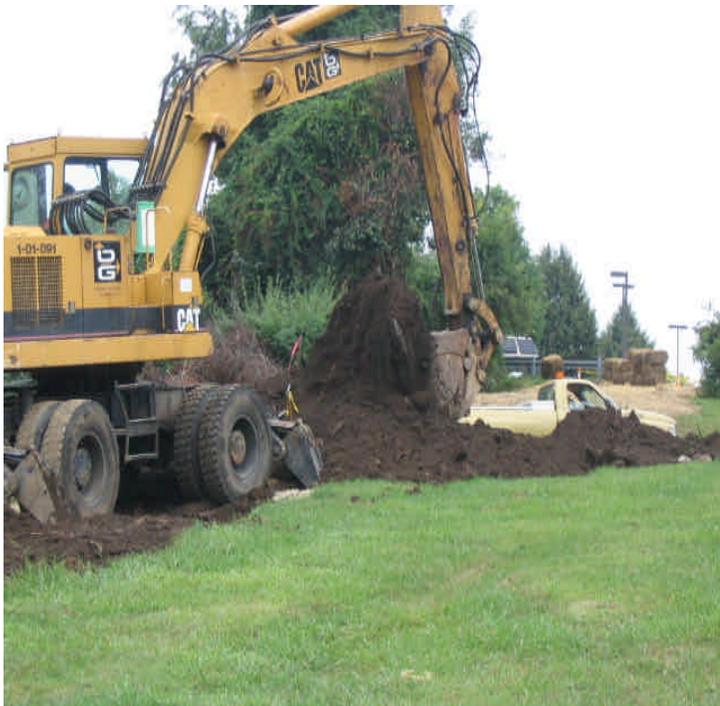
115kV (Bethel Education Park): Photo on the left: Topsoil is being replaced and lawns seeded and mulched in the school yard. Photo on the right: Concrete work is underway to restore all sidewalks and berms. 8/19/05

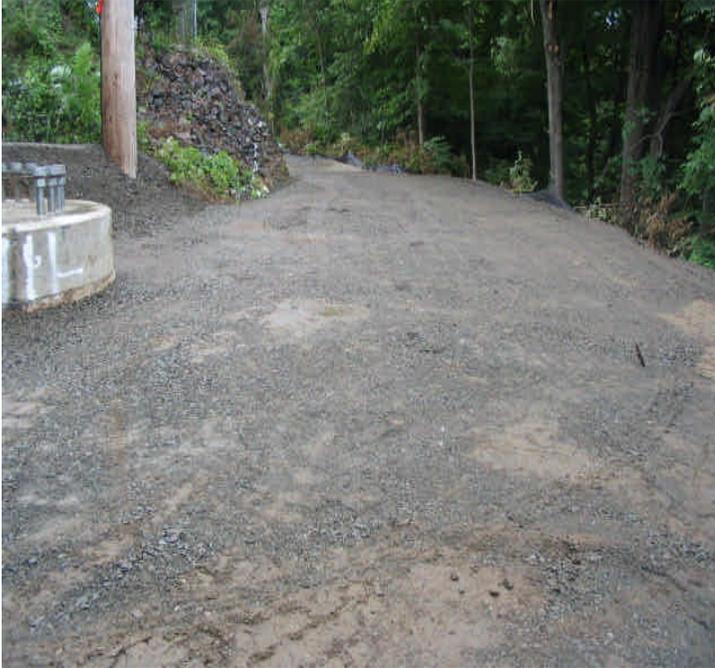
Photo on the left: Stone was placed near the southern transition structure to help stabilize the area. Photo on the right: Much of the stockpile near the ROW was removed with a few repairs needed to the silt fence. 8/19/05

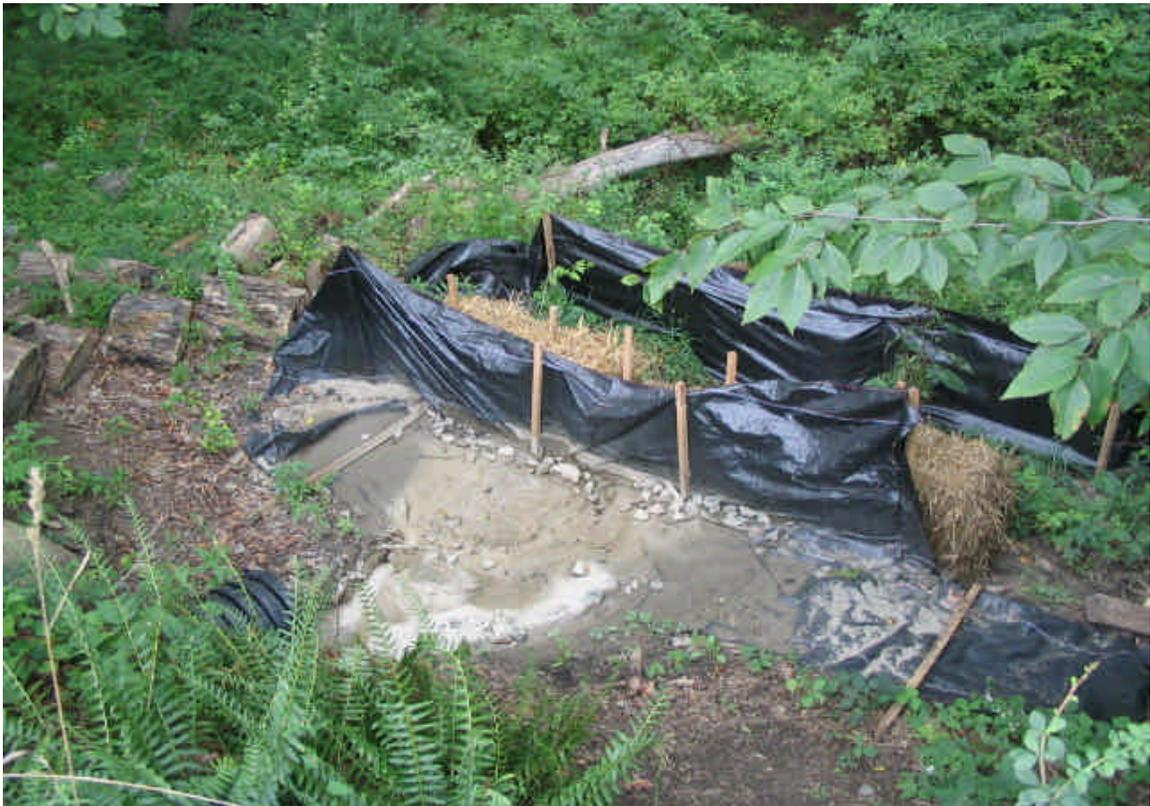
115kV (Redding Town Yard): The check dams were placed with filter fabric on the ground to catch any overflow from the concrete washout area. 8/19/05
