Docket No. 217 – Development and Management Plan Inspection

Northeast Utilities Service Company Certificate of Environmental Compatibility and Public Need for the construction of a 345-kV electric transmission line and reconstruction of an existing 115-kV electric transmission line between Connecticut Light and Power Company’s Plumtree Substation in Bethel, through the towns of Redding, Weston, and Wilton, and to the Norwalk Substation in Norwalk, Connecticut.

Date: October 5, 2005

Location: 115 kV Underground Route

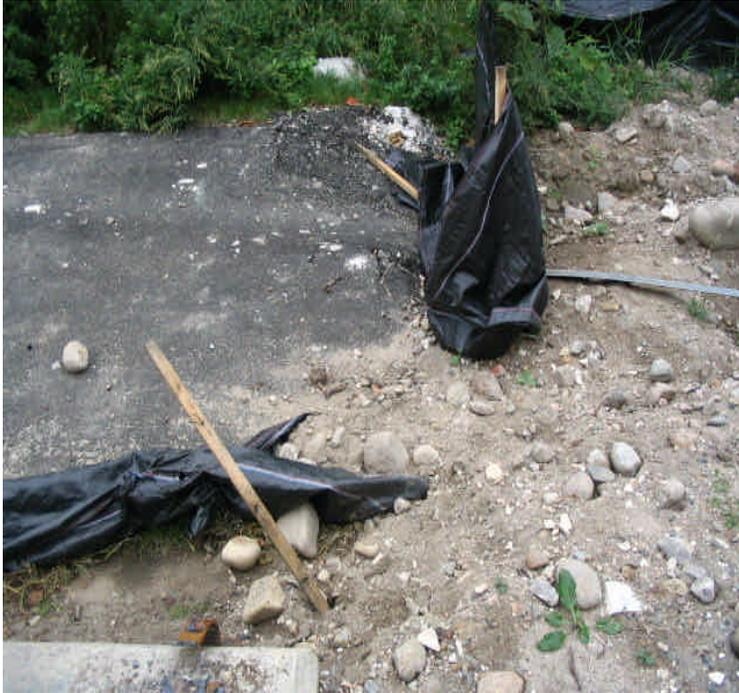
115kV (Broad Street and ROW): The photo on the left shows the corner of silt fence near the foundations and bike path at the substation which should be repaired. The remainder of the fence is in good shape. Photo on the right shows Broad St and the ROW which should be restored when feasible. (10/5/05)

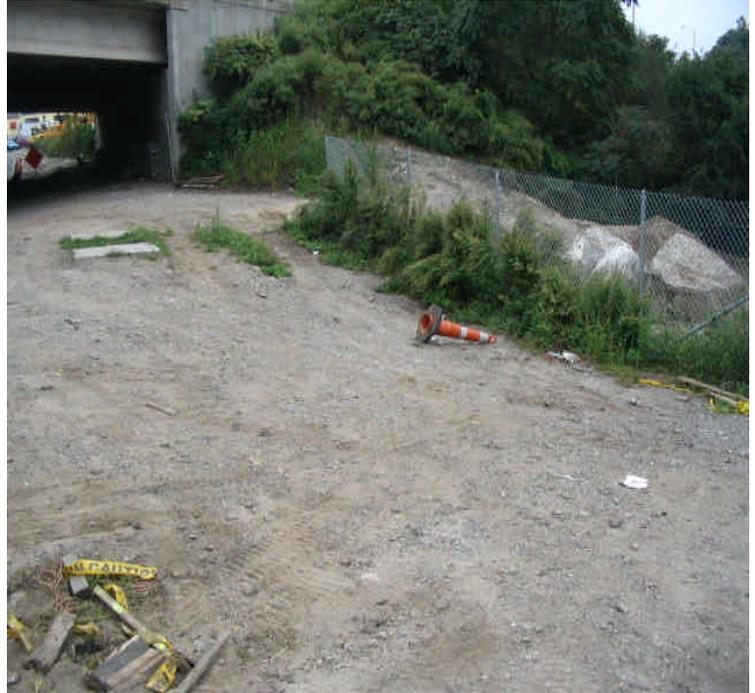
Areas of Inspection	Observation	Recommended Action
Broad Street and ROW, Norwalk	<ul style="list-style-type: none"> - A soil stockpile from the roadwork is being kept in the ROW but has been partially removed. 10/5/05 - The silt fence is well installed along most of the ROW but the corner at the substation near the bike path where foundations were installed could use some repair. 10/5/05 - A pile of debris apparently excavated during the trenching in the ROW is located just off Broad Street. 9/1-10/5/05 - Bare areas are located along the roadway edges as a result of the work, including a well point across the road. 10/5/05 - The jacking and receiving pits off Broad St. are well contained. 10/5/05 	<ul style="list-style-type: none"> -Maintain silt fence here as needed if any stockpile is to remain. 10/5/05 -Maintain silt fence as needed. 10/5/05 - NU should work with the contractor to determine how to dispose of this. 10/5/05 - Restore areas as feasible and within time limits specified by the D&M plan 10/5/05 - None at this time. 10/5/05

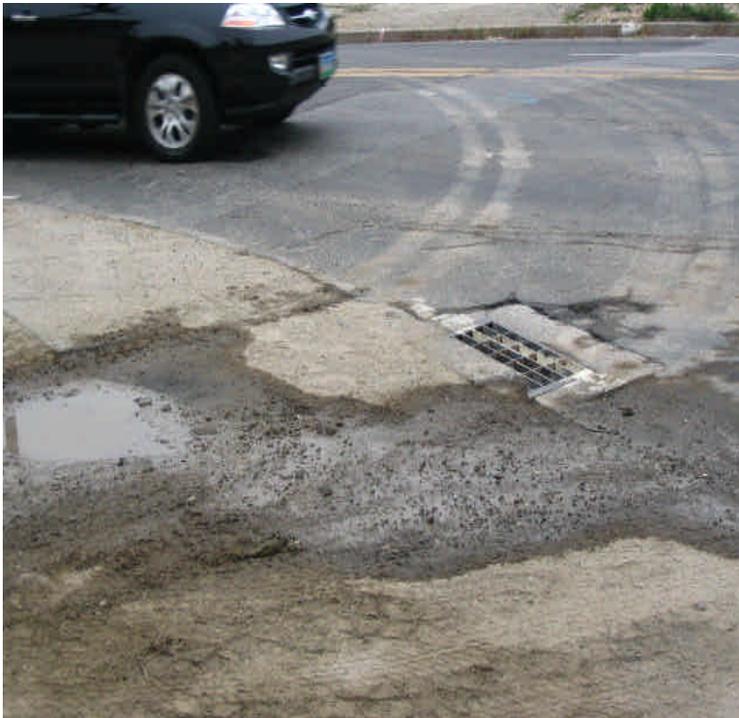
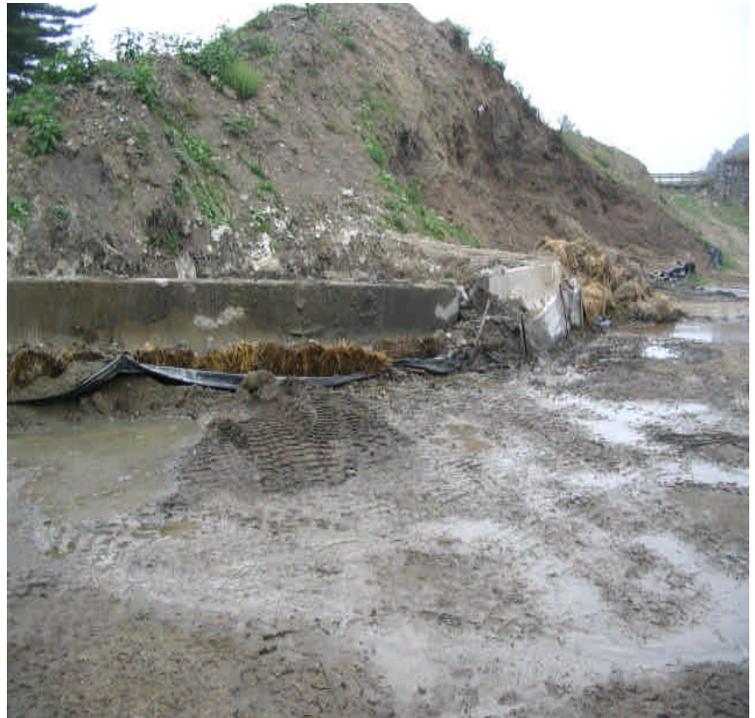
115kV (Route 7): Photos show the concrete washout station used for Rt. 7 night work as well as several other unrelated projects. Controls were down and washout water was reaching a catch basin. Contractors met on the site and made immediate repairs. See photo below. (10/5/05)

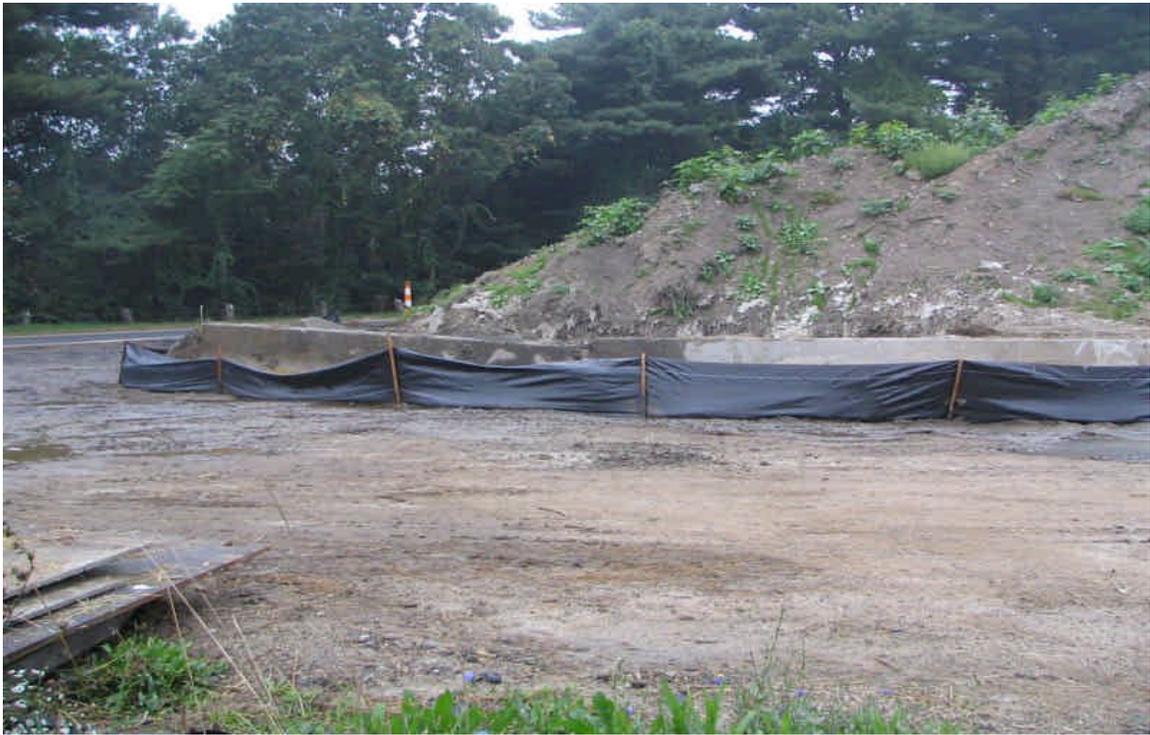
View of the concrete washout station following repairs made to the erosion controls and cleaning up excess concrete. (10/5/05)

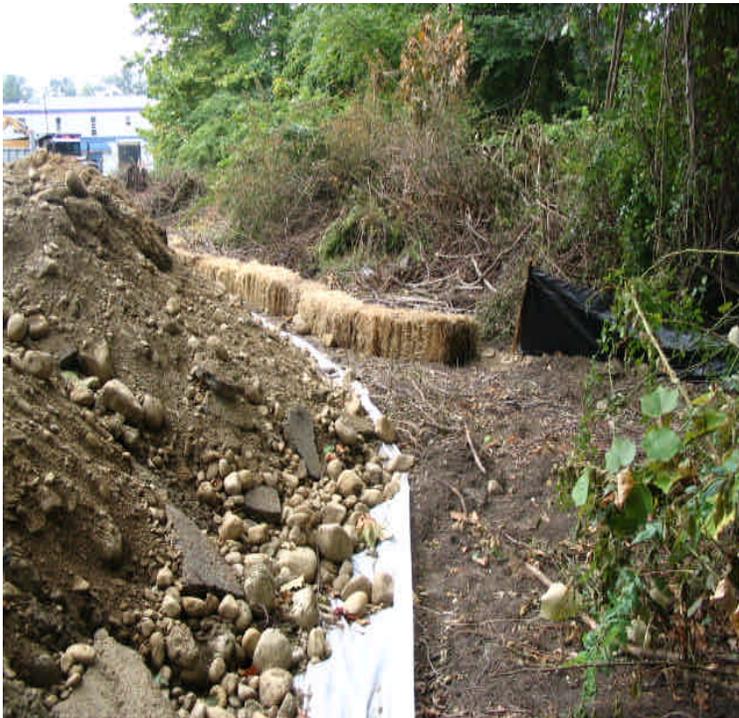
115kV (Rt 7 and Norwalk Junction). Work has begun in the vicinity of the Norwalk Junction transition station. Photo on the left shows excavate from where a caisson for a riser termination structure was installed. Erosion controls are well in place. Photo on the right shows where trenching for conduit installation is leading in from Rt. 7 (10/5/05)

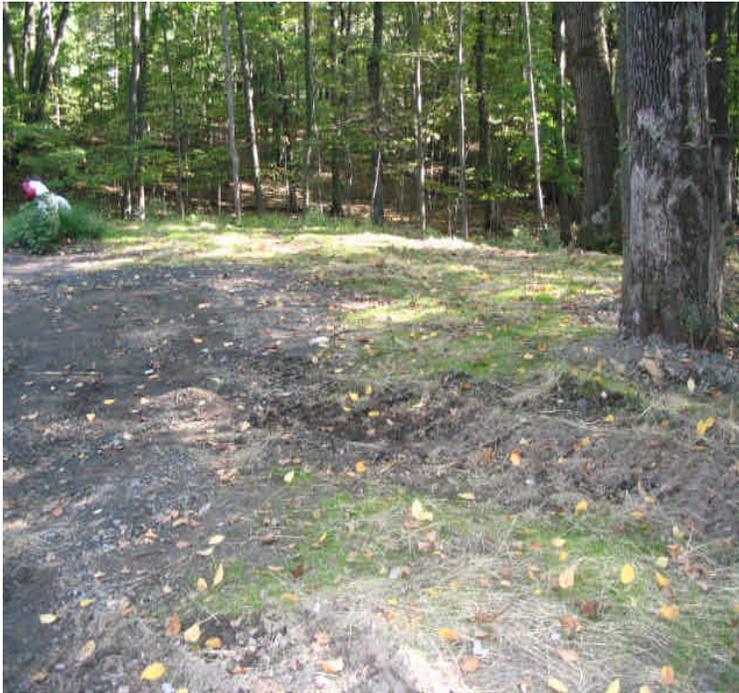
115kV: Photo on the left: (Gallows Hill Rd.) shows where the storage area has been restored, silt fence removed and the area beginning to show re-growth. Photo on the right: (Rt. 58) shows the Putnam Park area storage yard cleaned out for a ceremony at the park. This yard will return to use. (10/5/05)

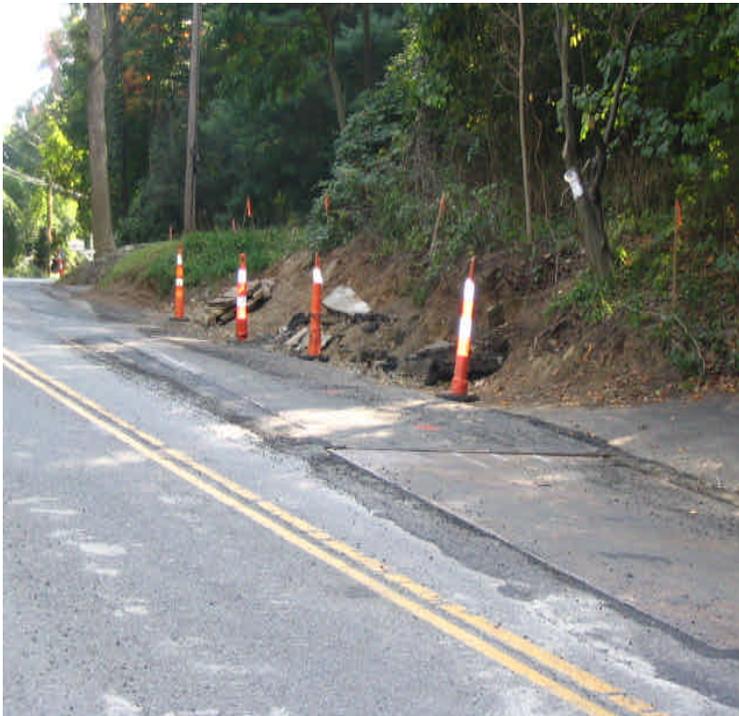
115kV: (Rt. 107 and Rt. 58). Photo on the left shows trench work near Lois Lane. Active work is occurring here but the area should be restored when completed. Photo on the right shows a good attempt to protect catch basins from sawcutting mud but some made it around the haybales. 10/5

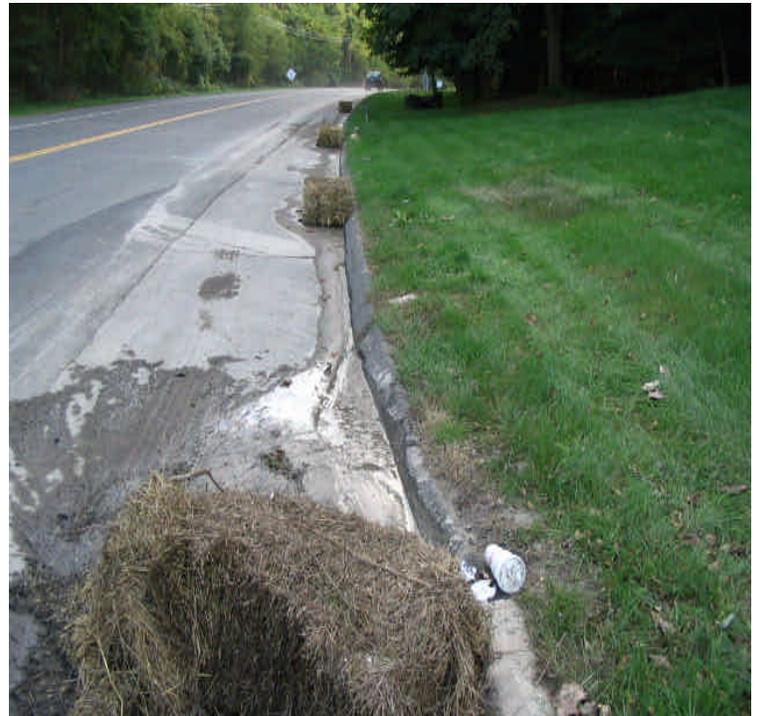
Areas of Inspection	Observation	Recommended Action
Route 58	<ul style="list-style-type: none"> - Most catch basins near the work areas are being consistently placed with either haybales or fabric and are well protected. 10/5/05 - Good efforts were made to protect catch basins from sawcutting mud near Sunset Hill Rd. but some made it around the haybale check dams to the inlet. 10/5/05 - The restoration measures for the stream cut at Sara's Way are completed and flow was returned to the channel. Pumps and downstream check dams were removed. The flow was very clear and the banks were well restored. 10/5/05 - Areas around Putnam Park were cleaned up very well for a ceremony at the park. Work will return the following day. 10/5/05 - Crews were working to proof vaults and ducts near vault number #5 north of the Sunoco station. 10/5/05 	<ul style="list-style-type: none"> -In general, contain slurry or mobile sediment to work areas and street sweep the road extent including the gutters, regularly and place and maintain controls on all catch basins and inlets. 10/5/05 - Scoop up the accumulated mud that the haybales prevented from getting in and remain aware of potential issues. 10/5/05 - None at this time. Continue to monitor as the stream is able to restore original patterns of pooling and flow. The settling tank will be removed soon. 10/5/0 - Silt fence in this area should be removed after the side of the road is seeded and mulched. 10/5/05

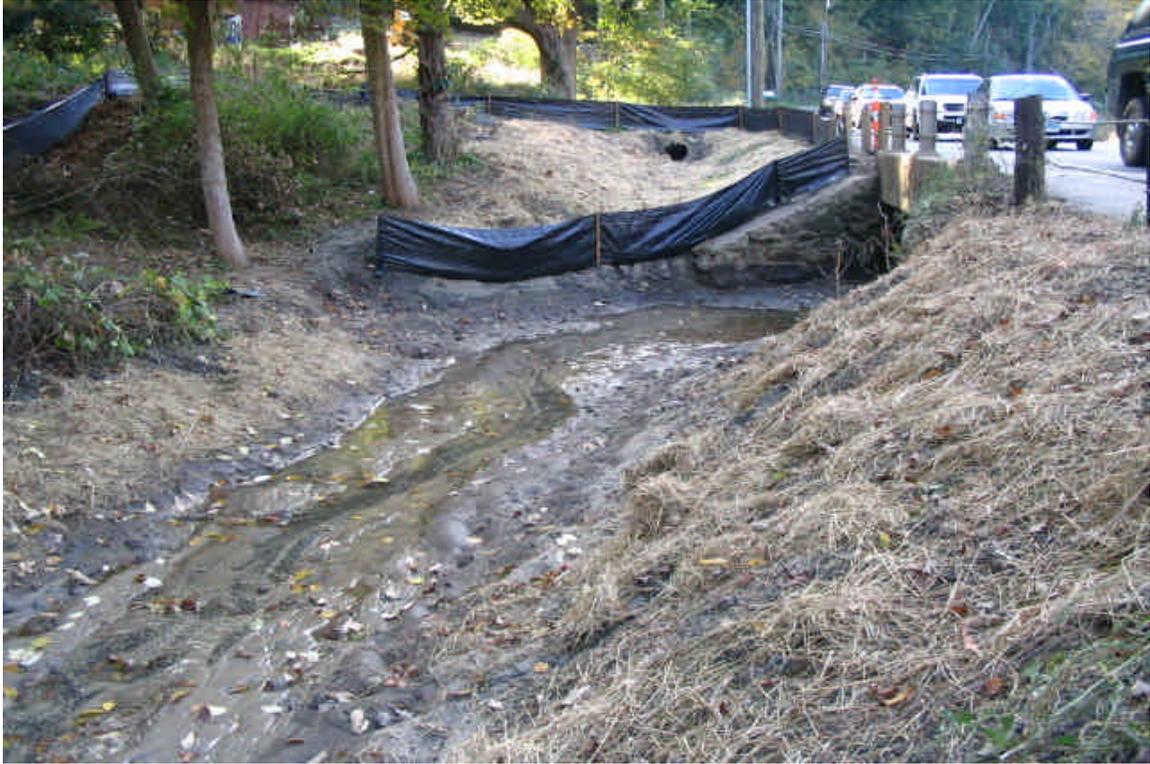
Areas of Inspection	Observation	Recommended Action
	Yard until they are trucked to Bridgeport or the landfill. 10/5/05	
Adjacent Wetlands and Waterways	-The stream cut near Sara's Way off Rt. 58 is well restored with mulch and haybales along the bank. All dams were removed and flow returned to the channel where sand had been placed. Water flow was very clear. 10/5/05	- None at this time, the restoration efforts look to be in good shape. Continue to monitor that the stream is able to reshape its channel and features through natural flow. 10/5/05
Staging, Storage, and Parking Areas	<p>- BSC and contractors met at the concrete storage area for Rt. 7 work near the Merritt Parkway cloverleaf. The controls were in disrepair, with accumulated concrete and with washout entering a nearby inlet on the road. Within the day, controls were repaired and the station was cleared of accumulated concrete. 10/5/05</p> <p>- In Redding Town Yard, soil excavate is only temporarily stored here until it can be trucked for disposal in the O&G facility in Bridgeport or the Redding landfill.</p> <p>The additional controls installed at the Redding Yard continue to be effective in retaining the concrete washout water. 9/15-10/5/05</p> <p>- At the storage area off Rt. 58 near the Putnam Park entrance, the entire yard was cleaned out for a ceremony at the park that day. 10/5/05</p> <p>- The silt fence at the yard at the intersection of Rt. 58 and Sunset Hill Rd was still holding up well . 10/5/05</p> <p>- Both of the Redding CC storage areas fences remains well in place. 10/5/05</p>	<p>- Although this washout is used for other O&G projects in the area, it still needs to be reinforced and controlled to the same standards as the 115kV since this project uses it. 10/5/05</p> <p>- Continue to monitor and maintain and confirm that a liner was placed within the corral. 10/5/05</p> <p>- None at this time, continue to maintain the controls as needed. 10/5/05</p> <p>-Work will return to the yard so continue to maintain fence, especially near the pond where it was starting to come down . 10/5/05</p> <p>- Continue to maintain fence and treat it as a limit of work. Vehicles should stay within the fenced areas. 10/5/05</p> <p>-None at this time. 10/5/05</p>

115kV (Rt. 58): View of the stream restoration near Sara's Way following the open cut. Flow was returned to the channel and the banks and disturbed areas were well restored. (10/5/05)

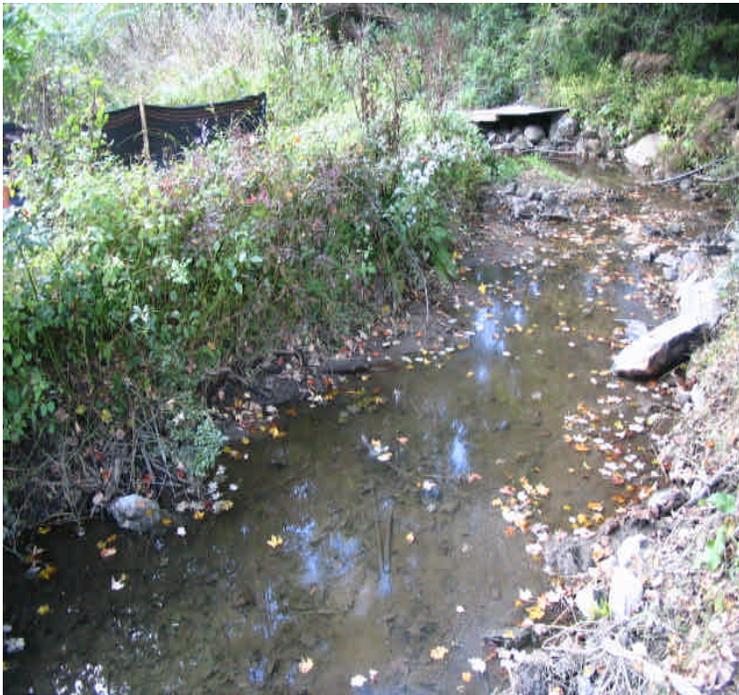
Photo on the left shows the downstream area well restored with all the check dams removed. The stream flow had very good clarity with no noticeable sedimentation. The photo on the right shows the area upstream of the cut with the dams removed. (10/5/05)

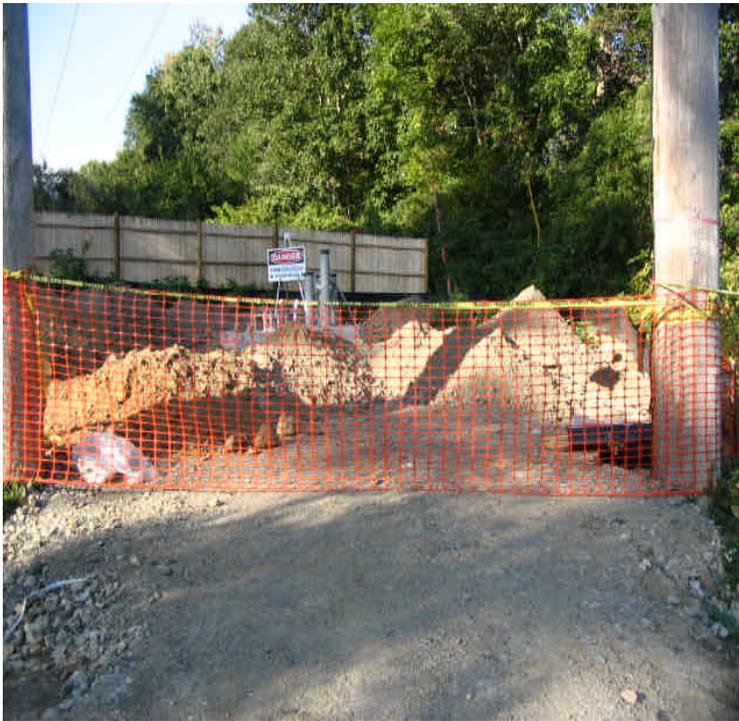
115kV (Hoyts Hill and Bethel Ed. Park): Photo on the left shows excavation for grounding the foundation of the riser termination structure (RTS) across from Hoyts Hill. The photo on the right shows the riser termination structure installed at the northern end of the ROW at Bethel Ed. Excavation for grounding is also ongoing here. (10/5/05)

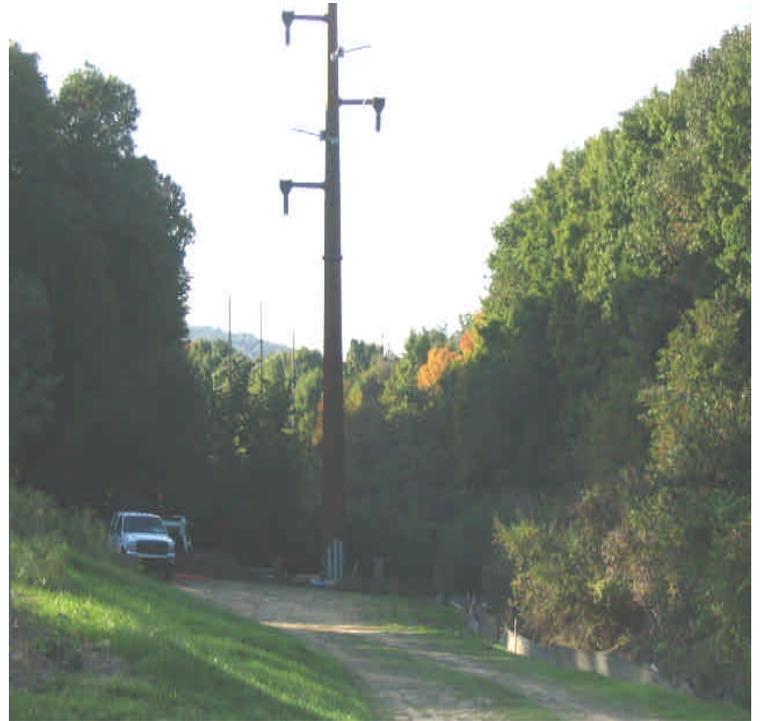
Areas of Inspection	Observation	Recommended Action
Vault Openings and Trench Construction	- Bethel Educational Park: The riser termination structures were installed at both the northern and southern end of the ROW. Excavation for grounding the structures was occurring. Trenching the last section to the structure at the southern end was also occurring. 10/5/05	-See erosion control section for specifics. 10/5/05
Hoyts Hill Transition Structure	-Excavation for grounding the structure foundation was ongoing here. 10/5/05	- See erosion control and spill section for site specific information. 10/5/05
Gallows Hill Road and Rt. 107, Redding	-Restoration continued along Gallows Hill and the roadway and edges are almost completely restored. 10/5/05 - Some trenching was noted along Rt. 107 near Lois Lane. 10/5/05	- Restoration efforts continue to be noted in locations. See erosion control and additional sections for more specific information. 10/5/05

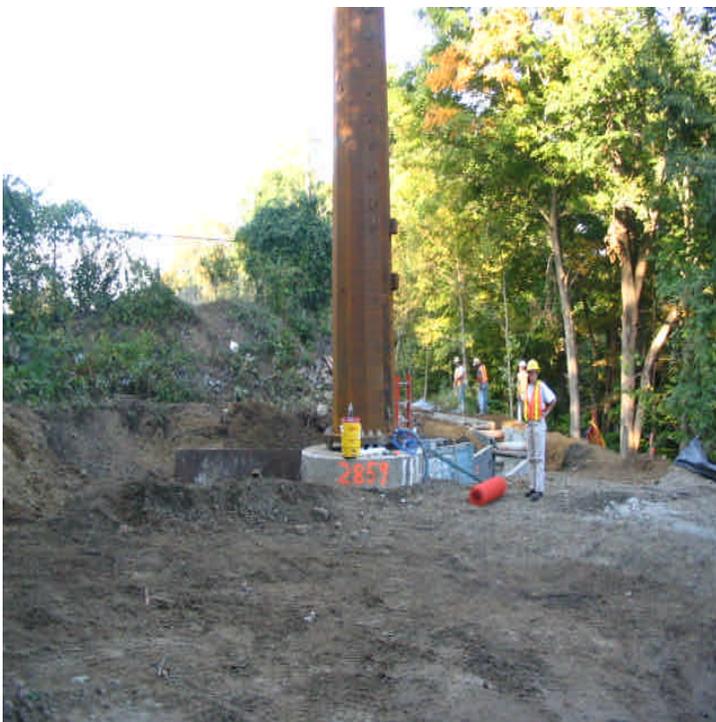
115kV (Bethel Ed. Park): Photo on the left shows grounding for the installed RTS at the southern end of the ROW and the remaining trenching up to the structure. The photo on the right shows the gully near the northern end of the ROW which continues to washout following repair. 10/5

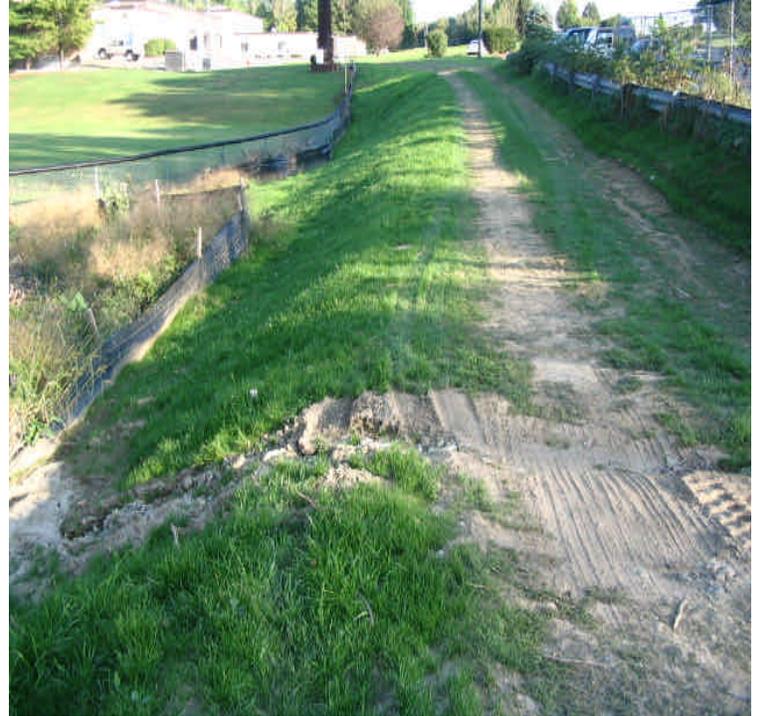
Areas of Inspection	Observation	Recommended Action
<p>Bethel Educational Park</p>	<ul style="list-style-type: none"> - All disturbed areas continue to show very good grass growth including edge areas along the ROW. 9/29-10/5/05 - The gully noted on the northern part of the ROW was repaired but appears to be an issue again. 10/5/05 - All excavation for grounding at the new structures was well contained within silt fence. 10/5/05 - A few spots of silt fence should be repaired near the last piece of trenching and conduit installation ongoing in the southern ROW. 10/5/05 	<ul style="list-style-type: none"> - None at this time. 10/5/05 - Continue to stabilize and repair as needed. 10/5/05 - None at this time. 10/5/05 - Repair and reinforce the silt fence here as a steep grade is present beyond. 10/5/05
<p>Hoyts Hill Riser Termination Structure (Off Rt. 58)</p>	<ul style="list-style-type: none"> - Erosion controls are mostly in good shape here and the excavation for grounding was contained within the silt fence. 10/5/05 - The contractor is in the process of removing the homeowner's wood debris pile. 9/29-10/5/05 	<ul style="list-style-type: none"> - Keep all areas of erosion control maintained. 10/5/05 - The siting council suggested that NU could offer to remove the wood/debris for the owner. 8/25-10/5/05
