Docket No. 217 – Development and Management Plan Inspection

Northeast Utilities Service Company Certificate of Environmental Compatibility and Public Need for the construction of a 345-kV electric transmission line and reconstruction of an existing 115-kV electric transmission line between Connecticut Light and Power Company’s Plumtree Substation in Bethel, through the towns of Redding, Weston, and Wilton, and to the Norwalk Substation in Norwalk, Connecticut.

Date: October 19, 2005

Location: 115 kV Underground Route

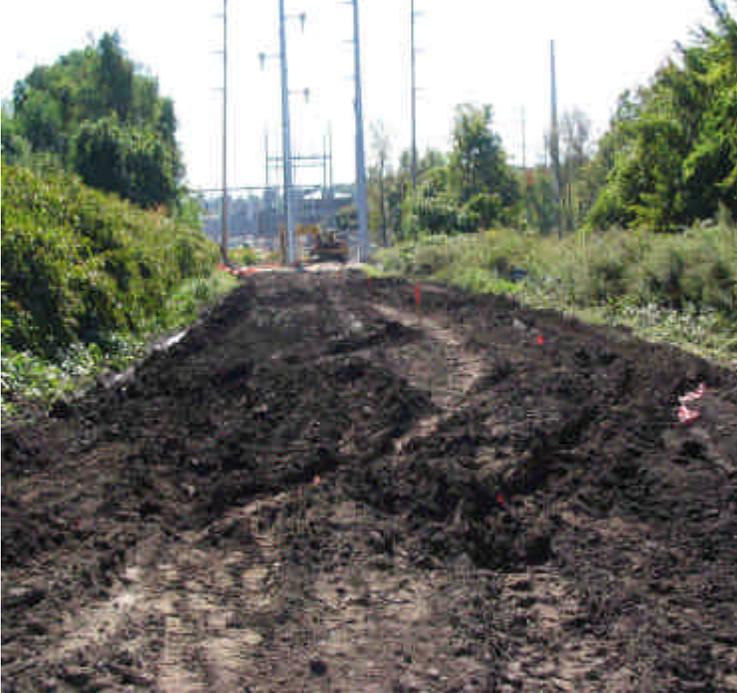
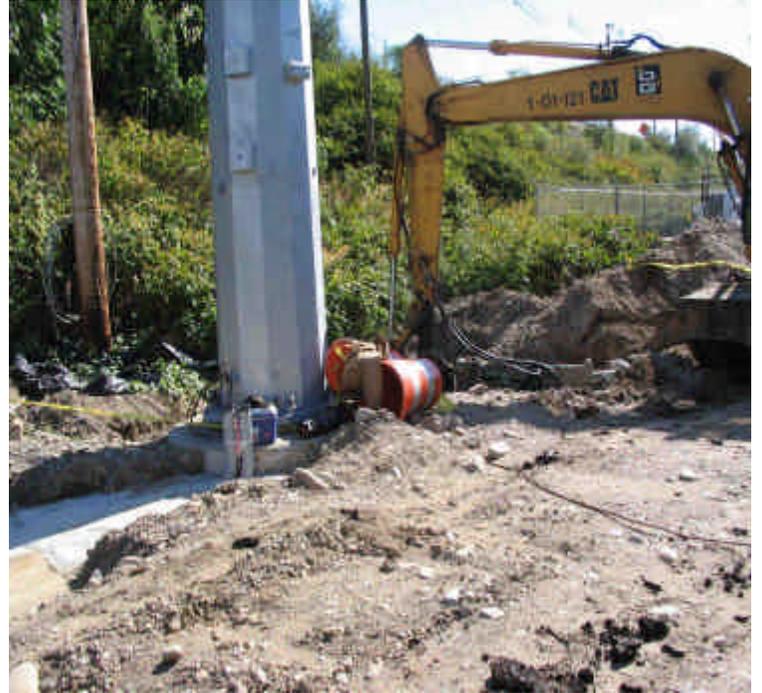
115kV (Broad Street and ROW): The photo on the left shows the ROW which was somewhat muddy following the rains but well contained within silt fence. Photo on the right shows excavation ongoing near the substation and structures. (10/19/05)

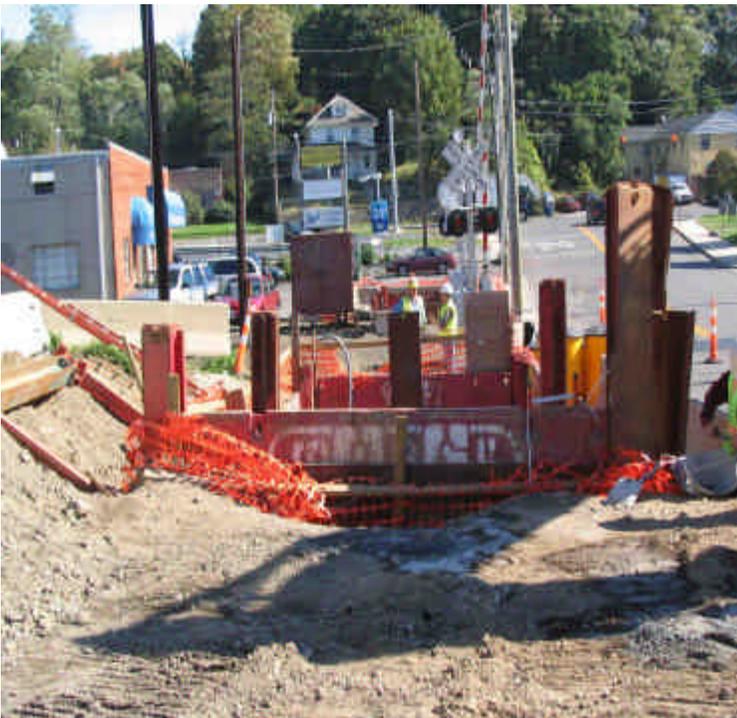
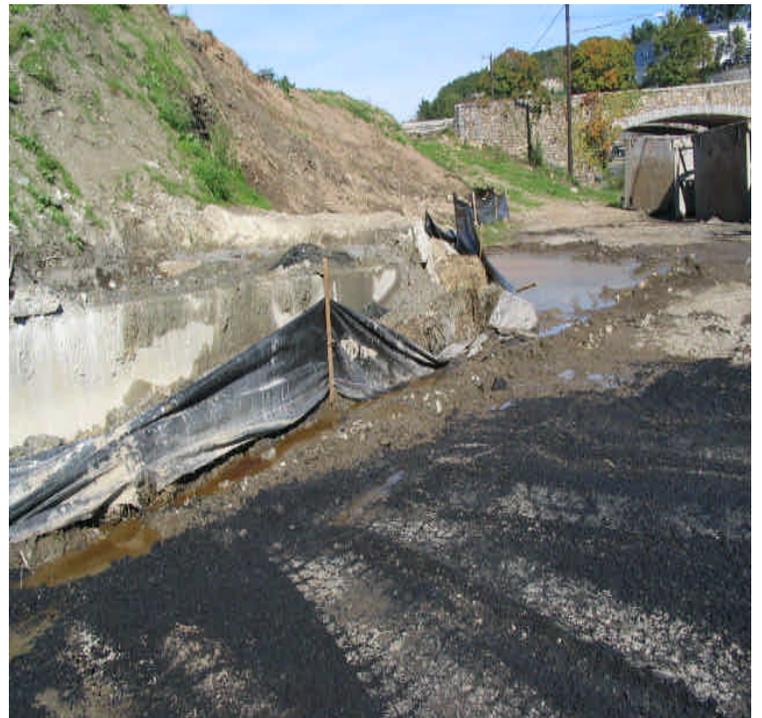
115kV (Route 7): Photo on the left shows the jack and bore in the process of being backfilled. Photo on the right shows the Merritt cloverleaf concrete washout with controls in disrepair again. Contractors were aware and were going to make repairs including the installation of the plastic liner. (10/19/05)

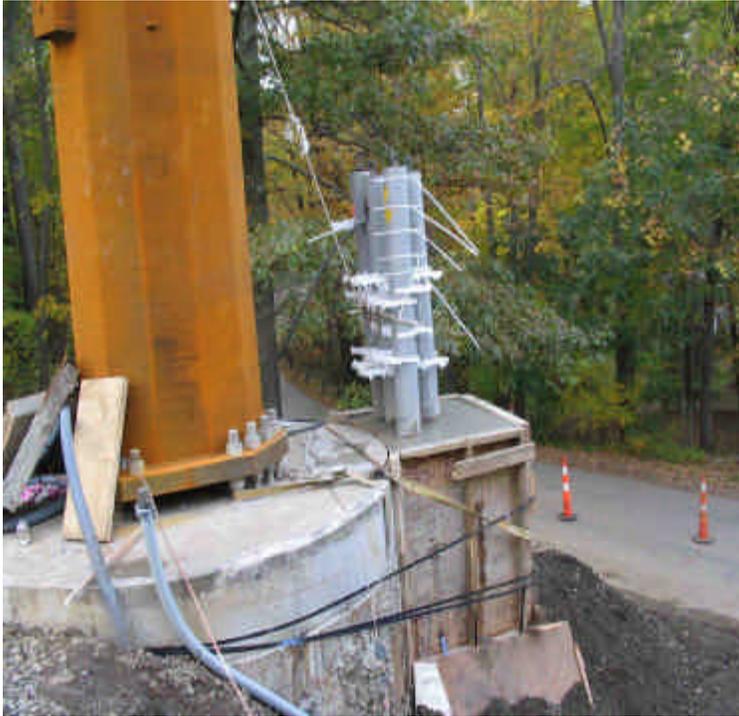
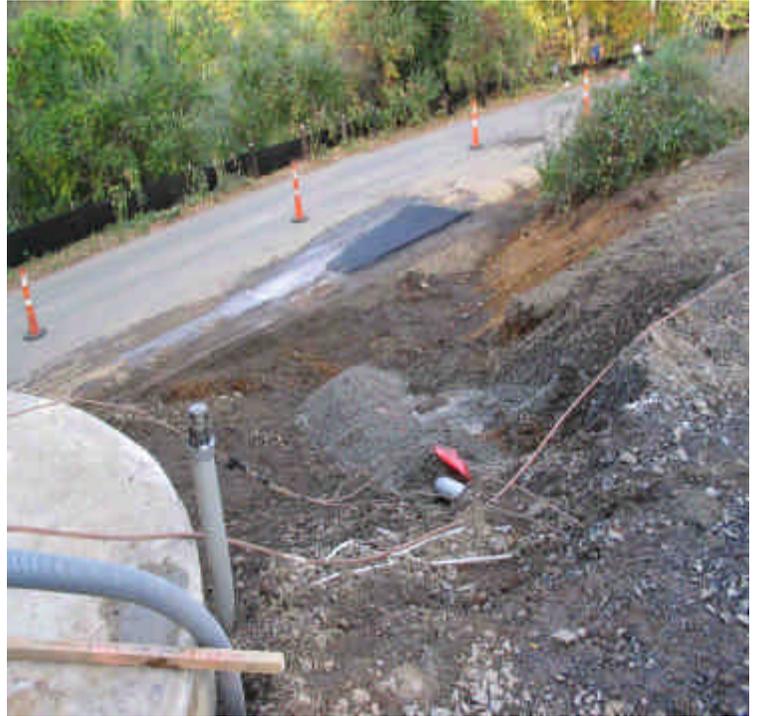
115kV (Gallows Hill Road). Both photos show the conduit newly installed up to the riser transition structure at the ROW. The slope here will have to be restored either with stone or vegetation when work is complete. (10/19/05)

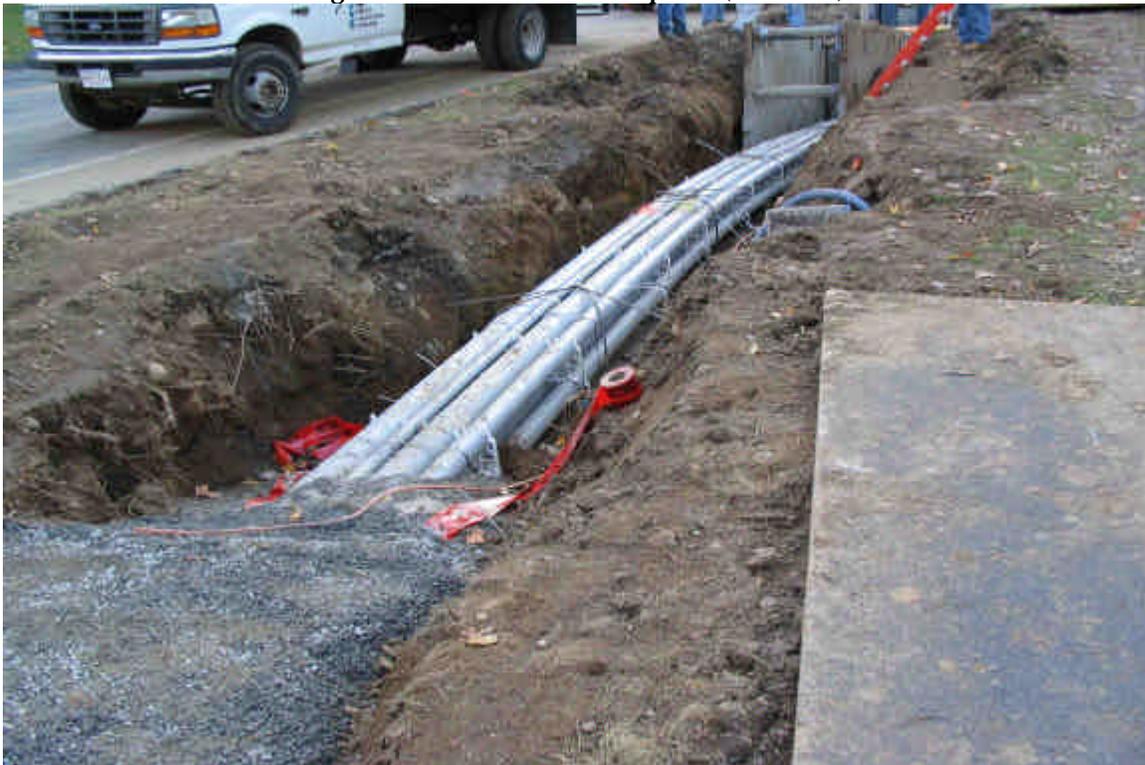
115kV (Rts 107 and 58). View of the conduit installation transitioning into the vault here. A few transitions remain along the project route. (10/19/05)

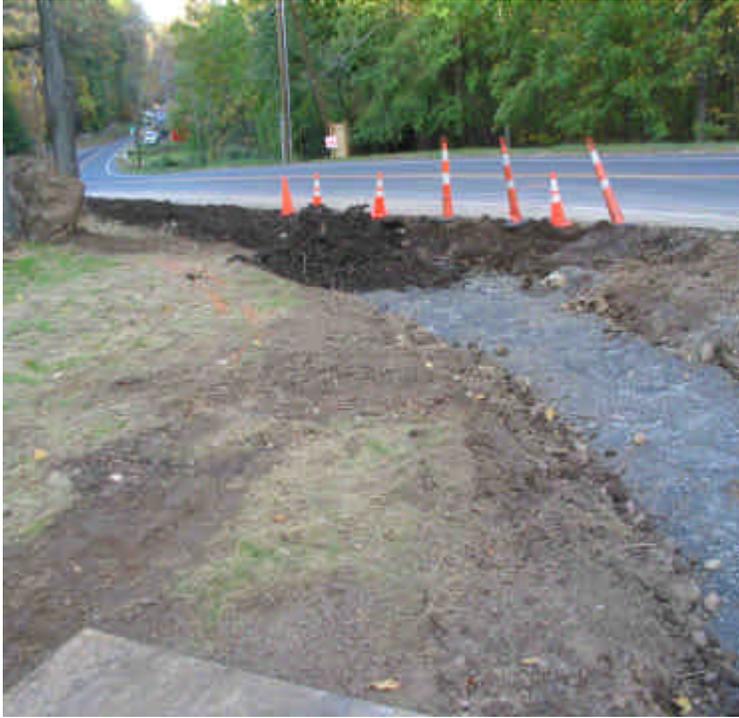
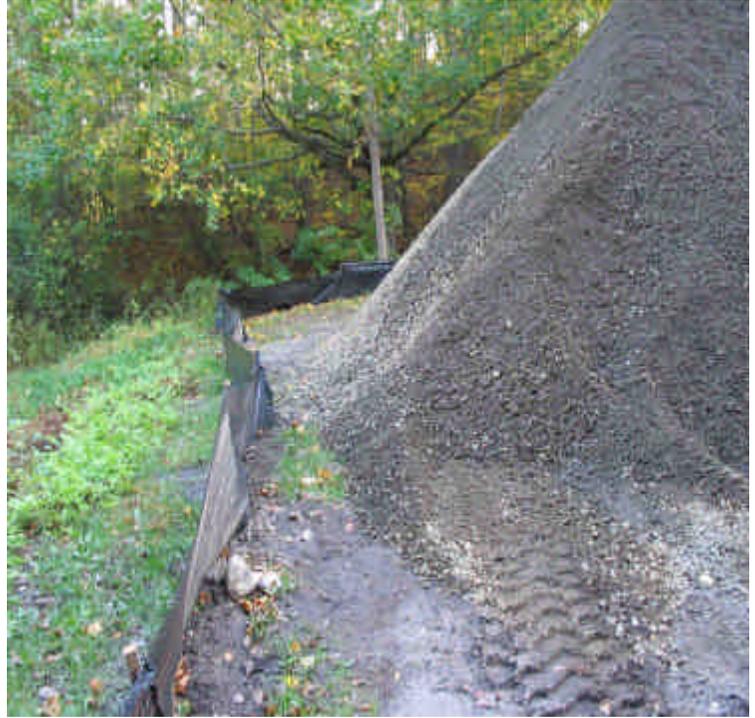
115kV: (Rt. 58) Photo on the left shows trench work turning the corner from Rt. 58 to Rt. 107 at Putnam Park.. Photo on the right shows the storage yard with the well repaired silt fence behind the stockpile. Haybales placed here would add another level of controls due to the proximity of the pond. (10/19/05)

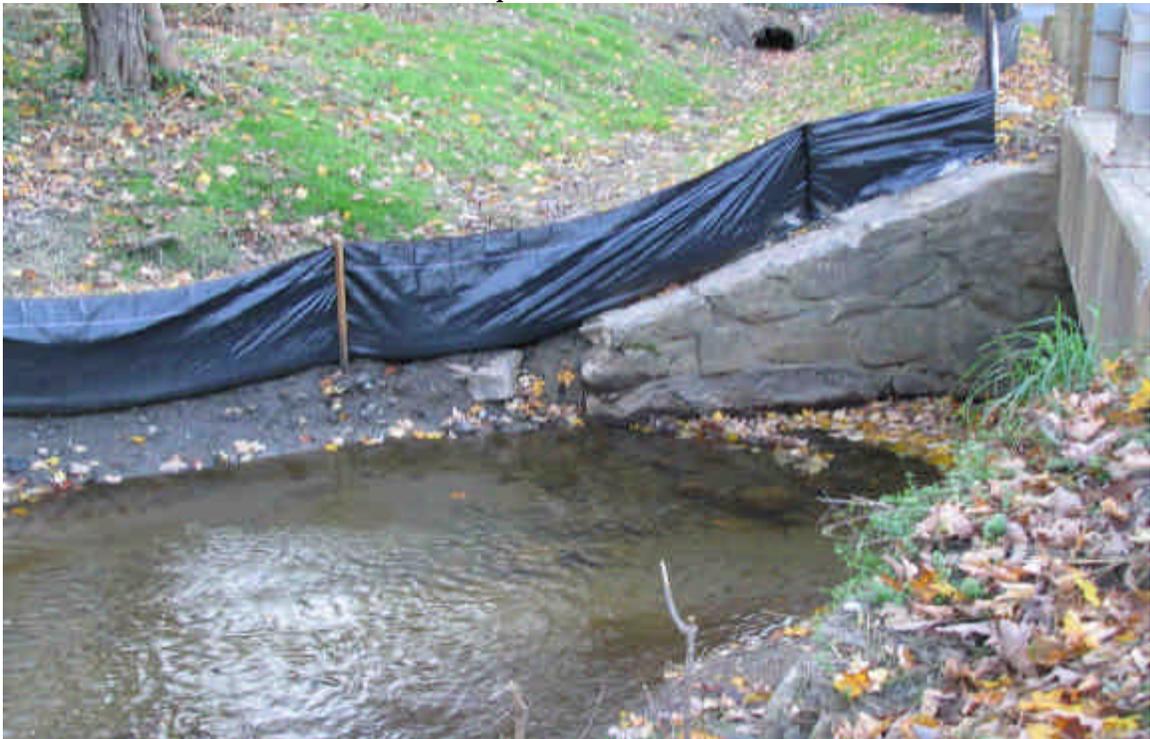
Adjacent Wetlands and Waterways	<p>-The stream cut near Sara’s Way off Rt. 58 was very successful and the stream is returning to original contours. The increased flow did wash away some of the mulch but no erosion was noted. 10/19/05</p>	<p>- None at this time, the restoration efforts are in very good shape. Continue to monitor for final vegetative stabilization. 10/19/05</p>
Staging, Storage, and Parking Areas	<p>-The controls at the concrete washout near the Merritt cloverleaf had degraded again and plastic liner should still be installed here. 10/12/05</p> <p>- In Redding Town Yard, soil excavate is only temporarily stored here until it can be trucked for disposal in the O&G facility in Bridgeport or the Redding landfill.</p> <p>The additional controls installed at the Redding Yard continue to be effective in retaining the concrete washout water. Heavy flow from the outlet was observed being contained for the most part.</p>	<p>- The contractor was aware of the situation and controls were to be repaired later that day and the plastic liner should be installed. (This washout area is also used for other O&G projects). 10/19/05</p> <p>- None at this time, continue to maintain the controls as needed. 10/19/05</p>

115kV: (Rt. 58/Sara's Way). The rain helped re-create the original flow patterns and substrate of the stream. The surrounding area and the stream look very well restored with vegetation returning. The stream cut method here was very successful. 10/19/05

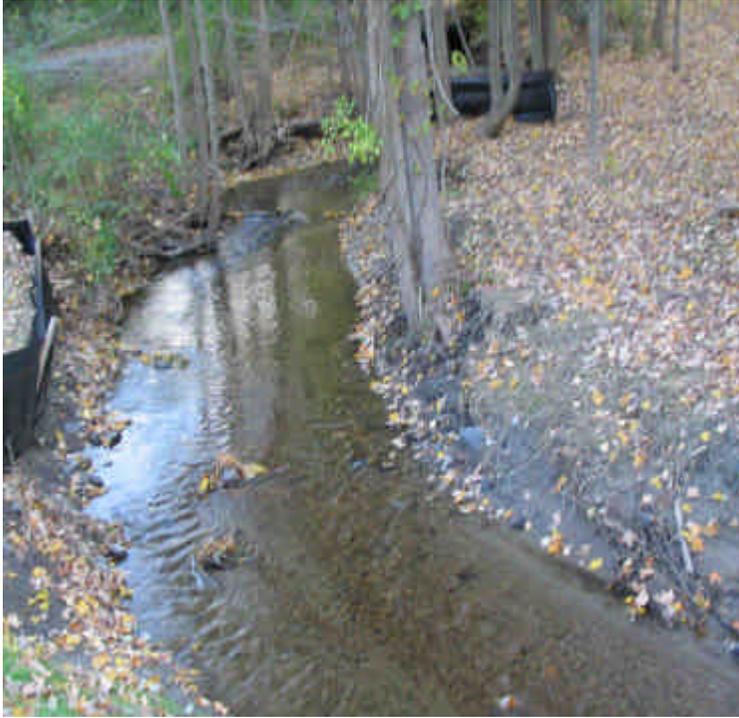
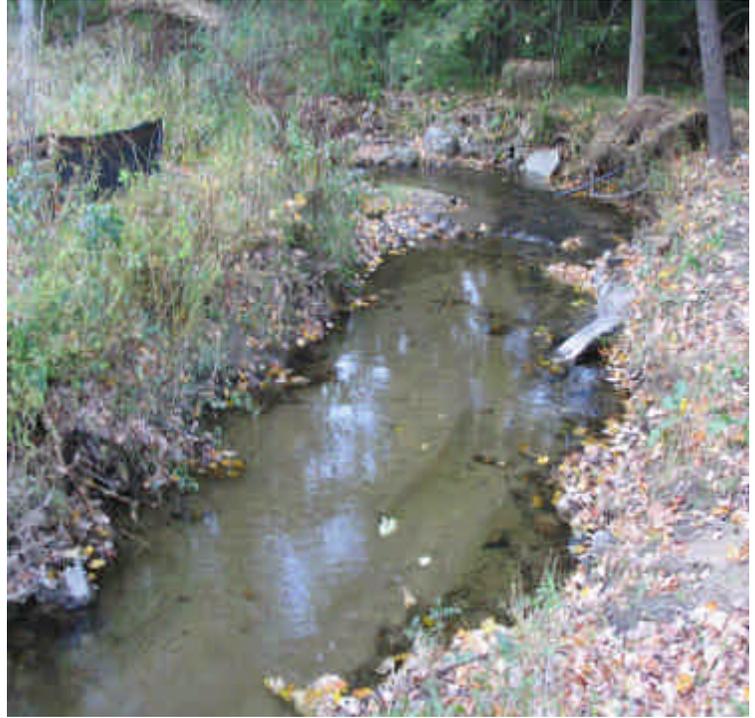
115kV (Rt. 58): More views of the well restored stream channel including up and down stream views from the bridge at Rt. 58. Water was very clear and flowing well after the rains. (10/19/05)

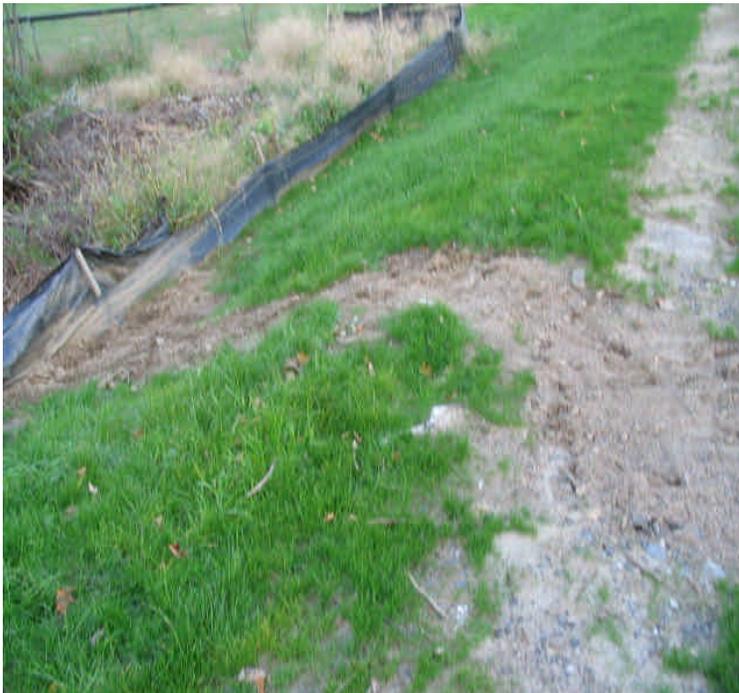
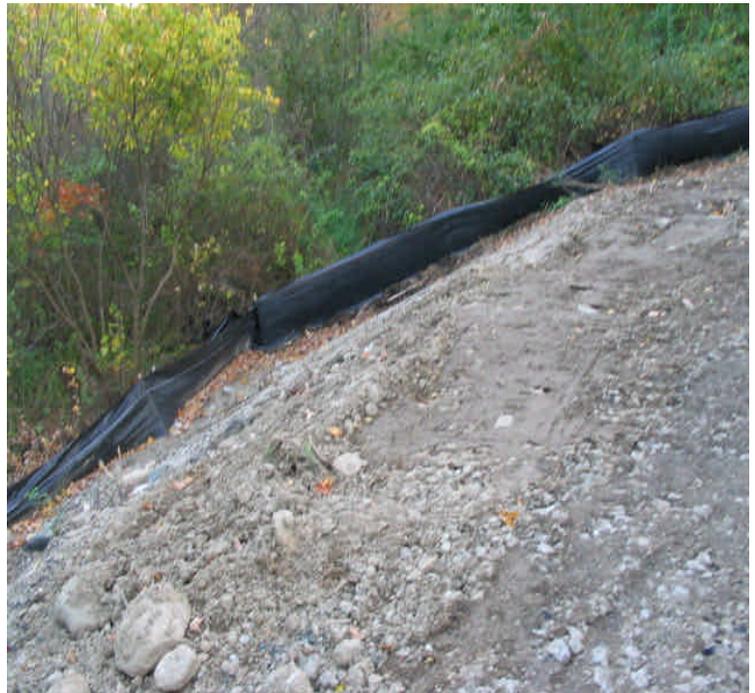
<p>Bethel Educational Park</p>	<p>- The gully noted on the northern part of the ROW has been repaired again and haybales are in place to try to divert flow. 10/19/05</p> <p>-Silt fence was in good shape in all locations. The slope at the southern end of the ROW should be restored with vegetation even as the road surface is retained per the request of the high school. 10/19/05</p>	<p>- Continue to monitor and repair. 10/19/05</p> <p>- Place mulch and seed or less preferable, stone along the slope. 10/19/05</p>
<p>Hoyts Hill Riser Termination Structure (Off Rt. 58)</p>	<p>- Erosion controls are in good shape here and additional work had not occurred. 10/19/05</p>	<p>- Keep all areas of erosion control maintained until the area can be restored. 10/19/05</p>
<p>Route 58</p>	<p>- Most catch basins near the work areas are being consistently placed with either haybales or fabric and are well protected. 10/19/05</p> <p>- Handhole installation work near the Sunoco had put some stress on the silt fence here. 10/19/05</p>	<p>-In general, contain slurry or mobile sediment to work areas and street sweep the road extent including the gutters, regularly and place and maintain controls on all catch basins and inlets. 10/19/05</p> <p>- Repair any holes and areas that were pushed over. Restore the edge of roadway with seed/mulch when work is finished. 10/19/05</p>

115kV (Bethel Ed. Park): Photo on the left shows the continued attempts to repair the washout area at the northern end of the ROW. The photo on the right shows the southern end of the ROW. Even though the area will be used as a running road as requested by the school, attempt to restore this side slope with vegetation if possible. 10/19/05
