Docket No. 217 – Development and Management Plan Inspection

Northeast Utilities Service Company Certificate of Environmental Compatibility and Public Need for the construction of a 345-kV electric transmission line and reconstruction of an existing 115-kV electric transmission line between Connecticut Light and Power Company's Plumtree Substation in Bethel, through the towns of Redding, Weston, and Wilton, and to the Norwalk Substation in Norwalk, Connecticut.

Date: December 1, 2005

Location: 115 kV Underground Route

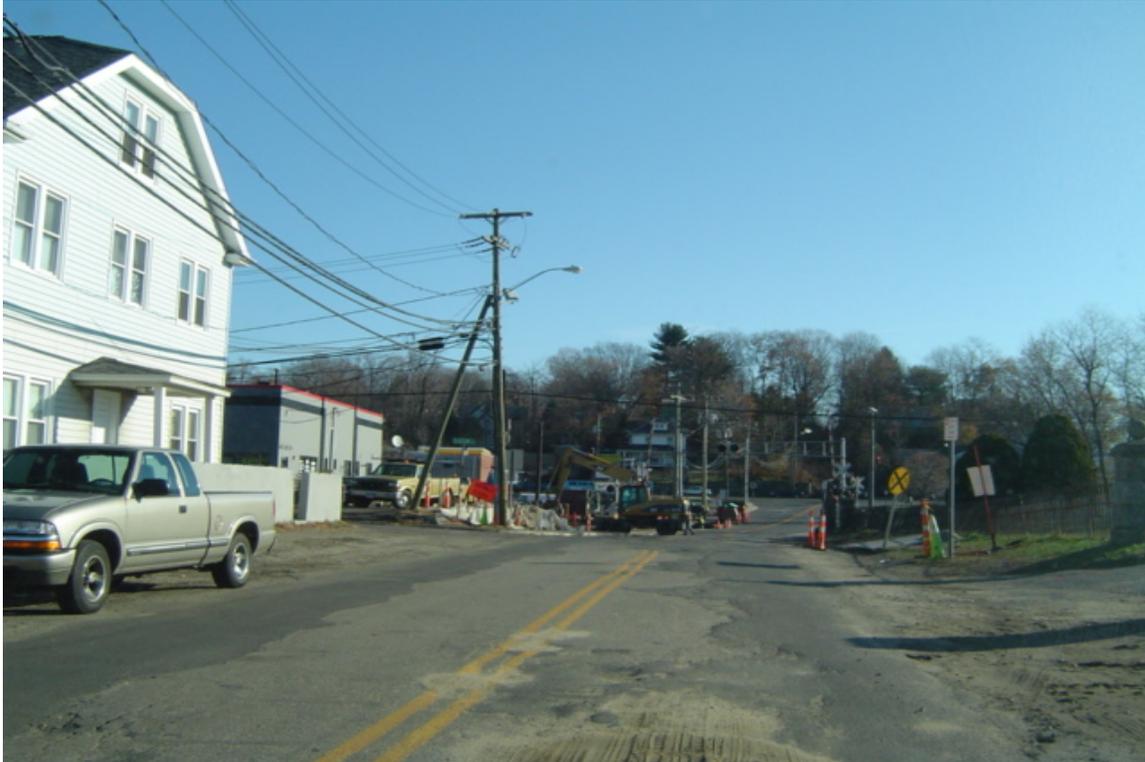
115kV (Broad Street): General overview of the site near the J&B railroad site where both O&G and the separate contractor Henckels and McCoy had been working. Note sediment on the street which should be swept. 12/1/05

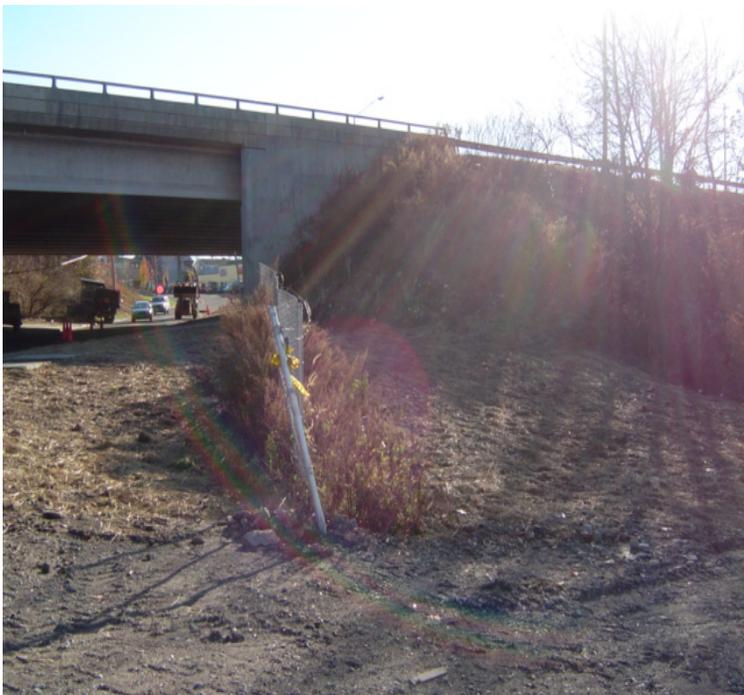
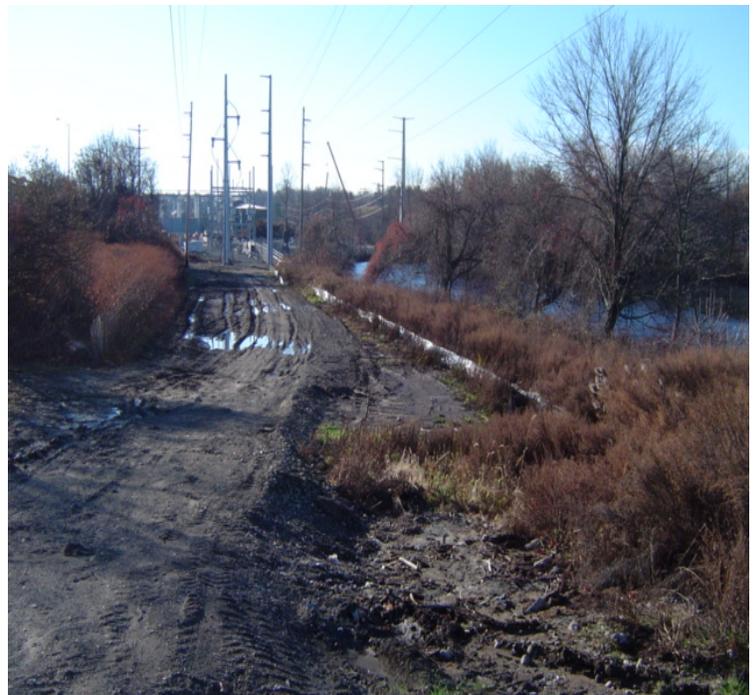
115kV (Broad St. and ROW): Photo on the left shows where mulch was placed along the bare soil slope leading to the ROW from the overpass. Photo on the right shows the ROW waiting for bike path construction. 12/1/05

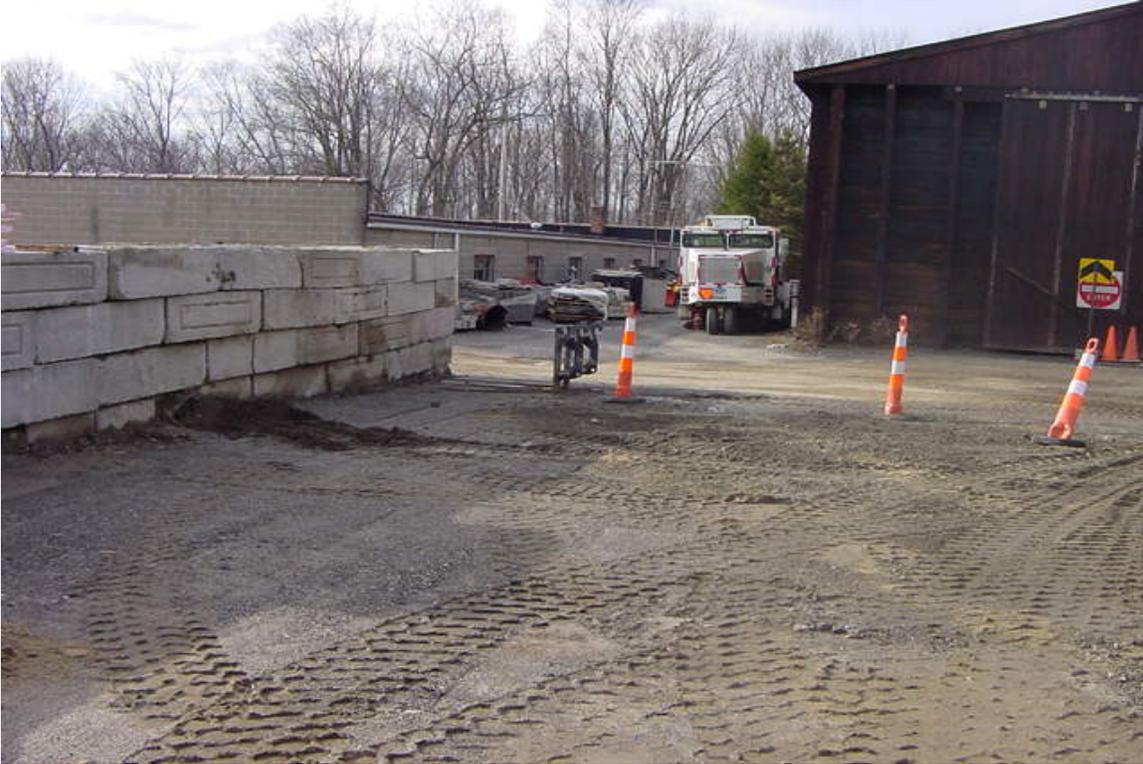
115kV (Redding Yard). The concrete washout is no longer needed by the project and materials have been removed appropriately from the town yard. The area is well restored. 12/1/05

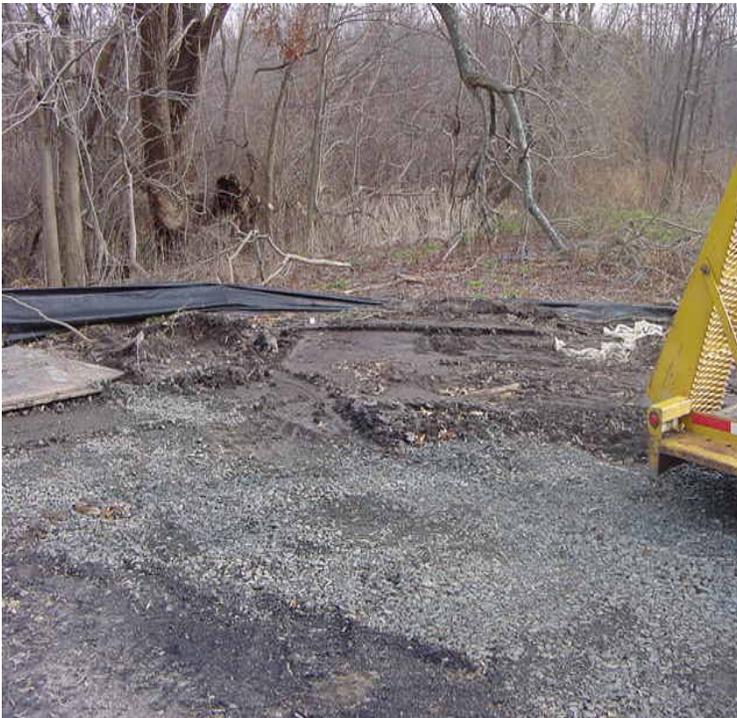
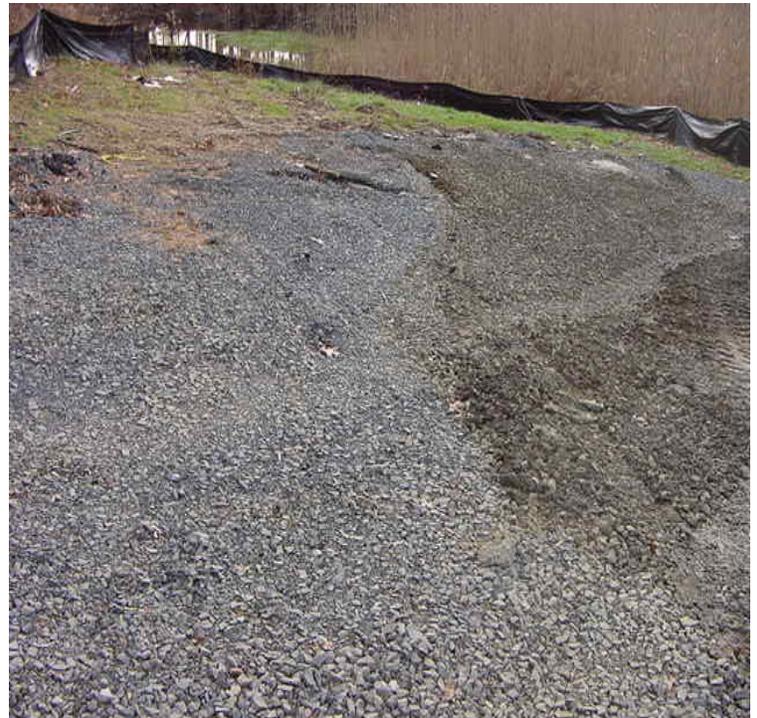
115kV (Rt 107). View of the storage area adjacent to the Redding Country Club. Silt fence was down in a few spots and should be repaired until the yard is no longer in use. 12/1/05

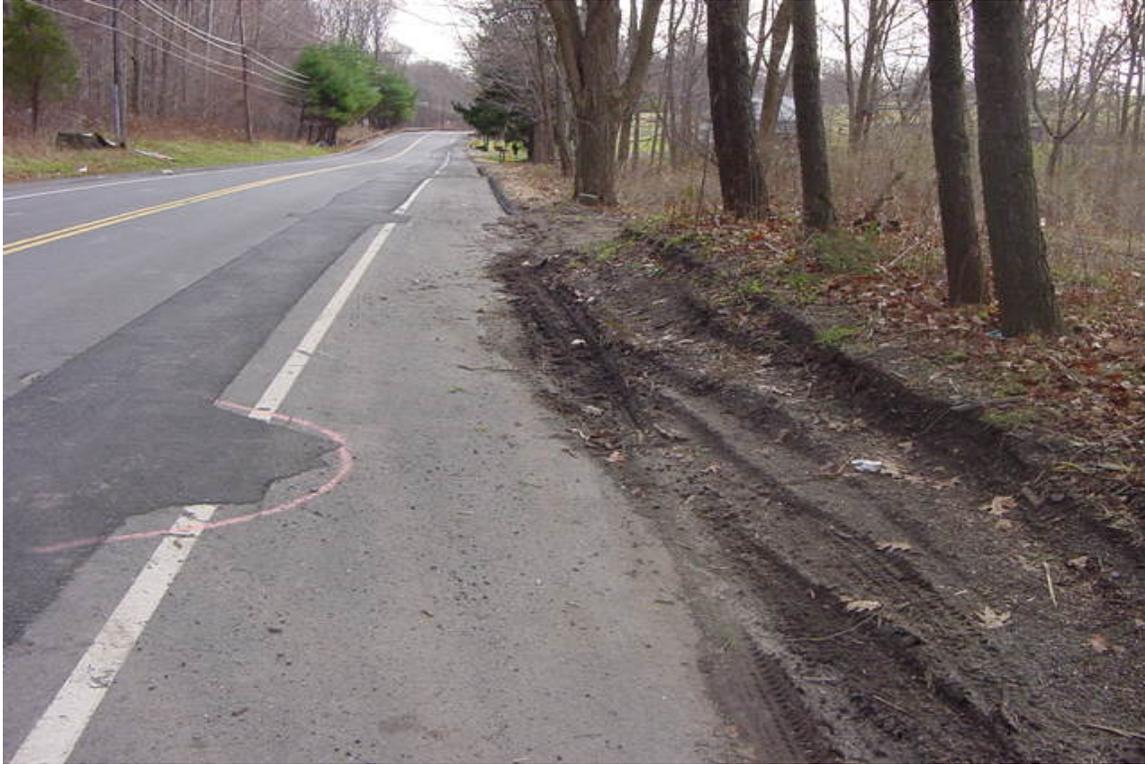
115kV: (Rt. 107 and 58) Areas along the recently repaired roadways are still being placed with bituminous curbing and the soil behind it is being restored. Restoration should continue in all areas with ruts caused by equipment, such as in the foreground of the photo. 12/1/05

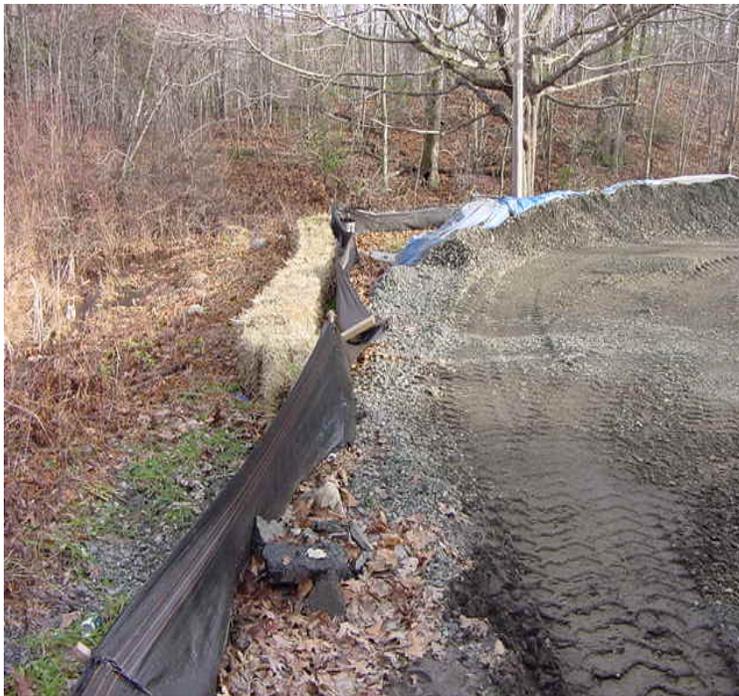
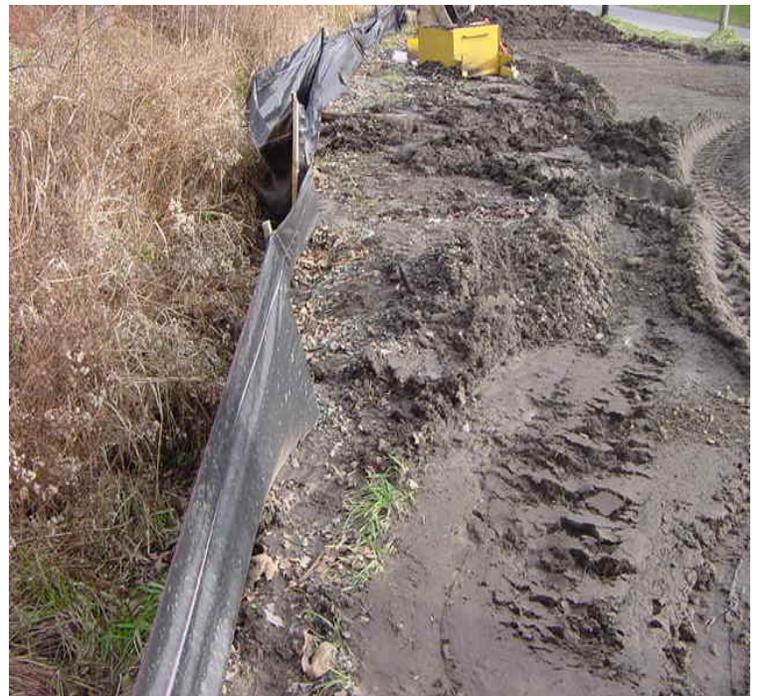
115kV: (Rt. 58) Photo on the left shows the Putnam Park storage area where most equipment and process stone has been removed. Controls remain in place. Photo on the right shows the Sunset Hill Rd. area where equipment and stone are also being removed. 12/1/05

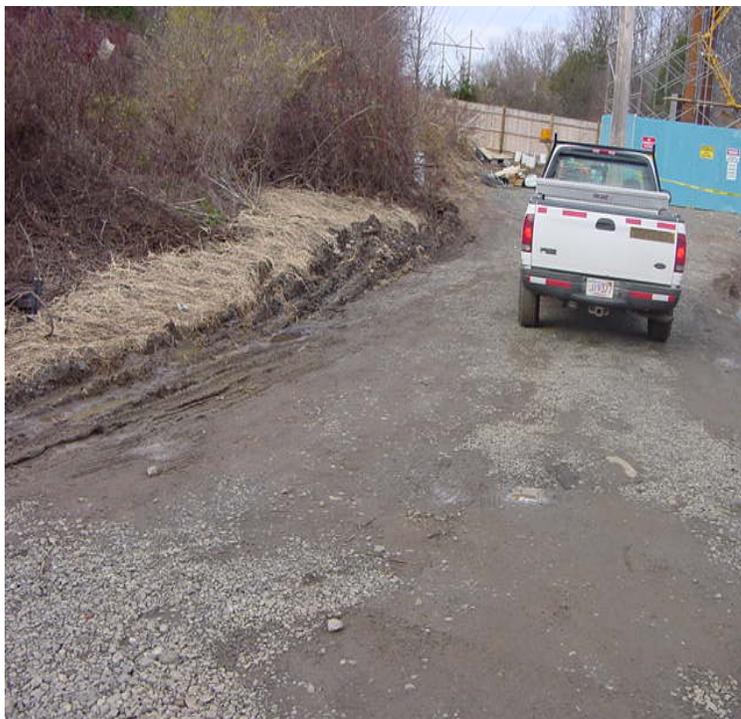
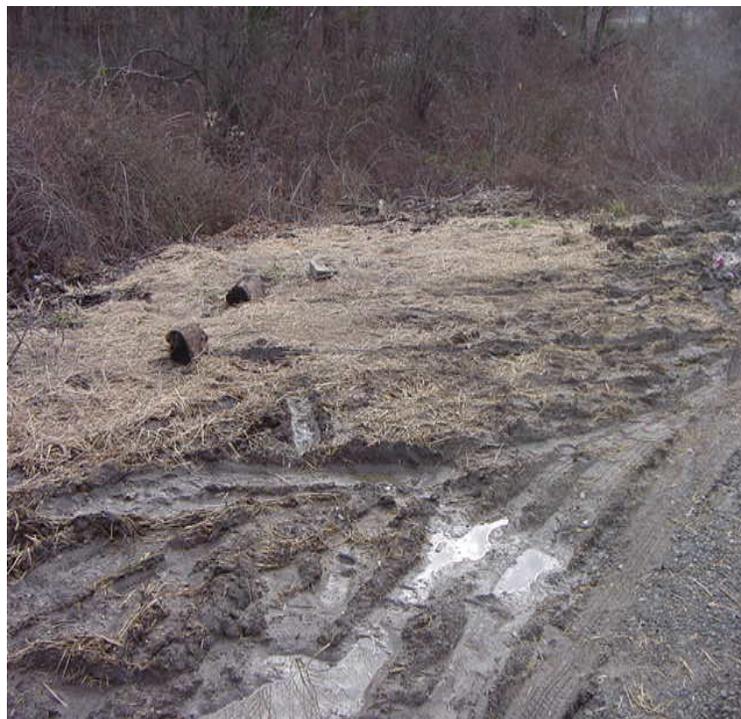
115kV (Hoyts Hill Transition Structure): Both photos (close-up on right) show the area along the access drive into the structure work where equipment movement created ruts in the mud. The area should be re-stabilized when all access needs are complete. 12/1/05

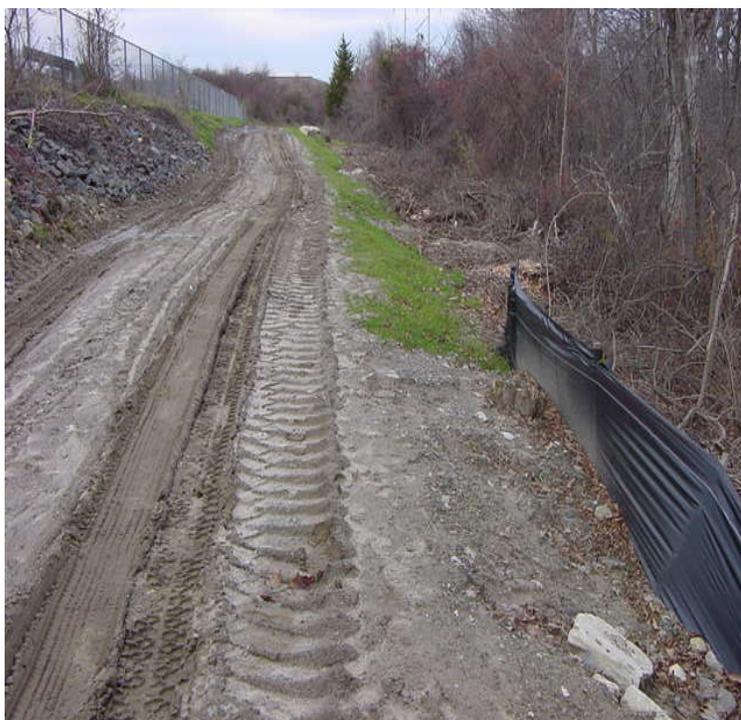
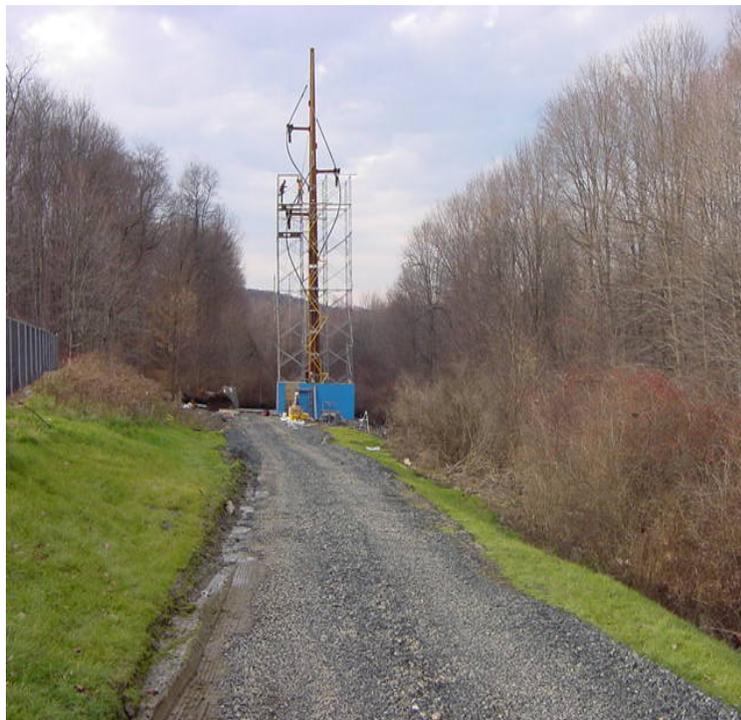
115kV (Bethel Ed. Park): Photo on the left shows ruts along the southern access road due to equipment access. Continue to address any issues when all access needs are complete. Photo on the right shows the northern ROW section looking at work on the tower and stone placed on the access road. 12/1/05
