**Docket No. 217 – Development and Management Plan Inspection**

Northeast Utilities Service Company Certificate of Environmental Compatibility and Public Need for the construction of a 345-kV electric transmission line and reconstruction of an existing 115-kV electric transmission line between Connecticut Light and Power Company's Plumtree Substation in Bethel, through the towns of Redding, Weston, and Wilton, and to the Norwalk Substation in Norwalk, Connecticut.

**Date:** December 14, 2005

**Location:** 115 kV Underground Route

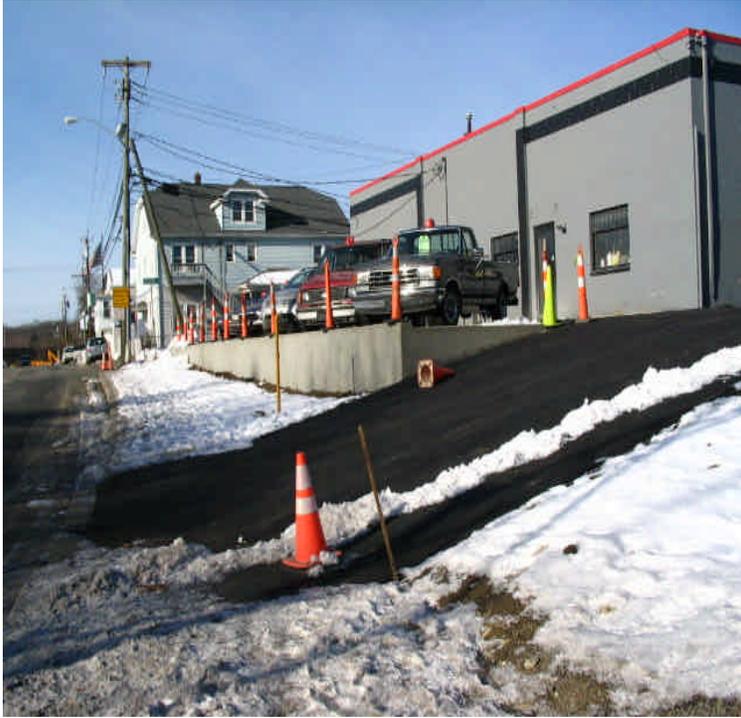
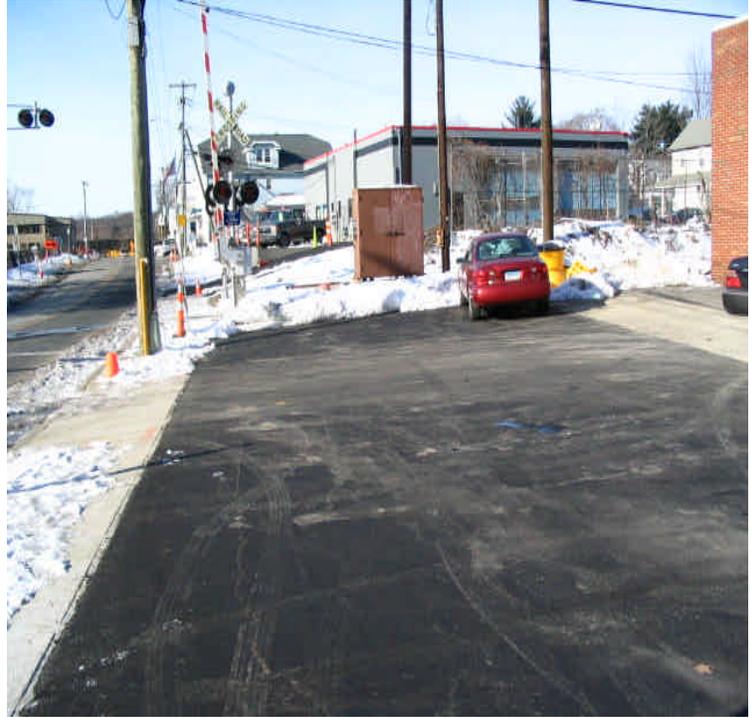
**115kV (Broad Street):** Photo on the left shows a view of the parking lot where the bore pit was previously located. Photo on the right shows the parking lot where the receiving pit was previously located. Both have been restored and repaved. 12/14/05

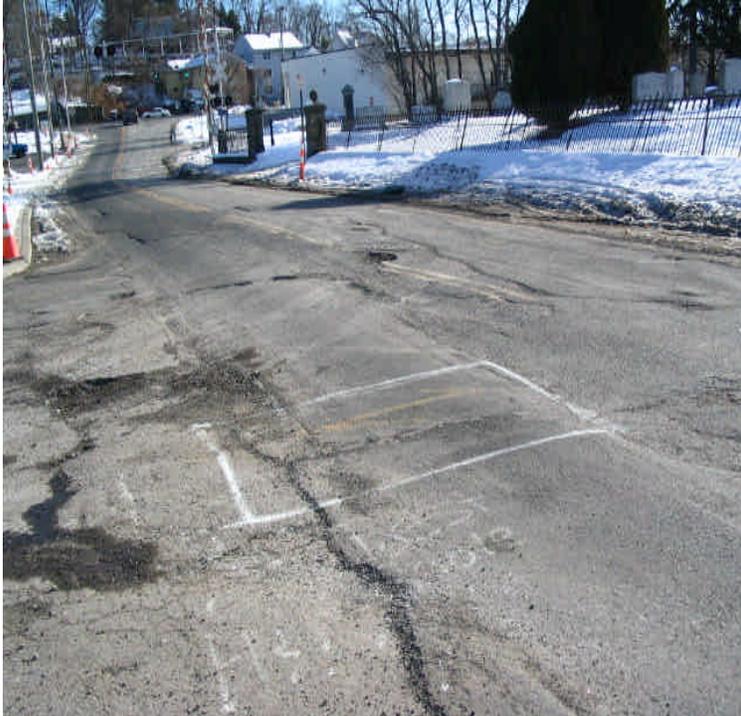
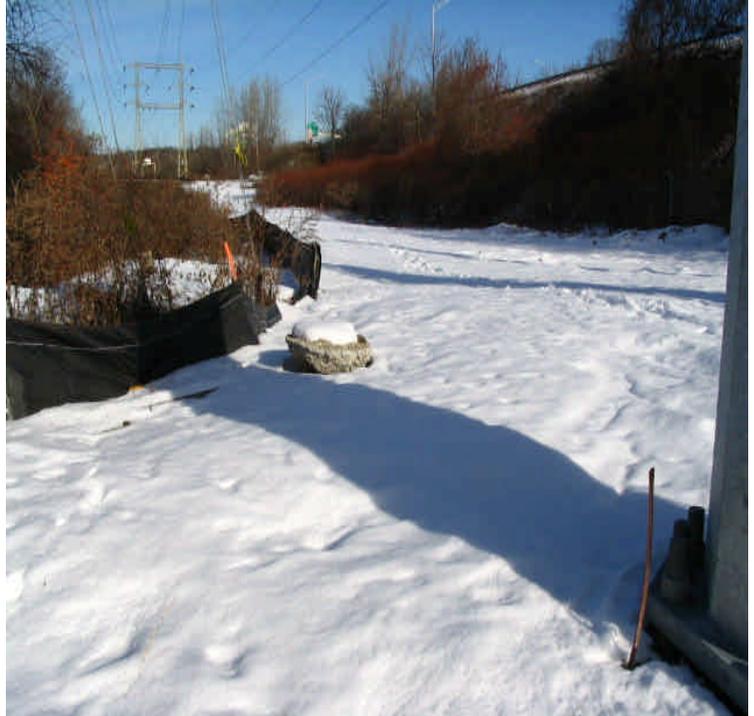
**115kV (Broad St. and ROW):** Photo on the left shows Broad St. following the work. Portions of the work area are fairly rough and may need further re-paving. Photo on the right is the view from the ROW at the substation towards Broad St. 12/14/05

<b>Rt. 58, Bethel</b>	- Several crews were noted working internal to the vaults throughout the project route. 12/14/05	- See additional sections for more information. 12/14/05
<b>Broad Street/ROW, Norwalk</b>	- The jack and bore under the railroad on Broad St. is completed and all affected parking lots and drives have been repaired. 12/14/05	-A few materials were left behind here and the road surface is still fairly rough. 12/14/05

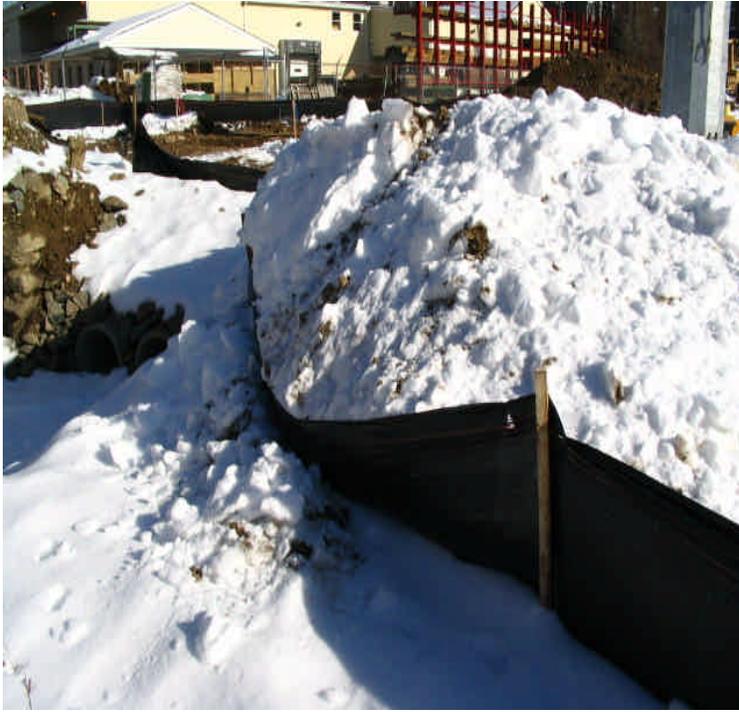
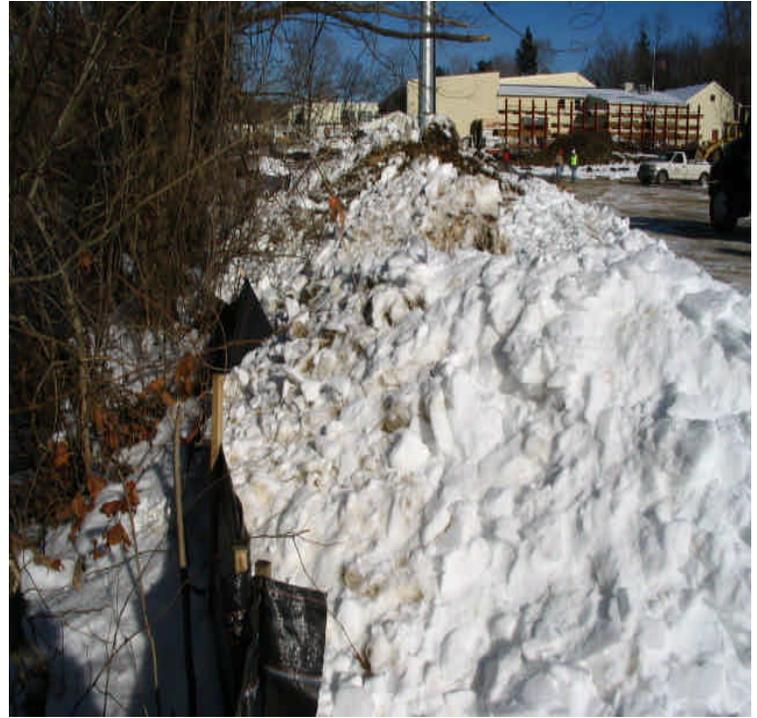
Areas of Inspection	Observation	Recommended Action
<b>Main Ave/ Rt. 7, Norwalk</b>	-Erosion controls were pushed over as a result of the snow plowing at Norwalk Junction- apparently for 115kV related work on the structure. This has pushed sediment laden snow towards the river beyond the silt fence. 12/14/05	- The 115kV contractors should repair the fence and pull back the snow piles if it is determined to be their responsibility. 12/14/05
Contaminated Soils	-Soil disposal is no longer a major component of the project as the trench work is completed. Clean process was brought in to bring roadways to grade and is mostly used up. All remaining soil work is still being handled as approved. 12/14/05	- All soils appear to be handled appropriately. A few stone piles remain at the storage areas. 12/14/05
Adjacent Wetlands and Waterways	-The stream near Sara's Way off Rt. 58 remains clear and banks are free from erosion. 12/14/05  - A small stream crossing near Putnam Park at a vault also remains clear at this time. 11/23-12/14/05	- None at this time. Continue to monitor for final vegetative stabilization. 12/8/05  - Monitor as bare soil remains around the stream. A few haybales could be installed. 12/14/05

**115kV (Norwalk Junction). Both photos show areas where snow was plowed up to and over the existing perimeter fence. Although this is at a transition station, the plowing was apparently part of the 115kV work. The snow should be pulled back and the fence repaired. 12/14/05**

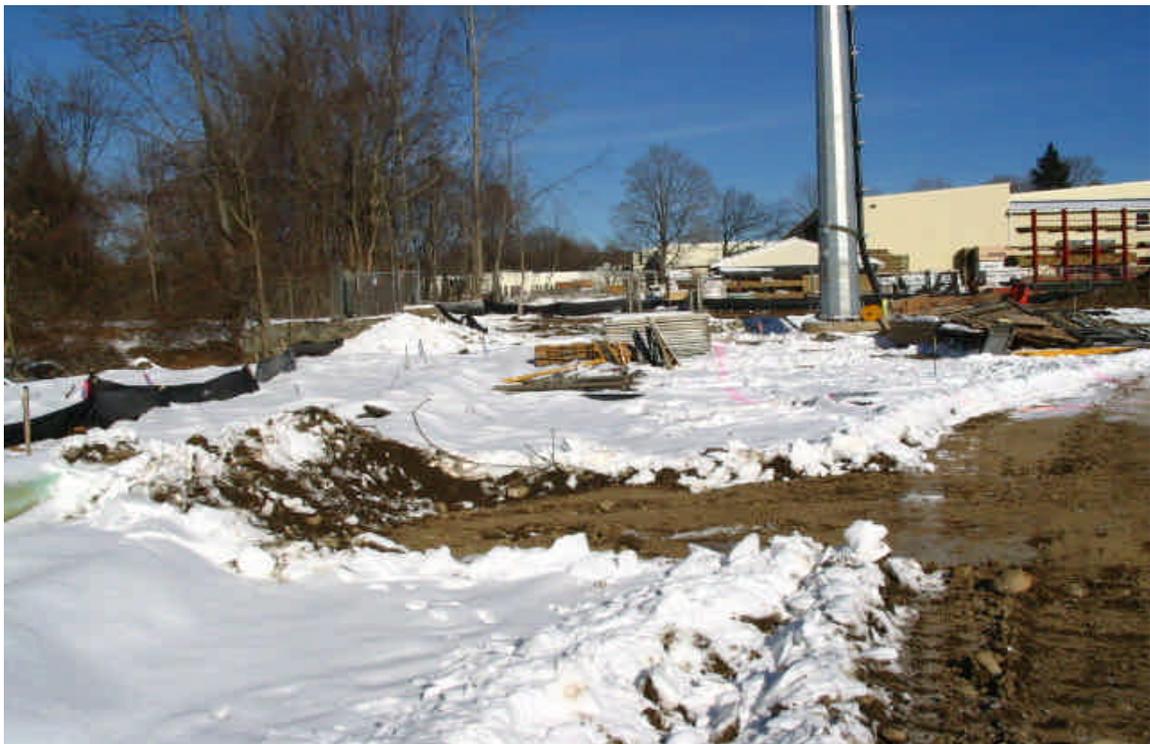
**Overall view of the transition station in the vicinity of the 115kV work. The snow plow pile is noted in the background of the photo up against the silt fence. Plowed snow has associated sediment which is now placed beyond the perimeter barrier. 12/14/05**

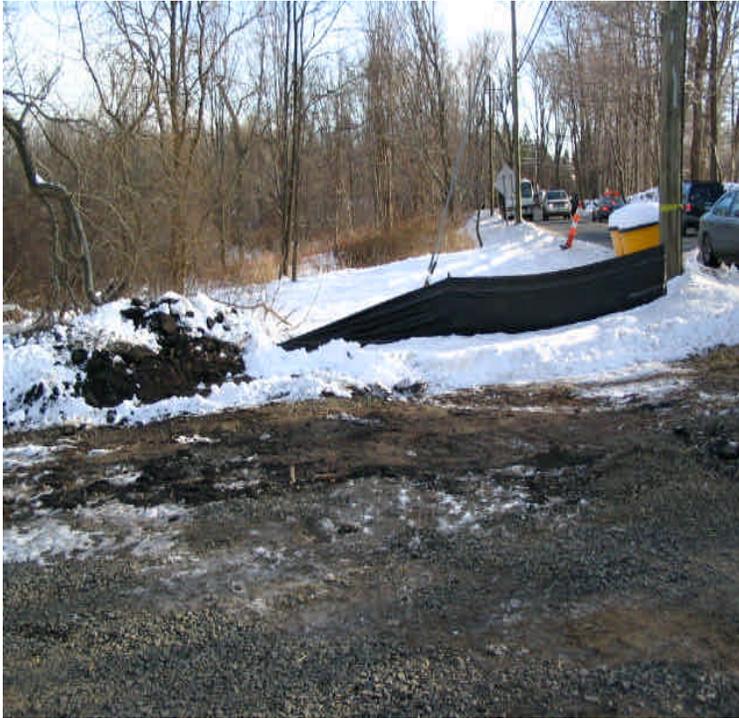
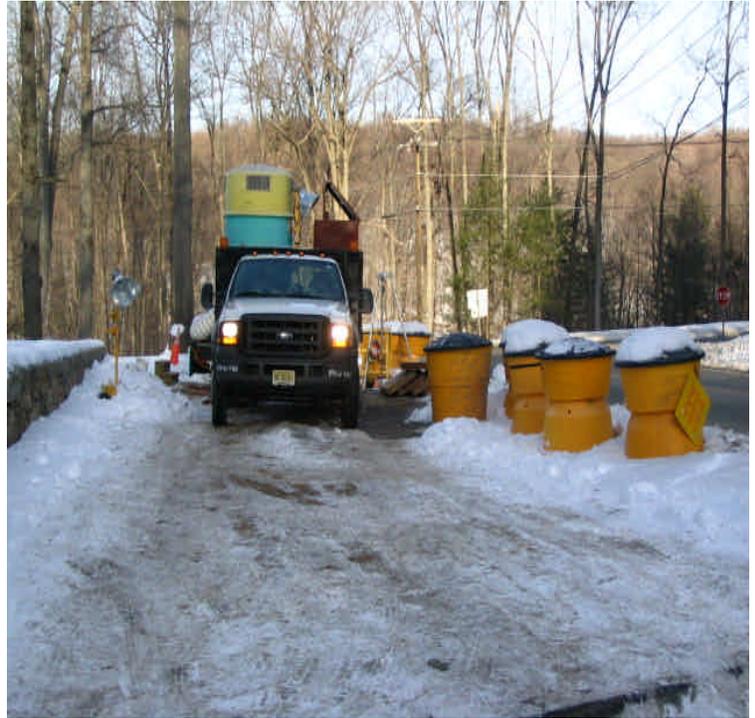
**115kV (Storage yards). Photo on the left shows the storage area near the Rt. 107 90 degree turn. Similar issues with snow plowing were noted here and fence was down. Photo on the right shows internal vault work near Putnam Park. 12/14/05**

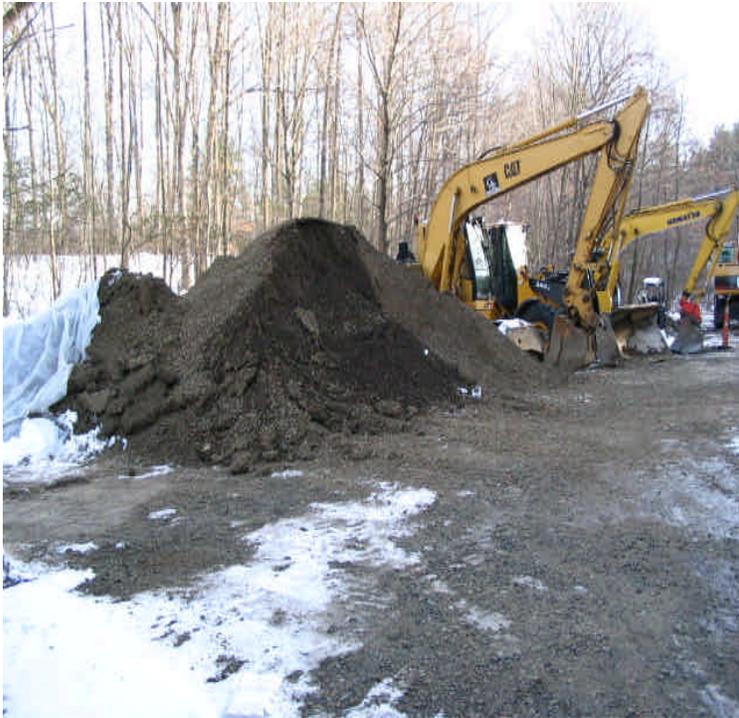
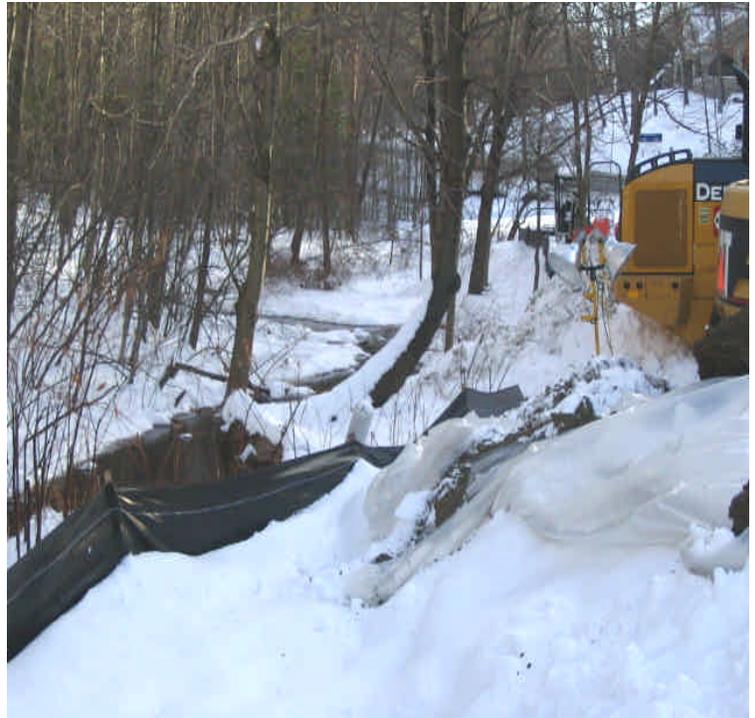
Staging, Storage, and Parking Areas	- At the storage area off Rt. 58 near Putnam Park controls were pushed over by sediment laden snow plow piles in some locations. 12/14/05  - The Sunset Hill Rd. storage yard has similar snow plow issues. 12/14/05  -The area across from the country club near the 90 degree turn on Rt. 107 has similar snow plow issues. 12/14/05	-Snow needs to be pulled back and erosion controls repaired. Retain the silt fence here due to the proximity of the pond while the yard surface is disturbed. 12/14/05  - Maintain fence as long as the area is being used but it can be pulled if the storage areas are mulched/restored. Snow cover may now be factor.12/8-12/14/05  - Maintain fence in the Rt. 107 yards as they are in use and have disturbed soil. 12/14/05
State species of concern, threatened and endangered species	- No species of concern are located in the areas of construction.	- N/A

**115kV (Putnam Park Storage Area) Photo on the left shows a stockpile remaining at the storage area, partially covered in plastic and contained to the site. Photo on the right shows similar issues with snowplowing piled up and over the silt fence adjacent to the wetland. 12/14/05**

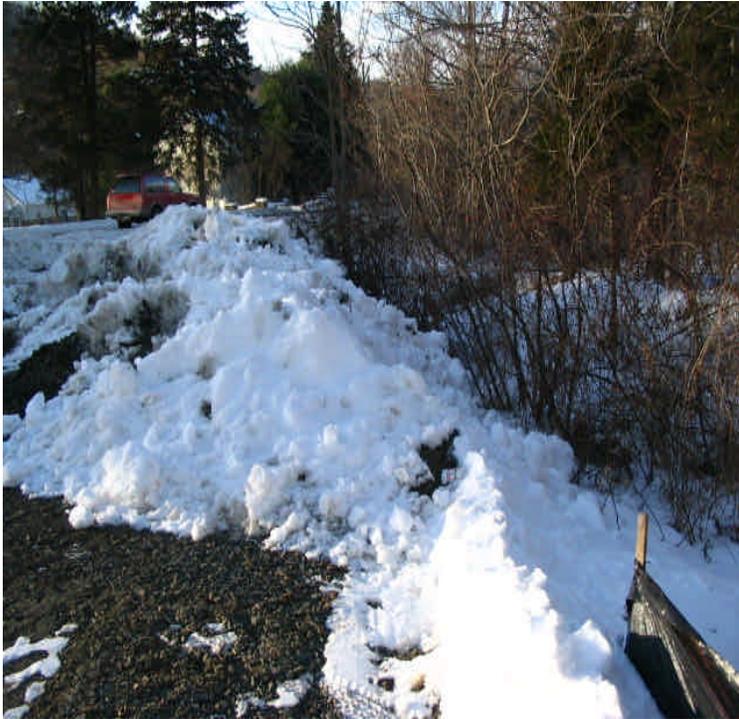
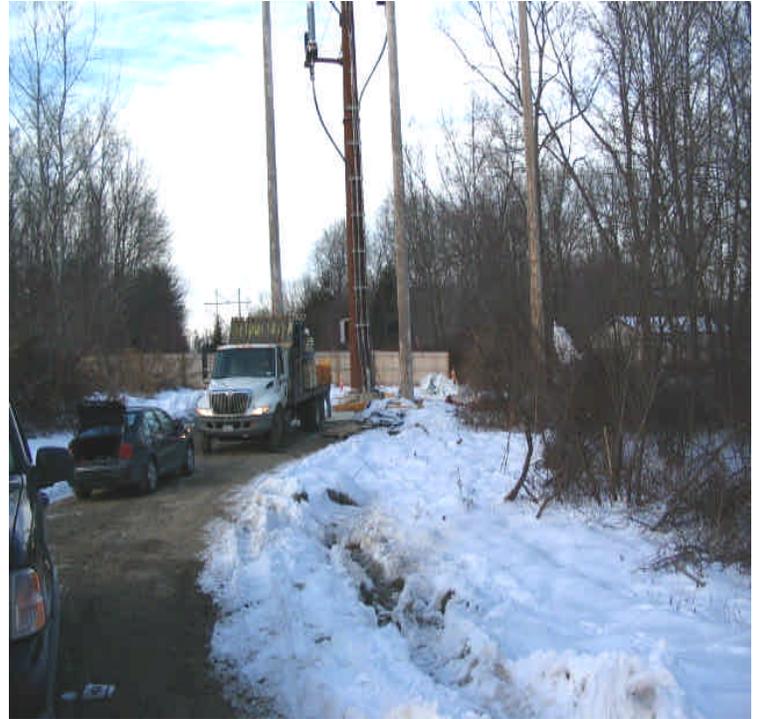
**115kV: (Sunset Hill and Hoyts Hill) Photo on the left shows similar snow issues at Sunset Hill Storage Area. Photo on the right shows the work on the pole structure here. Note that additional ruts were created to the right of the access drive due to equipment access. 12/14/05**

<b>Hoyts Hill Riser Transition Structure (Off Rt. 58)</b>	- Work is nearing completion on the pole structure. 12/14/05 - Equipment access has created additional ruts along the sides of the drive in the mud. 11/23-12/14/05	- The ruts should be graded and mulch added to the area when the equipment access is complete but snow cover is now a factor. 12/14/05

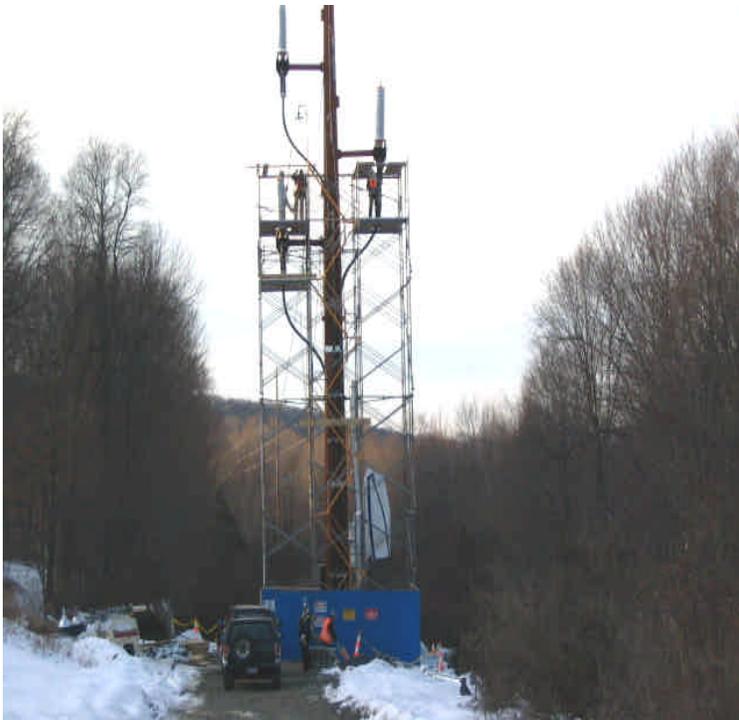
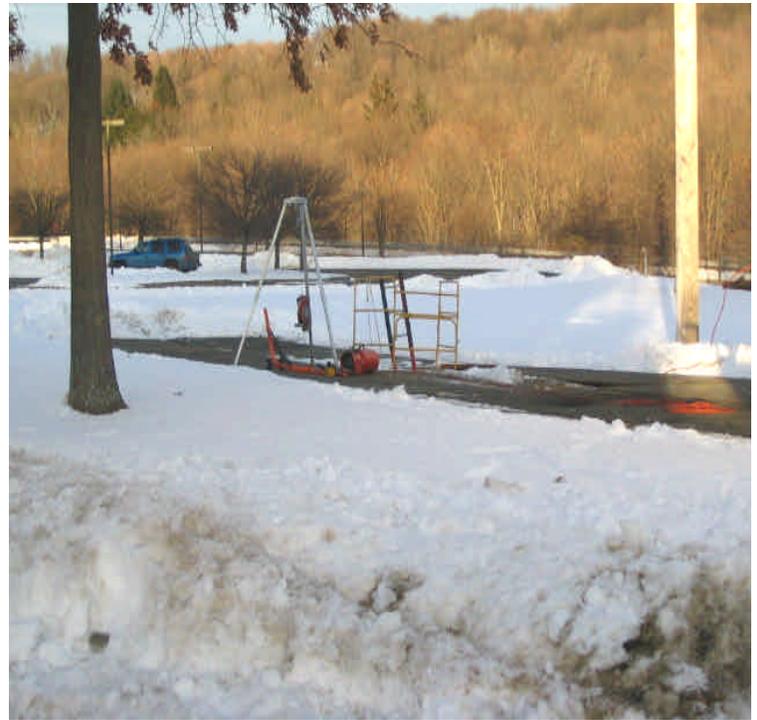
**115kV: (Bethel Education Park) Photo on the left shows a view of the work on the north tower with scaffolding. Photo on the right shows work internal to the vault located near Bethel Middle School. 12/14/05**
