Docket No. 217 – Development and Management Plan Inspection

Northeast Utilities Service Company Certificate of Environmental Compatibility and Public Need for the construction of a 345-kV electric transmission line and reconstruction of an existing 115-kV electric transmission line between Connecticut Light and Power Company's Plumtree Substation in Bethel, through the towns of Redding, Weston, and Wilton, and to the Norwalk Substation in Norwalk, Connecticut.

Date: January 19, 2005

Location: 345kV XLPE Component

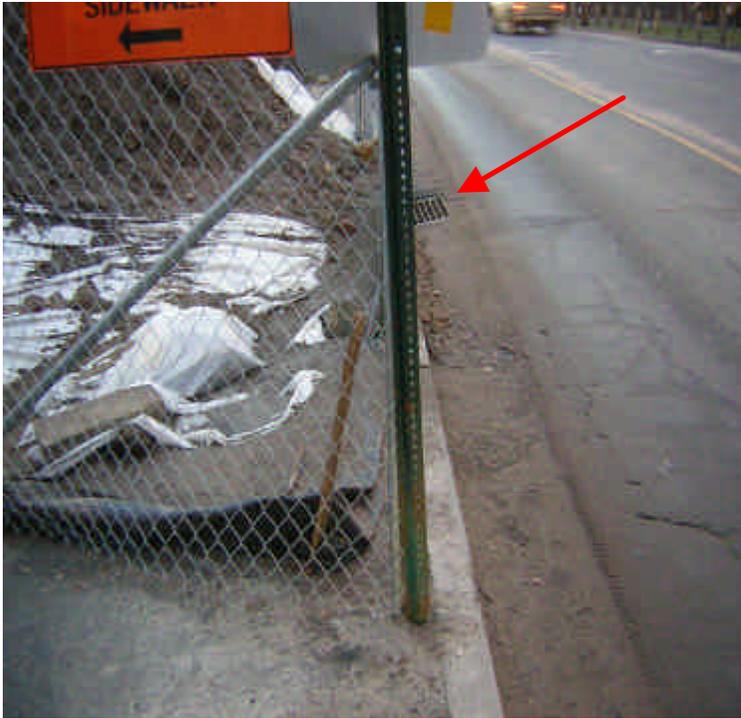
Erosion and Sediment Controls (includes inspection within 24 hours of a storm event)	<ul style="list-style-type: none"> -The plastic covering slipped off the stockpile on site due to the heavy rains. Sedimentation was noted over the downed silt fence here and it entered the street to some degree. 1/19/06 	<ul style="list-style-type: none"> - Repair and toe in the silt fence if feasible. If not, install haybales. Repair the plastic covering and secure it to reduce runoff. 1/19/06

345kV XLPE (Jack and Bore): Photo on the left shows where the plastic covering slipped off the stockpile and sediment migrated into the roadway. The fence needs to be righted and repaired and haybales should be placed if the fence cannot be toed. Catch basins need controls installed.

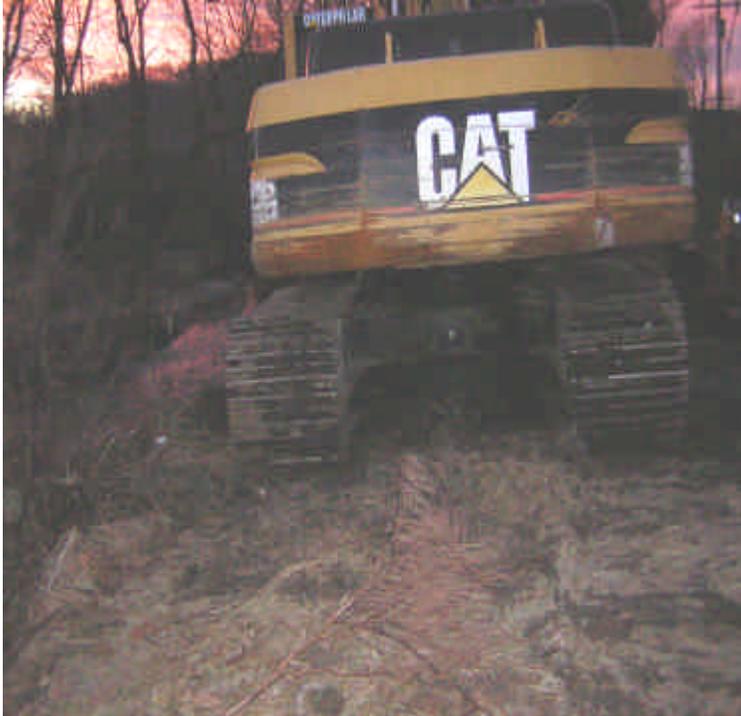
Photo on the left shows work beginning on the receiving pit on the opposite side of the intersection. Equipment was left overnight immediately on the bank of the river. Machinery should be moved back from resource areas when there are alternatives. Photo on the right shows the beginning of sheet piling installation here. 1/19/06
