**Docket No. 217 – Development and Management Plan Inspection**

Northeast Utilities Service Company Certificate of Environmental Compatibility and Public Need for the construction of a 345-kV electric transmission line and reconstruction of an existing 115-kV electric transmission line between Connecticut Light and Power Company’s Plumtree Substation in Bethel, through the towns of Redding, Weston, and Wilton, and to the Norwalk Substation in Norwalk, Connecticut.

**Date:** January 26, 2005

**Location:** 345kV XLPE Component

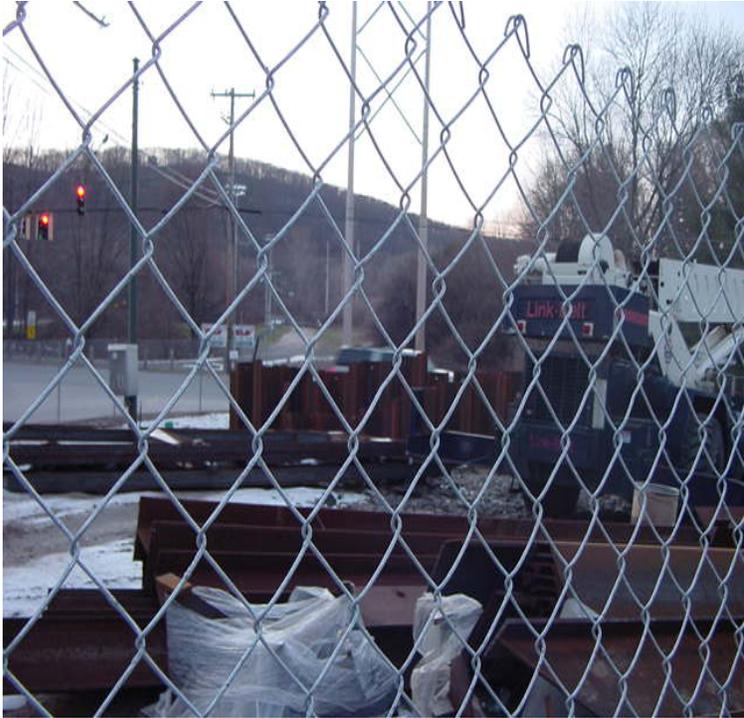
345kV XLPE (Jack and Bore): Photo on the left shows a view of the site with sheet piling. Photo on the right shows the stockpile which needs to be recovered or better controls placed at the base. 1/26/06

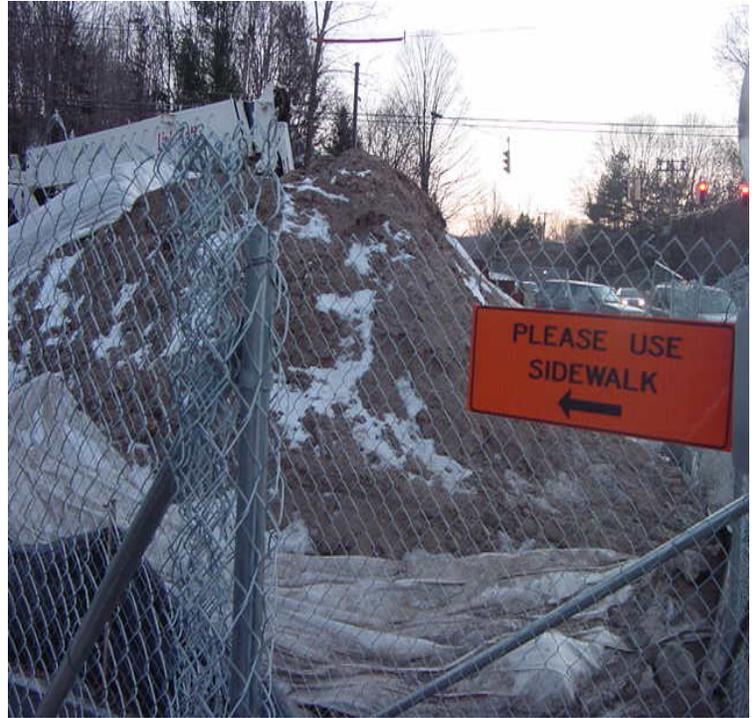
Erosion and Sediment Controls (includes inspection within 24 hours of a storm event)	<p>-The plastic covering slipped off the stockpile on site due to the previous heavy rains. Sedimentation was noted over the downed silt fence here and</p>	<p>- Repair and toe in the silt fence if feasible. If not, install haybales. Repair the plastic covering and secure it to reduce runoff. 1/19-1/26/06</p>

Areas of Inspection	Observation	Recommended Action
	<p>it had entered the street to some degree. 1/19-1/26/06</p> <p>-Fabric was placed in the adjacent catch basin in the roadway to prevent sedimentation as recommended. 1/26/06</p> <p>- The silt fence adjacent to the river still appears to be well in place but run-off from a storm pipe has created a small gap. 1/4-1/26/06</p> <p>-Silt fence was installed on the receiving side as recommended. 1/26/06</p>	<p>- None at this time. 1/26/06</p> <p>- Place a haybale here if feasible in order to provide some filtration. 1/12-1/26/06</p> <p>-Continue to monitor and maintain and extend to provide further coverage if necessary. 1/26/06</p>
<p>Inland Wetland and Watercourse encroachment and mitigation</p>	<p>-East Swamp Brook crosses under Plumtrees Rd. and is located to the east of the pad. The stream was clear at this time. 1/26/06</p> <p>- Vegetative clearing was occurring in the wetland adjacent to Hoyts Hill. 1/26/06</p>	<p>- None at this time.1/26/06</p>

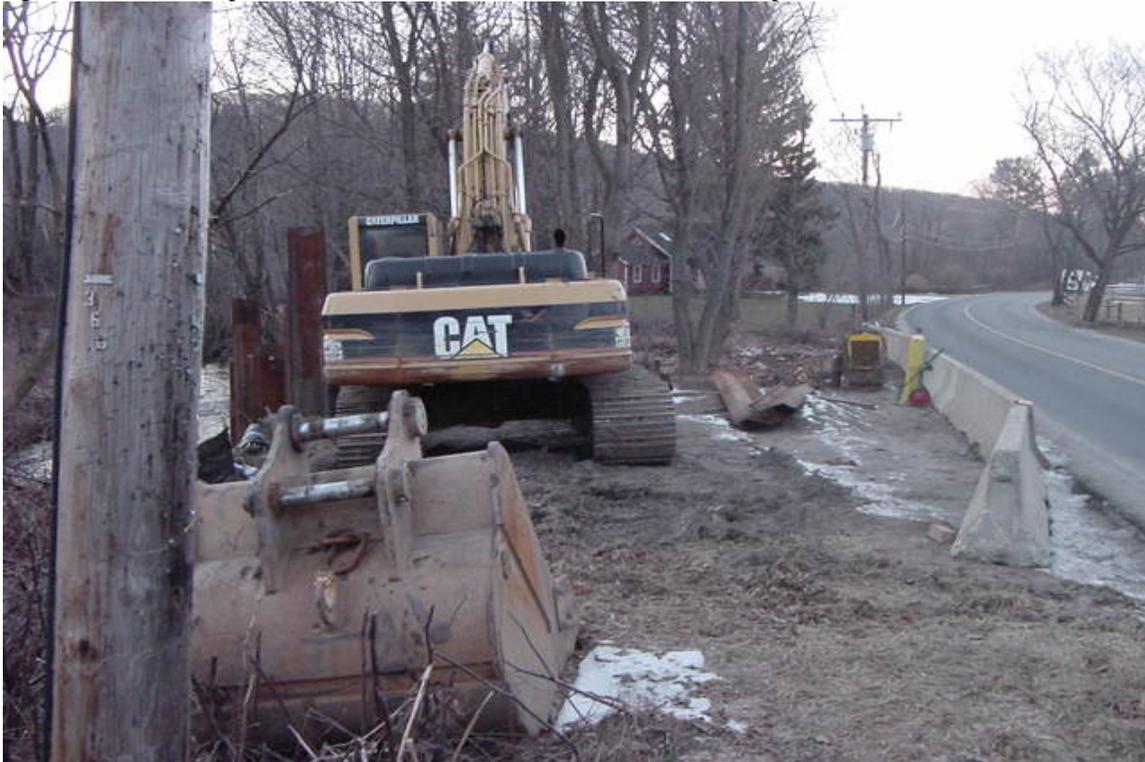
Photo shows the beginning of the work at the receiving side of the stream. Some silt fence had been installed as recommended but continue to maintain as necessary. 1/26/06
