Docket No. 217 – Development and Management Plan Inspection

Northeast Utilities Service Company Certificate of Environmental Compatibility and Public Need for the construction of a 345-kV electric transmission line and reconstruction of an existing 115-kV electric transmission line between Connecticut Light and Power Company's Plumtree Substation in Bethel, through the towns of Redding, Weston, and Wilton, and to the Norwalk Substation in Norwalk, Connecticut.

Date: February 16, 2005

Location: 345kV XLPE Component

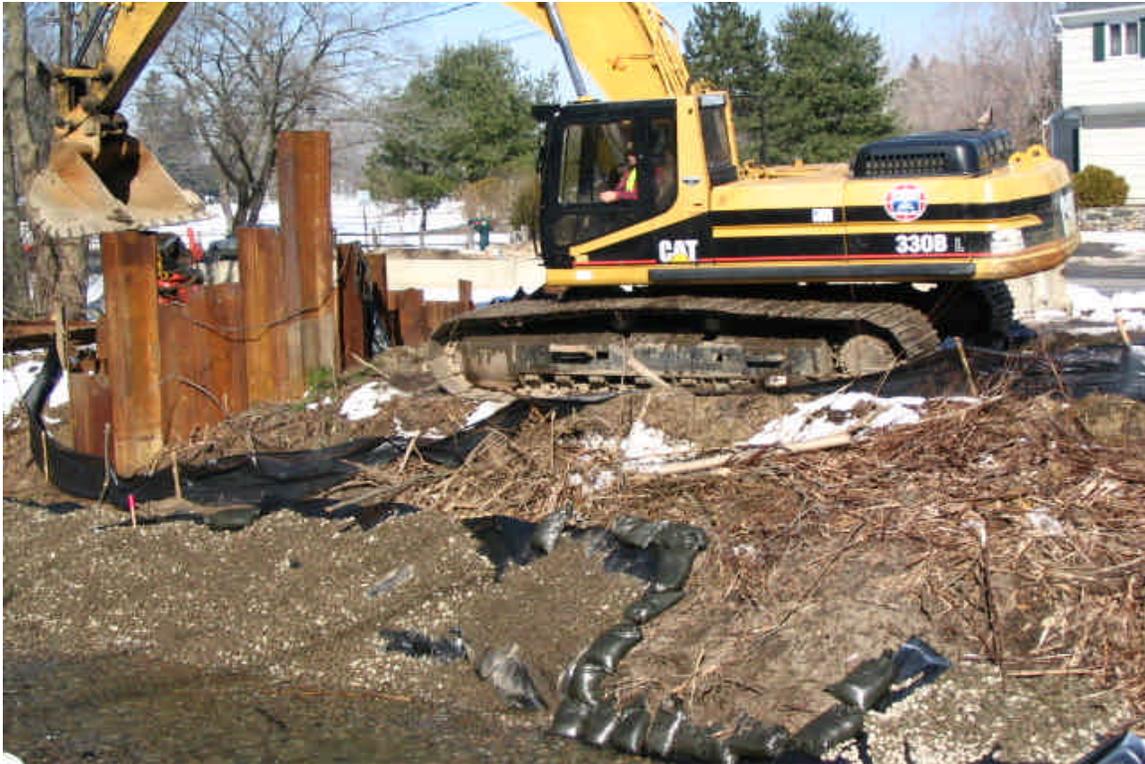
345kV XLPE (Jack and Bore): Photo shows the receiving side of the stream where a plastic liner has been installed under the stream bed and up along the bank. Soil was placed back over the liner. Watch for any erosion issues. 2/16/06

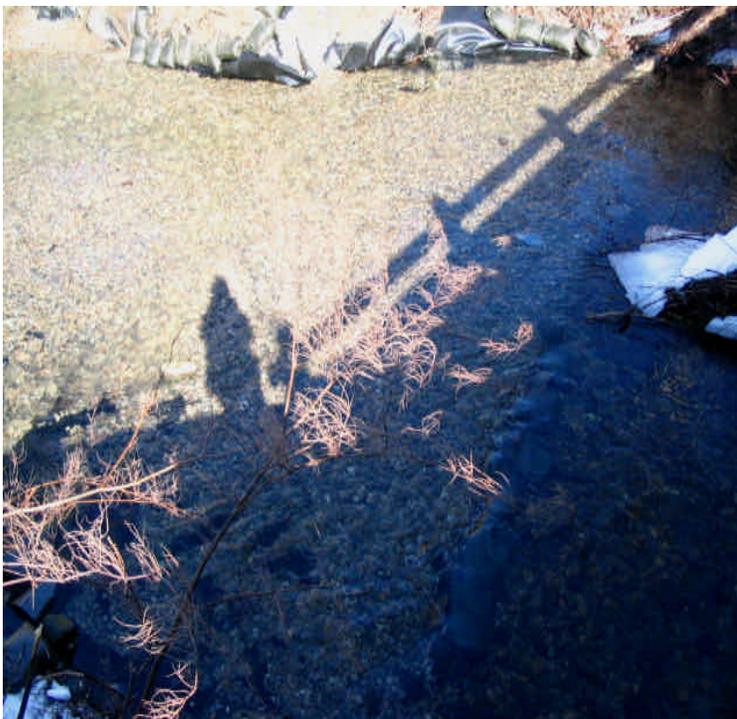
Photo on the left shows the streambed with the liner installed and stones put in place over it. The liner is intended to keep water from seeping into the bore trench. Photo on the right shows the pad where the stockpile was removed and silt fence was righted. 2/16/06

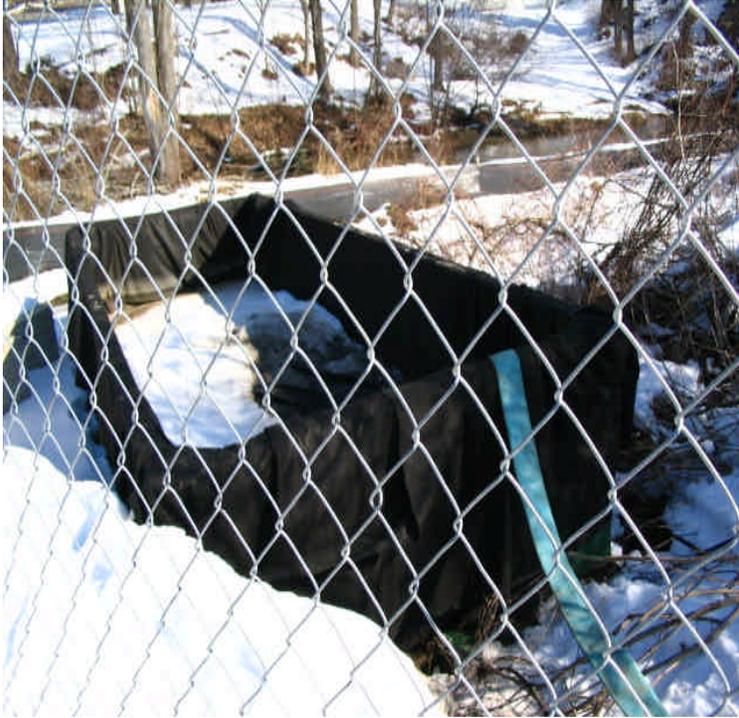
Photo on the left shows the dewatering box at the jack and bore. Minor dewatering has been necessary and it was handled well by the controls. Photo on the left is of the clearing at Hoyts Hill. Stone has been installed at the access point from Rt. 58 for stability. 2/16/06

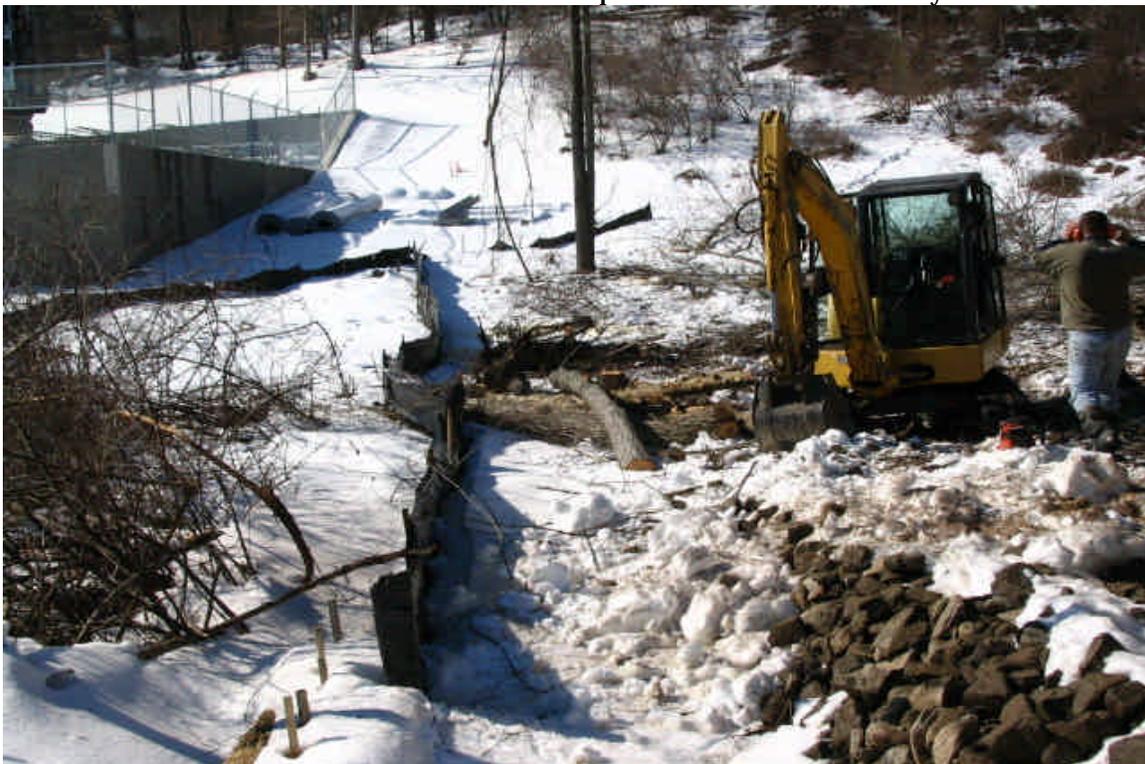
Hoyts Hill: Clearing is almost complete with several trees remaining and others being chipped. The stone access was in place and an additional stone or a mat may be necessary beyond. Contractors were going to check the status of the soil here. 2/16/06
