**Docket No. 217 – Development and Management Plan Inspection**

Northeast Utilities Service Company Certificate of Environmental Compatibility and Public Need for the construction of a 345-kV electric transmission line and reconstruction of an existing 115-kV electric transmission line between Connecticut Light and Power Company's Plumtree Substation in Bethel, through the towns of Redding, Weston, and Wilton, and to the Norwalk Substation in Norwalk, Connecticut.

**Date:** February 23, 2005

**Location:** 345kV XLPE Component

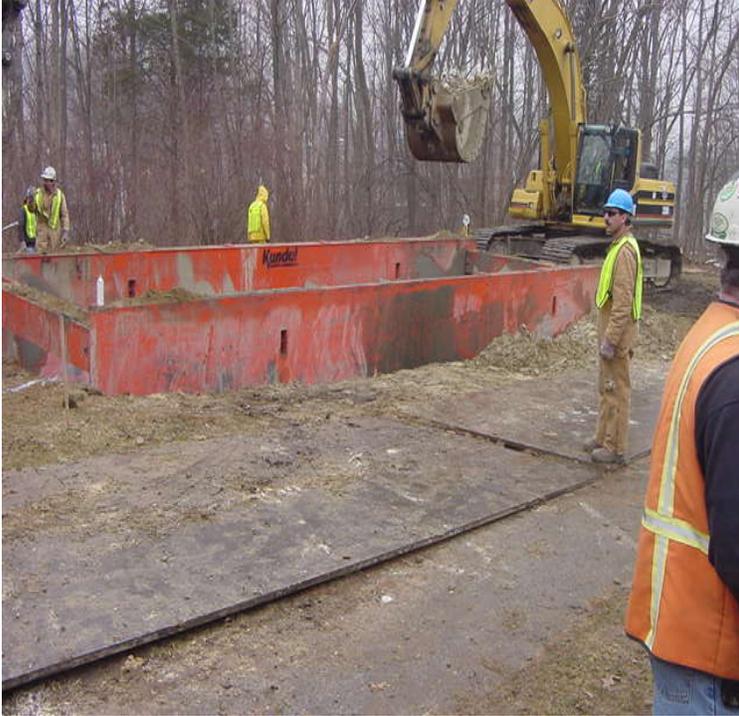
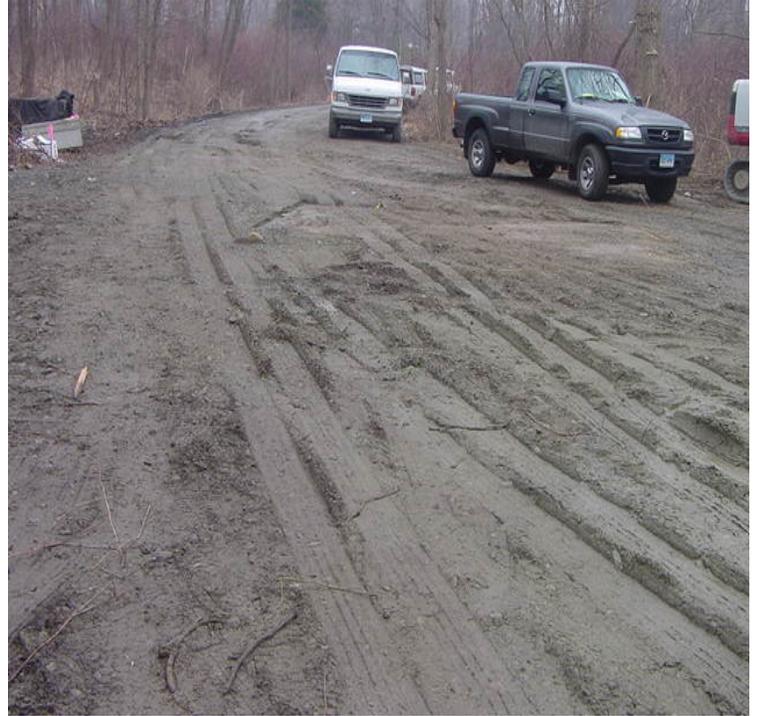
345kV XLPE (Vault 1A-B): Both photos show the work within the access drive to Plumtree Substation where a vault is being installed and trenching is beginning for this portion of the project. 2/23/06

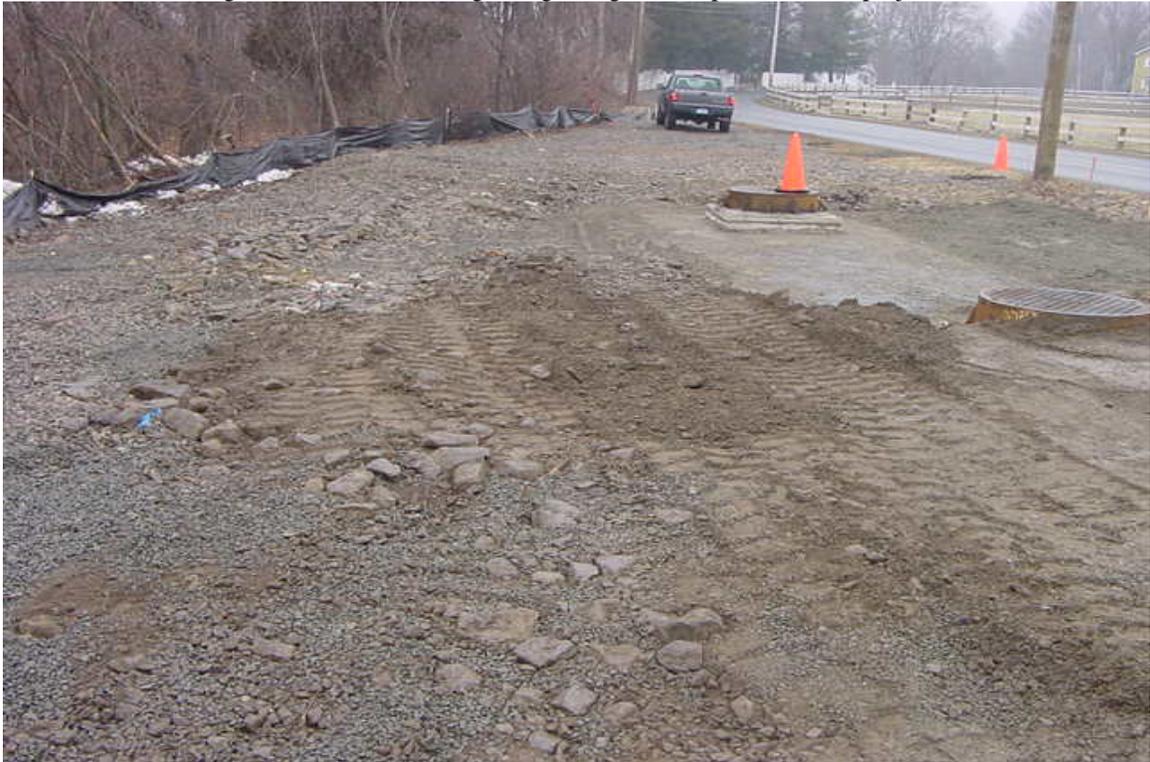
(Vault 2A-B) Photo shows a view of the pull-off along Walnut Hill Rd. where the vault was installed and stone was placed as permanent cover. A small repair was needed to the silt fence. 2/23/06

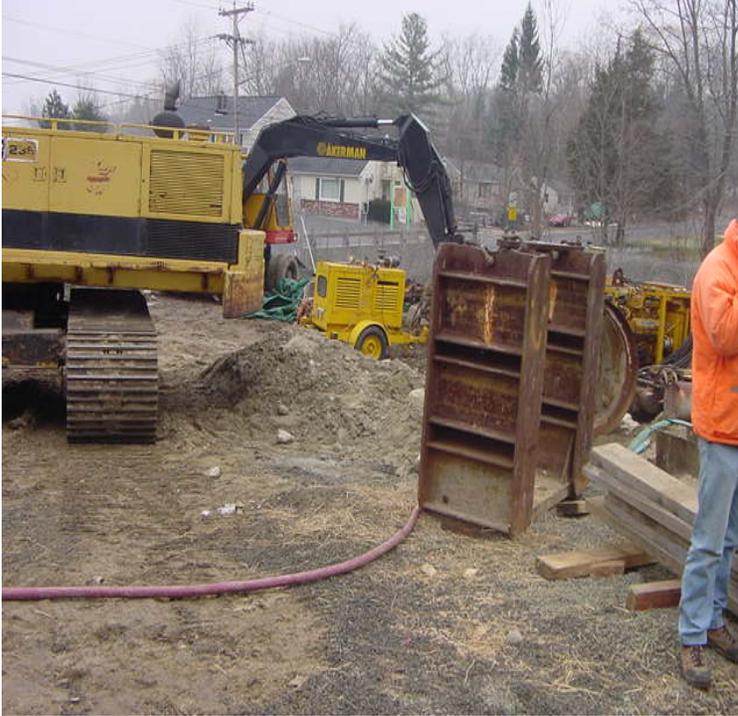
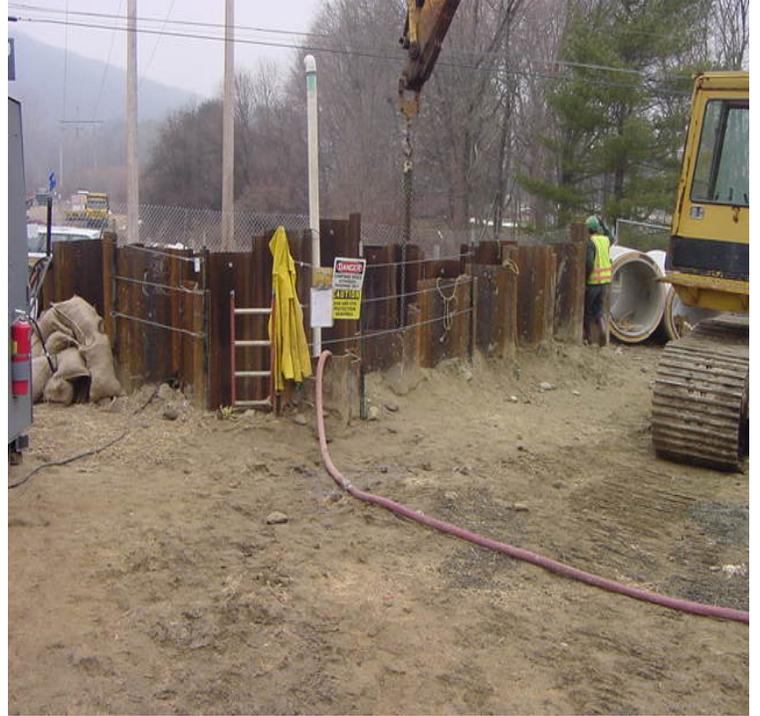
(Jack and Bore): Both photos show a view of the pad on the bore pit side of the stream. Excavation is ongoing within the shoring. Some dewatering has been requires and is well contained. 2/23/06

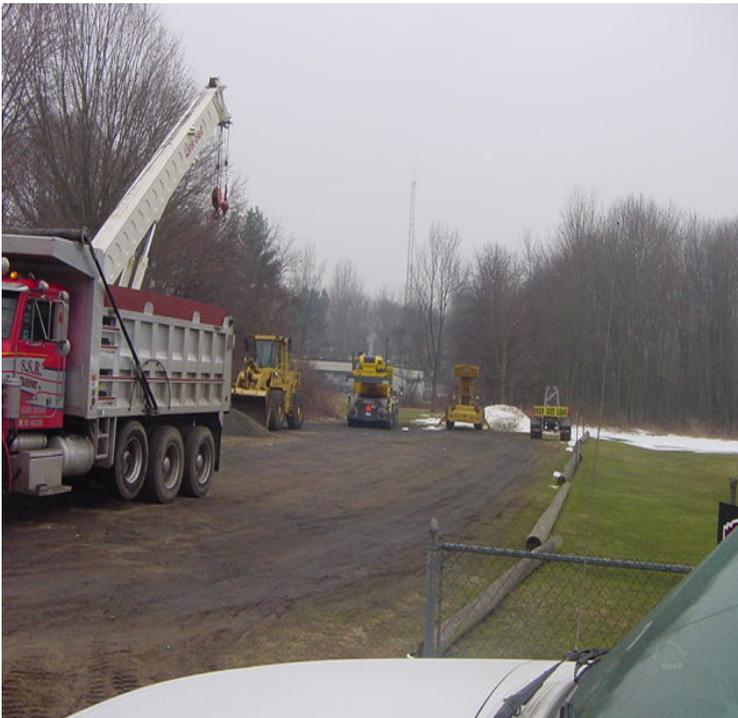
(J&B and Hoyts Hill): Photo on the left shows the ball park where equipment is temporarily stored and parked. Photo on the right shows the completed clearing along the stretch between Hoyts Hill and Rt. 58. Controls remain in place. 2/23/06
