Docket No. 217 – Development and Management Plan Inspection

Northeast Utilities Service Company Certificate of Environmental Compatibility and Public Need for the construction of a 345-kV electric transmission line and reconstruction of an existing 115-kV electric transmission line between Connecticut Light and Power Company's Plumtree Substation in Bethel, through the towns of Redding, Weston, and Wilton, and to the Norwalk Substation in Norwalk, Connecticut.

Date: March 9, 2005

Location: 345kV XLPE Component

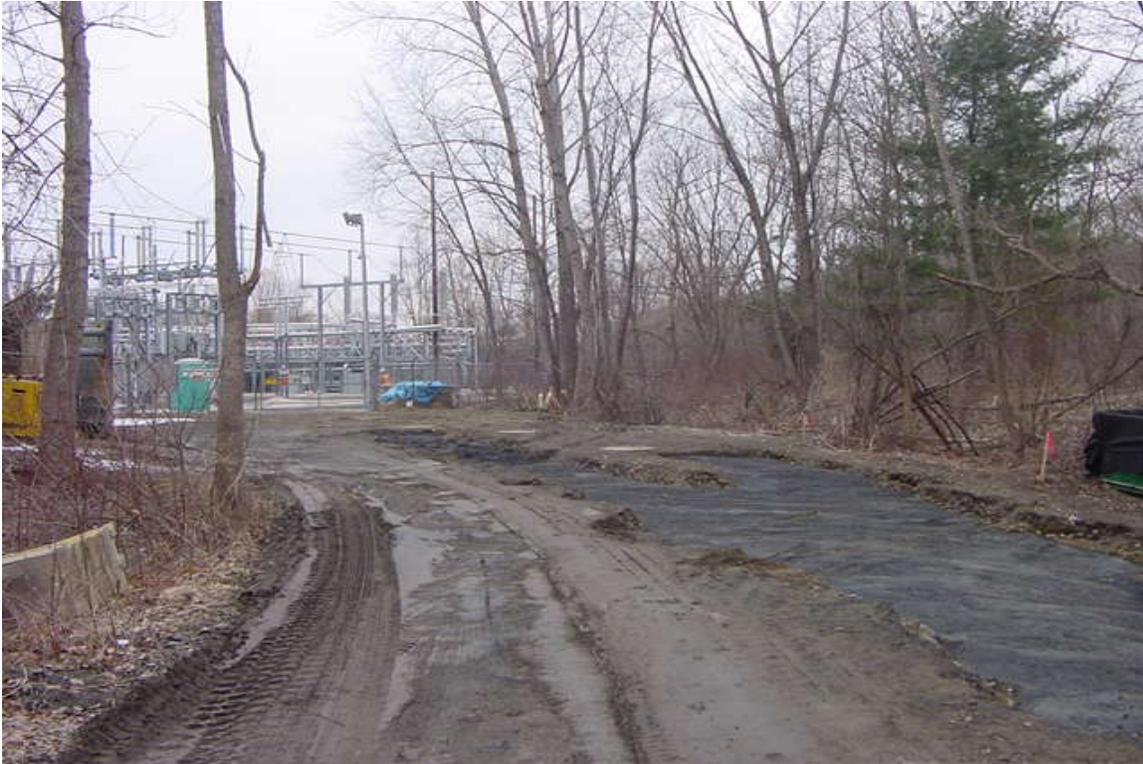
345kV XLPE (Plumtree Substation): View of the work adjacent to Plumtree Substation where the conduit and vault installation is complete. Backfill and grading is still scheduled to occur. 3/9/06

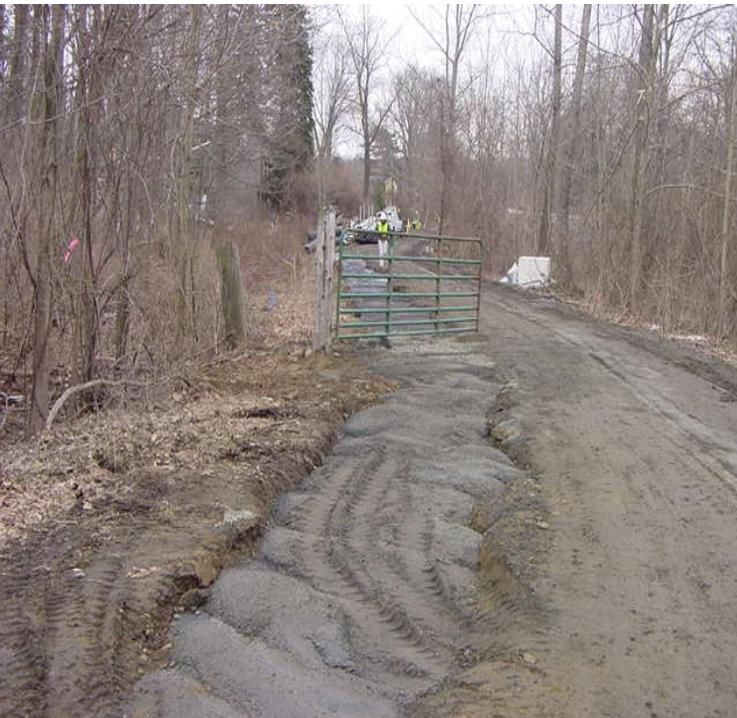
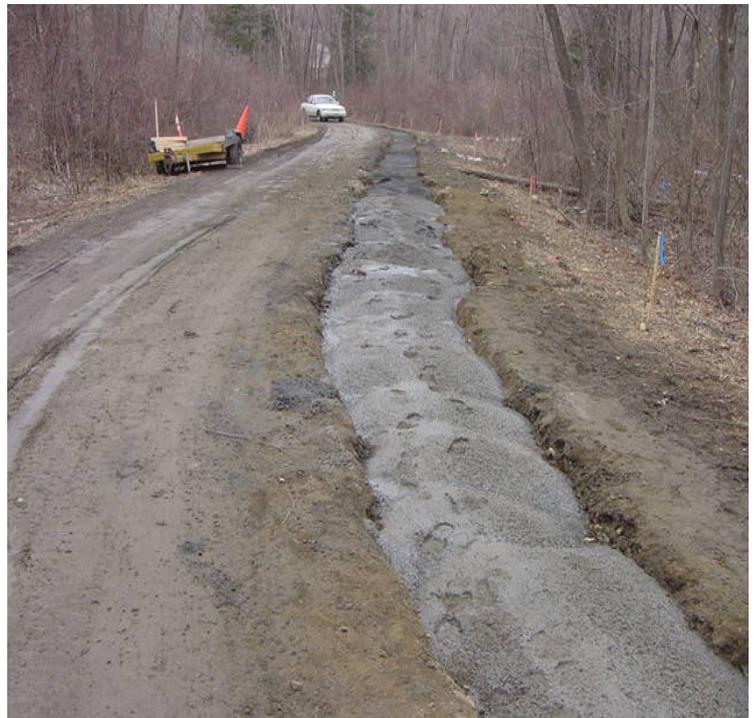
Both photos show the recently completed conduit installation along the access drive to Plumtree Substation. The areas are well contained. 3/9/06

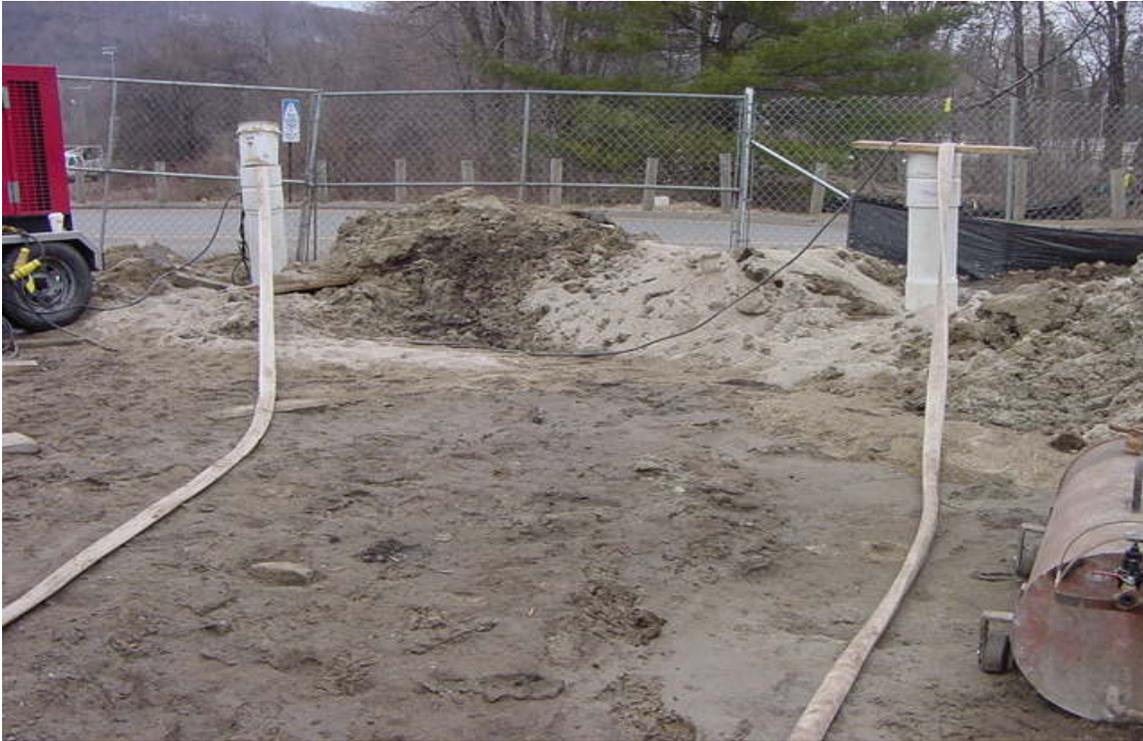
Jack and Bore: Photo shows a view of the well points installed along the jacking pad. The stockpiles resulting from the excavation were placed near the perimeter fence and erosion controls should be extended to encompass them. 3/9/06

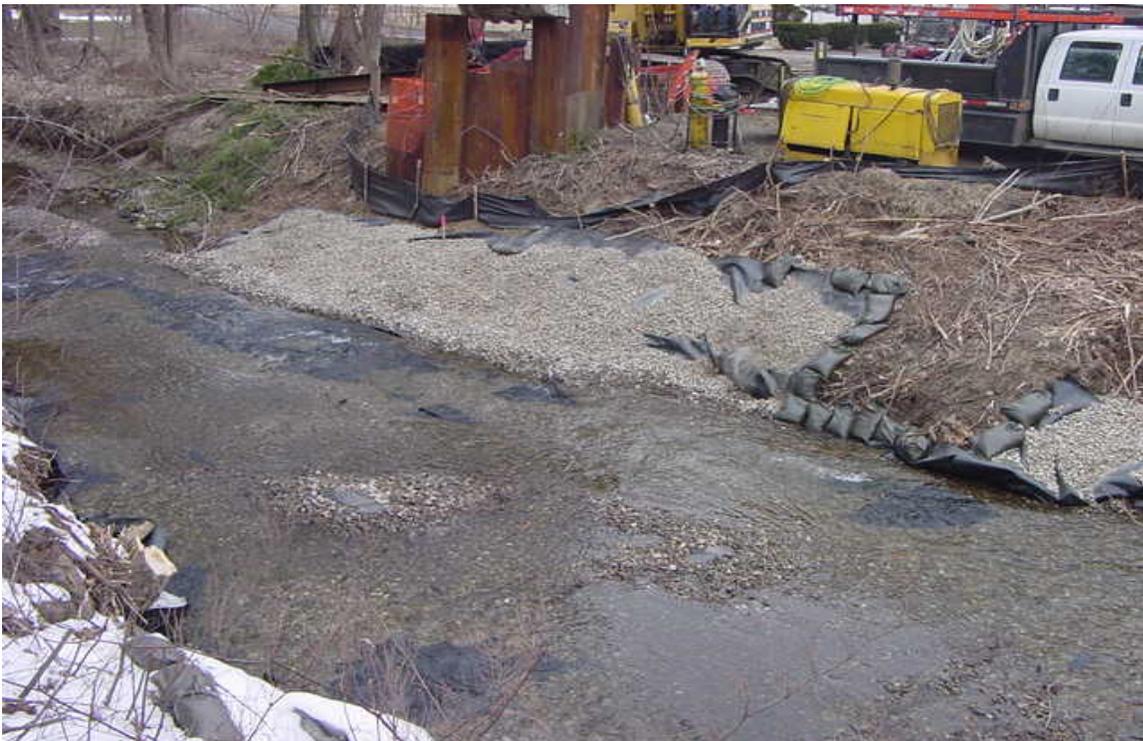
Photo on the left shows a view of the river looking towards the receiving side. Continue to monitor and maintain controls here near the stream. 3/9/06

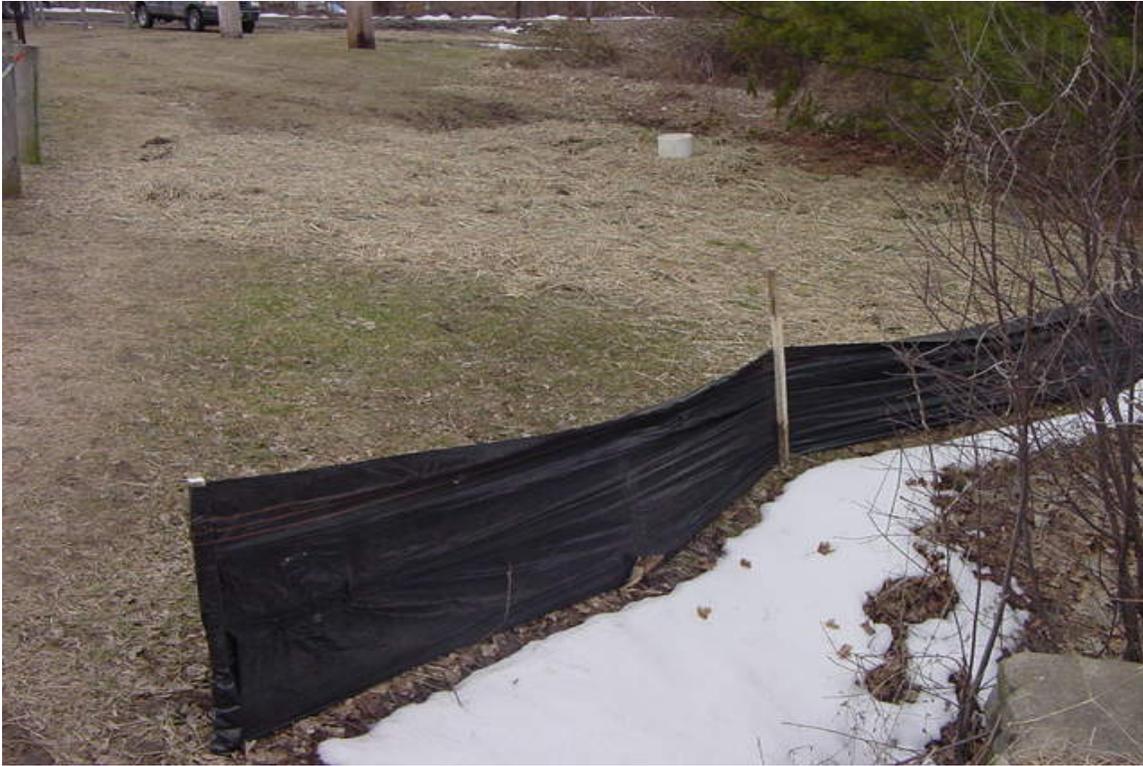
Photo shows the area adjacent to the streambank where the sediment pile resulting from the well point installation was removed as recommended. Controls remain in place. 3/9/06

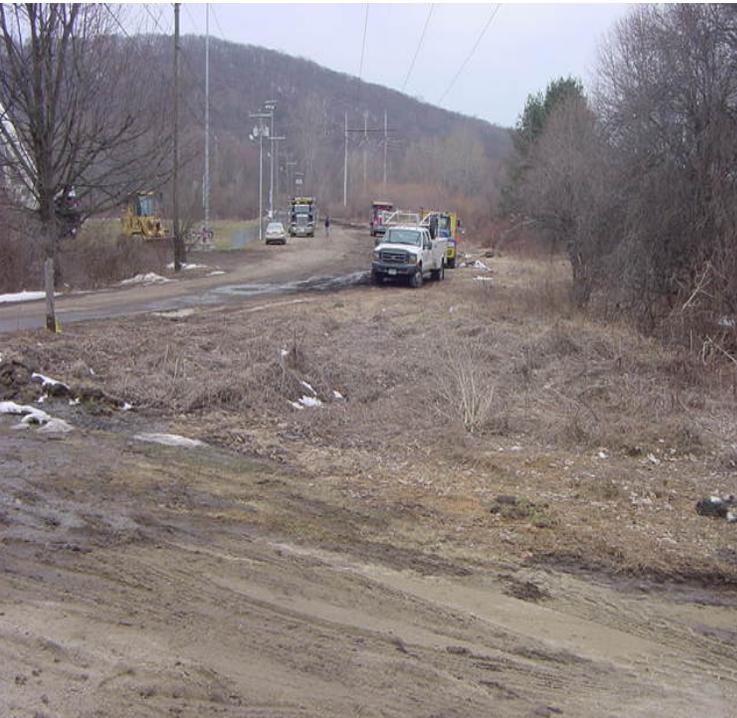
Photo on the left shows the baseball park where equipment and machinery park at this time. The adjacent roadway had some sediment tracking and street sweepers were called in. Photo on the right shows trenching within the student parking lot off Whittlesey Dr. 3/9/06
