Docket No. 217 – Development and Management Plan Inspection

Northeast Utilities Service Company Certificate of Environmental Compatibility and Public Need for the construction of a 345-kV electric transmission line and reconstruction of an existing 115-kV electric transmission line between Connecticut Light and Power Company's Plumtree Substation in Bethel, through the towns of Redding, Weston, and Wilton, and to the Norwalk Substation in Norwalk, Connecticut.

Date: March 23-24, 2005

Location: 345kV XLPE Component

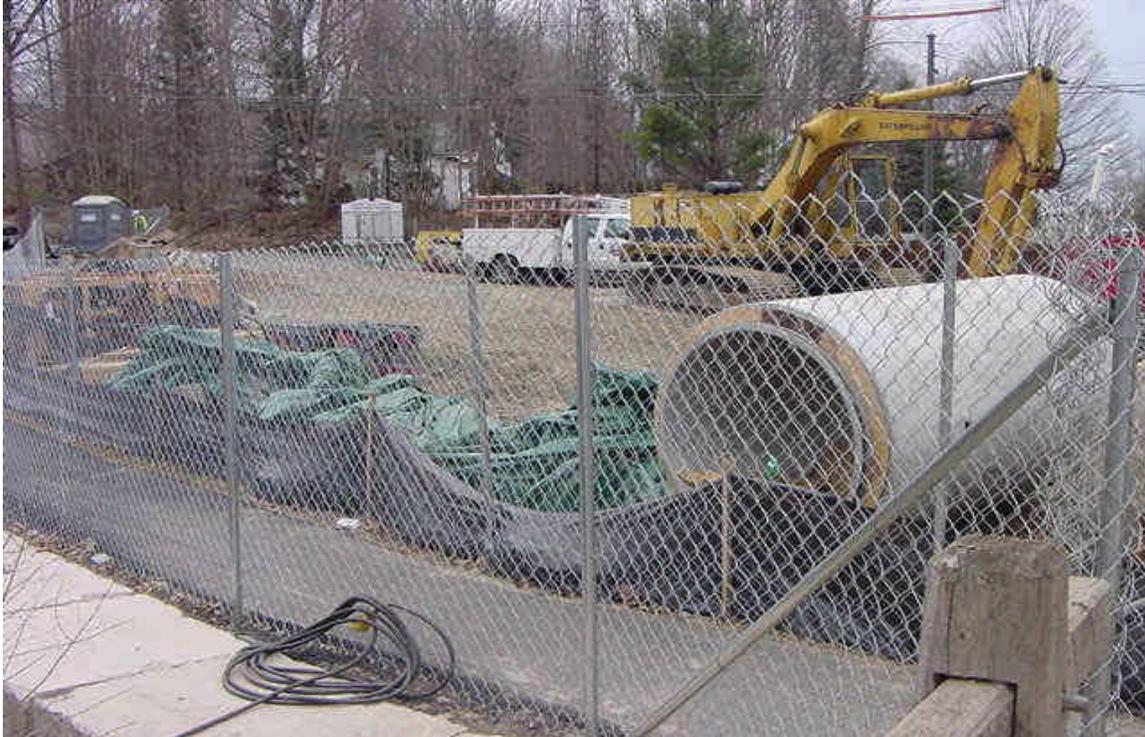
345kV XLPE (Jack and Bore): Overall view of the jacking pad. Work remains contained to the pad. 3/24/06

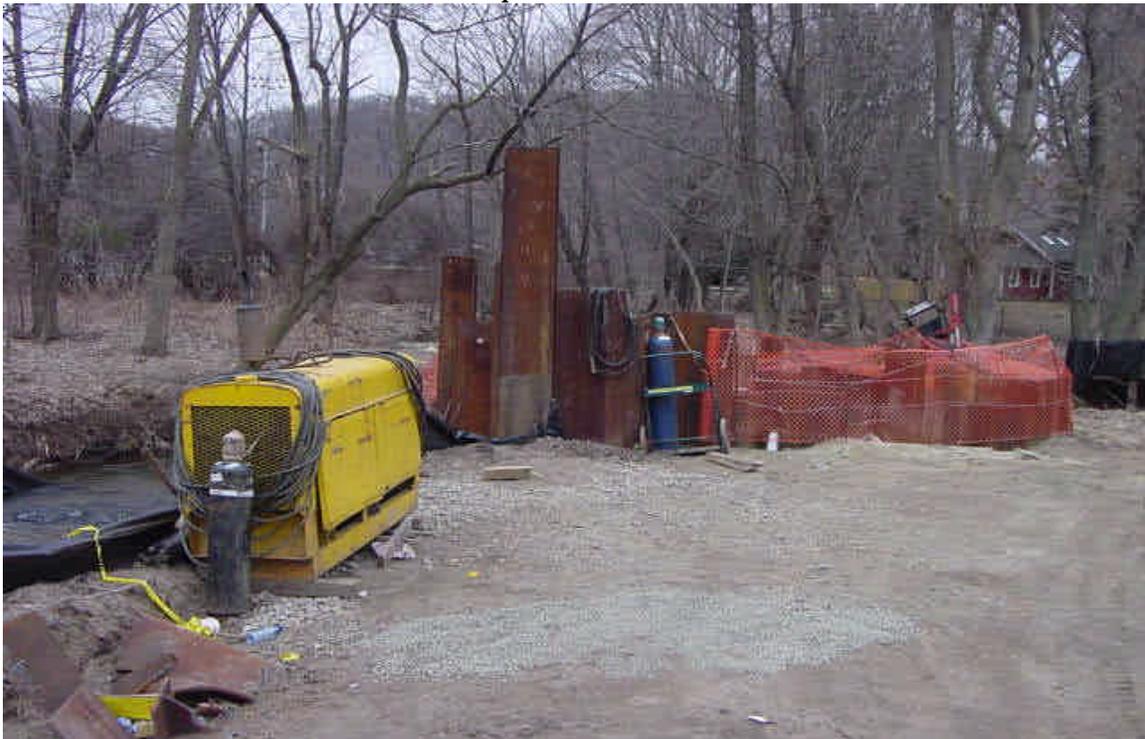
Photo shows the receiving area which also remains contained at this time. 3/24/06

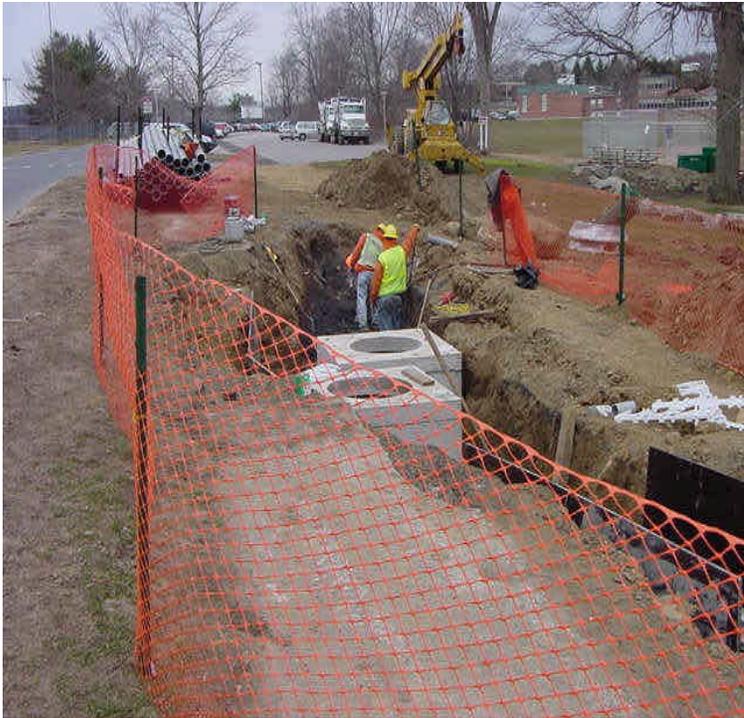
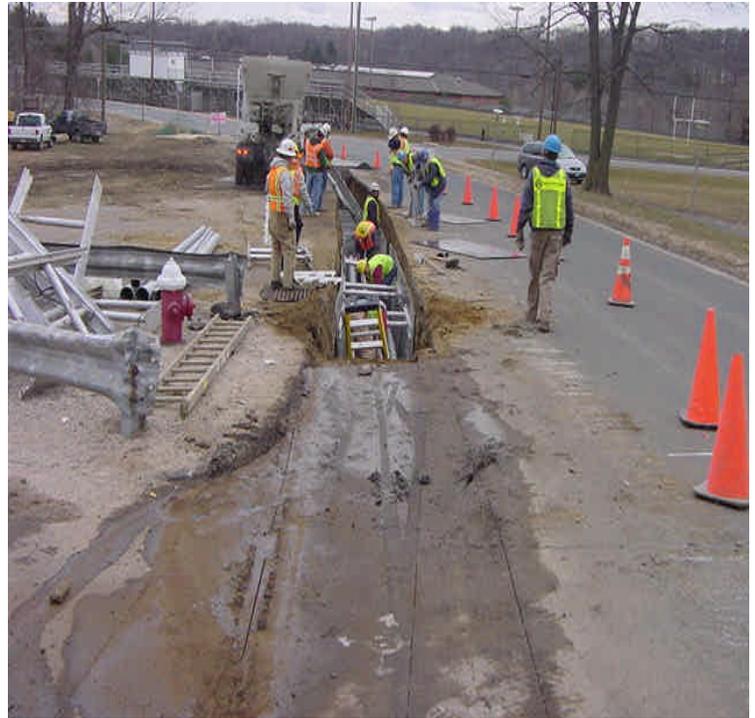
(Whittlesey Drive): Both photos show views of the active trenching in various stages of construction along Whittlesey Drive. Photo on the right shows sawcutting 3/24/06

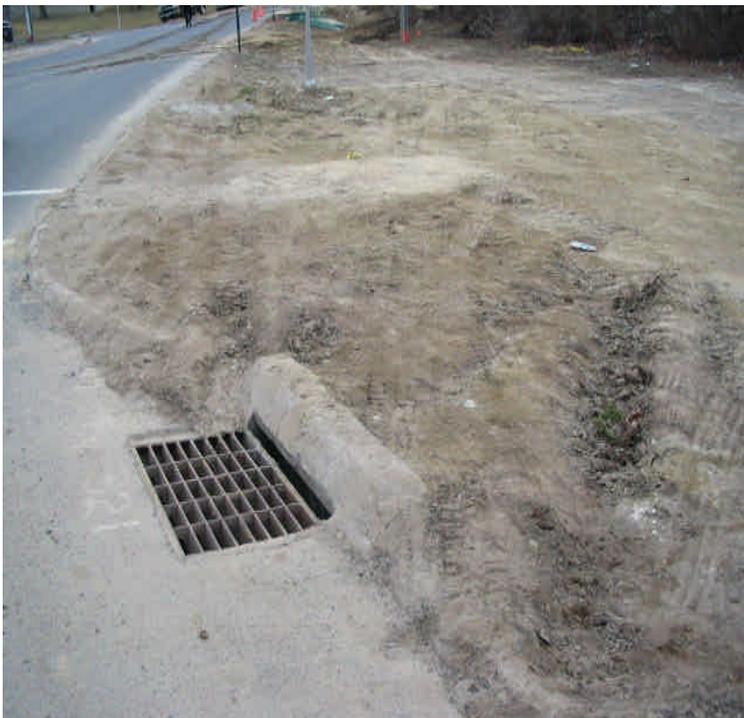
Photo on the left shows a catch basin which is not immediately adjacent to the active work but is downgradient and near disturbed soil which should be placed with controls. Photo on the right shows efforts to use controls on catch basins next to the work. 3/24/06

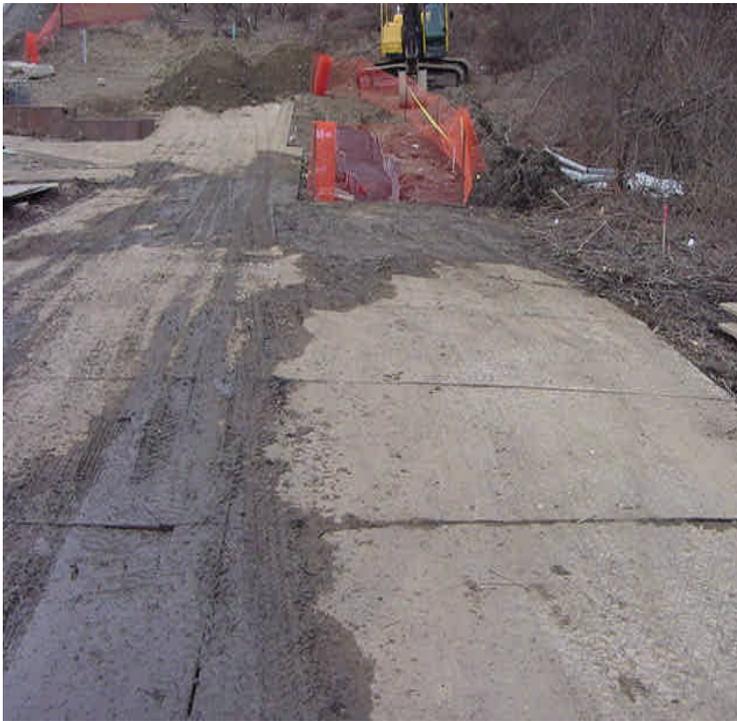
(Hoyts Hill): Photo on the left shows the access and mats into the Hoyts Hill station area. Trenching continues in this area. Watch placement of materials (such as trench boxes) off the mats and in the wetland. Photo on the right shows water from dewatering the trench after leaving the filter bag. 3/24/06

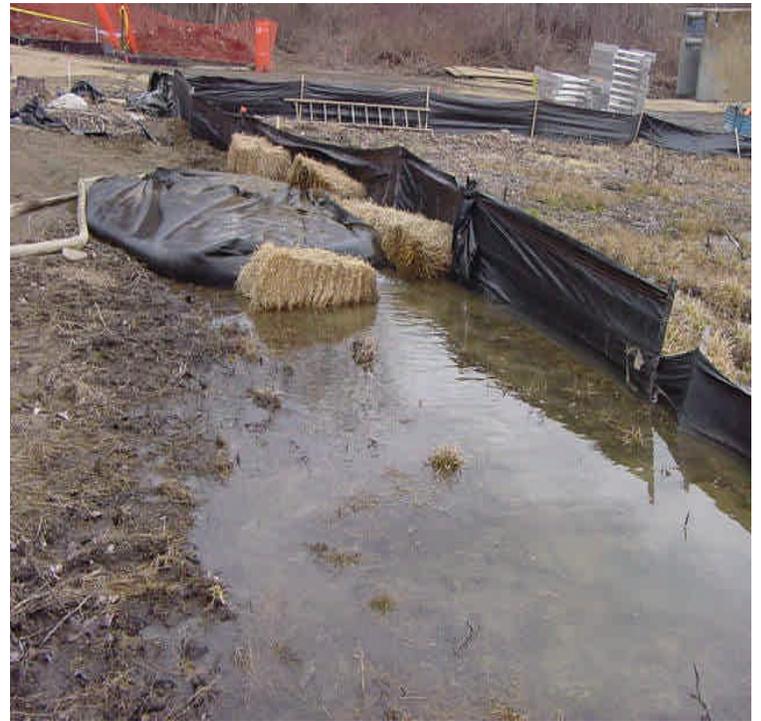
Dewatering	-Dewatering of clear water continues from the well points at the jack and bore. However, tests showed the water to have a high pH. 3/24/06 - Dewatering at Hoyts Hill continues. The controls showed a need for repair or replacement here as turbid water was escaping to the wetland. 3/24/06	- An agreement with the town allows the water to be collected, the pH lowered and the water is disposed of through the municipal system. 3/24/06 -See wetland and erosion control section for details. 3/24/06	-N/A
Blasting	- No blasting is occurring at this work area.	- None at this time.	-N/A
Soils	- Some soil is stockpiled along the active roadway shoulder trenching but will be returned as backfill. 3/15-3/24/06 - Topsoil was stripped and stockpiled at the contractor yard. 3/15-	- None at this time. 3/15-3/24/06 - None at this time. Controls are well installed here. 3/15-3/24/06	- N/A -N/A

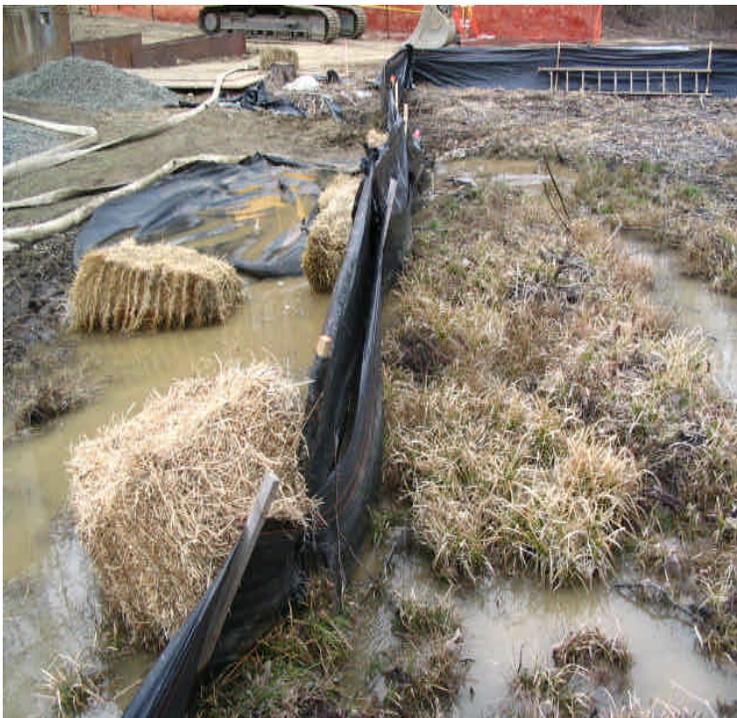
Areas of Inspection	Observation	Recommended Action	Corrective Action
Inland Wetland and Watercourse continued	access drive. 3/15-3/24/06 - The dewatering at Hoyts Hill led to turbid water escaping through the controls and into the wetland. Water remained slightly turbid by the time it reached the stream at Rt. 58. 3/24/06	- See erosion control section for more details. 3/24/06	
State species of concern, threatened and endangered species	-The D&M plan and clearance letter states that state-listed species are not located in this work area.	- N/A	-N/A
Vegetative clearing limits (including trees to save or danger trees noted)	-Most work on this project remains in the roadway, access drives or maintained lawn areas. 3/24/06	-Restore lawn and vegetation as necessary when work is complete during the growing season. This is needed especially where vaults were installed. 3/2-3/24/06	-N/A until work is complete.

These photos were taken later that day (3/24/06). Photo on the left shows the dewatering discharge becoming increasingly turbid due to a hole in the filter bag. Photo on the right shows water remaining slightly turbid by the time it reached the culvert at the roadway (right side).
