Docket No. 217 – Development and Management Plan Inspection

Northeast Utilities Service Company Certificate of Environmental Compatibility and Public Need for the construction of a 345-kV electric transmission line and reconstruction of an existing 115-kV electric transmission line between Connecticut Light and Power Company's Plumtree Substation in Bethel, through the towns of Redding, Weston, and Wilton, and to the Norwalk Substation in Norwalk, Connecticut.

Date: May 4, 2005

Location: 345kV XLPE Component

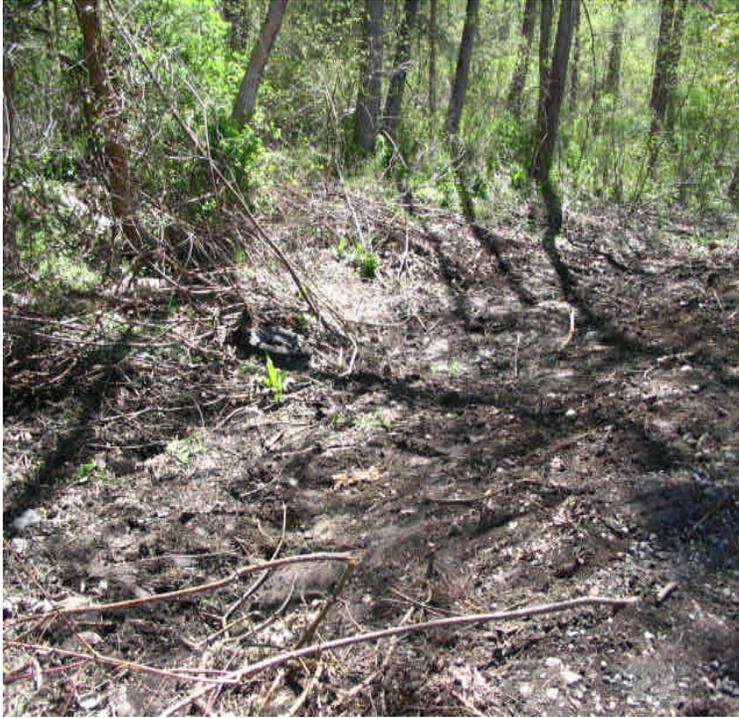
345kV XLPE (Plumtree Substation): Photo on the left shows where the wetland swale was repaired/restored after the dewatering box was removed a few weeks ago. Photo on the right shows where the stone pile was removed from the swale edge as recommended. 5/4/06

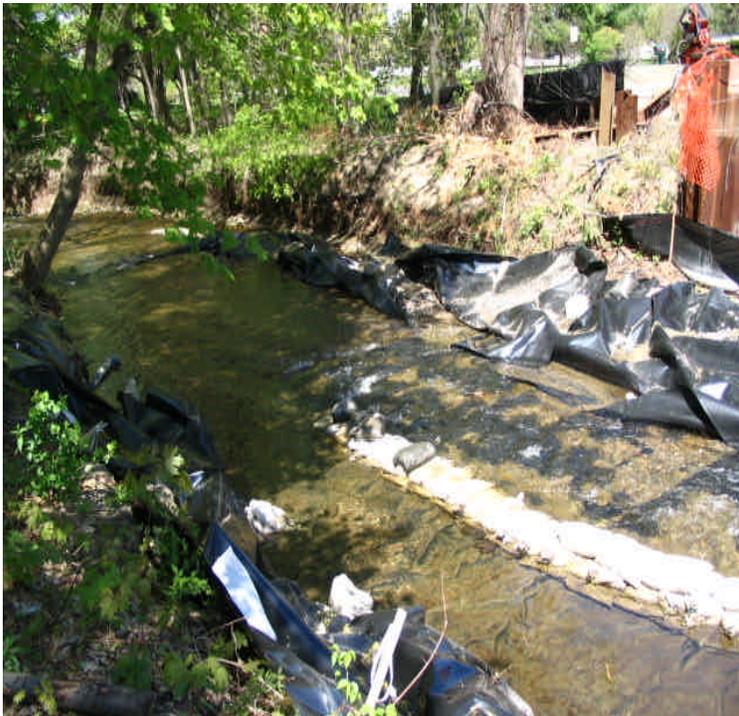
<p>Inland Wetland and Watercourse encroachment and mitigation</p>	<p>-East Swamp Brook crosses under Plumtrees Rd. A large plastic liner is in place across the bed and up along the banks to keep water out of the bore trench. The sandbag diversion was restored. 5/4/06</p> <p>-Problems with excess water continue in the trench and further methods are being evaluated. 5/4/06.</p>	<p>- The stream continues to run clear. Be sure to remove the liner and restore the natural bed when work is complete. Watch the banks where soil was disturbed for any erosion. 2/16-5/4/06</p> <p>- Sheet piling in the stream may be necessary and appropriate permits will be obtained. 5/4/06</p>	<p>-N/A at this time until the work is complete</p> <p>- N/A at this time.</p>
<p>State species of concern, threatened and endangered species</p>	<p>-The D&M plan and clearance letter states that state-listed species are not located in this</p>	<p>- N/A</p>	<p>-N/A</p>

(Jack & Bore) Photo on the left shows the stream where the sandbag diversion was repaired after the storm. Photo on the right shows some of the work for injecting the grout into the trench but excess water problems are still present here. 5/4/06

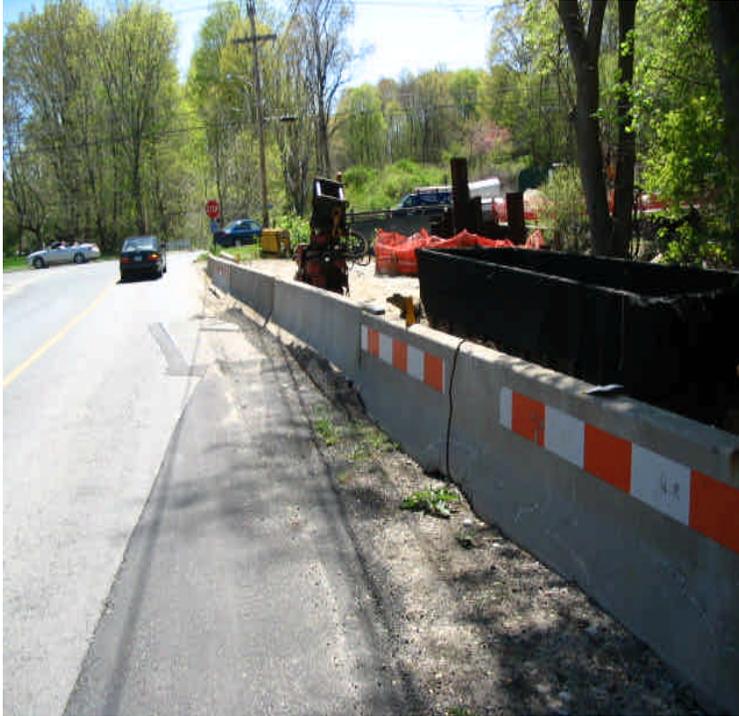
(Walnut Hill Rd) Photo on the left shows the completed trench work along the roadway, up to the receiving area of the J&B. Photo on the right shows a view of the vault 2 area where additional utility work had been completed. 5/4/06

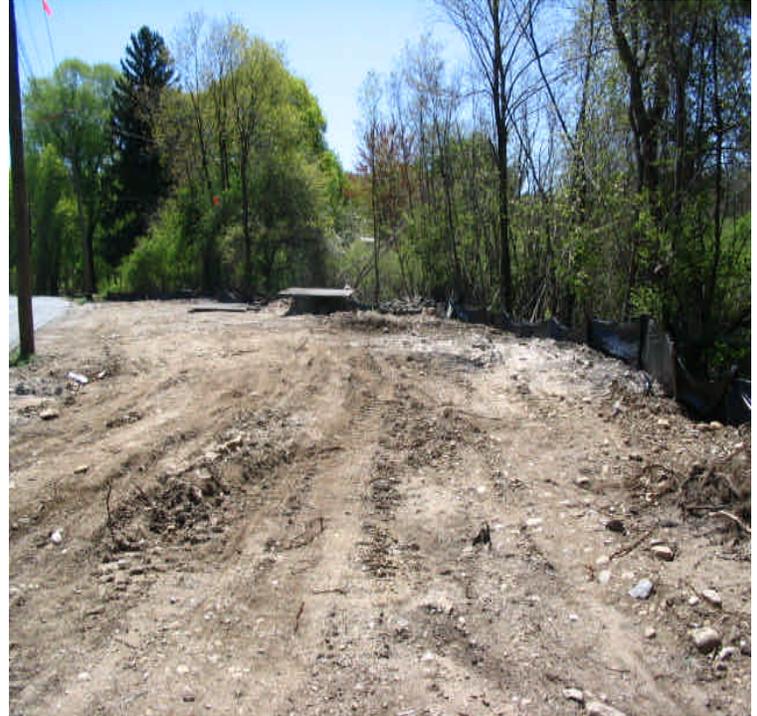
- Additional utility work occurred near vault 2A&B. Silt fence is in	- Restore when feasible and keep stone surface to the minimum necessary.	-Needs attention when feasible

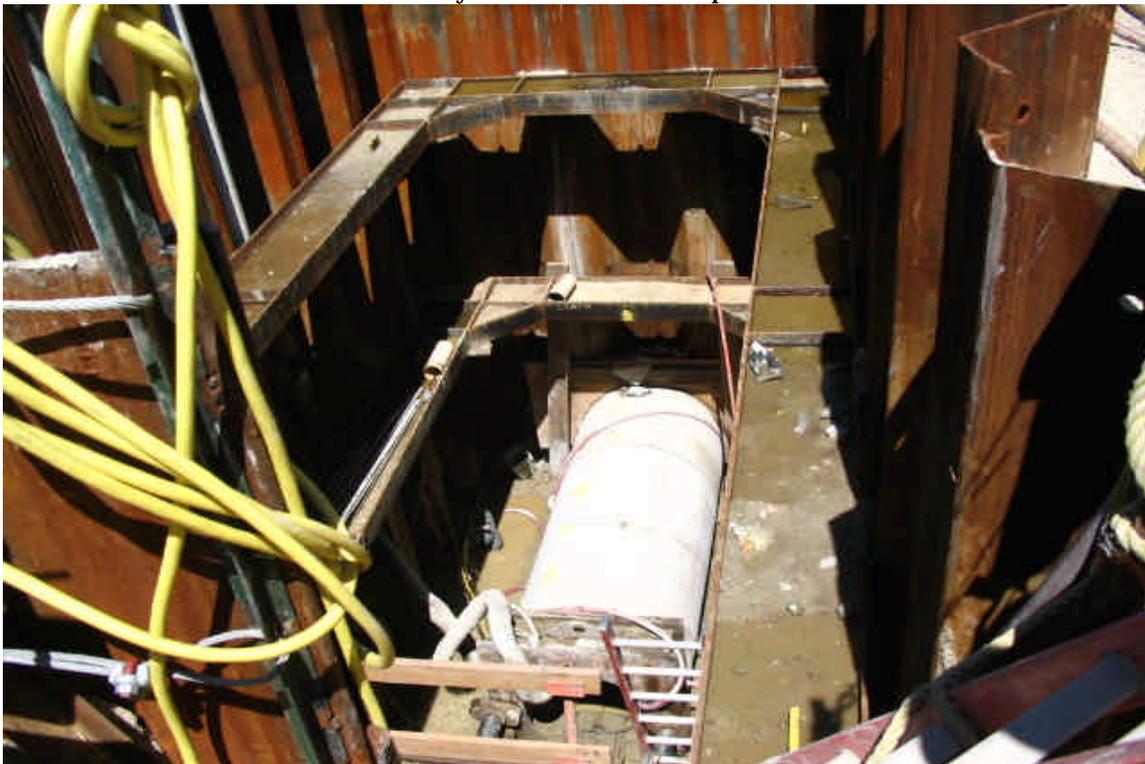
<p>Dewatering</p>	<p>-The amount of water continues to overwhelm the dewatering efforts at the jack and bore. Dewatering is occurring continuously in order to keep the trench workable. Further actions are being evaluated here. 5/4/06</p>	<p>- In addition, the frac tank had been in use and attempts continue to divert stream water from over the work area with sand bags which were restored following the heavy rains. 5/4/06</p>	<p>-N/A</p>
<p>Blasting</p>	<p>- No blasting is occurring at this work area.</p>	<p>- None at this time.</p>	<p>-N/A</p>
<p>Soils</p>	<p>- For the most part, soil is being removed directly from the remaining trenchwork and the operation is very clean. 5/4/06</p> <p>- Topsoil was stripped and stockpiled at the contractor yard. 3/15-5/4/06</p>	<p>- None at this time. Soil work is limited at the moment while the Rt 58 permit is being obtained. 5/4/06</p> <p>- None at this time. Controls are well installed here. 3/15-5/4/06</p>	<p>- N/A</p> <p>-N/A</p>

(J&B): Photo shows a view into the bore pit. Dewatering needs to occur continuously to handle the water here. 5/4/06

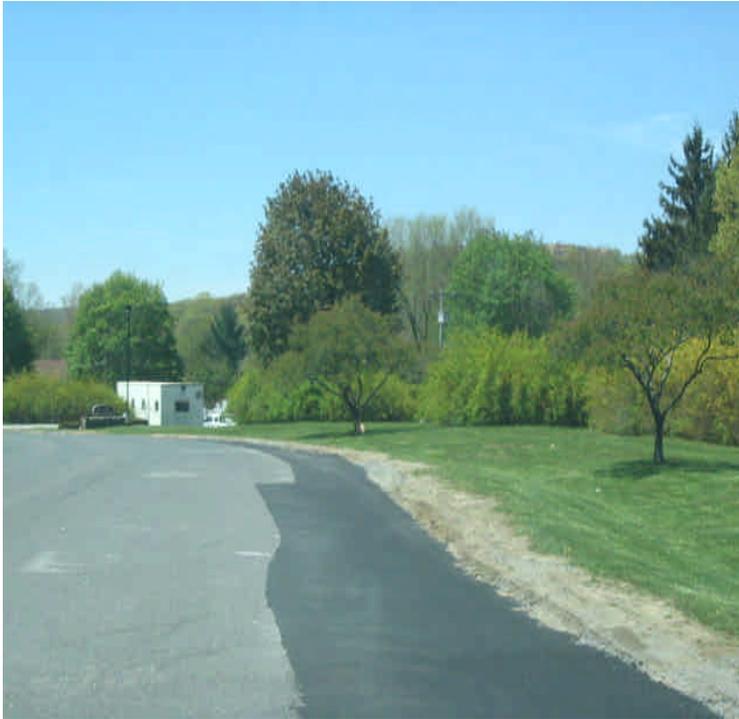
(Whittlesey Dr and Hoyts Hill) Photo on the left shows the completed trench in the roadway looking towards the contractor yard on Whittlesey Dr. Photo on the right shows the remaining open trench flooded with clear groundwater at the base of slope at Hoyts Hill. 5/4/06

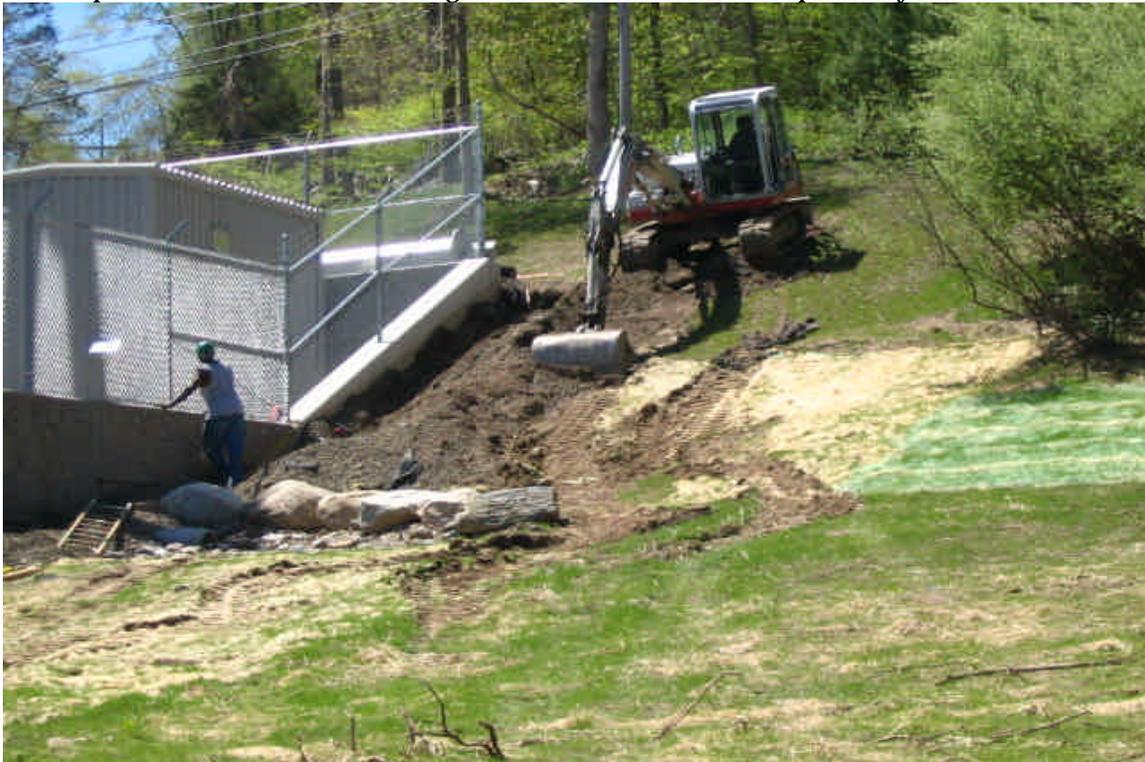
(Hoyts Hill) Photo shows where transition station work was necessary along the recently restored slope. Contractors at the transition station will be required to make repairs (not 345kV XLPE responsibility). 5/4/06
