Docket No. 217 – Development and Management Plan Inspection

Northeast Utilities Service Company Certificate of Environmental Compatibility and Public Need for the construction of a 345-kV electric transmission line and reconstruction of an existing 115-kV electric transmission line between Connecticut Light and Power Company's Plumtree Substation in Bethel, through the towns of Redding, Weston, and Wilton, and to the Norwalk Substation in Norwalk, Connecticut.

Date: June 1, 2005

Location: 345kV XLPE Component

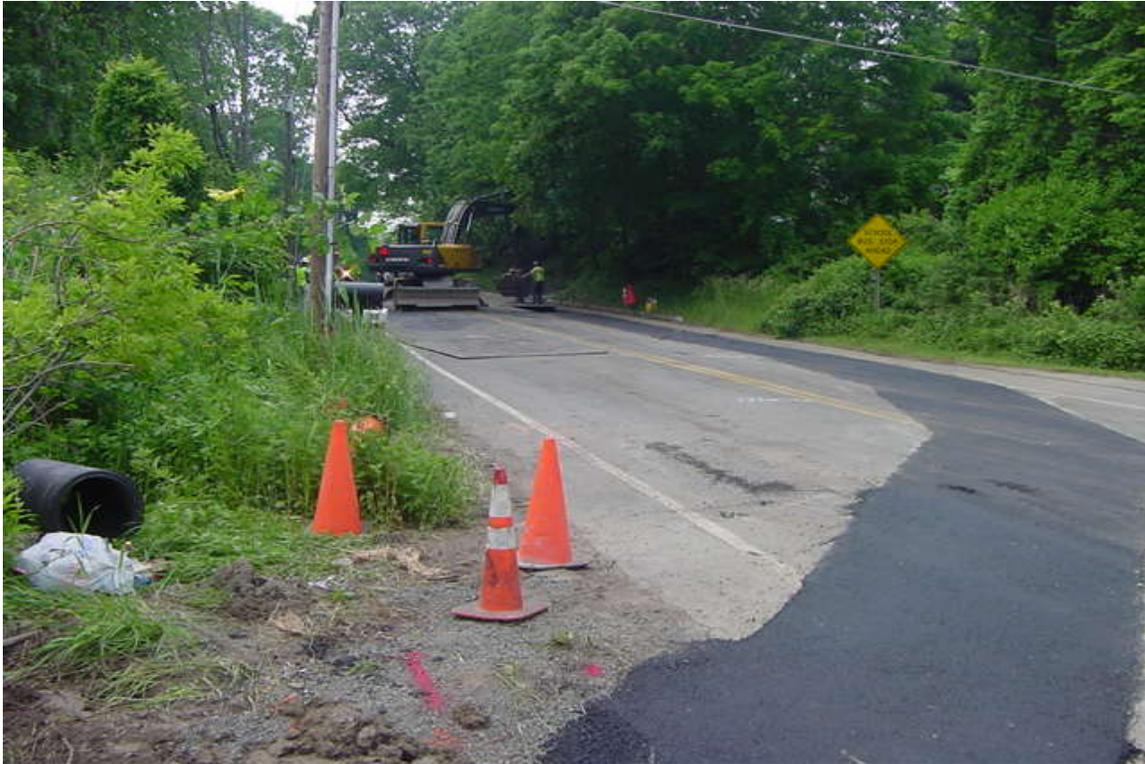
345kV XLPE: Photo shows the recent trenchwork leaving the Hoyts Hill transition station and continuing along Rt. 58. 6/1/06

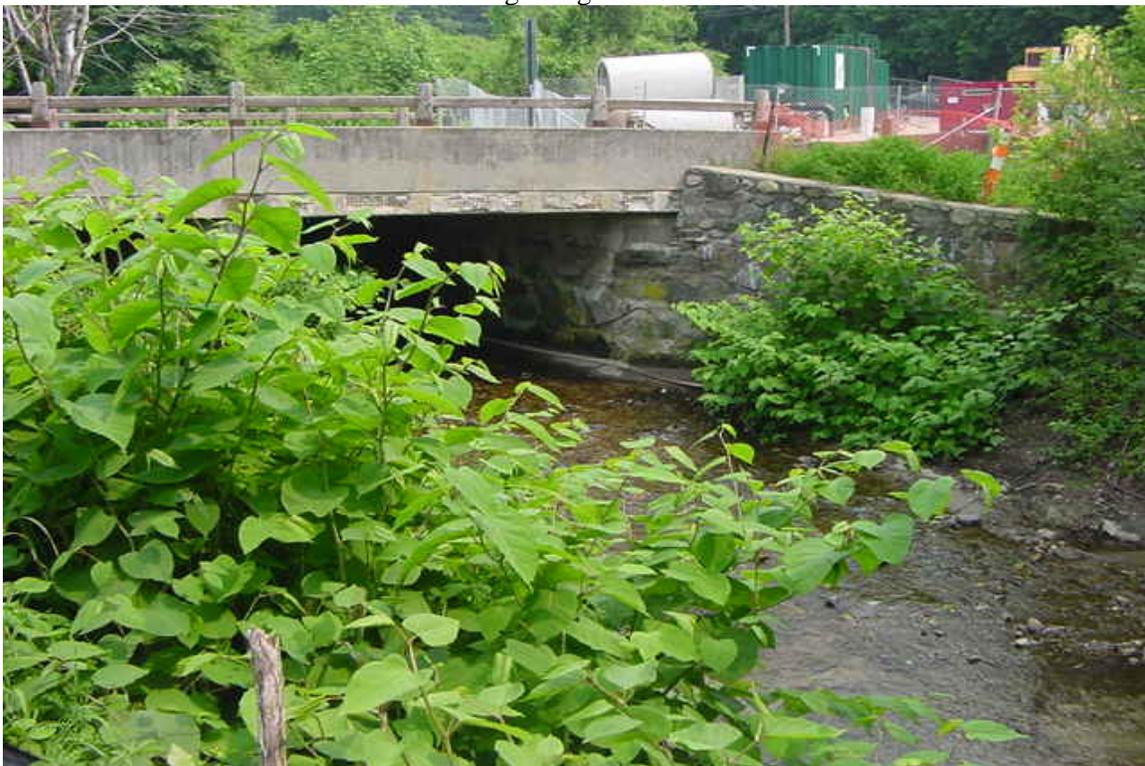
Areas of Inspection	Observation	Recommended Action	Corrective Action
	but wetland vegetation is returning near the silt fence. 5/4-6/1/06	the remaining area. 5/4-6/1/06	
Dewatering	-The amount of water continues to overwhelm the dewatering efforts at the jack and bore. Work is on hold. 6/1/06	- The diversions were all removed from the stream and sheet piling cofferdams are being permitted. 6/1/06	-N/A
Blasting	- No blasting is occurring at this work area.	- None at this time.	-N/A
Soils	- Soil was being handled appropriately in the Rt 58 trenchwork and the work site is clean and contained. 6/1/06	- None at this time. Soil work is limited at the moment. 6/1/06	- N/A

Photo shows the stream where the J&B operation is on hold for the time being. Additional permits are being obtained for installing sheet piling. 6/1/06

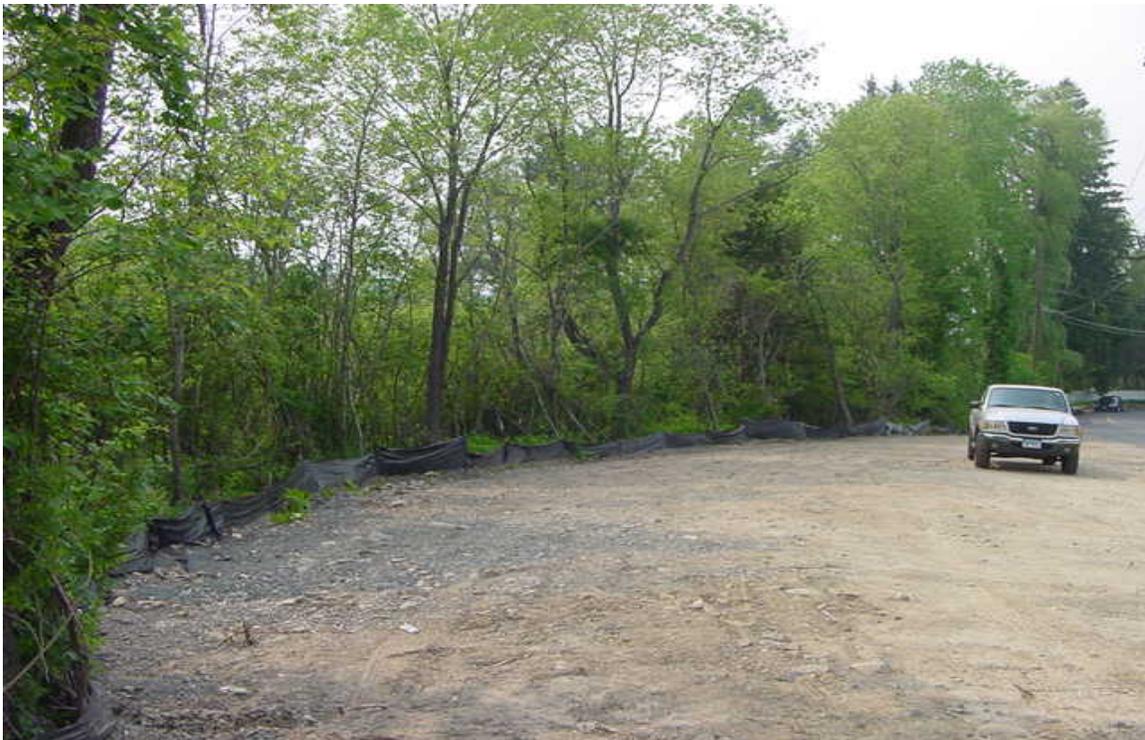
Photo shows the area of vault 2 which is still waiting to be restored with mulch and seed. Areas adjacent to the silt fence will be allowed to revegetate. 6/1/06

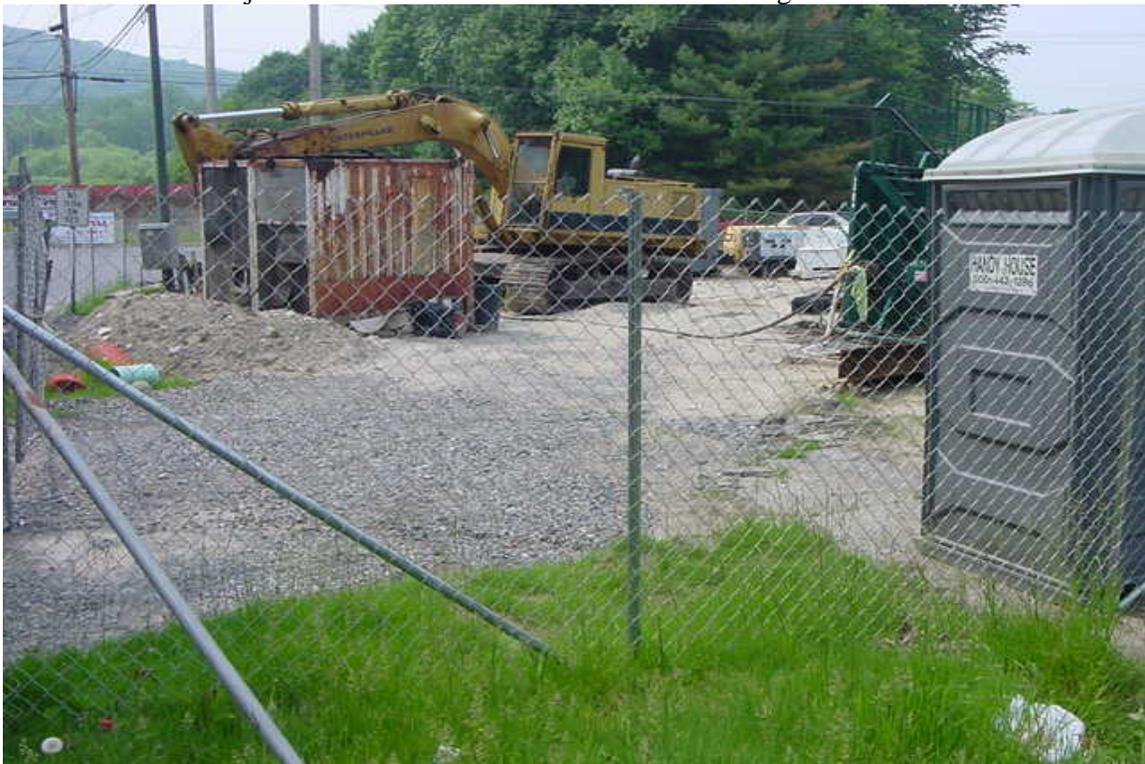
Photo shows the inactive J&B pad. 6/1/06
