Docket No. 217 – Development and Management Plan Inspection

Northeast Utilities Service Company Certificate of Environmental Compatibility and Public Need for the construction of a 345-kV electric transmission line and reconstruction of an existing 115-kV electric transmission line between Connecticut Light and Power Company's Plumtree Substation in Bethel, through the towns of Redding, Weston, and Wilton, and to the Norwalk Substation in Norwalk, Connecticut.

Date: June 7, 2005

Location: 345kV XLPE Component

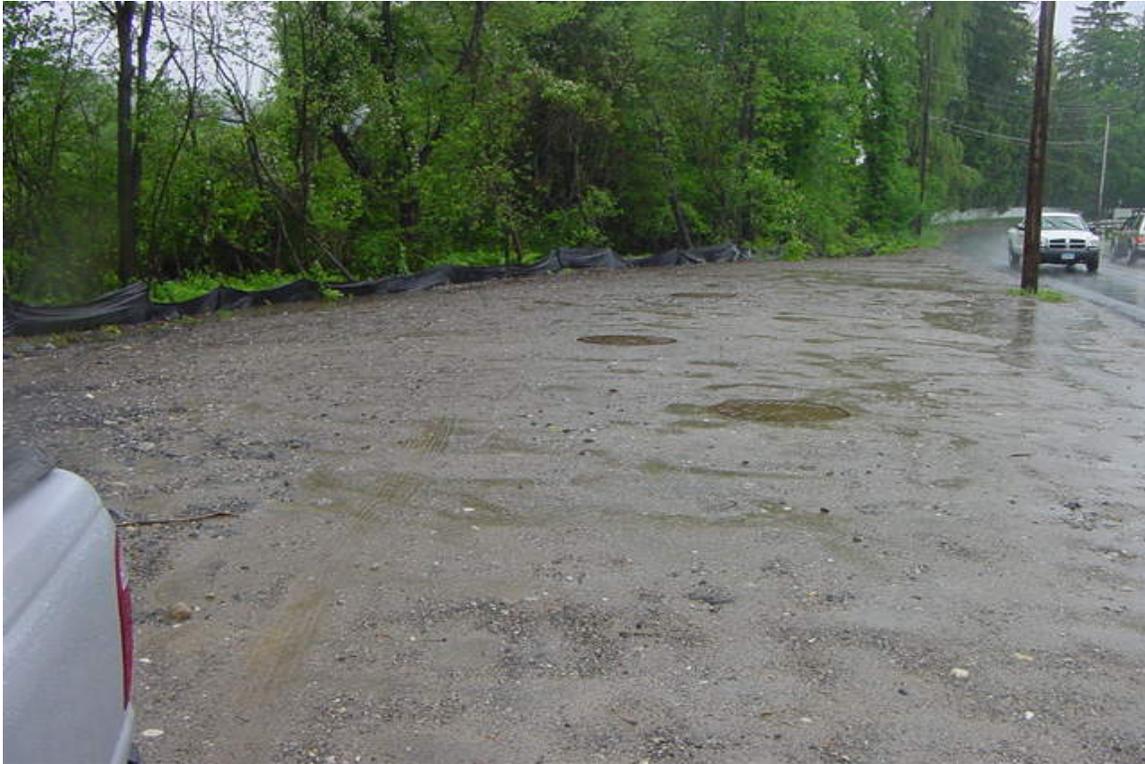
345kV XLPE: Photo shows the vault 2 area along Walnut Hill Rd which is still waiting for final restoration. 6/7/06

<p>-Work is complete in the pull-off near vault 2a and b and the area should be restored. 5/10-6/7/06</p>	<p>-See EC section for more details. 6/7/06</p>	<p>-Needs attention</p>
	<p>-Active trenchwork and conduit bank installation continues along Rt. 58. 6/7/06</p>	<p>- See EC section for more details. 6/7/06</p>	<p>-N/A</p>
	<p>-Vaults were being accessed to pull cable between some locations. 5/25-6/7/06</p>	<p>- None at this time. 6/7/06</p>	<p>- N/A</p>
	<p>-The connection between the open trench at the slope at Hoyts Hill on to Rt. 58 is almost complete. 6/7/06</p>	<p>- See erosion control section for more details. 6/7/06</p>	<p>- N/A</p>
<p>Erosion and Sediment Controls (includes inspection within 24 hours of a storm event)</p> <p>Walnut Hill Rd.</p> <p>Jack and Bore</p>	<p>- Work is complete near vault 2A&B. Silt fence remains in place but the area will need some restoration. 5/10-6/7/06</p> <p>-Work is on hold for the</p>	<p>- Efforts were made to bring in topsoil but recent rains caused delays. 5/17-6/7/06 Keep stone surface to the minimum necessary. Allow natural revegetation where possible. 5/10-6/7/06</p> <p>-The stream was still</p>	<p>-Needs attention</p> <p>-N/A at the time</p>

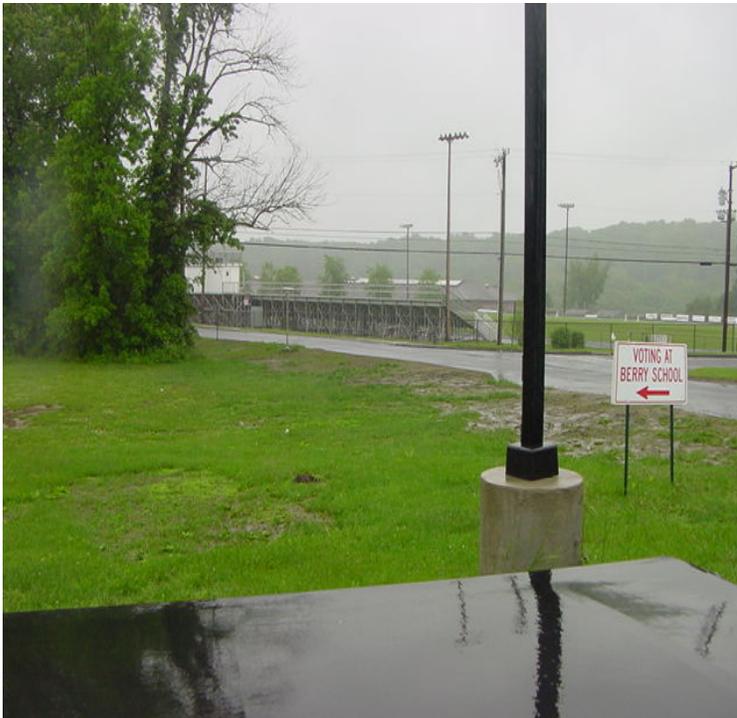
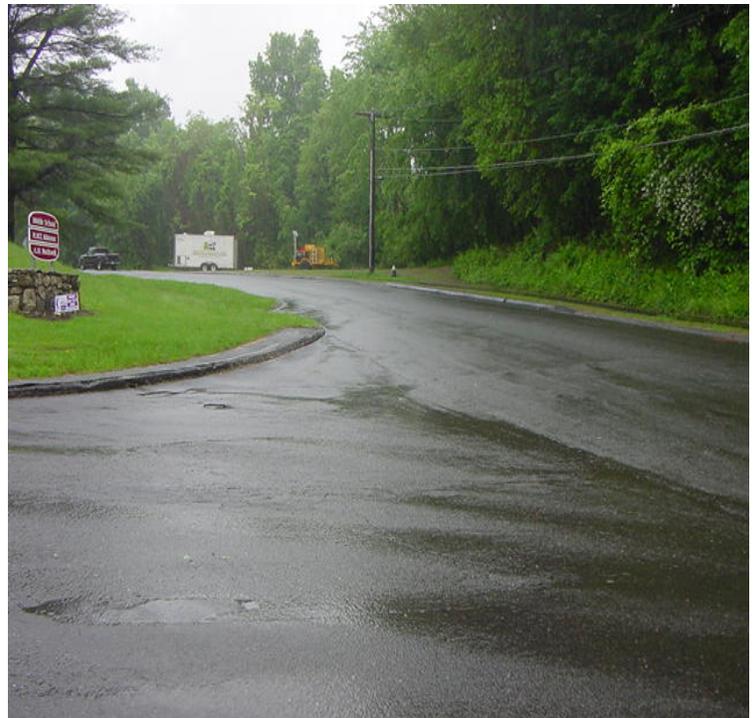
Both photos show some of the asphalt and curbing repair and restoration work performed within the roadways of the Bethel Ed Park. 6/7/06

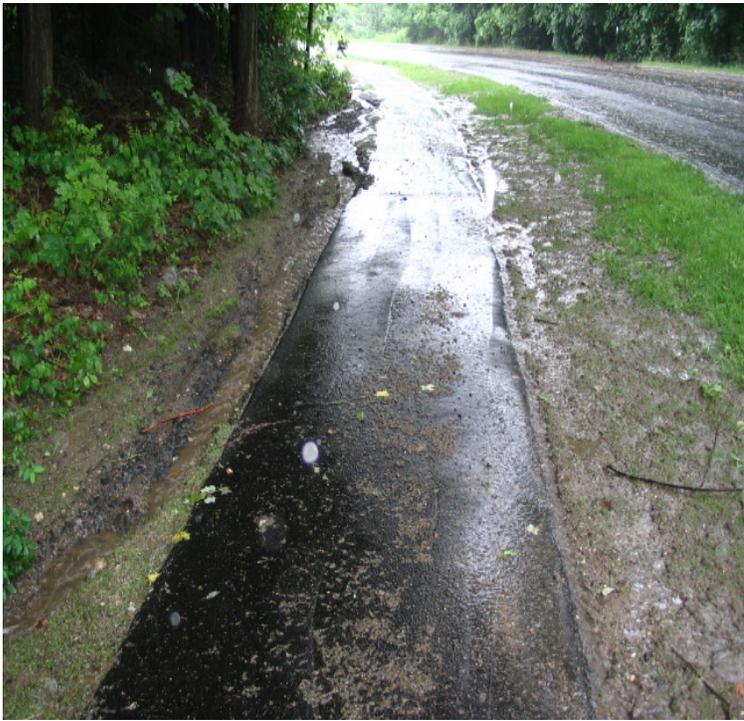
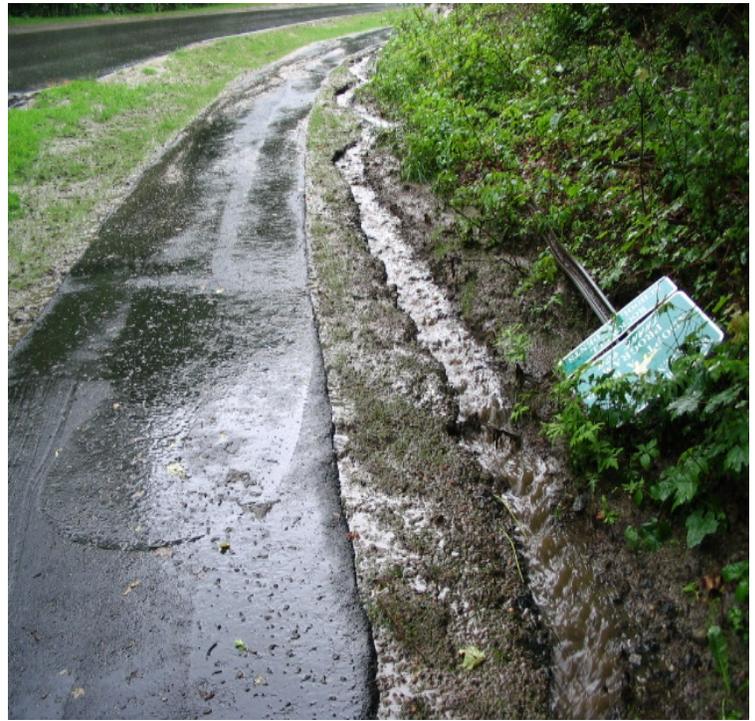
- A continuous gully/washout along the slope of Whittlesey Dr. was noted due to the heavy rain, adjacent to the new sidewalk. Sediment had also washed out onto the sidewalk down gradient. 6/7/06	-The gully formed before vegetation could establish in the recently seeded areas. The area will have to be restored and haybales check dams should be installed to slow run-off velocity. 6/7/06	- N/A.

Both photos show an erosive gully/washout along the entire slope on Whittlesey Drive along the recently restored sidewalk and roadside. Heavy rains washed the area out before vegetation was able to establish. Contractors should repair this and possibly place haybale check dams. 6/7/06

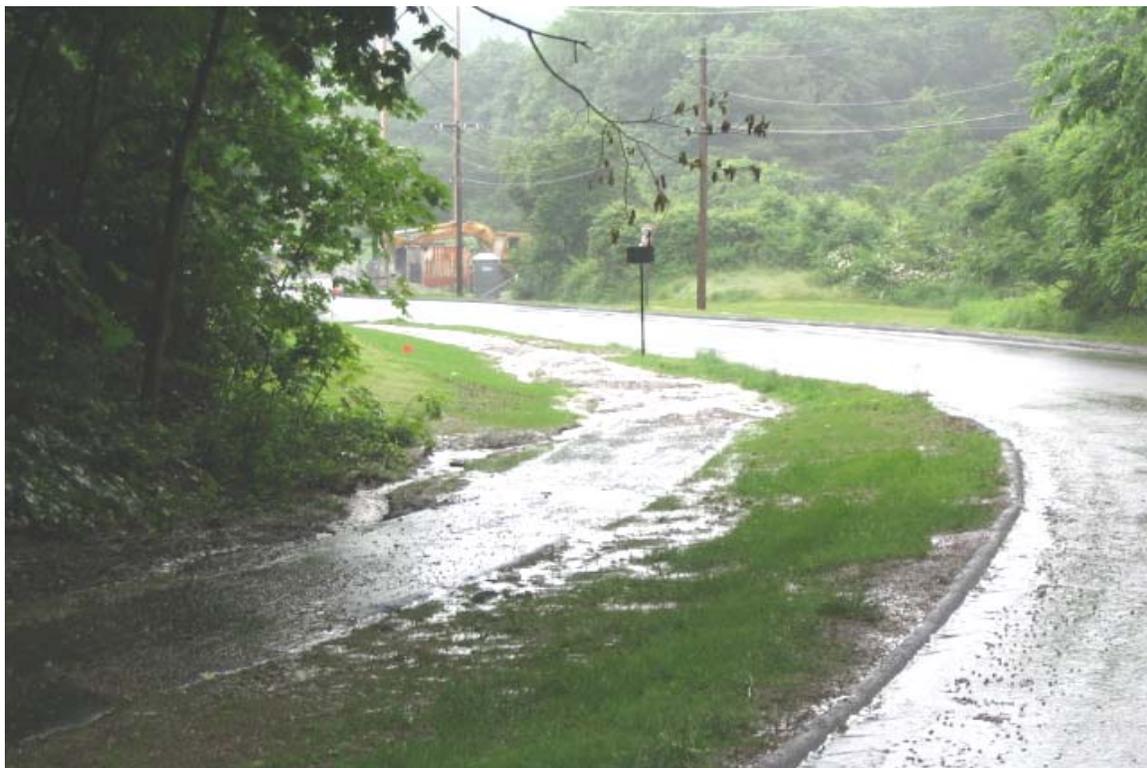
Photo shows another view of the gully. Sediment is washing onto the sidewalk just down gradient from here. 6/7/06
