Docket No. 217 – Development and Management Plan Inspection

Northeast Utilities Service Company Certificate of Environmental Compatibility and Public Need for the construction of a 345-kV electric transmission line and reconstruction of an existing 115-kV electric transmission line between Connecticut Light and Power Company's Plumtree Substation in Bethel, through the towns of Redding, Weston, and Wilton, and to the Norwalk Substation in Norwalk, Connecticut.

Date: June 14, 2005

Location: 345kV XLPE Component

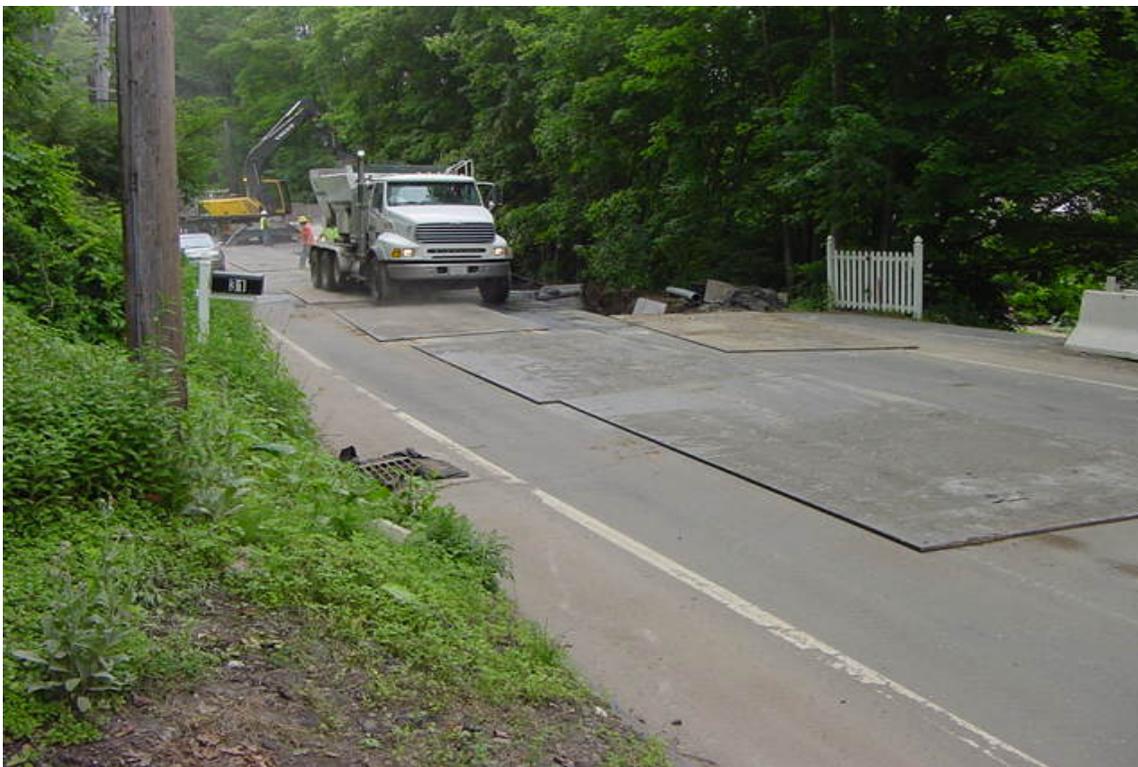
345kV XLPE: Photo shows the trench work along Rt 58. All catch basins in the area have filter fabric controls in place. 6/14/06

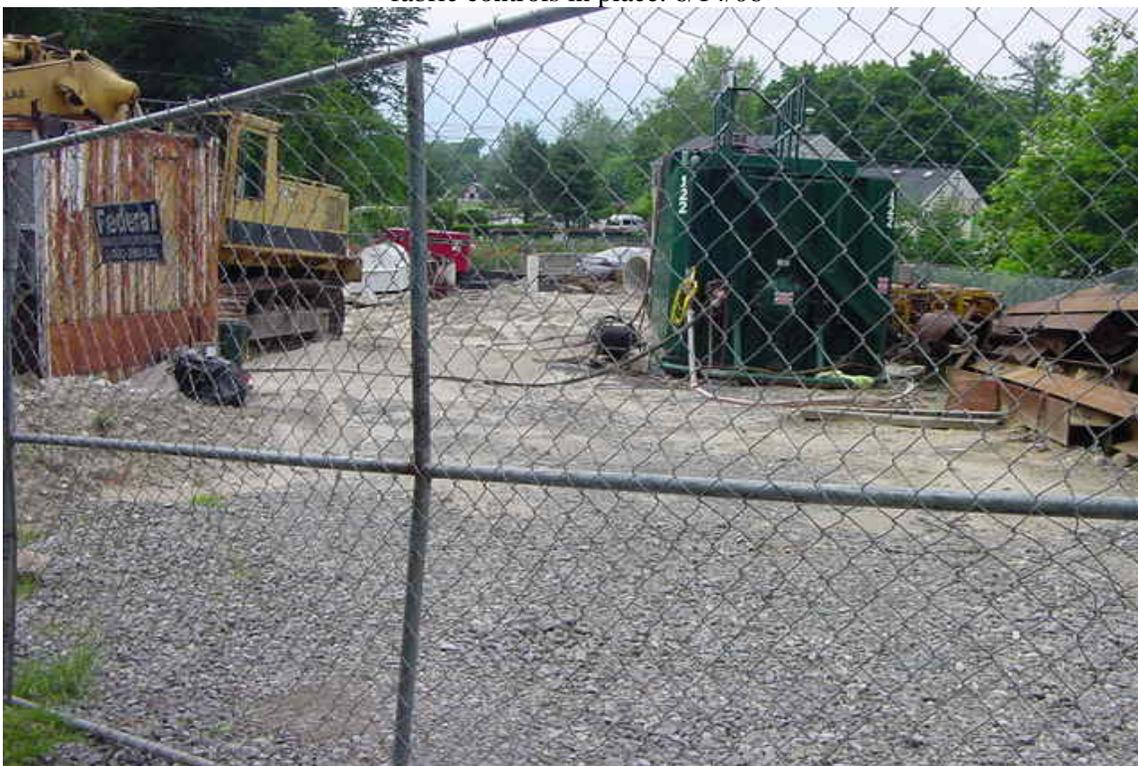
Photo shows an overview of the Jack and Bore pad. Work remains inactive until the ACOE permit is finalized. 6/14/06
