**Docket No. 217 – Development and Management Plan Inspection**

**Date:** July 5, 2005

**Location:** 345kV XLPE Component

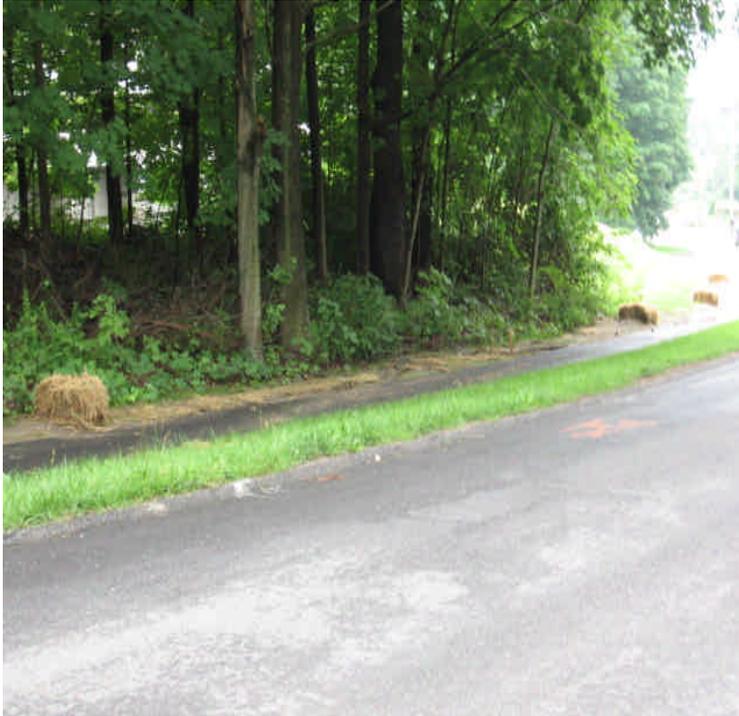
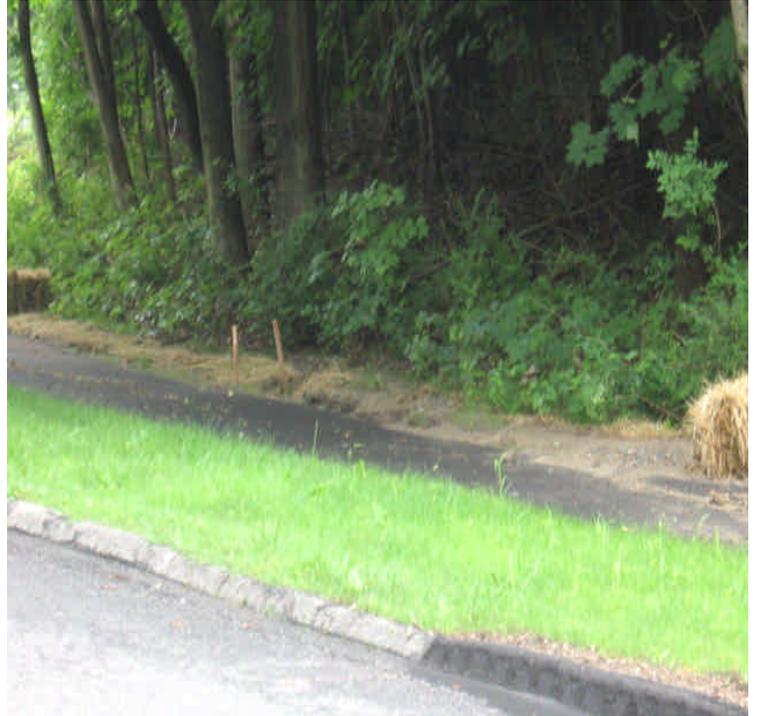
<p>Vegetative clearing limits (including trees to save or danger trees noted)</p>	<p>-The washout adjacent to the sidewalk at the Whittlesey Dr slope was repaired but washed out again. 7/5/06</p> <p>- Other restored areas had noticeable grass growth. Roadside areas</p>	<p>-See erosion control section. 7/5/06</p> <p>- Continue to monitor for final stabilization. 7/5/06</p>	<p>-Area was repaired</p> <p>- Rt 58 roadside areas were restored</p>

**345kV XLPE: Both photos show the slope along Whittlesey Drive where repairs had been made to the erosion along the sidewalk. However, even with the haybale check dams and good restoration efforts, the timing of the rain event caused some additional washouts. 7/5/06**

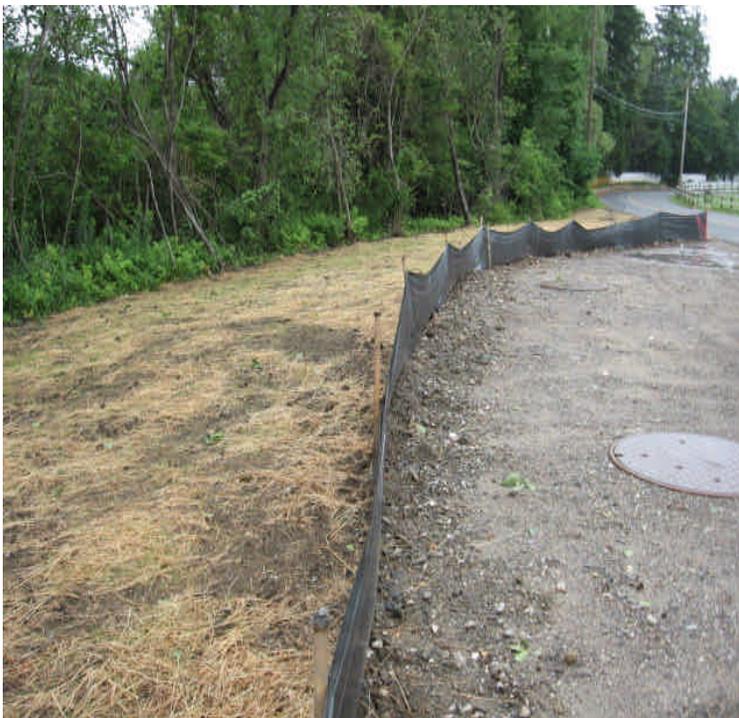
Areas of Inspection	Observation	Recommended Action	Corrective Action
	<p>along Rt 58 were restored. 7/5/06</p> <ul style="list-style-type: none"> <li>- Vault 2 remains well restored with vegetation allowed to return adjacent to the manhole access area. 7/5/06</li> <li>- The area near vault 5 and adjacent to the ballpark remain to be restored. 7/5/06</li> </ul>	<ul style="list-style-type: none"> <li>- The area is in good condition. 7/5/06</li> <li>- These areas will be restored when access needs are complete. 7/5/06</li> </ul>	<ul style="list-style-type: none"> <li>- N/A</li> <li>- N/A until access needs are complete</li> </ul>
Dewatering	<ul style="list-style-type: none"> <li>- The dewatering system from well points at the jack and bore had resumed in order to keep the trench workable. 6/28-7/5/06</li> </ul>	<ul style="list-style-type: none"> <li>- Continue to use all necessary controls. 6/7-7/5/06</li> </ul>	<ul style="list-style-type: none"> <li>- N/A</li> </ul>

**Photo on the left shows the vault 2 area well restored with erosion controls moved closer to the vault manholes. The adjacent area will be allowed to revegetate. Photo on the right shows some of the disturbance caused by accessing the stream work. However, silt fence is in place and the area will be restored following work. 7/5/06**

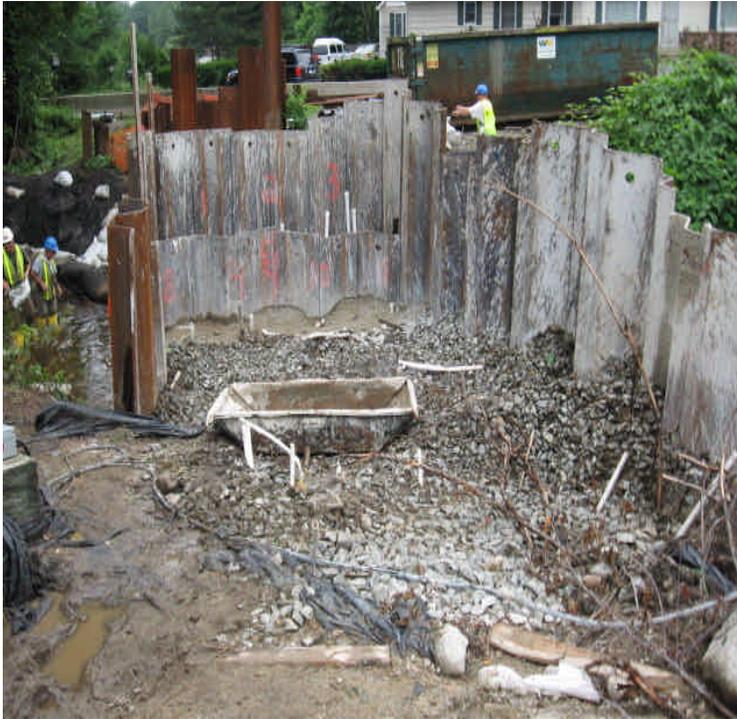
<p>Inland Wetland and Watercourse encroachment and mitigation</p>	<p>-Work in East Swamp Brook continues under ACOE clearance. Sheet piling remains in the stream bed and is about to be shifted to the opposite bank. Gravel fill is in place inside the diversion. 7/5/06</p>	<p>- Work in the stream should be carefully monitored. It is currently in good condition. Remove fill and replace river stones in the bed before flow is allowed back through the area. 7/5/06</p>	<p>-N/A at this time</p>
<p>State species of concern, threatened and endangered species</p>	<p>-The D&amp;M plan and clearance letter states that state-listed species are not located in this work area.</p> <p>-The wood turtle was noted at Plumtree Substation during the 5/25/06 inspection.</p>	<p>- N/A</p> <p>-345kV XLPE crews should also be performing daily walkthroughs before moving equipment while working in the vault. Be vigilant when moving equipment. 4/26-7/5/06</p>	<p>-N/A</p> <p>- Crews were informed</p>

Photo on the left shows the view into the area enclosed by the sheet piling. Gravel fill had been placed in this area above the bore. It will be removed when work is complete and river stone will be placed in the streambed. Photo on the right shows where sandbags were moved to the opposite streambank in preparation for shifting the sheet piling. 7/5/06

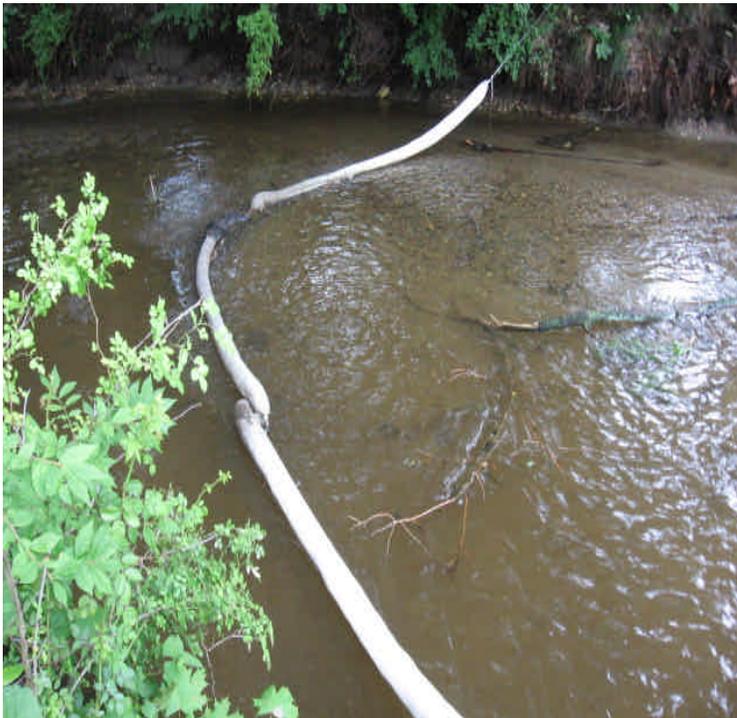
Photo on the left shows the boom in place across the river. Some minor turbidity resulted from the crews moving the sandbags by hand but water remains fairly clear. Photo on the right shows the access pad off Rt 58 to Hoyts Hill which 345kV XLPE crews will be restoring following wire pulling. Be sure to remove all stone and gravel and replace with soil with high organic content.
