Docket No. 217 – Development and Management Plan Inspection

Northeast Utilities Service Company Certificate of Environmental Compatibility and Public Need for the construction of a 345-kV electric transmission line and reconstruction of an existing 115-kV electric transmission line between Connecticut Light and Power Company's Plumtree Substation in Bethel, through the towns of Redding, Weston, and Wilton, and to the Norwalk Substation in Norwalk, Connecticut.

Date: August 30, 2005

Location: 345kV XLPE Component

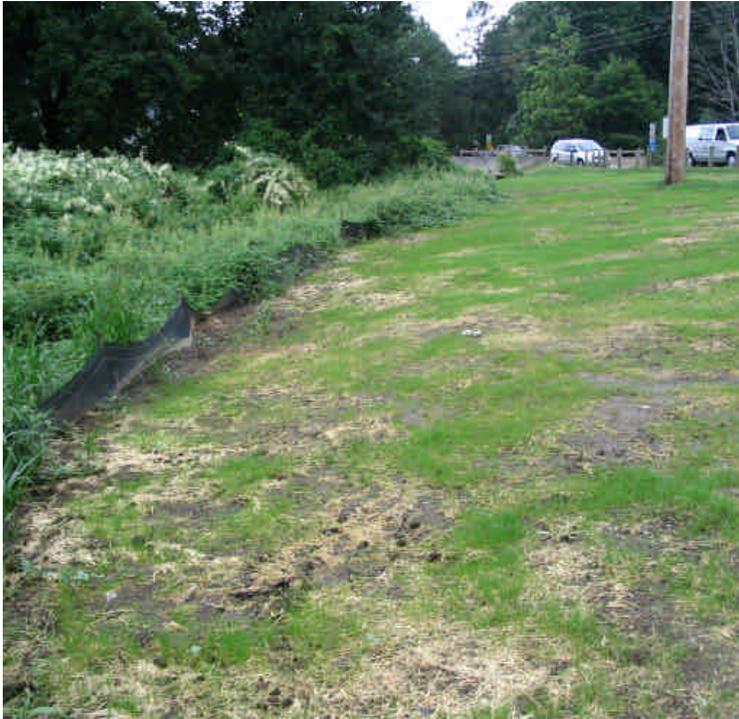
345kV XLPE: Photo on the left shows the lawn area in the ball park just off Plumtrees Rd. Grass growth is returning but the recent rain caused the grass seed to wash out to some degree. Continue to monitor. Photo on the right shows vegetative growth progressing along the top of the streambank 8/30/06

- A small area along the ball park access drive remains disturbed due to trailers having parked there 8/16-8/30/06	- Restore this adjacent area when feasible. Continue to monitor the lawn area for stabilization. 8/16-8/30/06	- Continue to restore park.

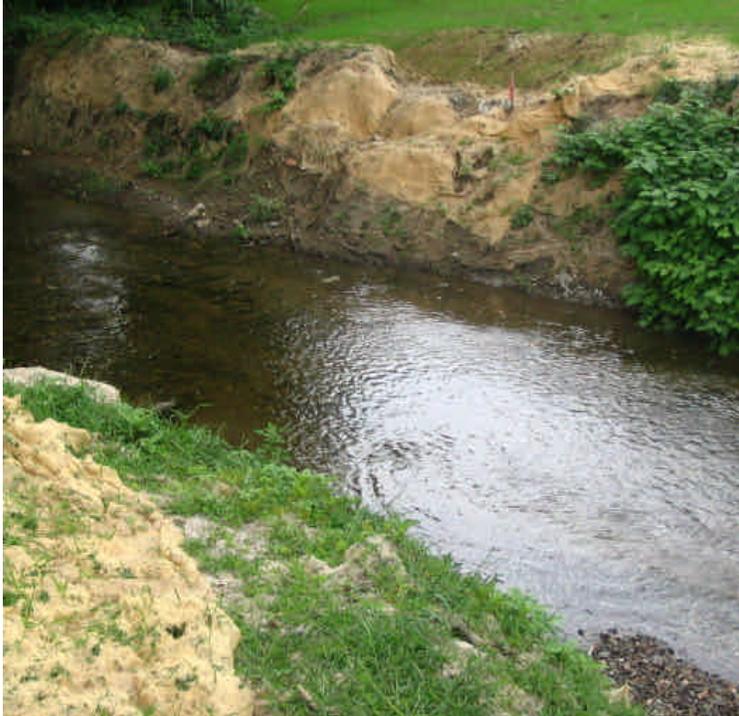
-The banks of East	-Continue to monitor until	-N/A

Photo on the left shows vegetative growth returning along the streambanks with the erosion control blankets in place even after the recent rain. Photo on the right shows the jacking pit area which had been re-excavated in order to make a repair. 8/30/06

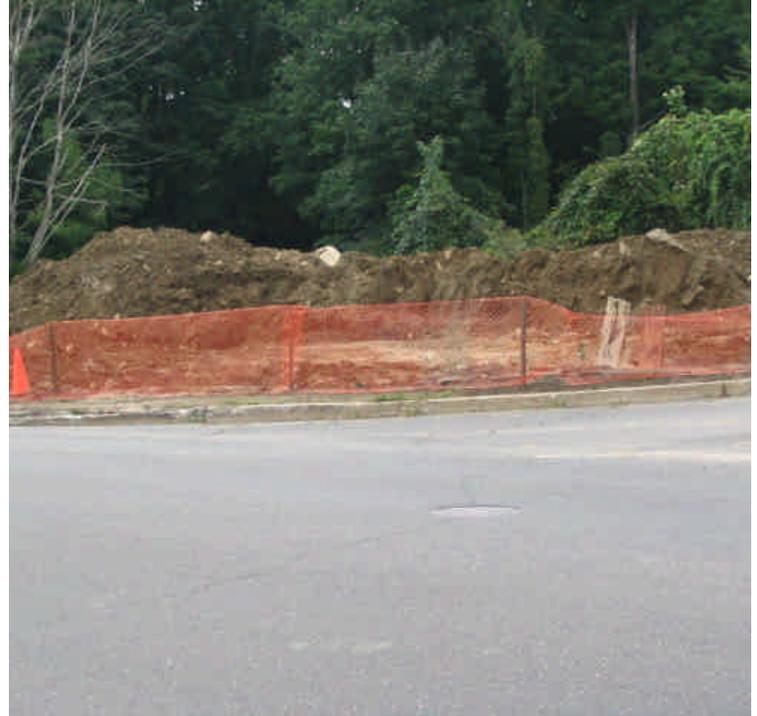
Areas of Inspection	Observation	Recommended Action	Corrective Action
Access Roads and Adjacent Roadways	-At the jack and bore of East Swamp Brook, the jacking pit had been restored but required re-excavation to make a repair. Access is gained from Whittlesey Dr. 8/30/06.	- Continue to keep roadways swept as equipment enters. Some tracking/run-off to the gutter was noted on Plumtrees Rd. 8/30/06.	- Needs some attention

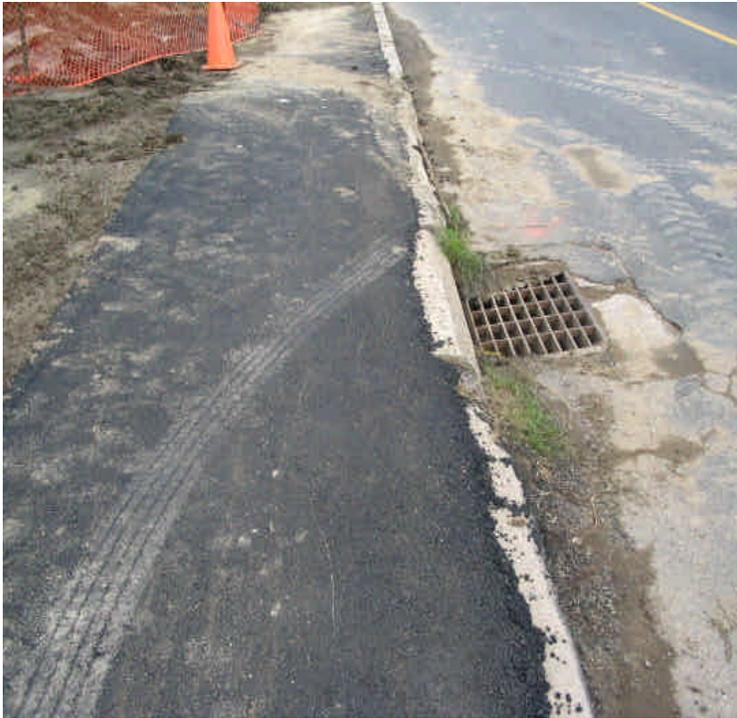
Photo on the left shows an adjacent catch basin to the disturbed jacking pit area. An old piece of filter fabric remained but should be replaced to reduce turbid run-off to the inlet. Photo on the right shows where a washout had undermined the silt fence. This was going to be restored and reinforced prior to the weekend. 8/30/06

- A catch basin adjacent to the work area had an old filter in place but required new controls. 8/30/06	- Replace the old fabric to prevent turbid run-off to the inlet. Clean gutters along the roadway. 8/30/06	-Needs attention

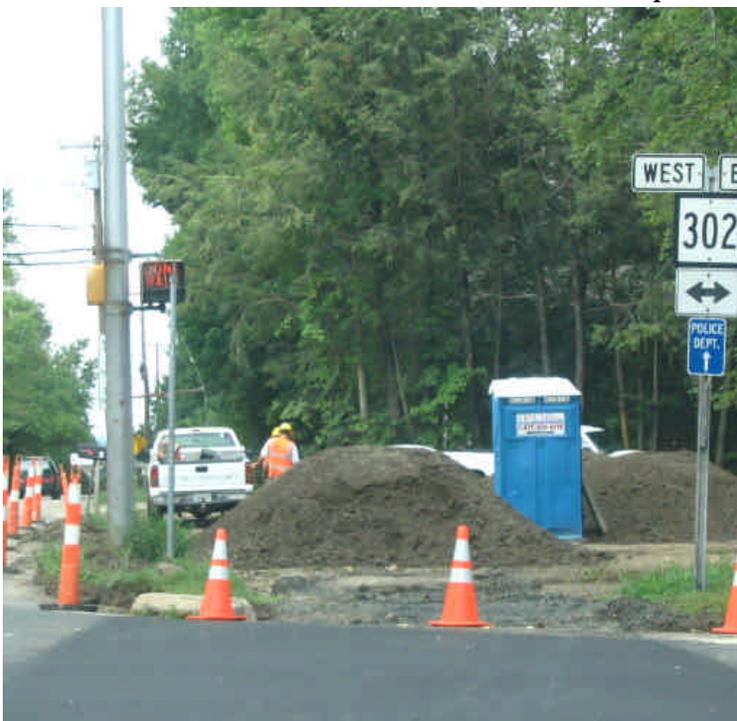
- Vault access continues to be necessary in a few locations including # 5. Vehicles had parked in temporarily restored, grassed areas. 8/16-8/30/06	- Plan to re-seed all these areas after access is complete. 8/16-8/30/06	- N/A until access is complete.

Photo on the left shows the vault #5 area with some loam stockpiles present. The area will be restored when access needs are complete. Photo on the right shows the restored wetland area off Rt 58 which is beginning to revegetate. Pooling water was also present after the rain. 8/30/06
