Docket No. 217 – Development and Management Plan Inspection

Northeast Utilities Service Company Certificate of Environmental Compatibility and Public Need for the construction of a 345-kV electric transmission line and reconstruction of an existing 115-kV electric transmission line between Connecticut Light and Power Company's Plumtree Substation in Bethel, through the towns of Redding, Weston, and Wilton, and to the Norwalk Substation in Norwalk, Connecticut.

Date: September 29, 2006

Location: 345kV XLPE Component

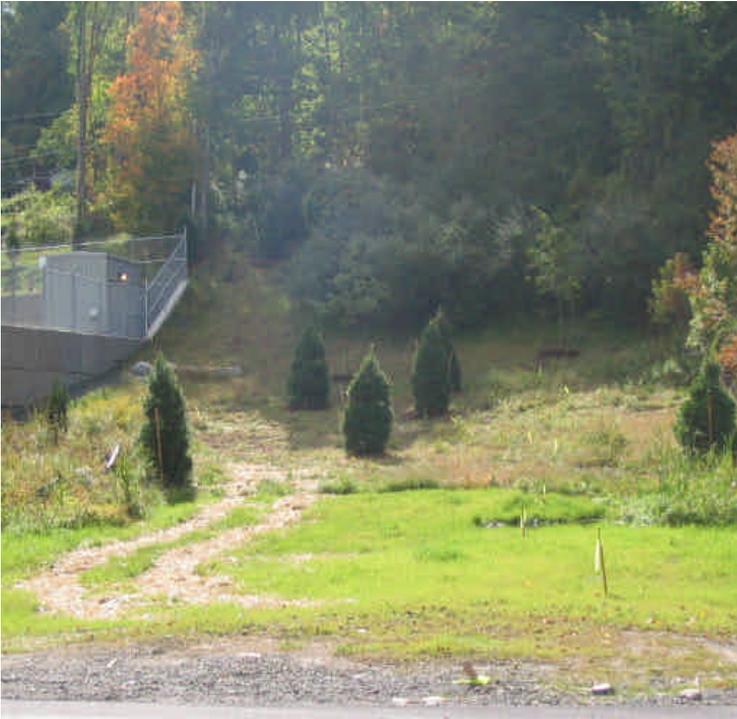
345kV XLPE: Photo on the left shows the restored wetland off Rt 58. Landscaping associated with the transition station was performed and the area is stabilizing well. Photo on the right shows the vault 5 area which quickly stabilized with good grass cover. 9/29/06

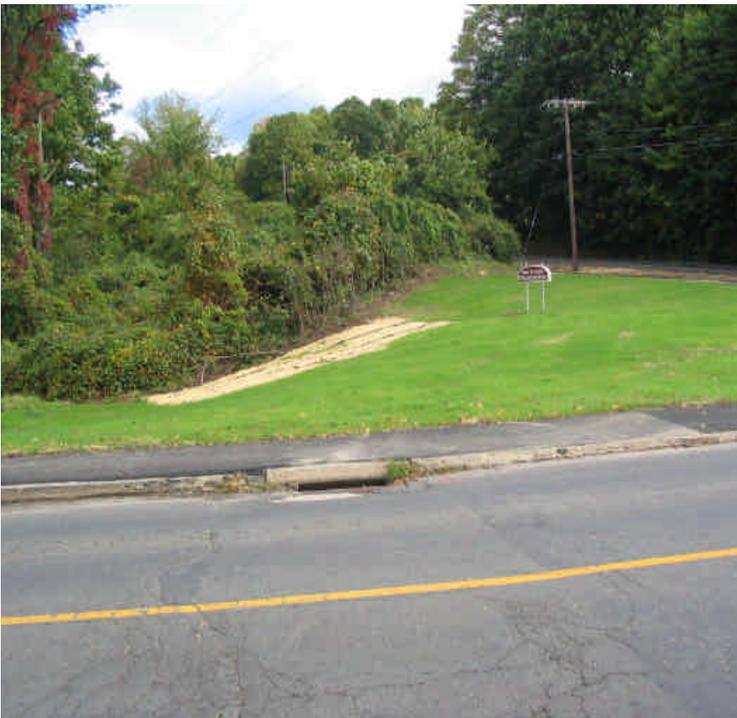
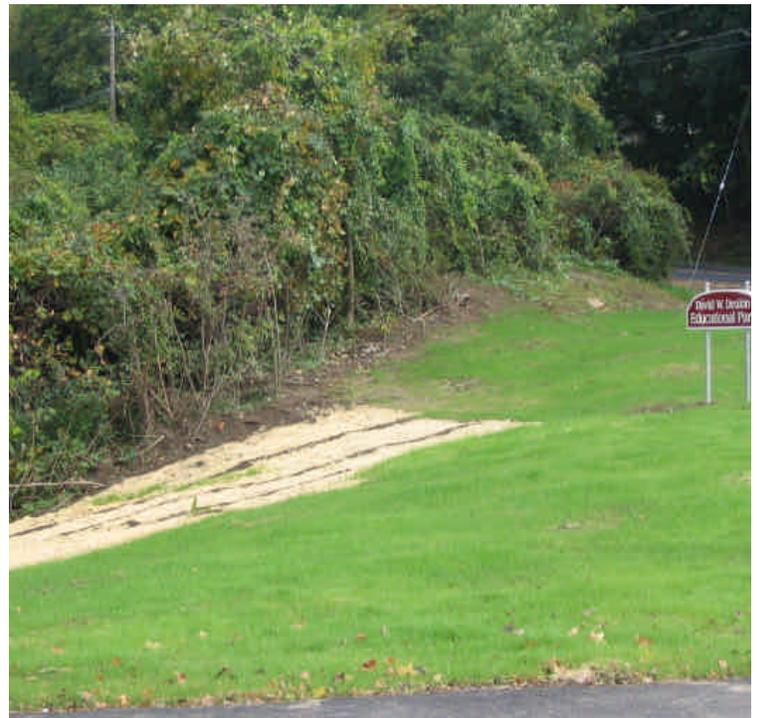
Both photos show the jacking pit side at the jack & bore following restoration. Grass cover is establishing well and the erosion control matting remains in good shape. 9/29/06

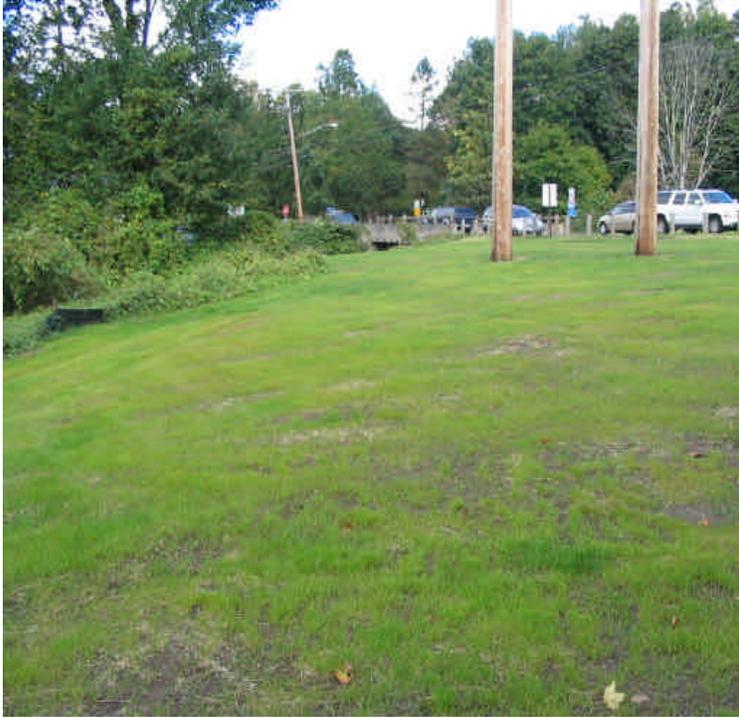
345kV XLPE: Photo on the left shows the restored area in the ball-park with grass cover establishing. Photo on the right shows a view looking towards East Swamp Brook. Vegetation is fairly established at the top of slope but still patchy on the banks. 9/29/06

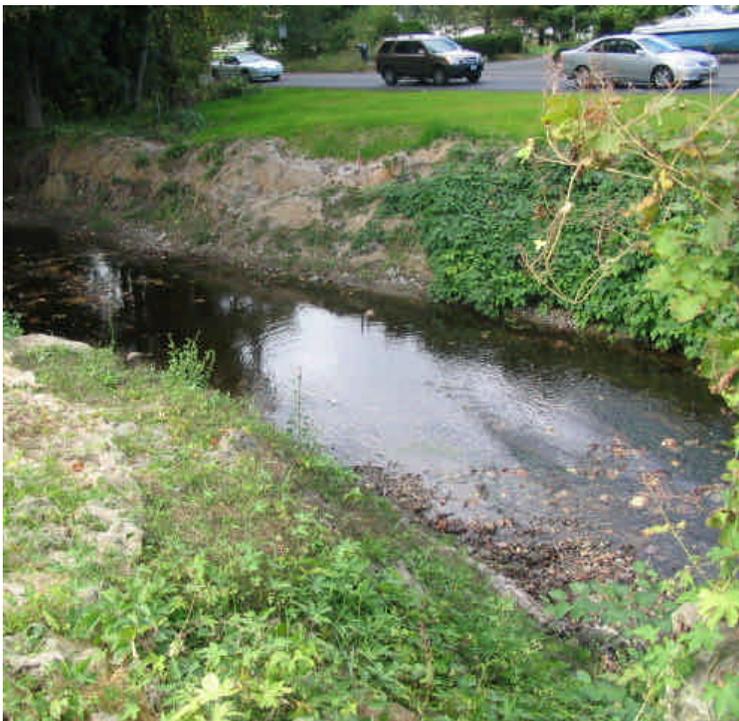
Photo on the left shows the streambank with patchy vegetation returning. Additional seed or cover may be necessary prior to the end of the growing season. Oct 15 is generally recommended as the end of fall seeding. Photo on the right shows the recent restoration efforts at vault 2. 9/29/06
