Docket No. 217 – Development and Management Plan Inspection

Northeast Utilities Service Company Certificate of Environmental Compatibility and Public Need for the construction of a 345-kV electric transmission line and reconstruction of an existing 115-kV electric transmission line between Connecticut Light and Power Company’s Plumtree Substation in Bethel, through the towns of Redding, Weston, and Wilton, and to the Norwalk Substation in Norwalk, Connecticut.

Date: January 12, 2006

Location: 345kV Underground Route

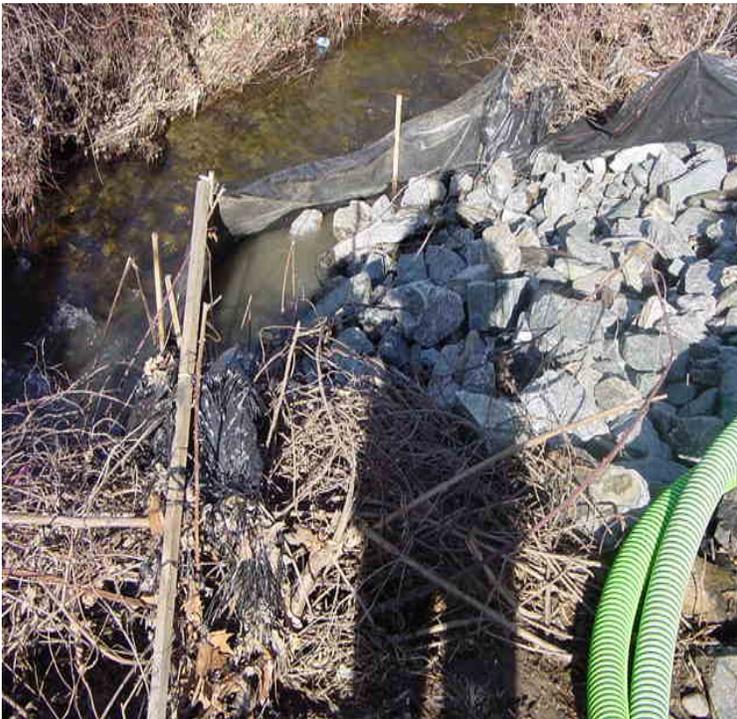
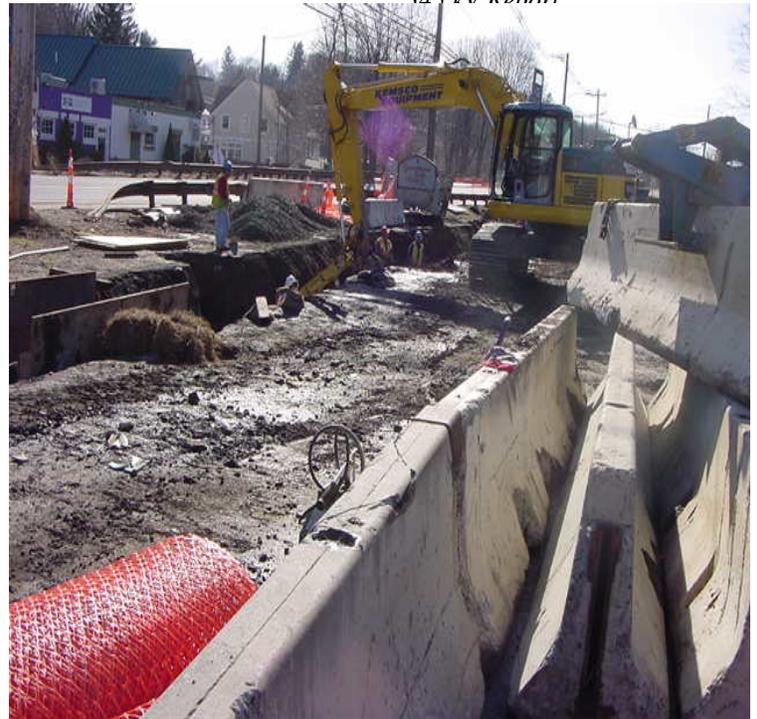
345kV (Georgetown Deli Jack and Bore): Photo on the left shows the stream with some minor turbidity retained in the silt fence. Photo on the right shows the receiving pit side where trenching continues from the pit. 1/12/06

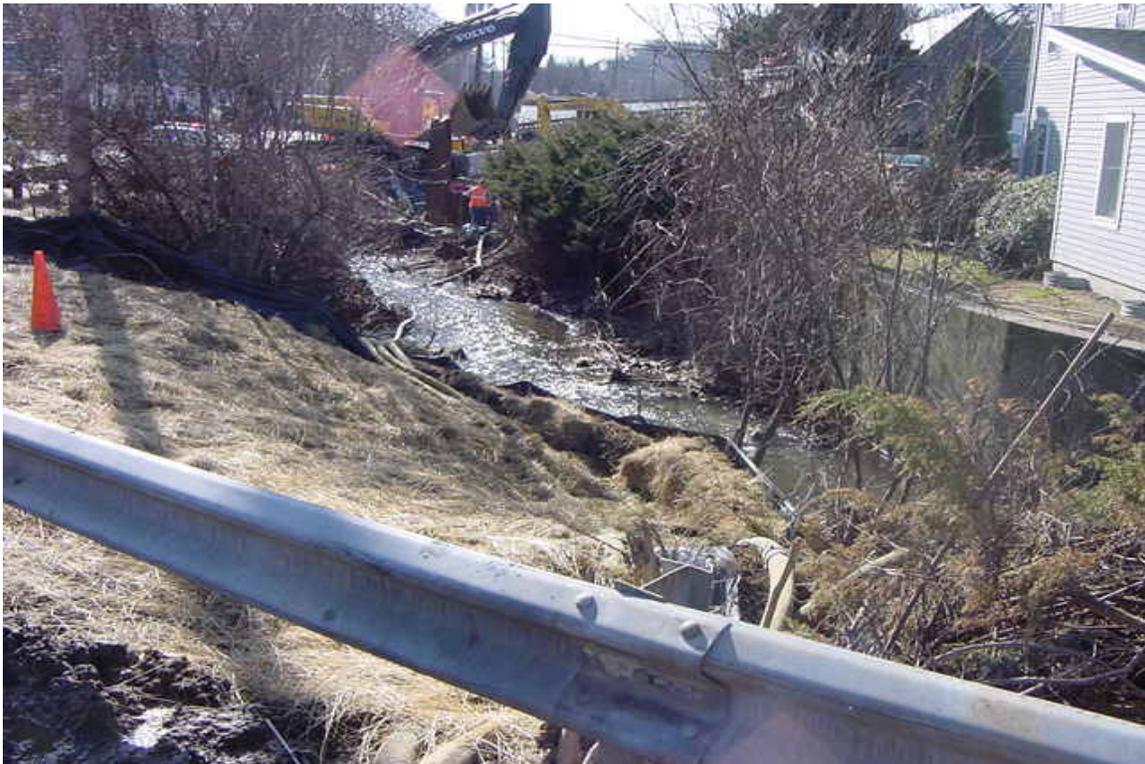
Photo on the left shows the bore pit side where backfilling has occurred. The slope has been well restored with straw mulch. 1/12/06

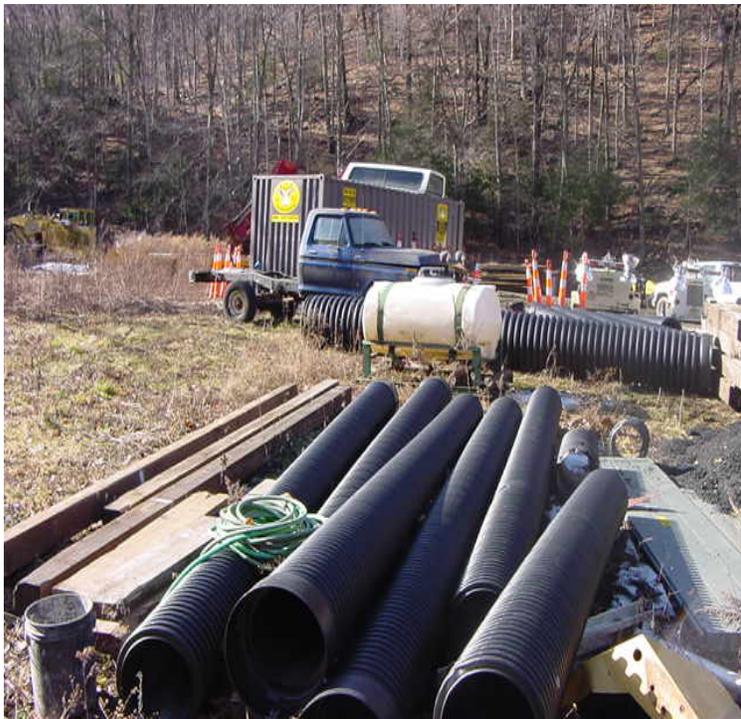
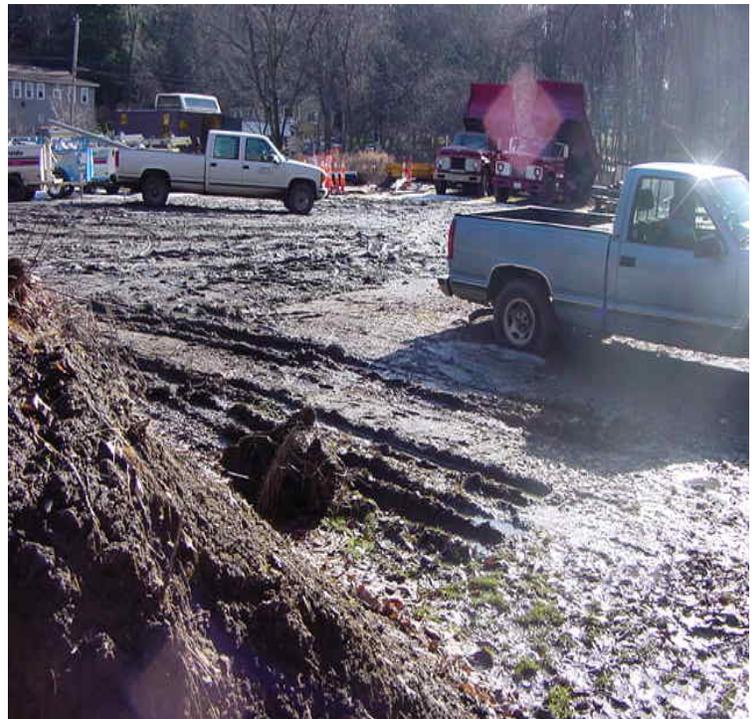
345kV (Rt. 107/ Rt. 7 storage area) Both photos show an overview of the storage area. Conditions are muddy here but the equipment is fairly well contained. The landowner did express some concerns to the inspector about cleaning up coffee cups and other litter. 1/12/06

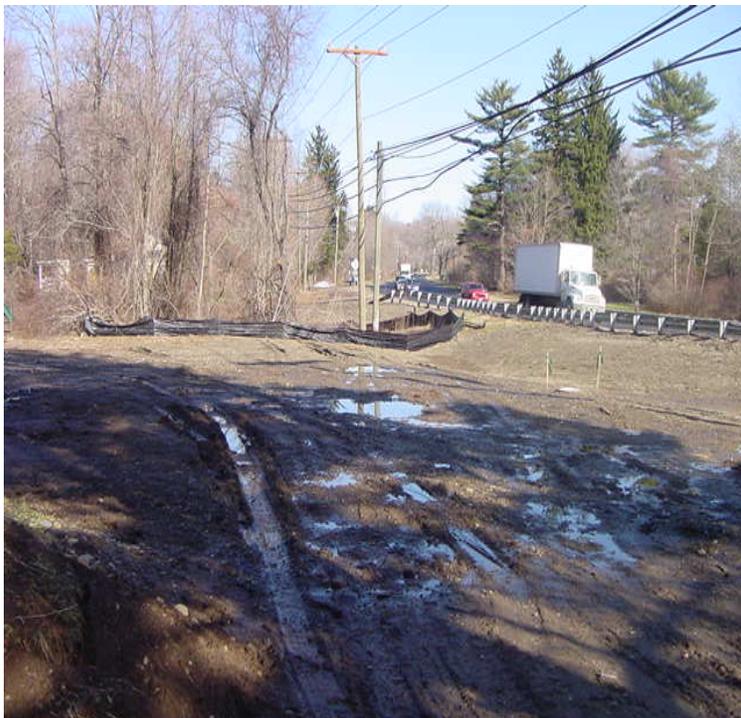
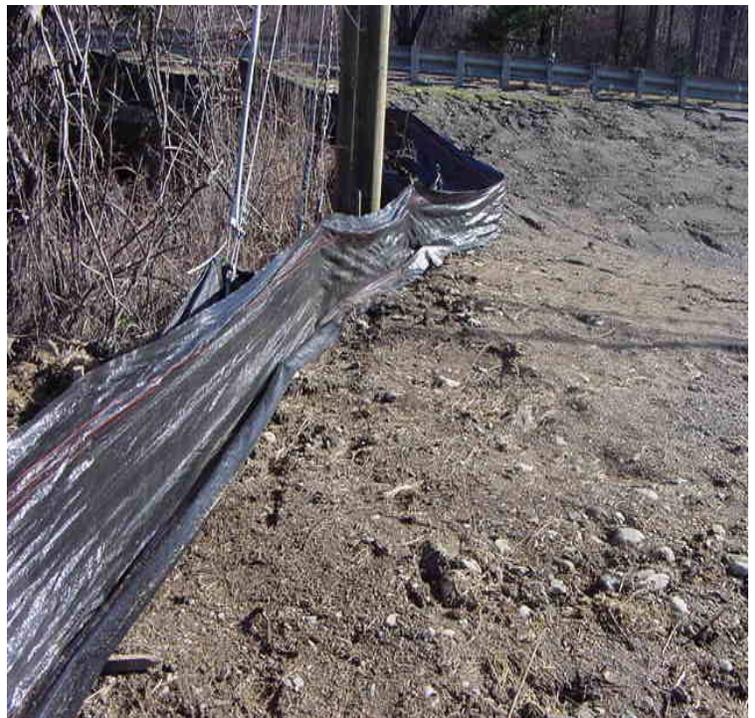
345kV (High School J&B): Overall view of the site. The silt fence was repaired in the worn spots as recommended but there are still some areas that need to be toed-in. 1/12/06

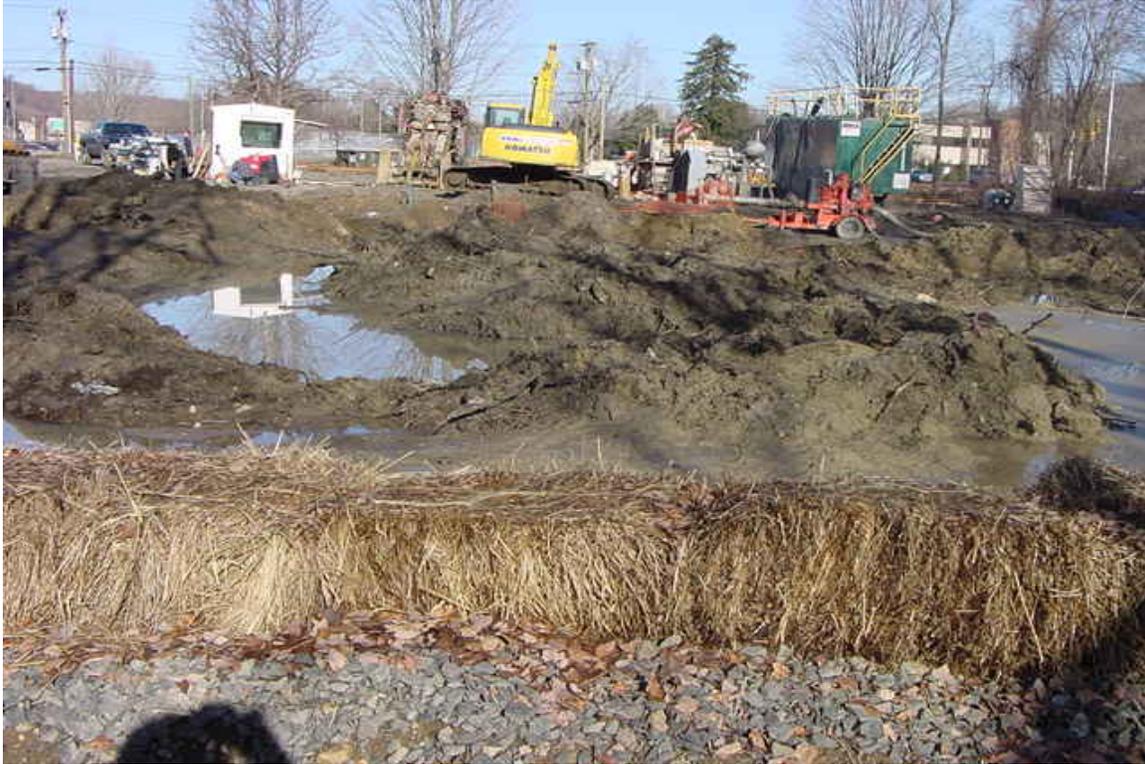
345kv (HDD): Overall view of the basin and bore site. It appears that excavation is occurring in some areas. The site still remains highly disturbed. 1/12/06

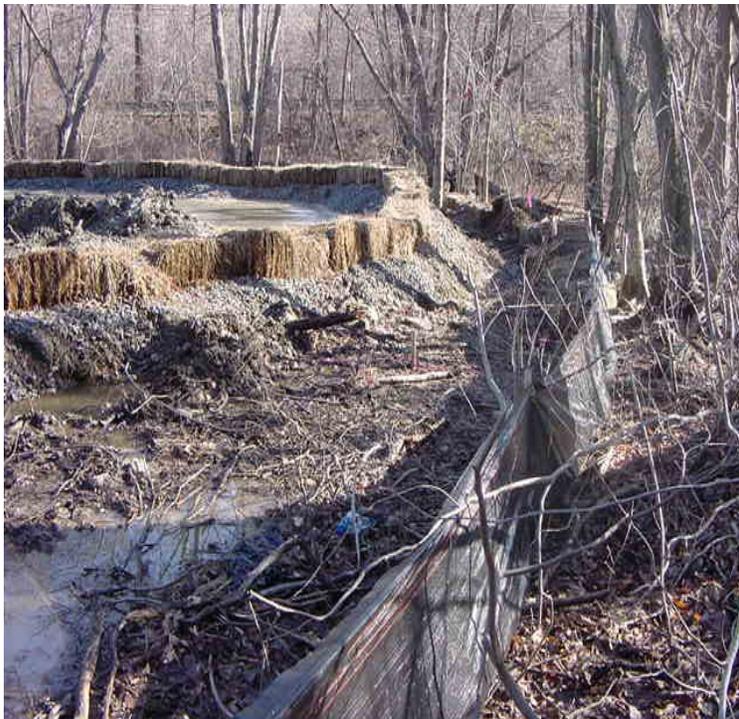
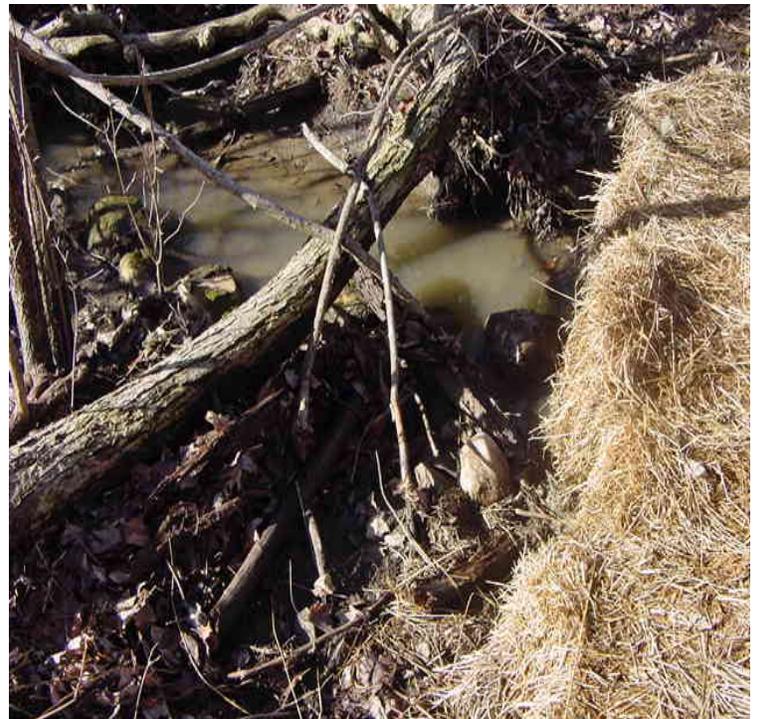
Photo on the left shows the basin where erosion controls appear to have been improved from previous weeks. The photo on the right shows some minor turbidity that was noted in the channels beyond the basin. This is likely due to the ponded turbid area to the east of the basin. 1/12/06

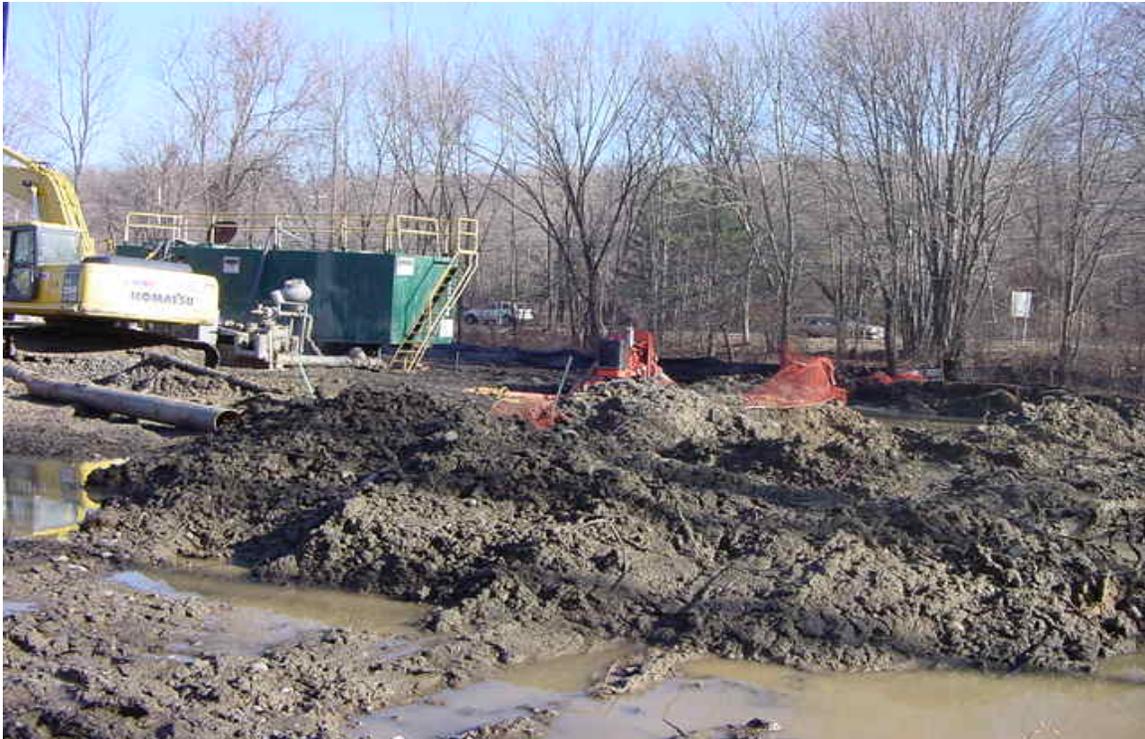
Another view of the overall site at some of the disturbed soil and attempts to excavate. Further stabilization is needed. 1/12/06

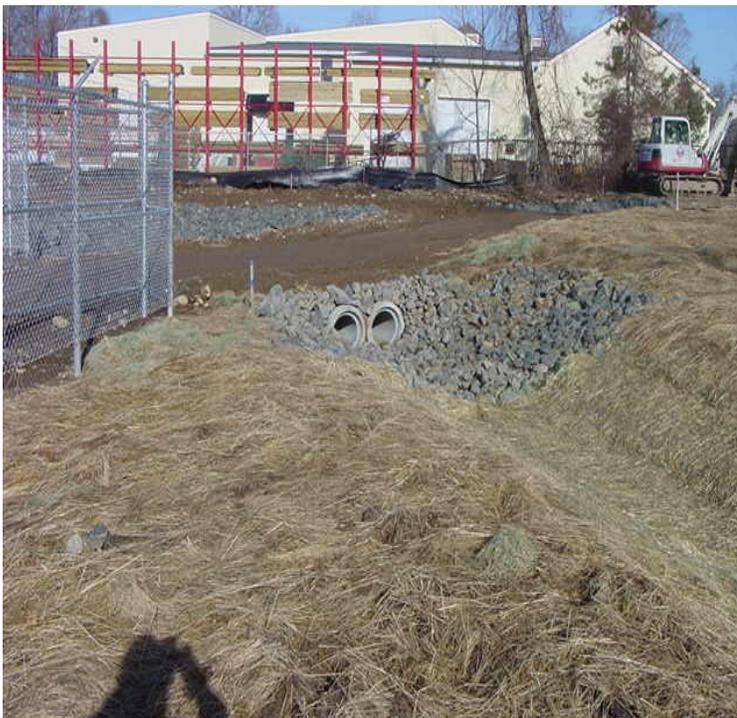
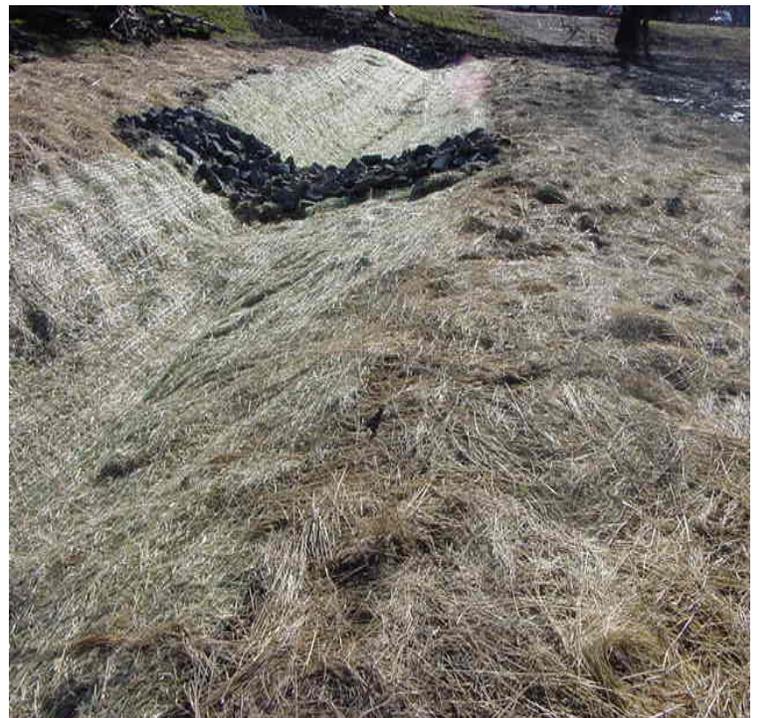
345kV (Norwalk Junction): Both photos show excellent restoration of the swale and adjacent area that was used for directing dewatering discharge from the vault installation. The swale was lined with erosion matting/netting and adjacent areas were heavily mulched. 1/12/06
