Docket No. 217 – Development and Management Plan Inspection

Northeast Utilities Service Company Certificate of Environmental Compatibility and Public Need for the construction of a 345-kV electric transmission line and reconstruction of an existing 115-kV electric transmission line between Connecticut Light and Power Company’s Plumtree Substation in Bethel, through the towns of Redding, Weston, and Wilton, and to the Norwalk Substation in Norwalk, Connecticut.

Date: January 26, 2006

Location: 345kV Underground Route

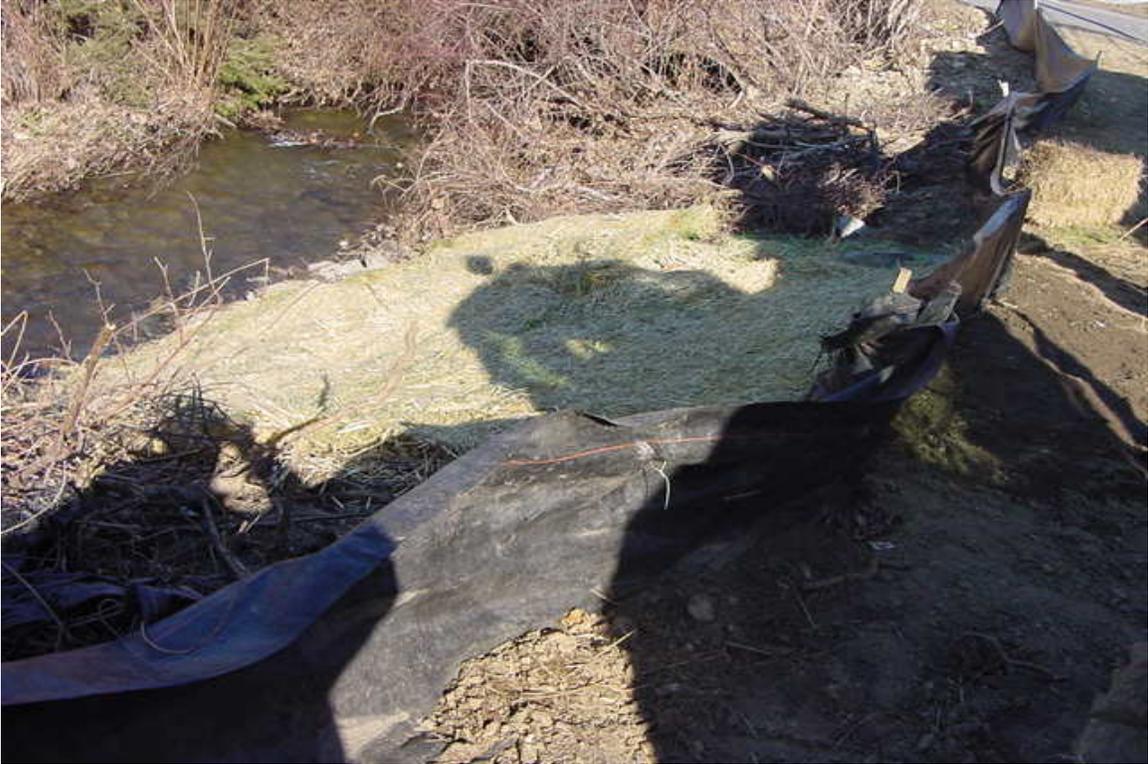
3345kV (Georgetown Deli Jack and Bore): View of the streambank where the dewatering riprap outlet was previously installed. It has since been removed and the bank well restored with erosion control matting. 1/26/06

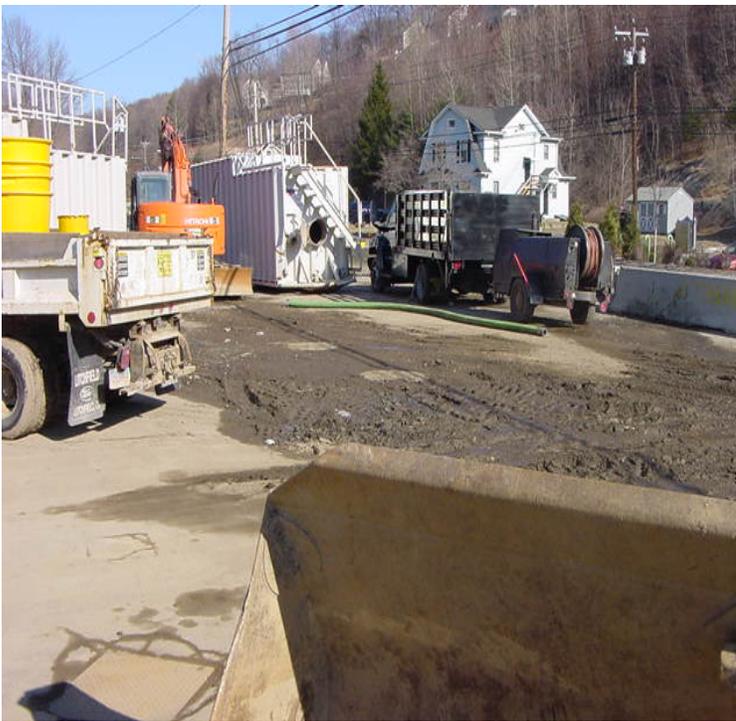
Photo on the left shows the parking lot where the tanks are being demobilized and removed. Photo on the right shows a view of the previously restored streambank, still in good shape. 1/26/06

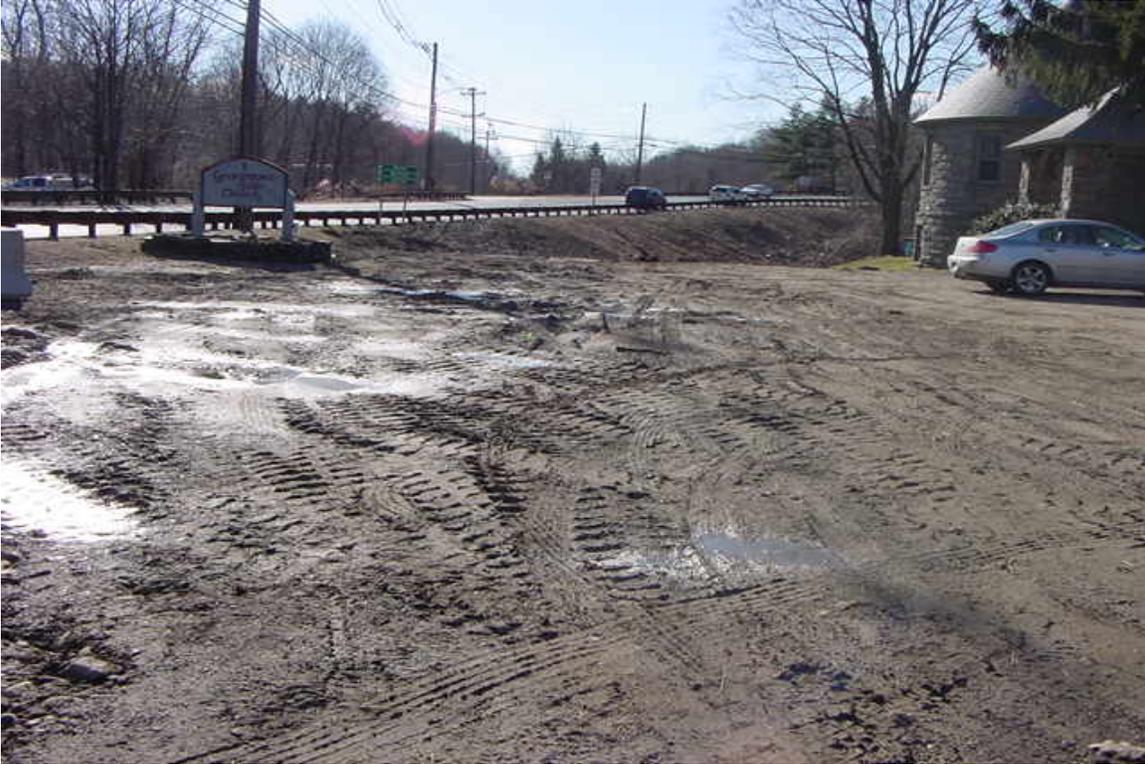
345kV (Rt. 107) Overview of the area where the trenchwork was located along Rt. 107. Any areas that were previously grassed/vegetated should be restored when feasible. 1/26/06

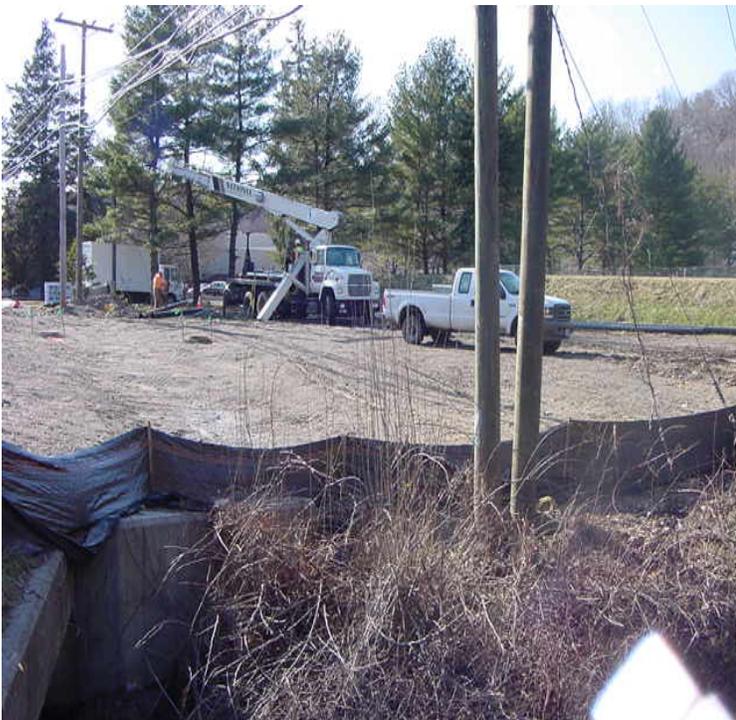
345kV (High School J&B and HDD): Photo on the left is a view of the J&B site with controls well in place. Contractors were on site removing conduit. Photo on the right shows the perimeter erosion controls at the HDD. Continue to maintain and keep in good shape. 1/26/06

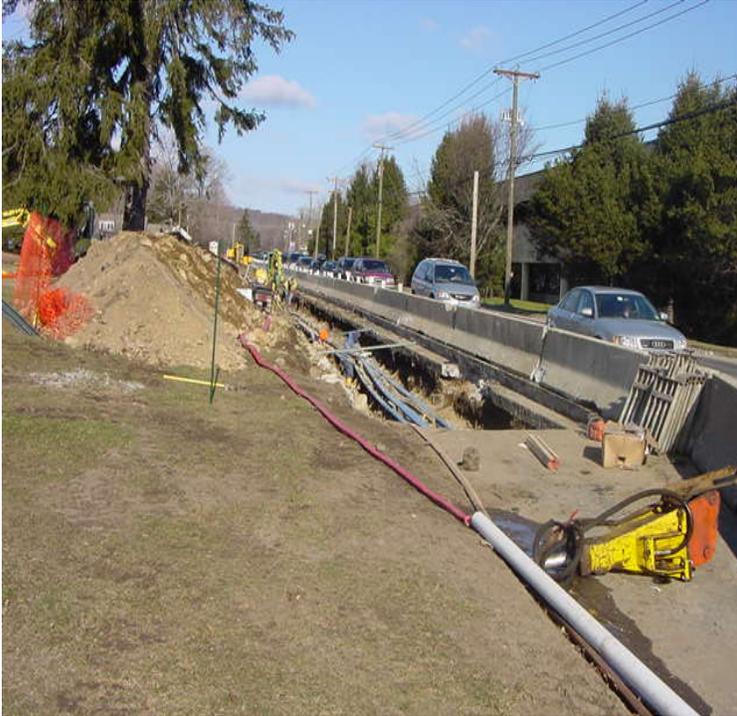
345kv (HDD-related): Photo on the left shows trenching along Rt. 7 for a project that is unrelated to the 345kV work. However, the trench is being dewatered to the street and is entering a catch basin that flows directly to the HDD site. Photo on the right shows the dewatering discharge.

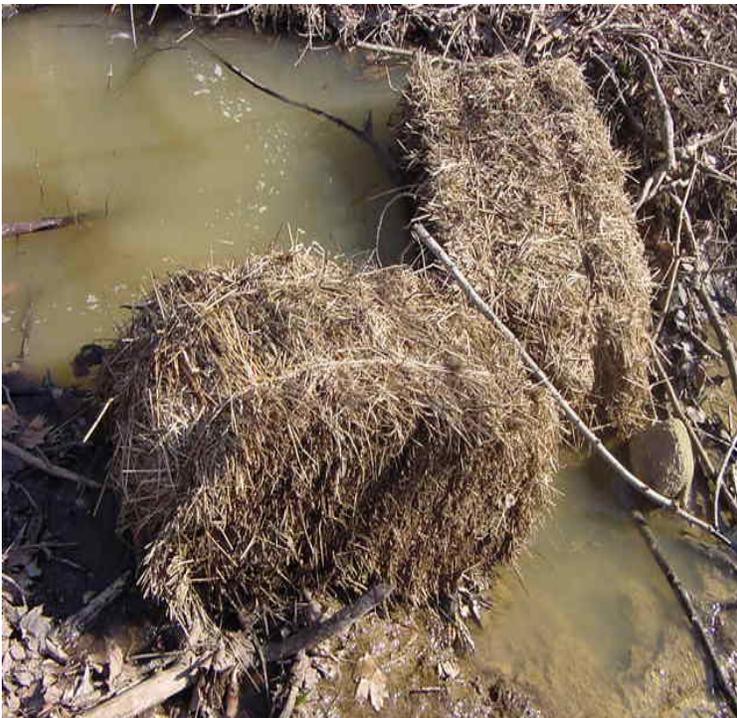
Photo on the left shows the additional water and turbidity that is passing through the controls beyond the basin. The flow is due to the offsite dewatering from a separate construction project on Rt. 7. Photo on the right shows the overview of the HDD site. Portions of the basin appears to have been excavated recently.
1/26/06
