Docket No. 217 – Development and Management Plan Inspection

Northeast Utilities Service Company Certificate of Environmental Compatibility and Public Need for the construction of a 345-kV electric transmission line and reconstruction of an existing 115-kV electric transmission line between Connecticut Light and Power Company’s Plumtree Substation in Bethel, through the towns of Redding, Weston, and Wilton, and to the Norwalk Substation in Norwalk, Connecticut.

Date: March 2, 2006

Location: 345kV Underground Route

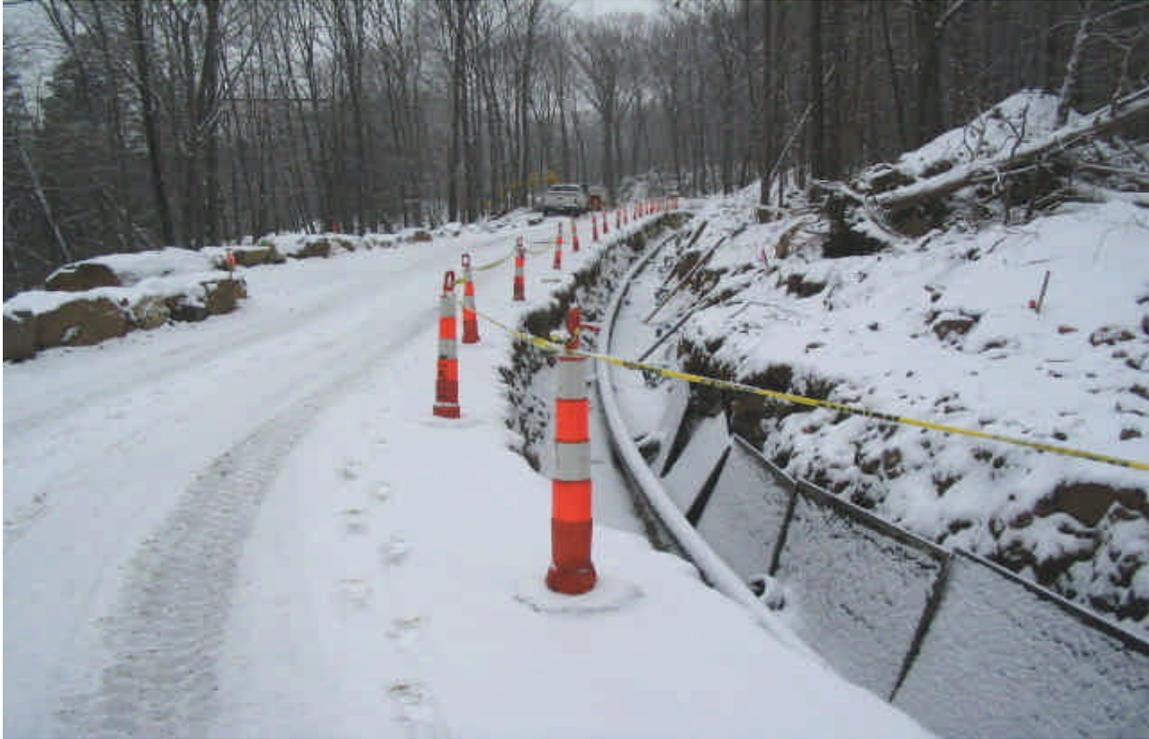
345kV (Archers Lane): View of the trenching for the 345kV work along the access drive into the Archers Lane station. Pipe is being installed and the site remains well contained at this time. 3/2/06

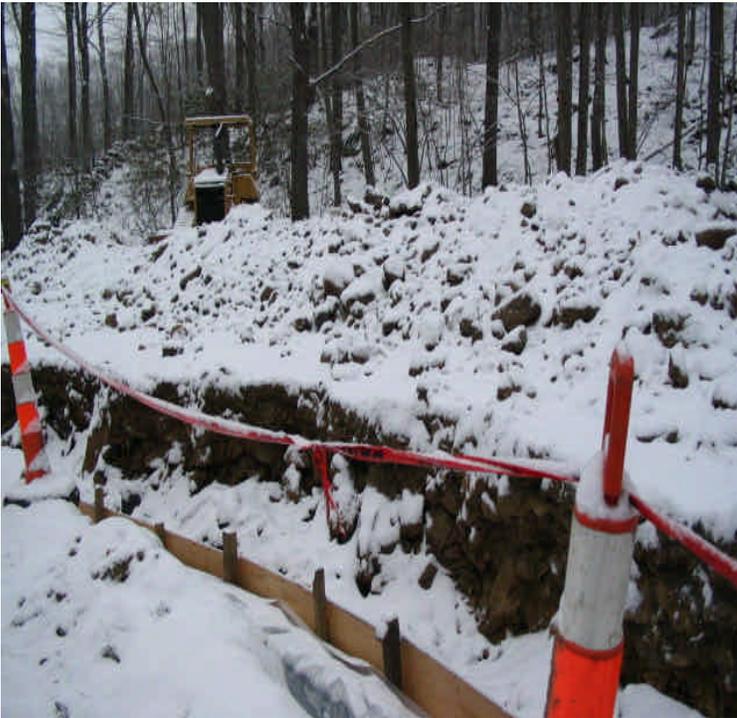
Photo on the left shows the stockpiling along the trench in the driveway. All areas on this side of the trench are upland. Photo on the right shows the trenching to connect the vault to the utilities. 3/2/06

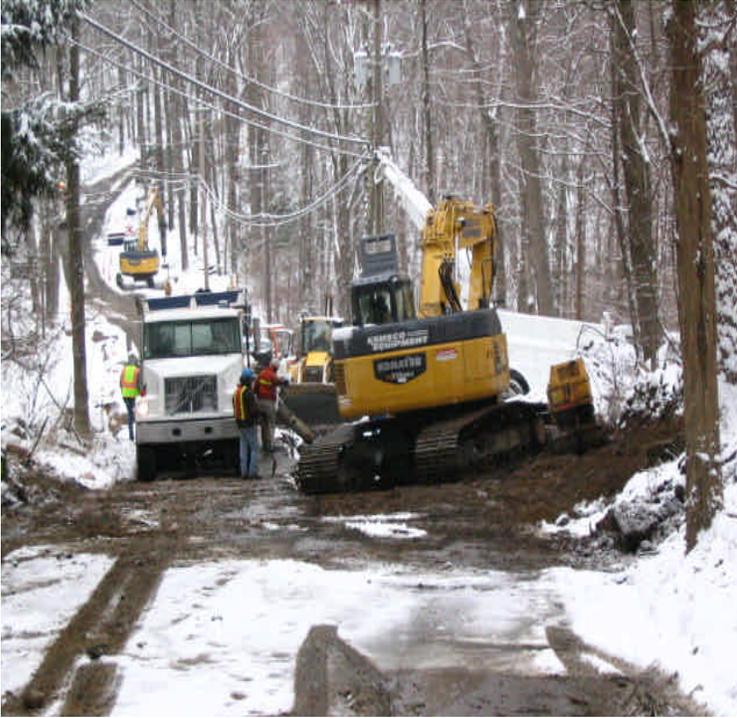
345kV (Umpawaug Rd) Photo on the left shows crews actively trenching along the roadway. The swale at the base of the hill near #79 has haybales in place. Photo on the right shows a view of the open trench. 3/2/06

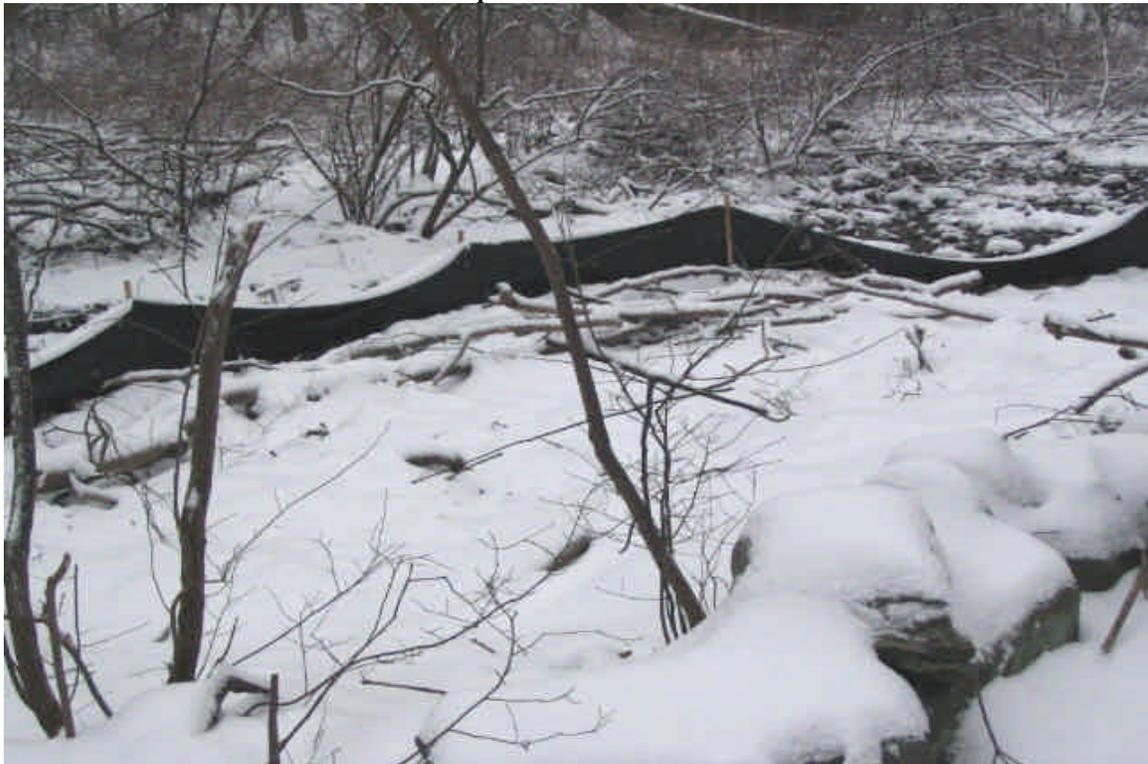
345kV (HDD): Photo shows the erosion controls which were installed within the wetland and adjacent to the recently disturbed soil as requested. 3/2/06

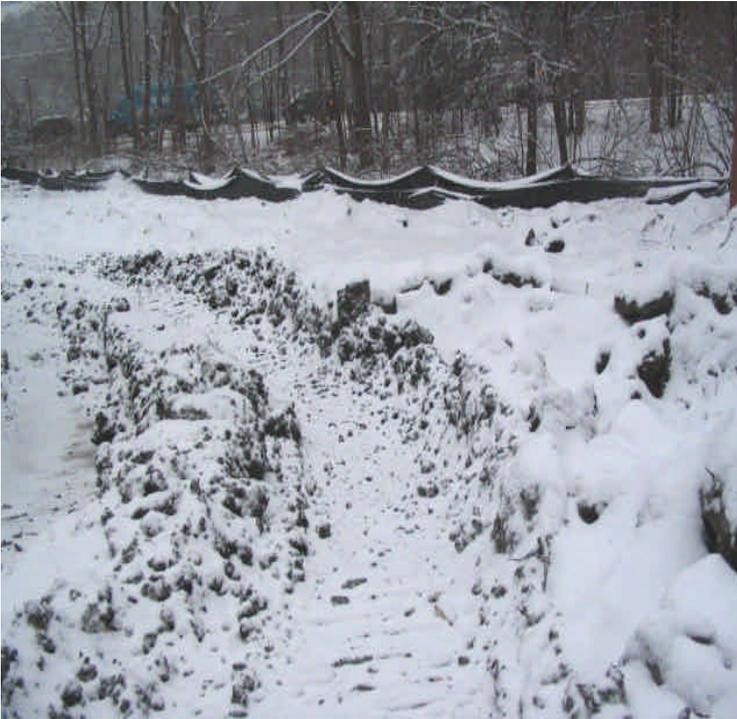
Photo on the left shows where the soil was bermed up and helps to keep water within the basin. Photo on the right shows the end of the utilities now that they have been installed within the bore hole. Trenching will continue from here to connect the project. 3/2/06

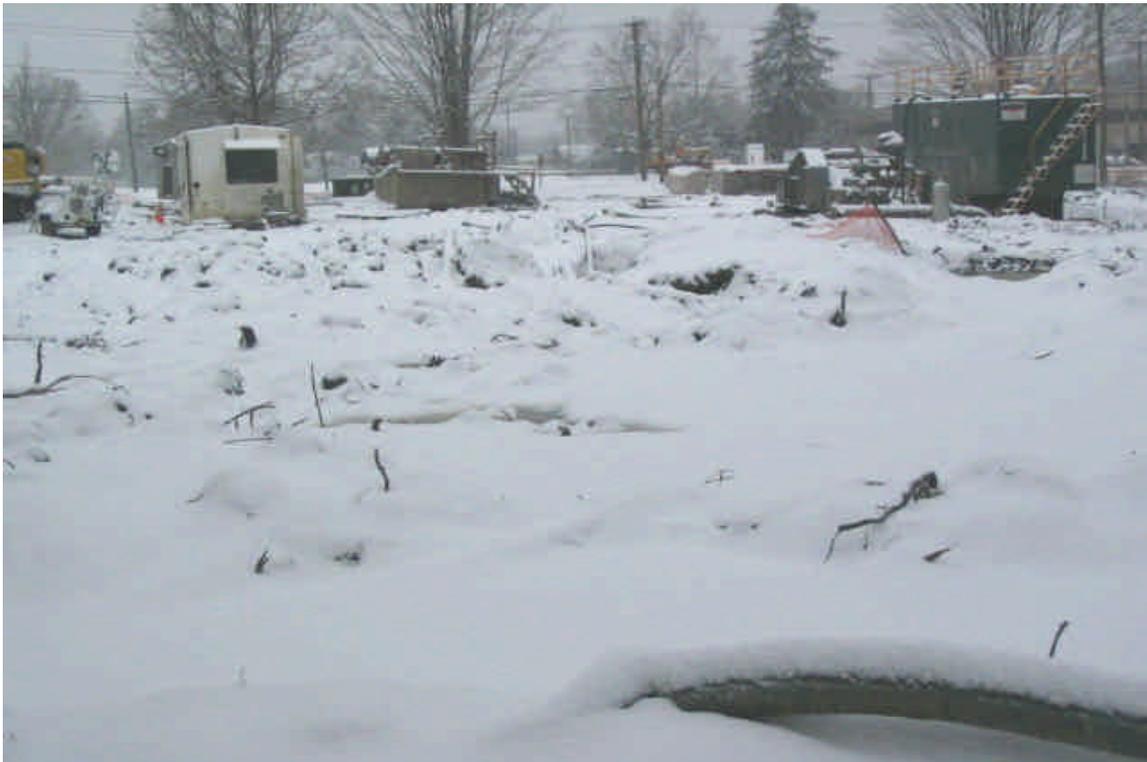
Overview of the remaining basin and the work site, equipment was being loaded up in preparation to move off site at the time of inspection. 3/2/06
