Docket No. 217 – Development and Management Plan Inspection

Northeast Utilities Service Company Certificate of Environmental Compatibility and Public Need for the construction of a 345-kV electric transmission line and reconstruction of an existing 115-kV electric transmission line between Connecticut Light and Power Company’s Plumtree Substation in Bethel, through the towns of Redding, Weston, and Wilton, and to the Norwalk Substation in Norwalk, Connecticut.

Date: March 15, 2006

Location: 345kV Underground Route

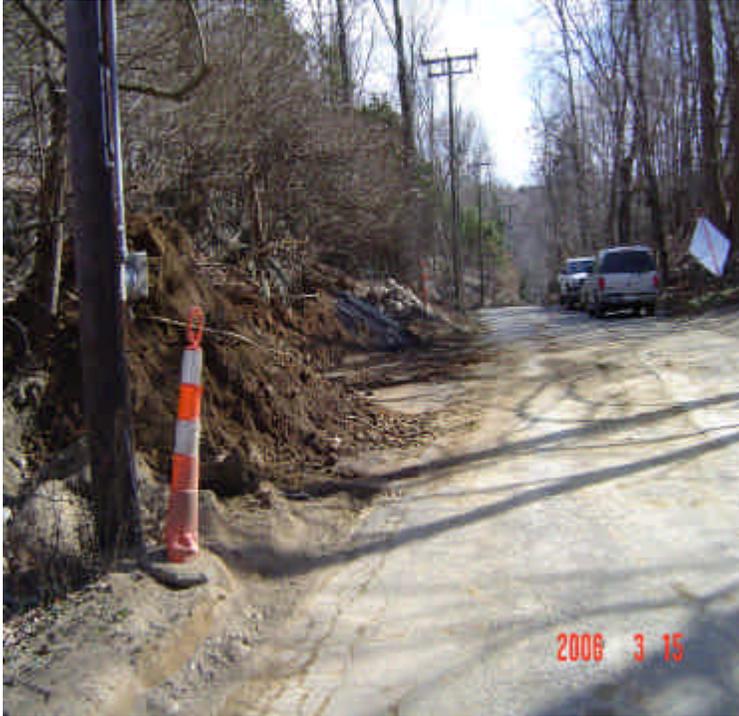
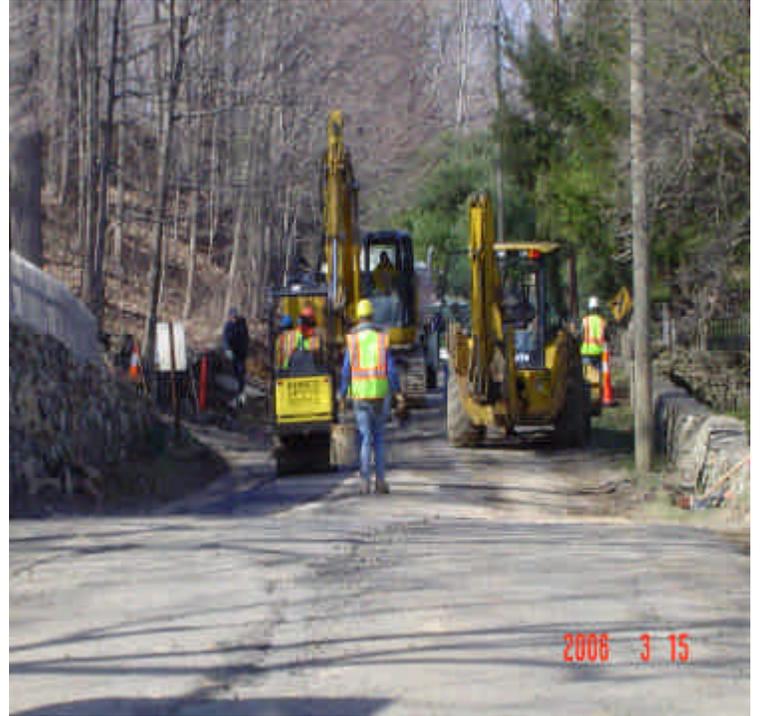
345kV (Umpawaug Rd): Both photos show the continuing trench work near #95 Umpawaug Rd. Photo on the left shows some soil remaining on the shoulder of the roadway which will be removed or placed back in the trench. 3/15/06

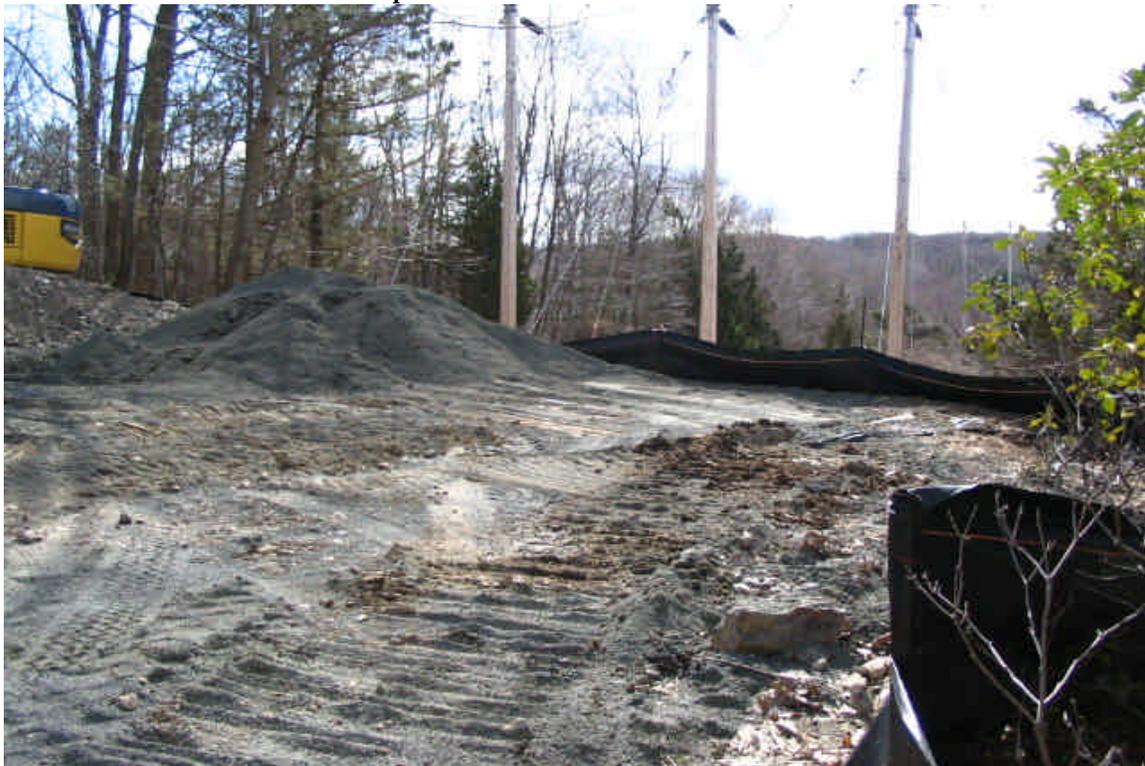
(Archers Lane): View of a stockpile of flowfill located adjacent to the drive and at the top of a slope. Silt fence was installed as recommended. 3/15/06

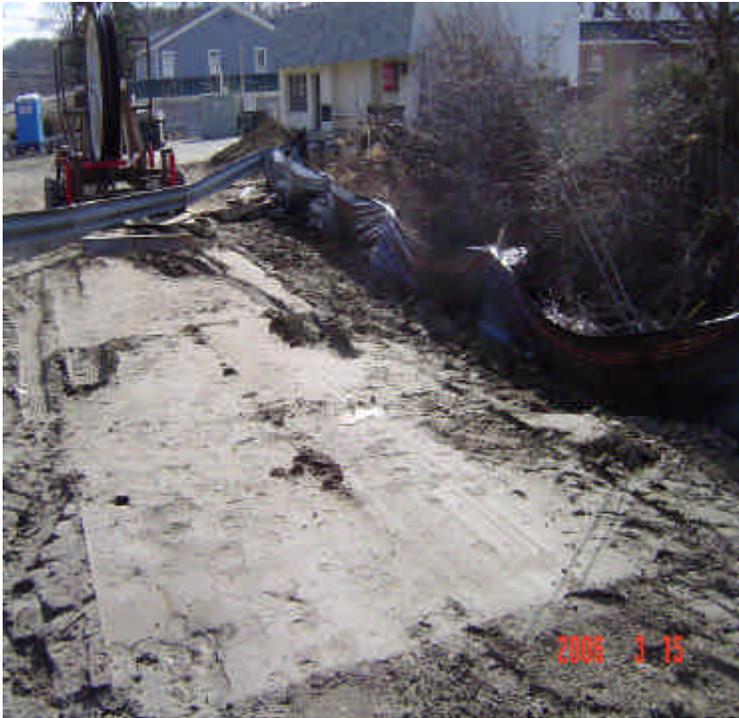
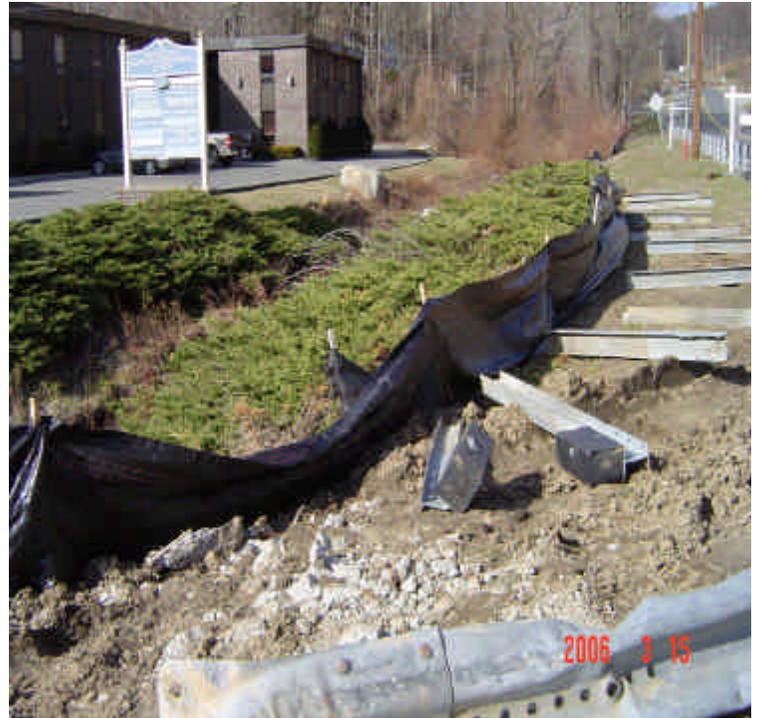
345kV (Rt 107) Photo on the left shows recent work near the Georgetown Deli with silt fence in place. Photo on the right s shows recent work immediately to the north of the deli where silt fence repairs were made. 3/15/06

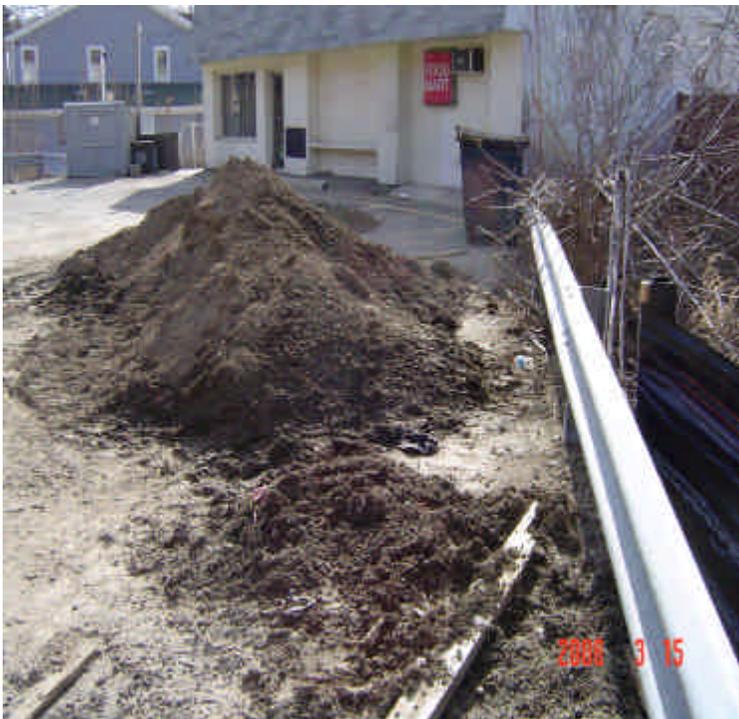
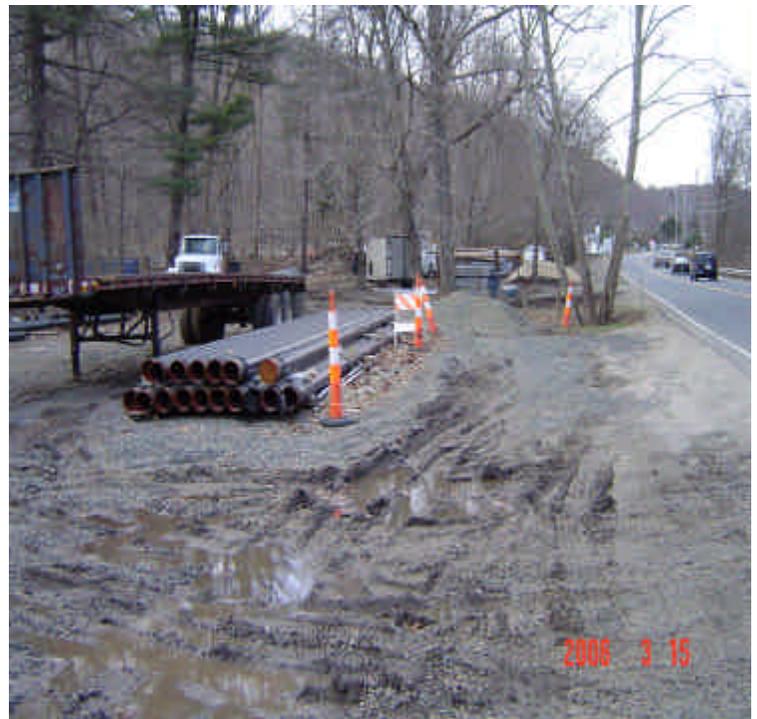
345kV (Rts. 107 and 7): Photo on the left shows a small stockpile by the deli where silt fence should be extended to encompass the pile. Photo on the right shows the Racquet Club storage area where a haybale needs to be installed in the swale. 3/15/06

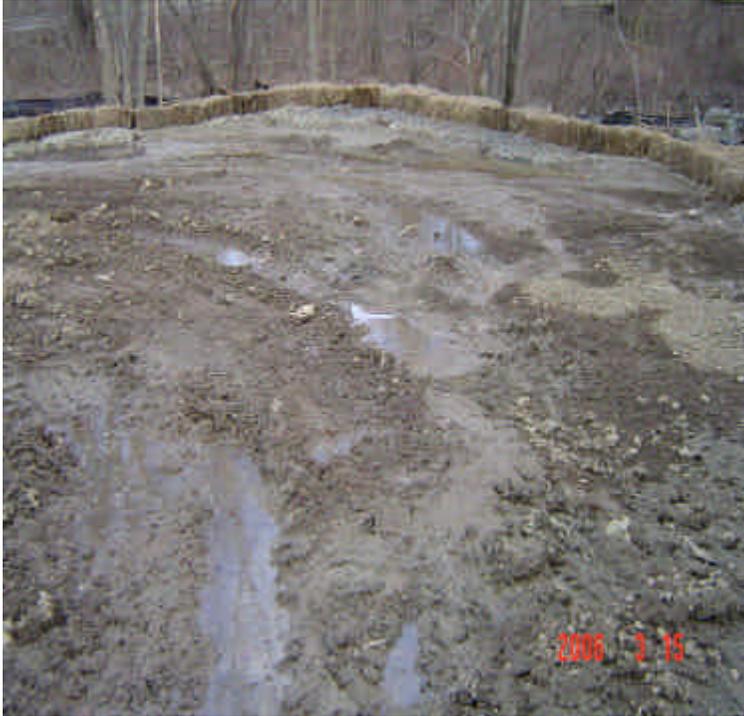
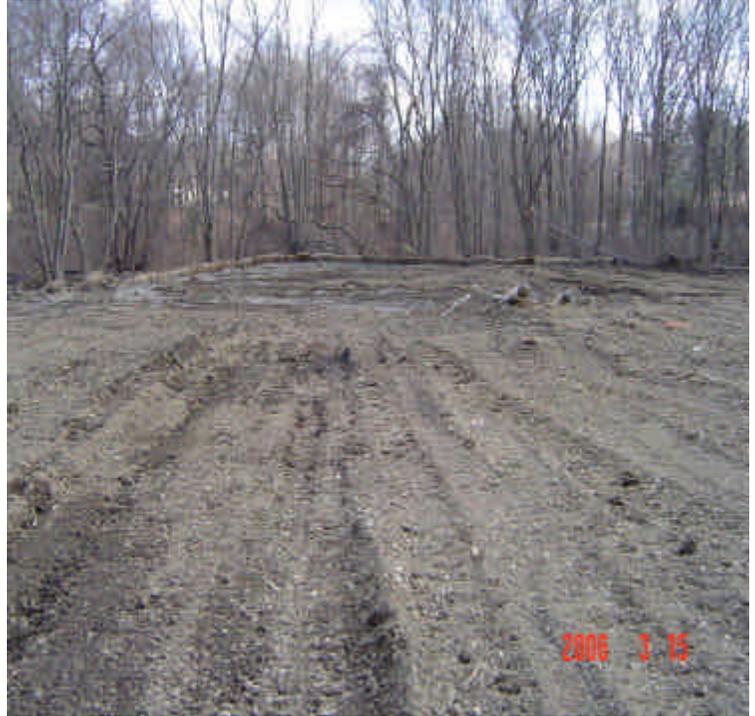
345kV(HDD): Both photos show a view of the HDD site after being regraded and the basin has been filled in. Perimeter controls remain in place and further restoration will be done when work finishes here. 3/15/06

- Equipment has demobilized from the Horizontal Direction Drill at School Rd. The basin has been filled in and graded as temporary stabilization. 3/15/06	- Further restoration will be necessary after the adjacent work is complete. See additional sections for more details. 3/15/06	- The basin has been graded which will help reduce sedimentation.
	-Trenching will need to continue here in the near future to link up the project. 3/9-3/15/06	- See other sections for more details. 3/15/06	-N/A

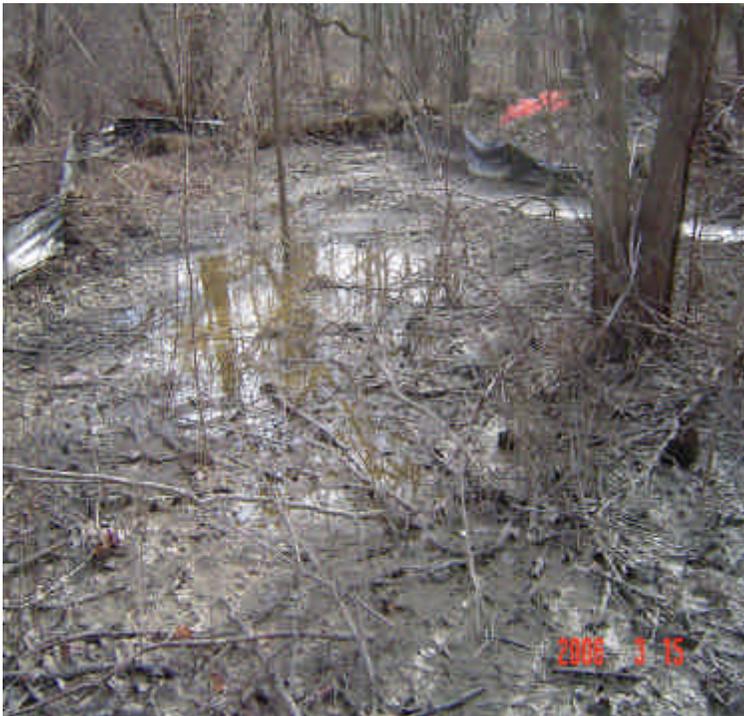
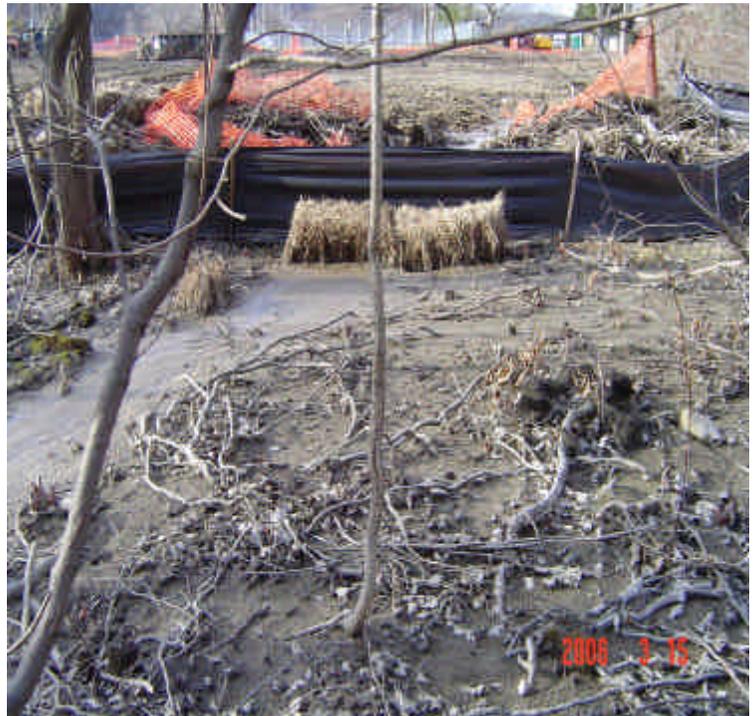
Photo on the left shows the eastern side of the wetland beyond the controls where off-site dewatering and site water caused sedimentation. Photo on the right shows a close-up of the sedimentation which should be removed where it has accumulated. 3/15/06

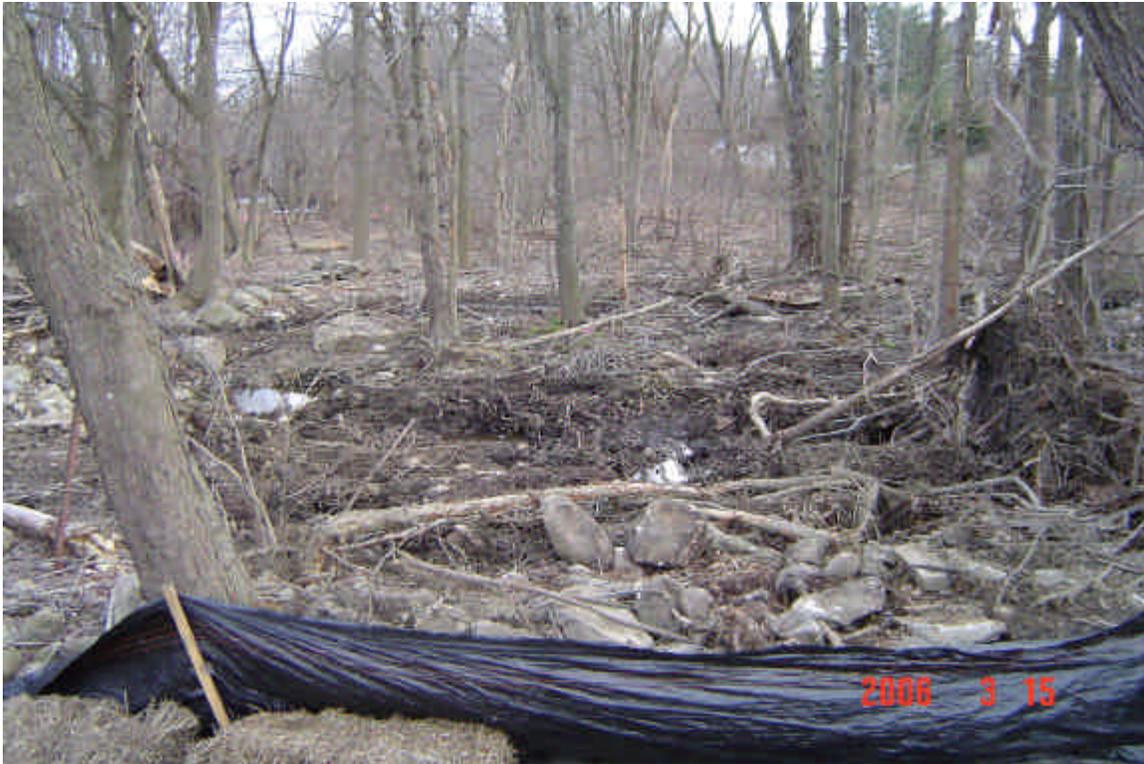
Photo shows a view of the wetland beyond the perimeter fence where the disturbance has occurred several weeks ago. Some restoration will be necessary here. 3/15/06

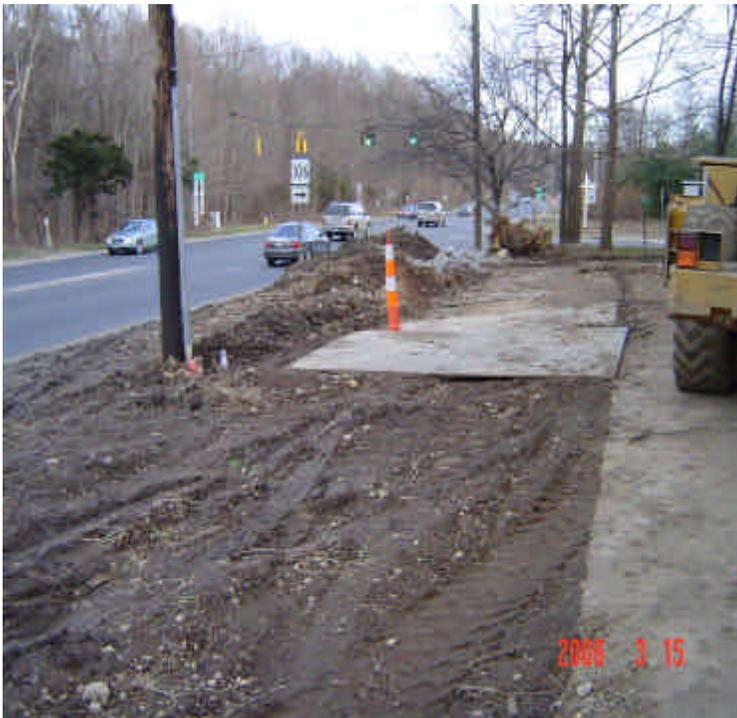
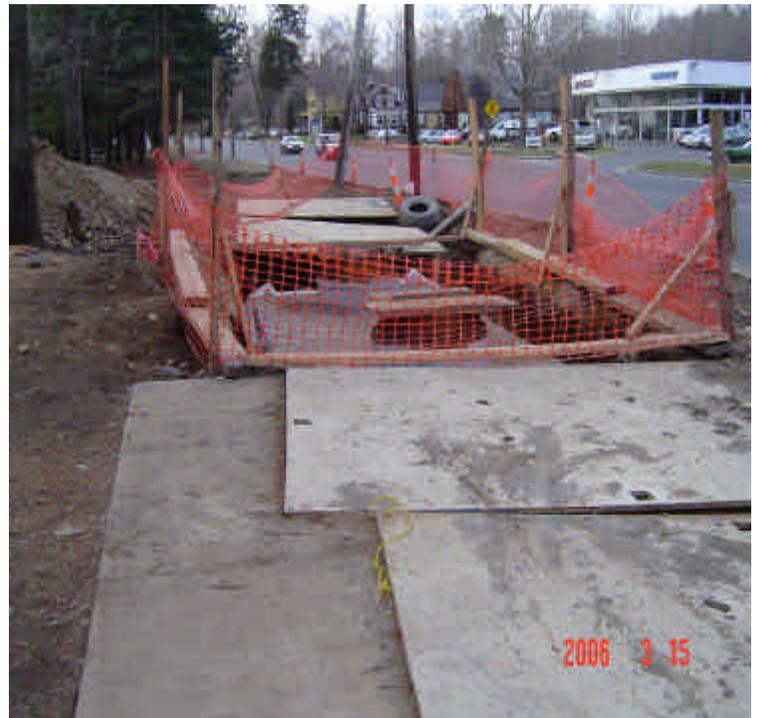
Photo on the left shows an area adjacent to the vault installation near the Wilton Corp. Park. Stockpiles near the street should have erosion controls. Photo on the right shows the open vault excavation. 3/15/06

Areas of Inspection	Observation	Recommended Action	Corrected Action
Vault Openings and Trench Construction	- An open vault excavation remains near Wilton Corporate Park on Rt. 7. 3/9-3/15/06	- Some attention is needed here. See erosion control section. 3/15/06
