Docket No. 217 – Development and Management Plan Inspection

Northeast Utilities Service Company Certificate of Environmental Compatibility and Public Need for the construction of a 345-kV electric transmission line and reconstruction of an existing 115-kV electric transmission line between Connecticut Light and Power Company's Plumtree Substation in Bethel, through the towns of Redding, Weston, and Wilton, and to the Norwalk Substation in Norwalk, Connecticut.

Date: April 19, 2006

Location: 345kV Underground Route

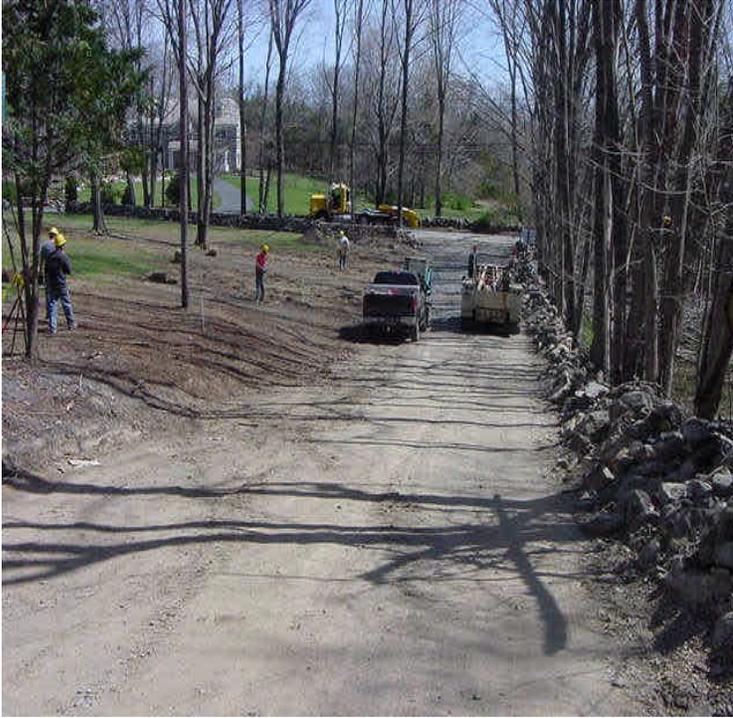
345kV (Archers Lane): Photo on the left shows crews restoring the lawn of the property adjacent to the access drive. Photo on the right shows a vault along the access drive. These areas remain to be restored even though they are not directly adjacent to a residence. 4/19/06

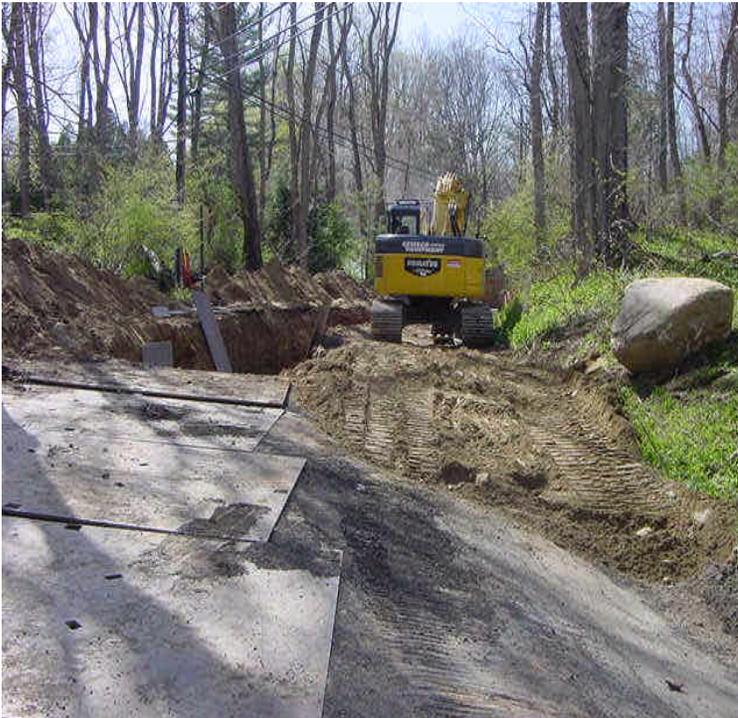
345kV (Diamond Hill Rd) Photo on the left shows active trenching along Diamond Hill Rd. Silt fence was adjacent to the work but was not toed in. Photo on the right shows where efforts were made to install haybales in swales and inlets adjacent to the work. 4/19/06

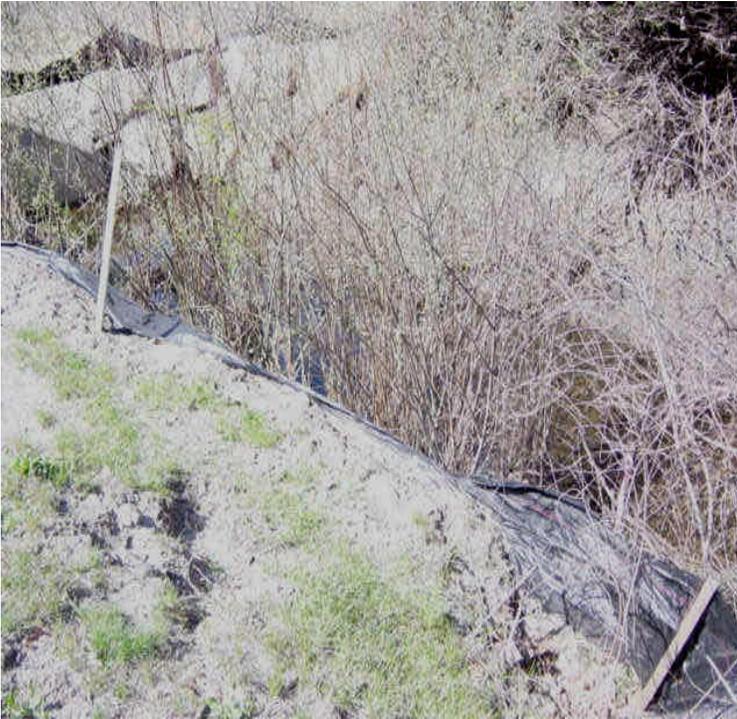
345kV (Rt 107 and Rt 7) Photo on the left shows where silt fence was down in the vicinity of Georgetown Deli. The area is also beginning to stabilize with vegetative growth. Photo on the right shows silt fence down with adjacent sediment at the storage area near the Rt. 107/7 intersection. This is due to landowner activities. 4/19/06

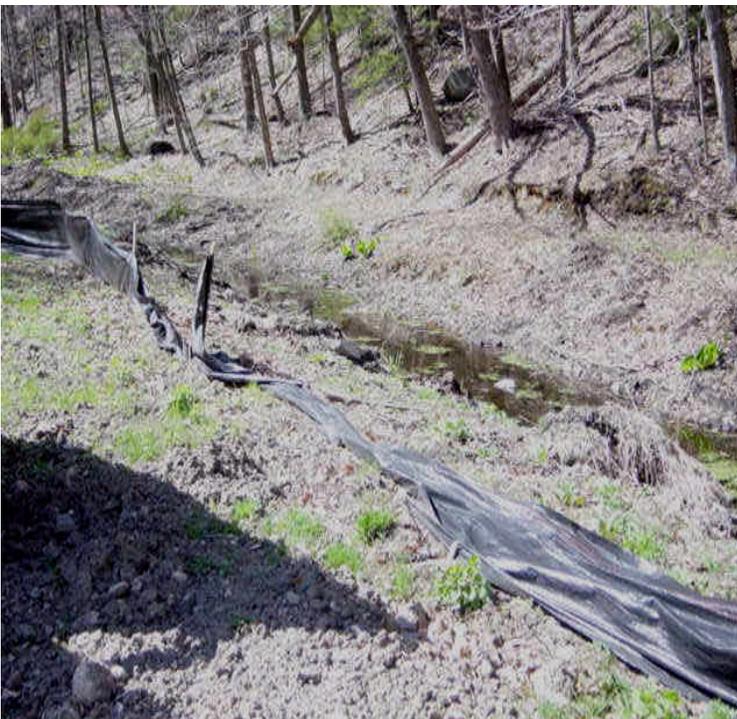
345kV (Rt 7-Wilton HS) Photo on the left shows another view of the back of the storage area with silt fence down. Photo on the right is a view of the Wilton HS old J&B where silt fence was removed prior to sufficient stabilization. Instream controls should also be removed. 4/19/06

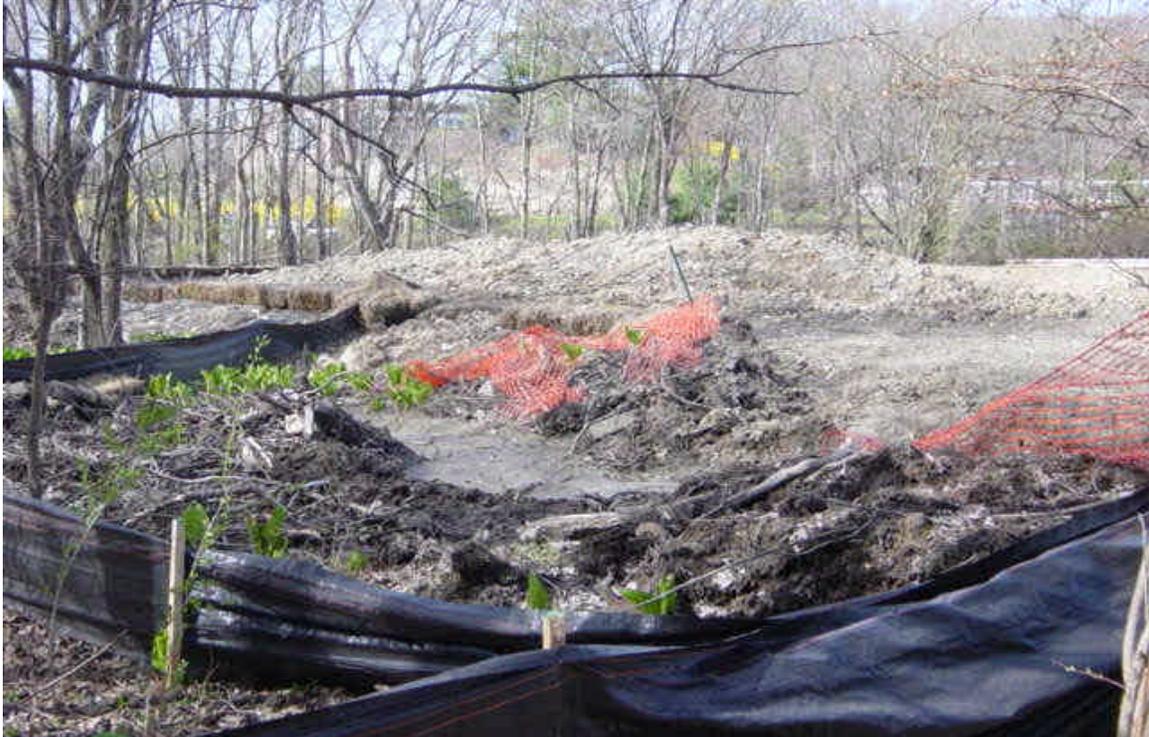
345kV (HDD) The photo shows an overall view of the site with the perimeter controls still in fairly good shape. However, there have been problems with sediment accumulation in the wetlands beyond. 4/19/06

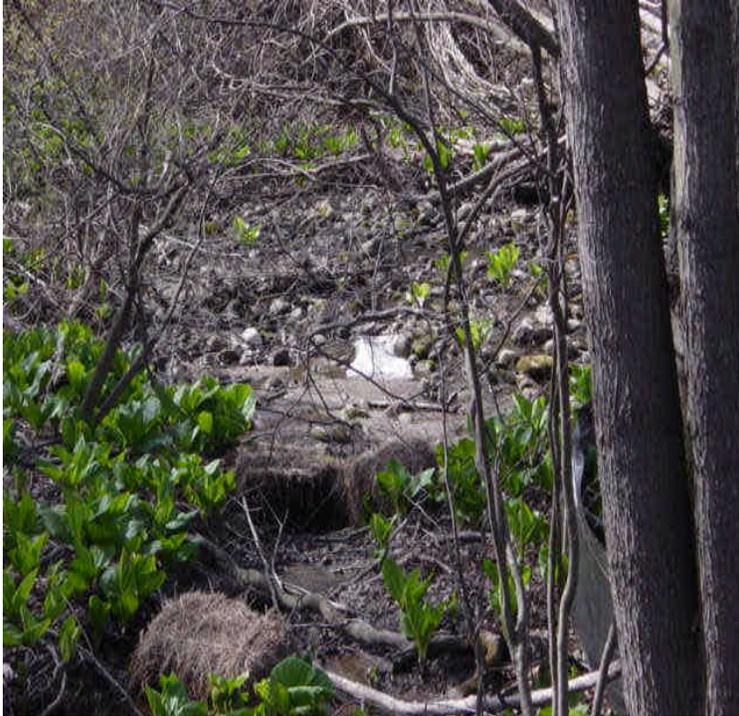
Photo on the left shows a view of some of the sediment accumulation in the wetlands beyond. It will become more difficult to remove sediment as the growing season progresses. Photo on the right shows another view of the site with equipment in place. 4/19/06
