Docket No. 217 – Development and Management Plan Inspection

Northeast Utilities Service Company Certificate of Environmental Compatibility and Public Need for the construction of a 345-kV electric transmission line and reconstruction of an existing 115-kV electric transmission line between Connecticut Light and Power Company’s Plumtree Substation in Bethel, through the towns of Redding, Weston, and Wilton, and to the Norwalk Substation in Norwalk, Connecticut.

Date: April 26, 2006

Location: 345kV Underground Route

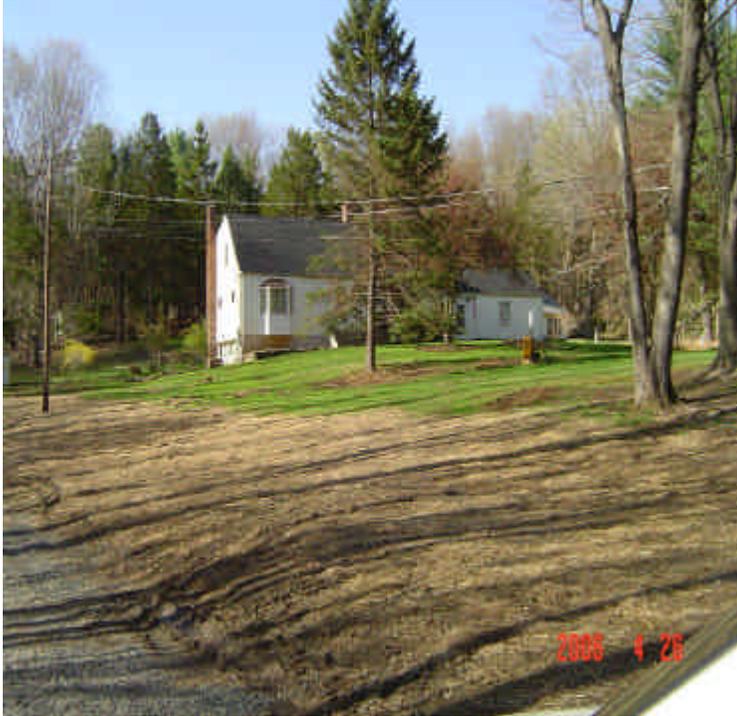
345kV (Archers Lane): Photo on the left shows the restored area of the lawn of the property adjacent to the access drive. Photo on the right shows where some minor sediment was able to migrate through the stone wall. Consider repairing the silt fence here. 4/26/06

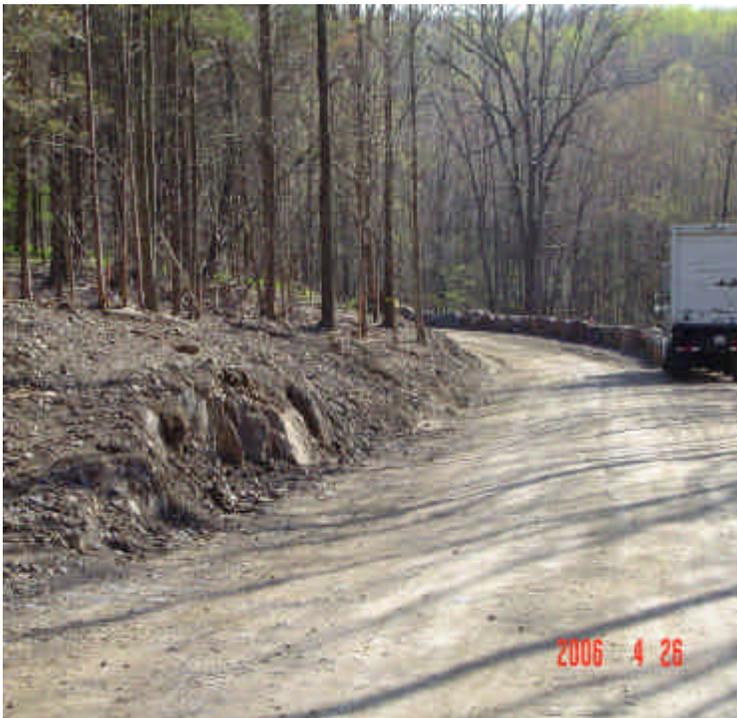
345kV (Archers Lane and Diamond Hill Rd) Photo on the left shows the slope along the AL access drive. This area should also be restored when feasible. Photo on the right shows where restoration efforts were noted along the Diamond Hill Rd. shoulders. 4/26/06

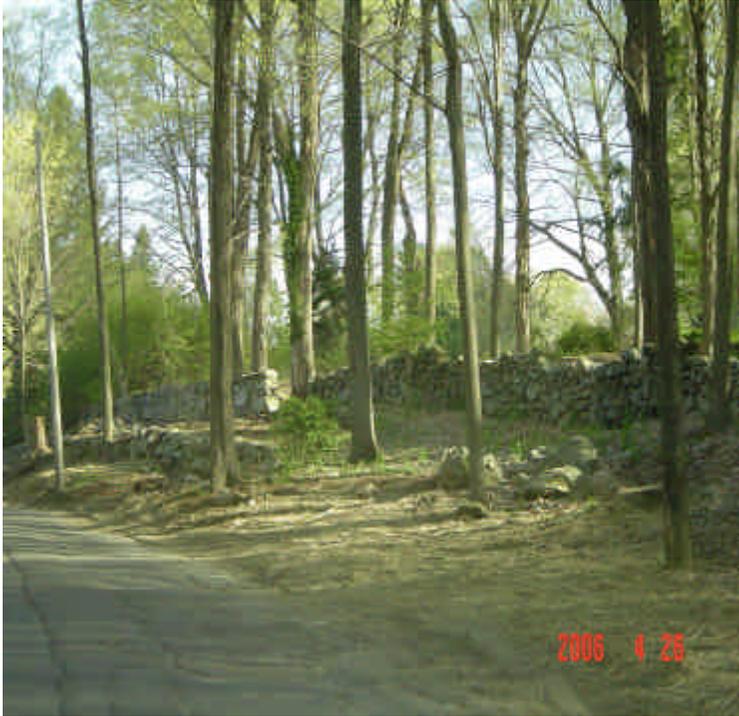
345kV (Umpawaug Rd) Photo on the left shows slopes along the roadway which have been seeded and mulched. Photo on the right shows the old storage area at the Rt. 107 intersection. Silt fence was pulled but the area remained disturbed. Either restore the area or replace silt fence. 4/26/06

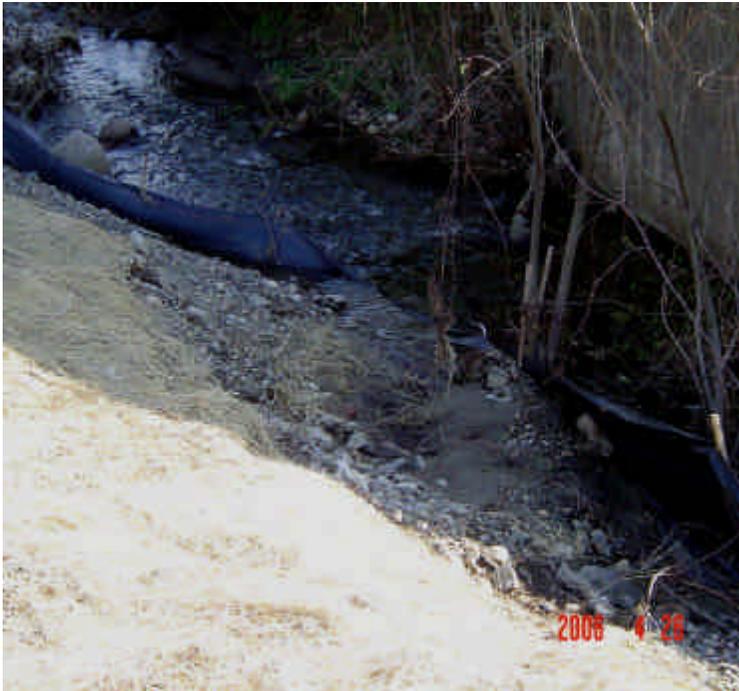
345kV (Georgetown Deli) Photo on the left shows the bank of the stream which washed out at the base due to the recent heavy rains. Photo on the right shows some erosion near the roadway. Crews may want to check the trench for stability here. 4/26/06

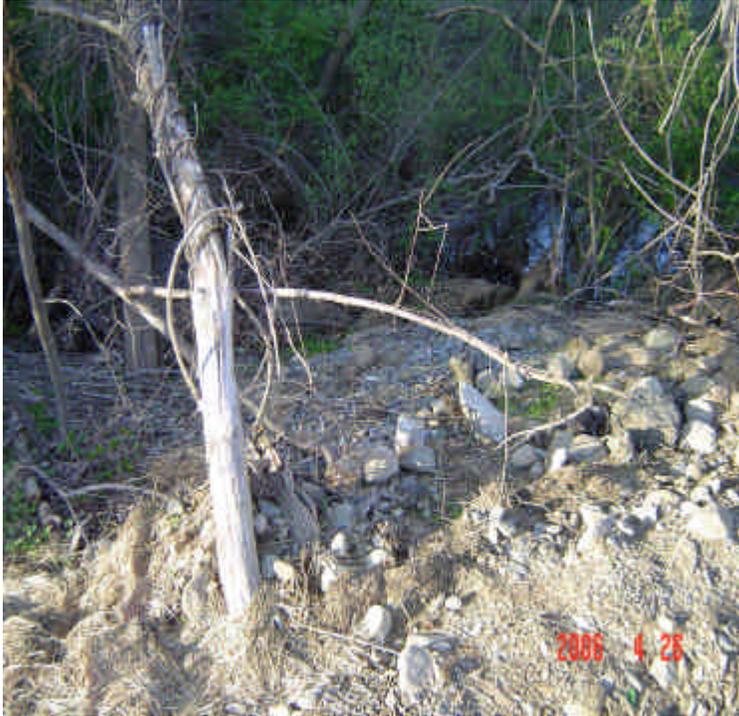
345kV (Wilton HS) The photo on the left shows the stone left along the bank of the stream from the old basin outlet. Restoration is still required in this area. Photo on the right shows the yard where some restoration efforts were made but silt fence was removed prematurely. 4/26/06

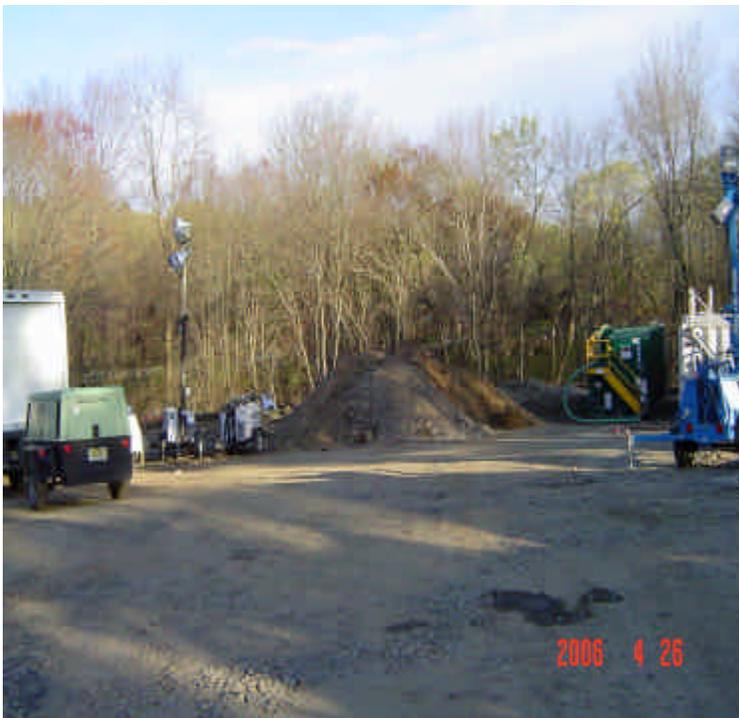
345kV (HDD) Photo on the left shows an overall view of the yard. Disturbed soil was still present in large areas. Photo on the right shows where asphalt spoil was left here in the yard. This area should not be used for dumping materials as it should be restored and vegetated when work is done. 4/26/06

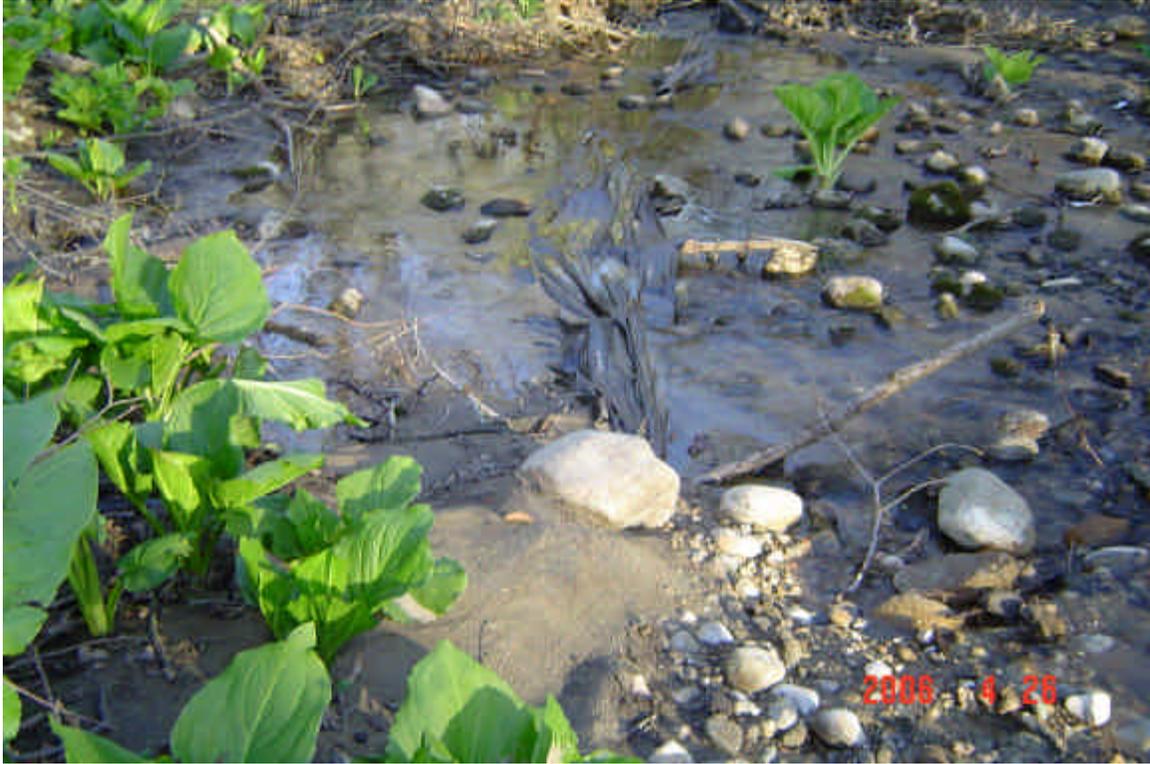
Photo shows where significant sediment has continued to deposit in the channels and wetlands beyond the basin due to the recent heavy rains. This sediment should be removed as soon as possible. 4/26/06

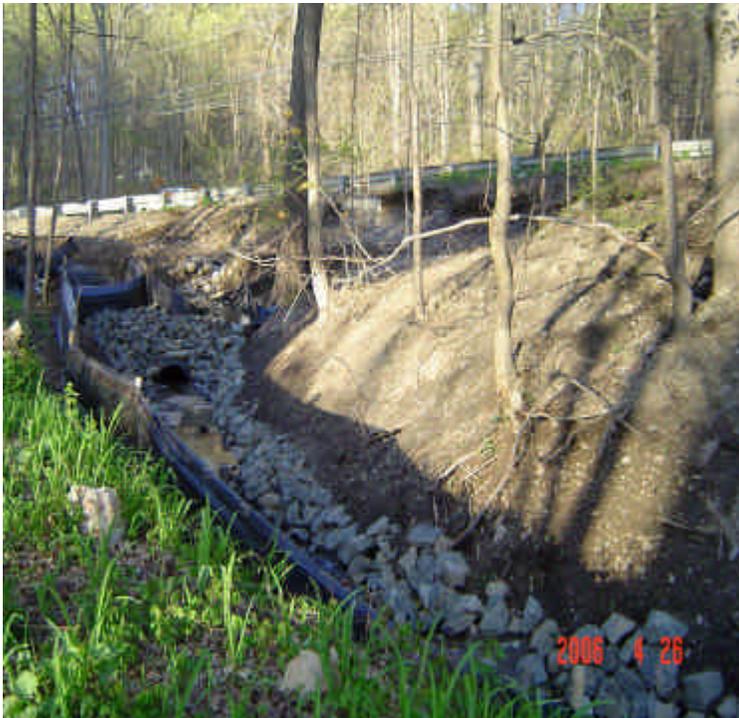
345kV(Rt. 7)Photo on the left shows active work in the area south of the HDD exit point. Some sediment was noted in the channel here from the exposed slope. Photo on the right shows a view near the open vault at the corporate park. Sediment was reaching the street here. 4/26/06
