Docket No. 217 – Development and Management Plan Inspection

Date: May 26, 2005

Location: 345 kV Underground Route

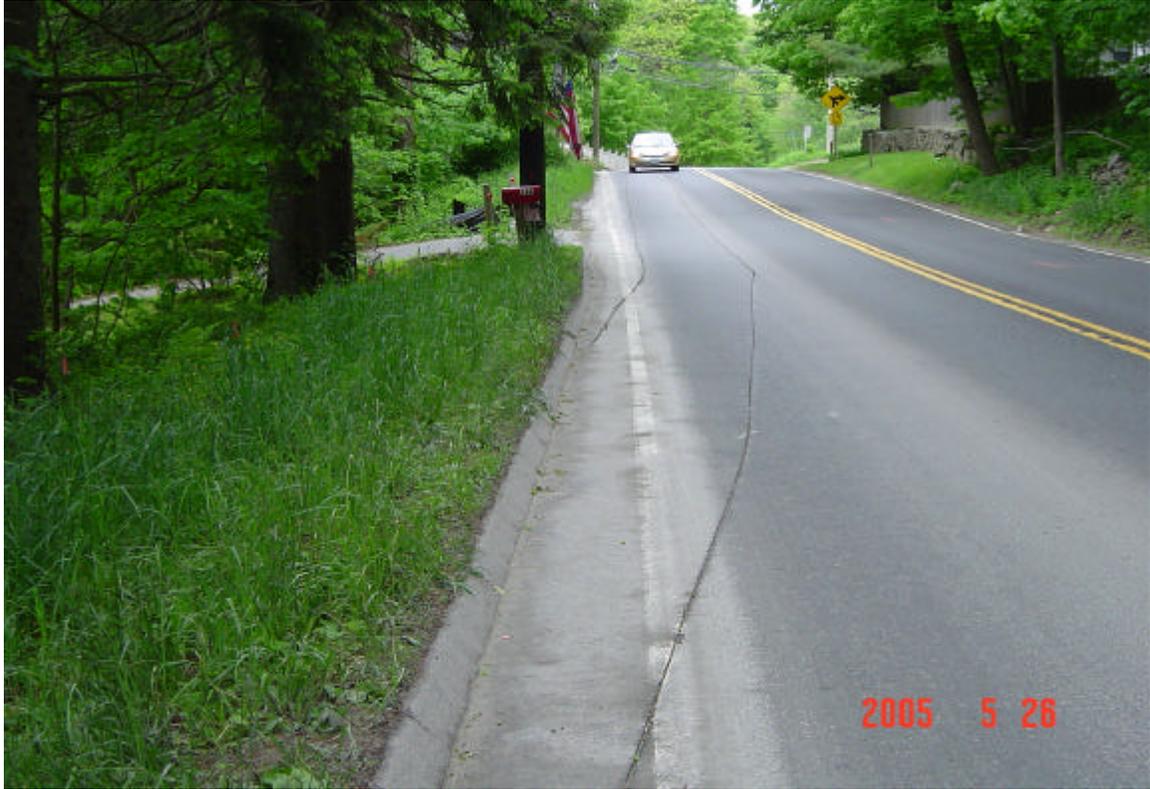
345 kV Rt. 107- Sawcutting has occurred along Rt. 107 for the 345 kV line. (5/26/05)

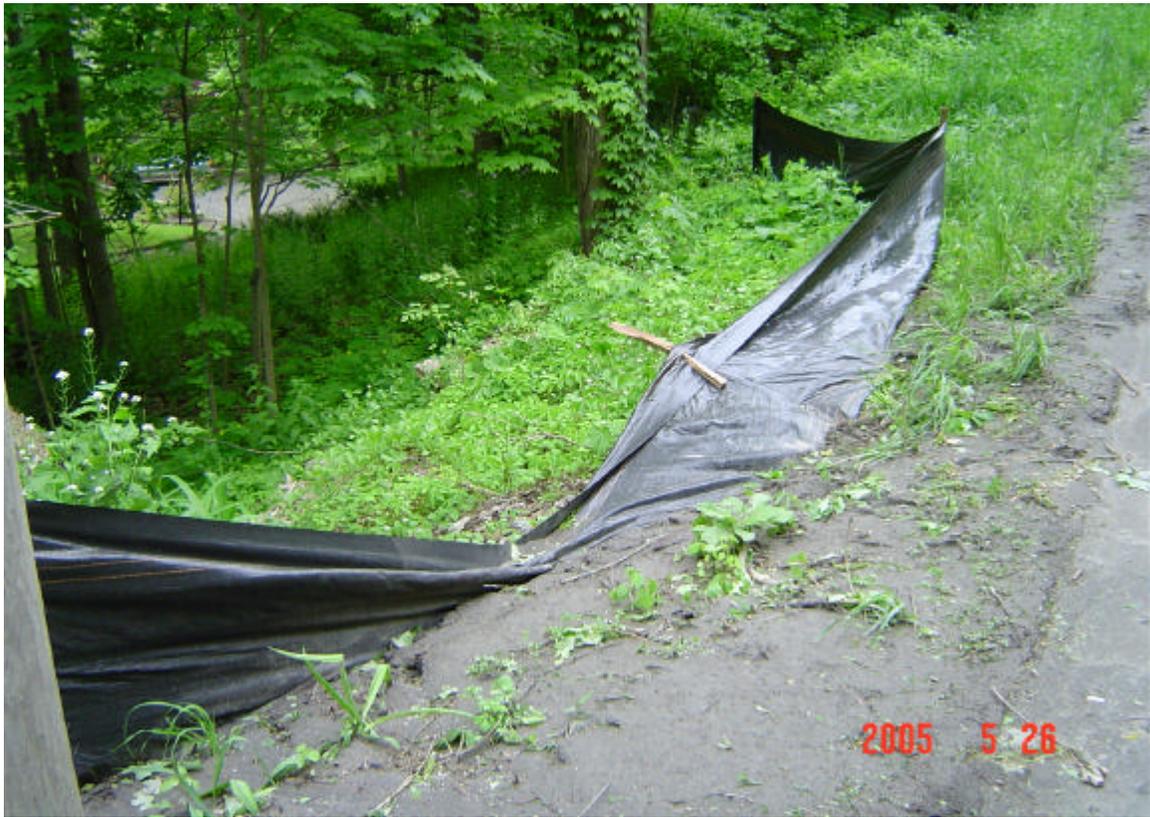
- One area of silt fence in the vicinity of house #191 on Rt. 107 had been pushed over as a result of stormwater runoff. Some sediment had collected here as well. The adjacent wetlands were not affected however. 5/26/05	- The silt fence should be repaired in this location before further trench work occurs in the adjacent area. 5/26/05 - Contractors should make sure silt fence is placed on the upgradient side of all of the stakes to prevent it from ripping easily. 5/26/05
Adjacent Wetlands and Waterways	-None of the wetland resource areas adjacent to the roadway work were affected by the activities. No sedimentation or turbidity was noted. 5/26/05	-None at this time. Continue to monitor.

Silt fence has been installed in some areas but this portion is in disrepair due to stormwater runoff- near house #191 on Rt 107. (5/26/05)
