Docket No. 217 – Development and Management Plan Inspection

Northeast Utilities Service Company Certificate of Environmental Compatibility and Public Need for the construction of a 345-kV electric transmission line and reconstruction of an existing 115-kV electric transmission line between Connecticut Light and Power Company’s Plumtree Substation in Bethel, through the towns of Redding, Weston, and Wilton, and to the Norwalk Substation in Norwalk, Connecticut.

Date: May 31, 2006

Location: 345kV Underground Route

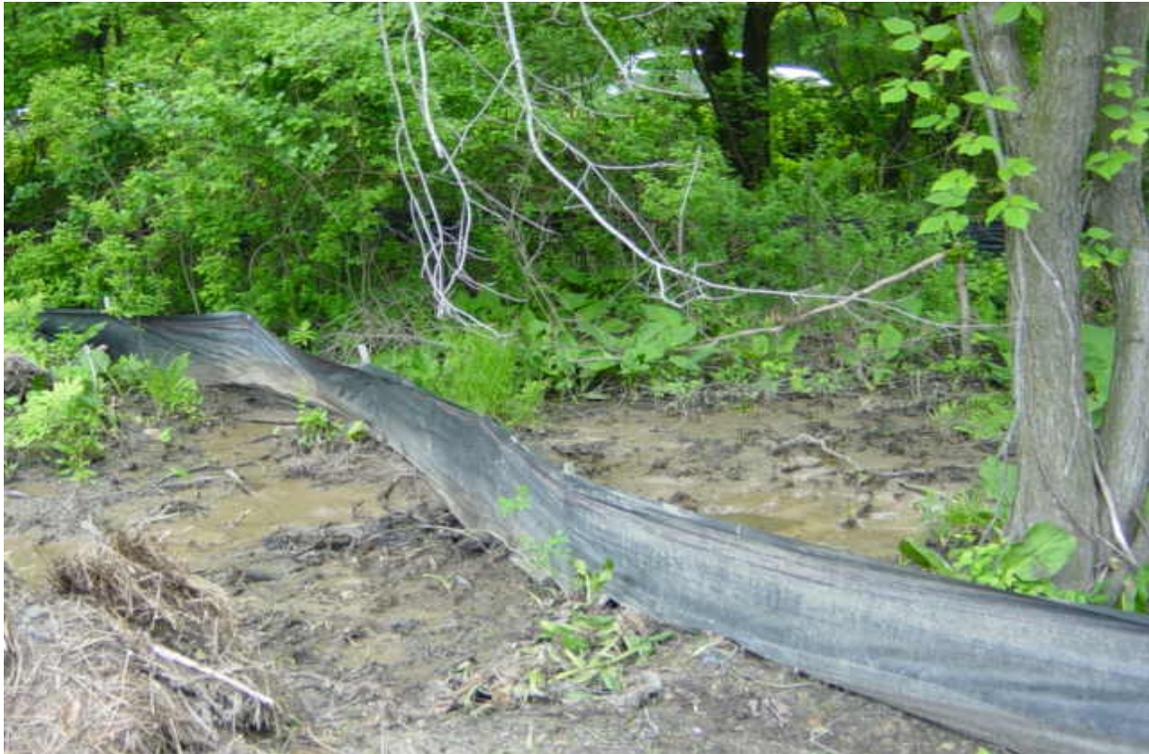
345kV (HDD) Photo shows where water has been flowing directly under the silt fence and depositing more sediment into the eastern wetland next to the basin. This will have to be picked up by hand again. 5/31/06

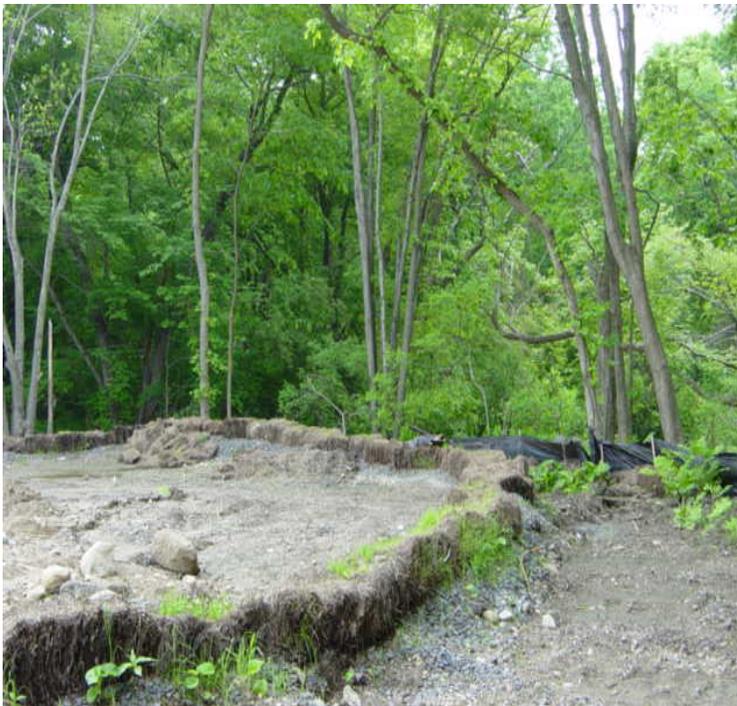
(Route 7): Photo on the left shows the basin at the HDD which will be graded shortly. Some surrounding areas should be restored as wetlands with new controls installed between them and the

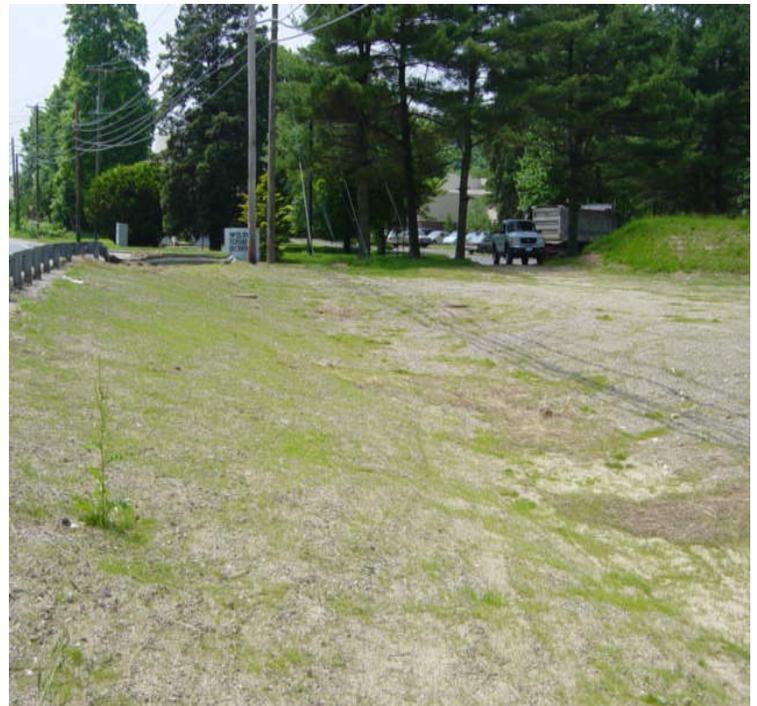
parking area. Photo on the right shows the Wilton HS with some patchy areas of grass growing. The

surface will have to be re-stabilized. 5/31/06

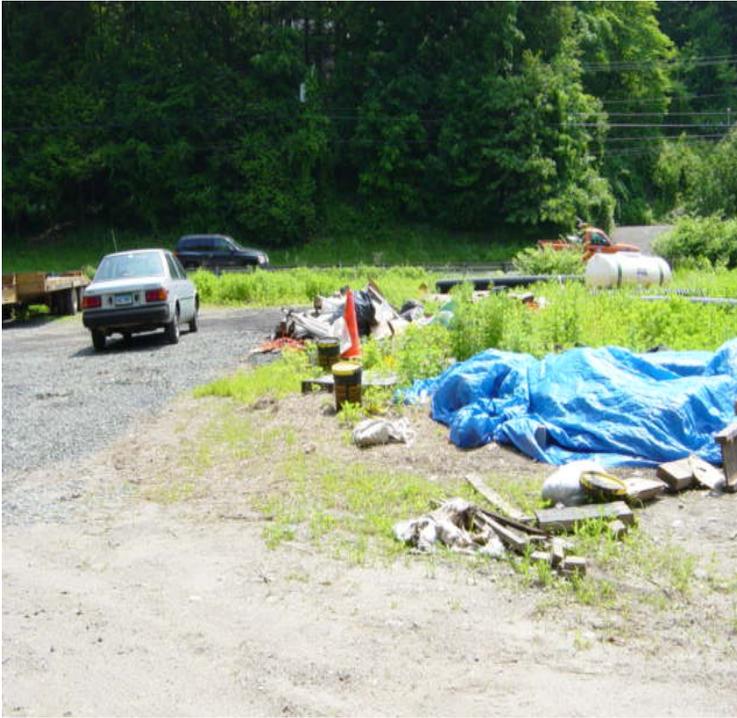
Photo on the left shows some of the debris areas at the active storage yard near the Rt 7/Rt 107 intersection. Straighten up the area when feasible. Photo on the right shows where the stream slope just south of the Georgetown Deli has additional mulch and seed. 5/31/06

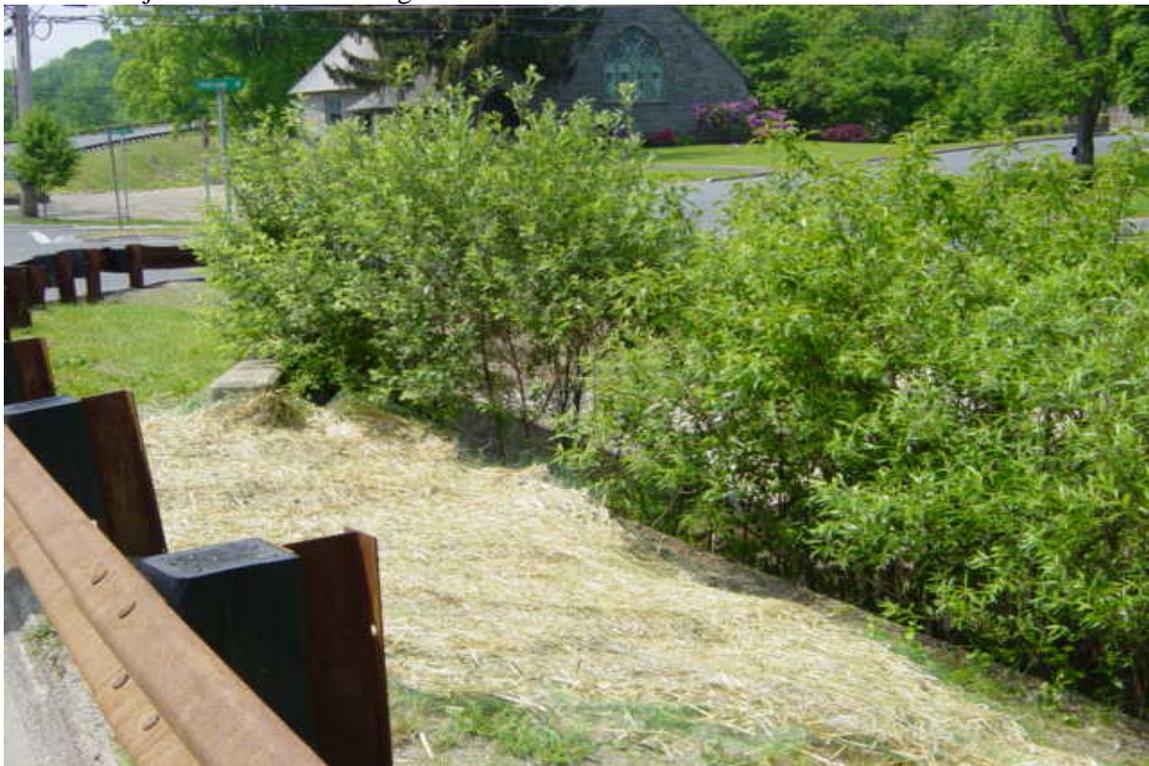
(Georgetown Deli): Photo shows where erosion control mats were placed above the culvert at the stream crossing. 5/31/06

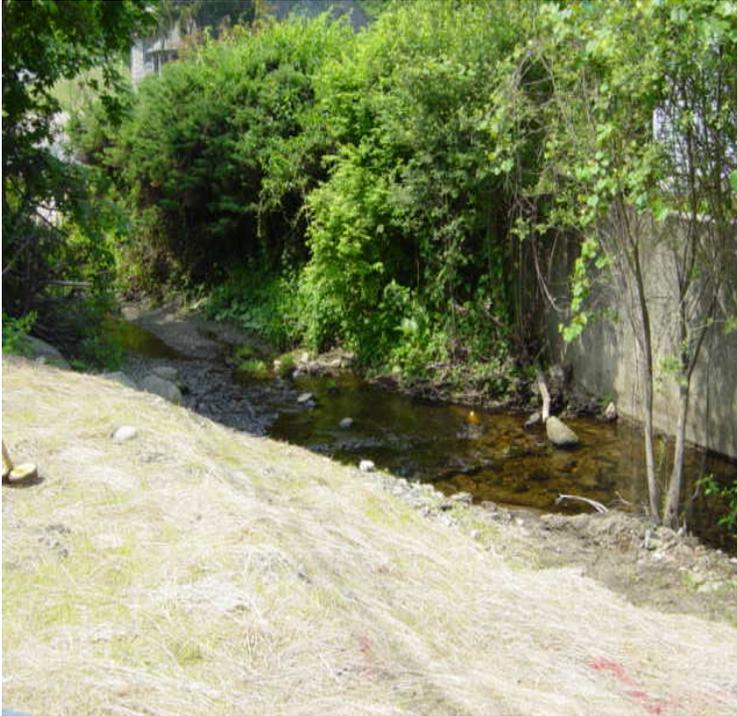
Photo on the left shows where erosion control mats will continue to be re-installed over the washout area in the stream. Photo on the right shows boulders stockpiled and ready to be installed in the streambank for stabilization. 5/31/06

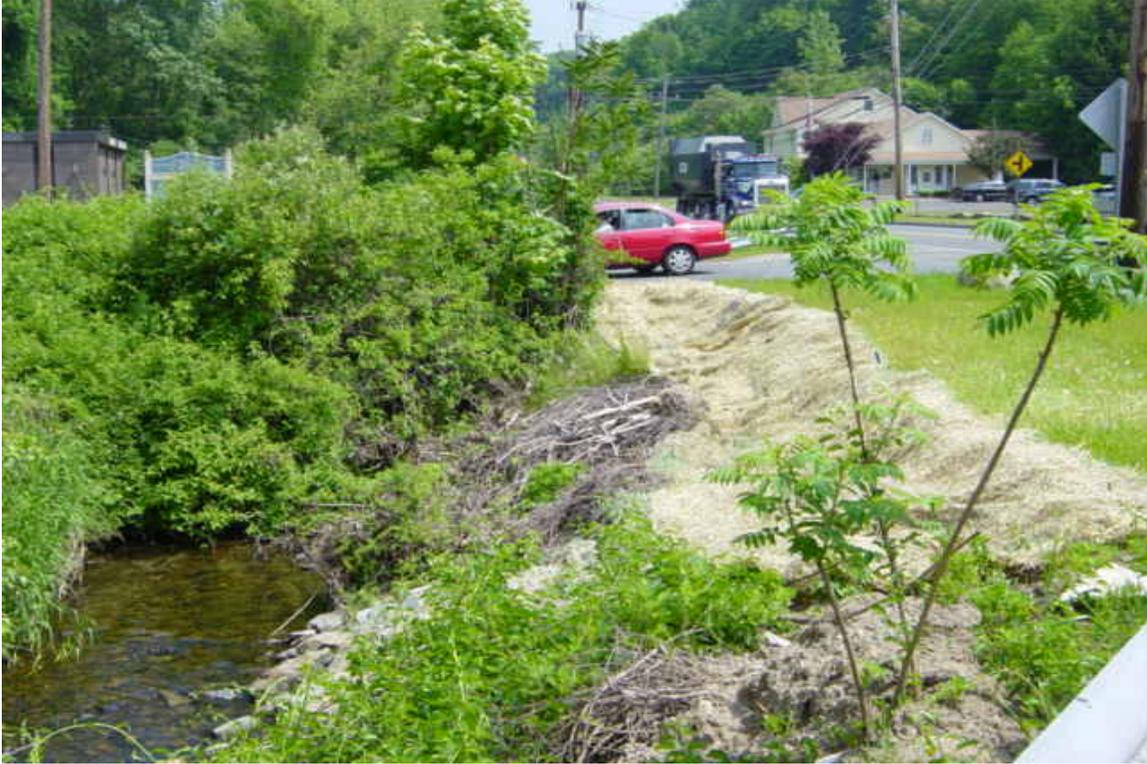
Photo shows where erosion control mat installation was completed along the stream bank in this previously eroded spot. 5/31/06
