Docket No. 217 – Development and Management Plan Inspection

Northeast Utilities Service Company Certificate of Environmental Compatibility and Public Need for the construction of a 345-kV electric transmission line and reconstruction of an existing 115-kV electric transmission line between Connecticut Light and Power Company's Plumtree Substation in Bethel, through the towns of Redding, Weston, and Wilton, and to the Norwalk Substation in Norwalk, Connecticut.

Date: June 9, 2005

Location: 345 kV Underground Route

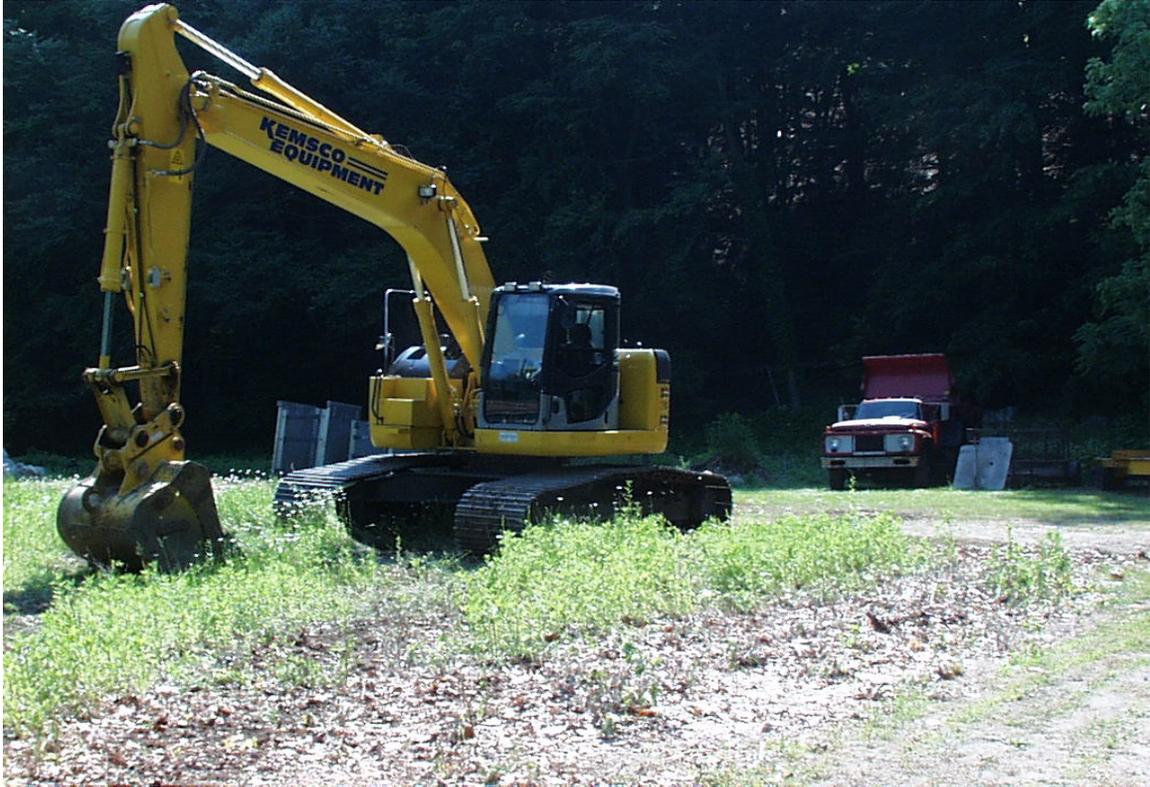
View of the 345kV equipment storage area located off Route 7 in Wilton. 6/9/05

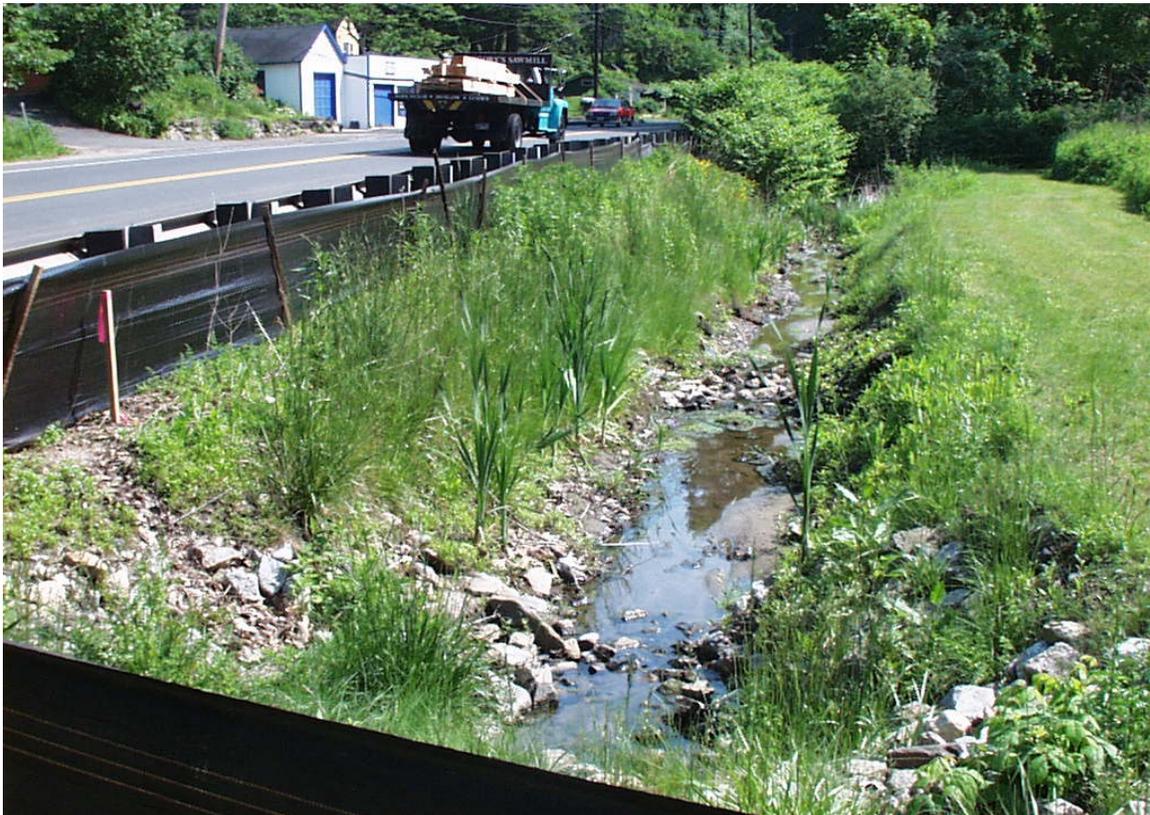
Silt fence along Route 7 in the vicinity of the equipment storage area and the beginning of the trench work. This fence is well installed but an area to the south requires work. 6/9/05

Areas of Inspection	Observation	Recommended Action
Vault Openings and Trench Construction	<ul style="list-style-type: none"> - Sawcutting and milling operations continue along Rt. 7. - Initial night-work for trench construction began this week in Wilton along Rt. 7 near the Rt 107 and 7 intersection. 6/09/05 	<ul style="list-style-type: none"> -All work is in the roadway and seems well contained for the most part. Trench covers were in place during the inspection. 6/09/05
Erosion and Sediment Controls (includes inspection within 24 hours of a storm event)	<ul style="list-style-type: none"> - Silt fence has been installed in the area of active work along Rt. 7 where wetlands are located adjacent to the roadway. 6/09/05 - However, one spot was noted to the south of the equipment storage yard (along Rt. 7) and just beyond the end of some visible sawcut where the silt fence had not been towed in accurately and a large gap was left where the topo drops into a road drainway. 6/09/05 	<ul style="list-style-type: none"> - Continue to monitor and maintain and repair the fence when necessary. 6/09/05 - A stream and wetland were located downgradient of this silt fence and they would not be protected from any run off. The fence should be repaired prior to active work in this area. 6/09/05 - Be sure to toe the bottom of the silt fence into the ground by several inches in all scenarios, otherwise it will not function as anticipated.
