Docket No. 217 – Development and Management Plan Inspection

Northeast Utilities Service Company Certificate of Environmental Compatibility and Public Need for the construction of a 345-kV electric transmission line and reconstruction of an existing 115-kV electric transmission line between Connecticut Light and Power Company’s Plumtree Substation in Bethel, through the towns of Redding, Weston, and Wilton, and to the Norwalk Substation in Norwalk, Connecticut.

Date: June 14, 2006

Location: 345kV Underground Route

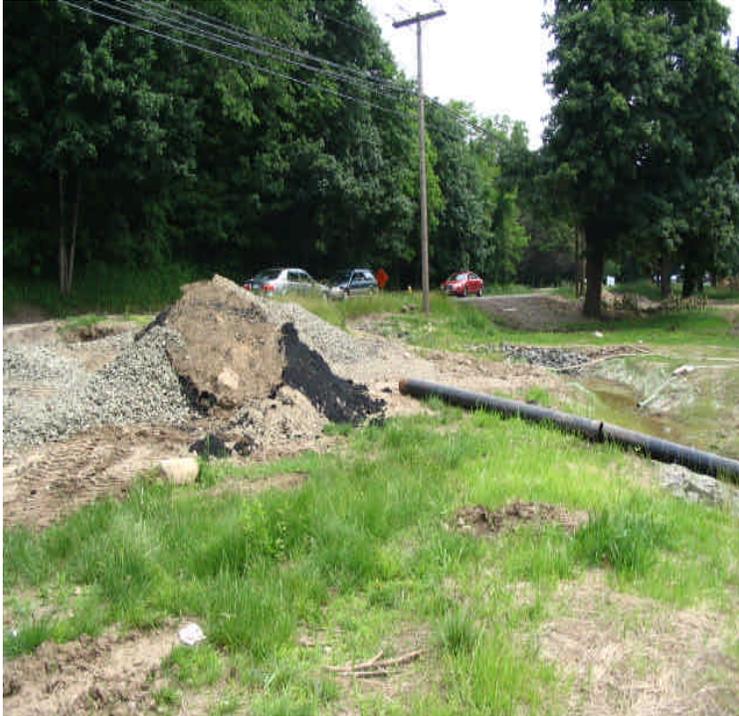
345kV (Norwalk Junction and Rt 7) Photo on the left shows some of the leftover stockpiles from work near the NJ access drive. Place controls here due to the proximity of the swale. Photo on the right shows the work near Old Danbury Rd which was graded for equipment access to the vault.

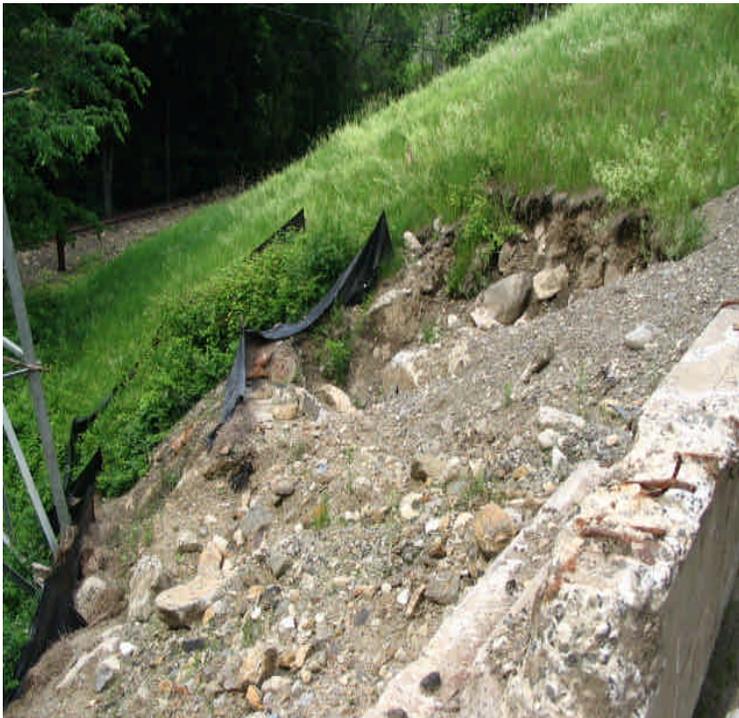
(School Rd HDD): Photo on the left shows the exit point of the HDD. The slope here has eroded and slumped. It will be stabilized with more boulders and soil. Photo on the right shows the HDD School Rd site following grading of the basin. The perimeter will be restored as wetlands. 6/14/06

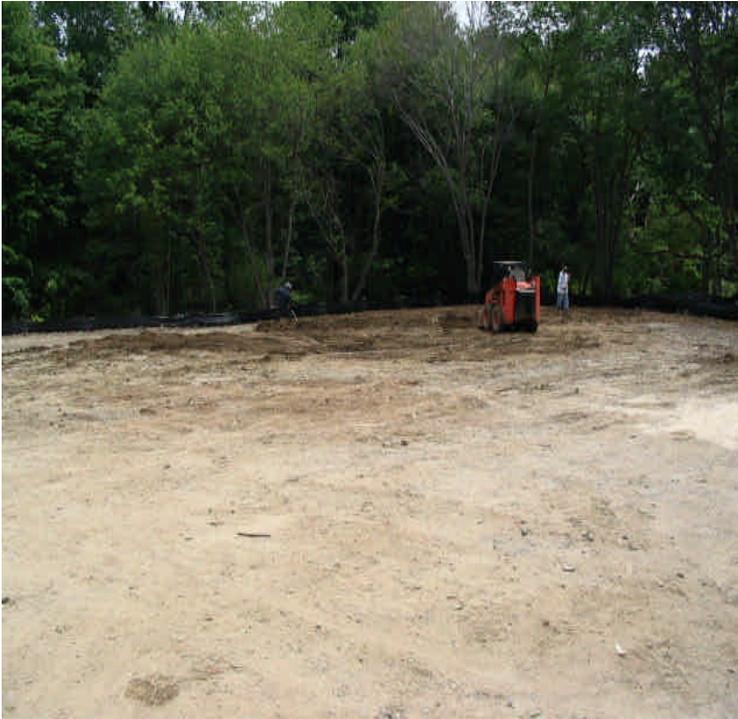
Photo on the left shows another view of the old basin area. Crews are spreading topsoil. Photo on the right shows the adjacent area to the east of the basin to be restored as wetlands. 6/14/06

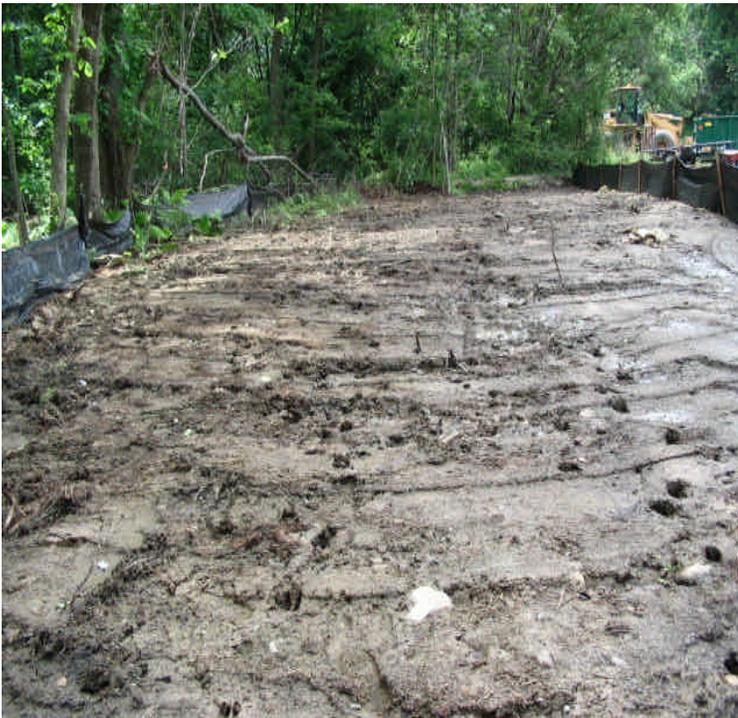
Photo on the left shows the graded area to the south of the old basin. This will also be restored with wetland vegetation. Photo on the right shows the area to the east which has several inches of sediment buildup from the site. Crews will be carefully removing the top few inches by hand. 6/14/06

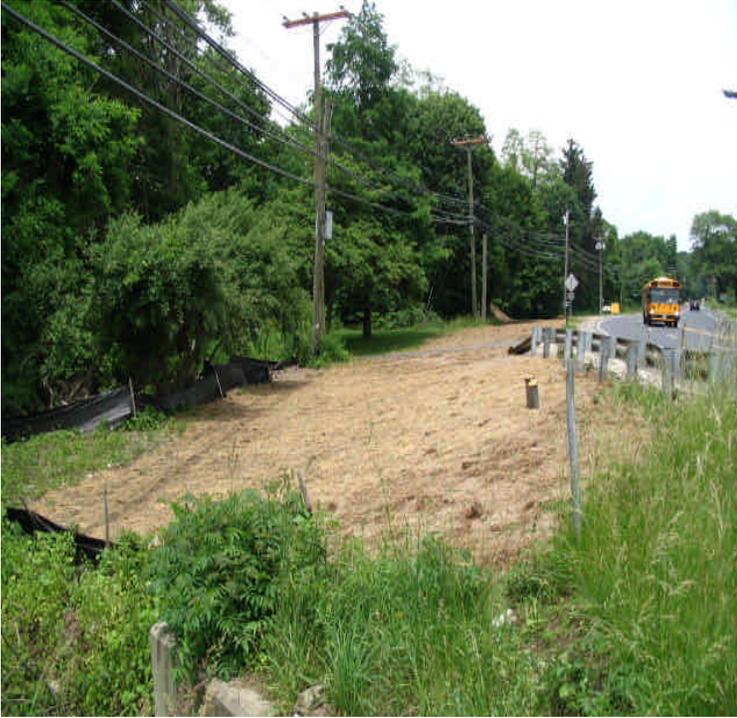
. (Rt 7- Allen's Meadow Park) Photo on the left shows where seed and mulch were placed on the receiving side of the old jack and bore for restoration. (Georgetown Deli) Photo on the right shows additional restoration with seed and mulch above the boulders. 6/14/06

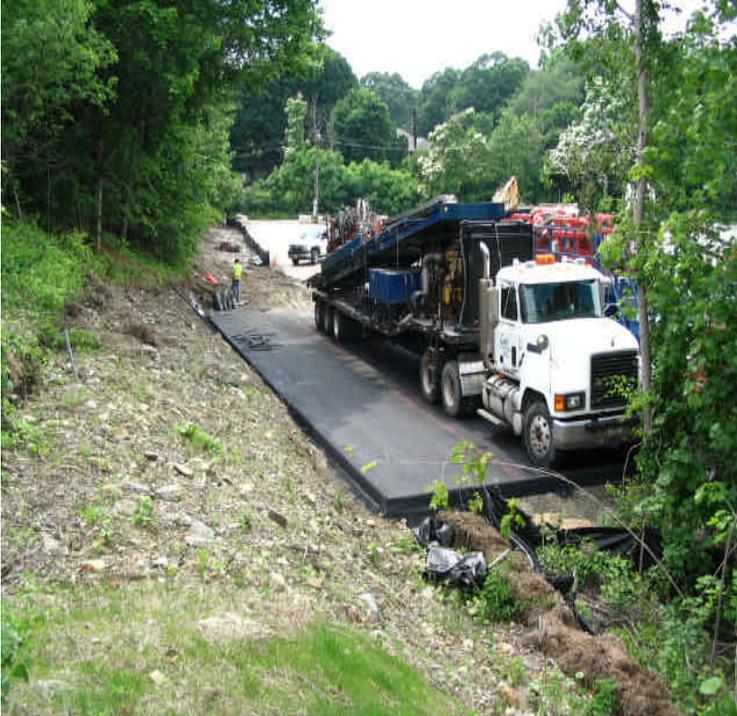
(New Georgetown HDD): Photo on the left shows the new HDD area off Rt 107. A bermed, asphalt pad was built to hold and contain the drilling equipment. Photo on the right shows the slope just north of this area which was well restored and stable. 6/14/06
