Docket No. 217 – Development and Management Plan Inspection

Northeast Utilities Service Company Certificate of Environmental Compatibility and Public Need for the construction of a 345-kV electric transmission line and reconstruction of an existing 115-kV electric transmission line between Connecticut Light and Power Company’s Plumtree Substation in Bethel, through the towns of Redding, Weston, and Wilton, and to the Norwalk Substation in Norwalk, Connecticut.

Date: June 29, 2006

Location: 345kV Underground Route

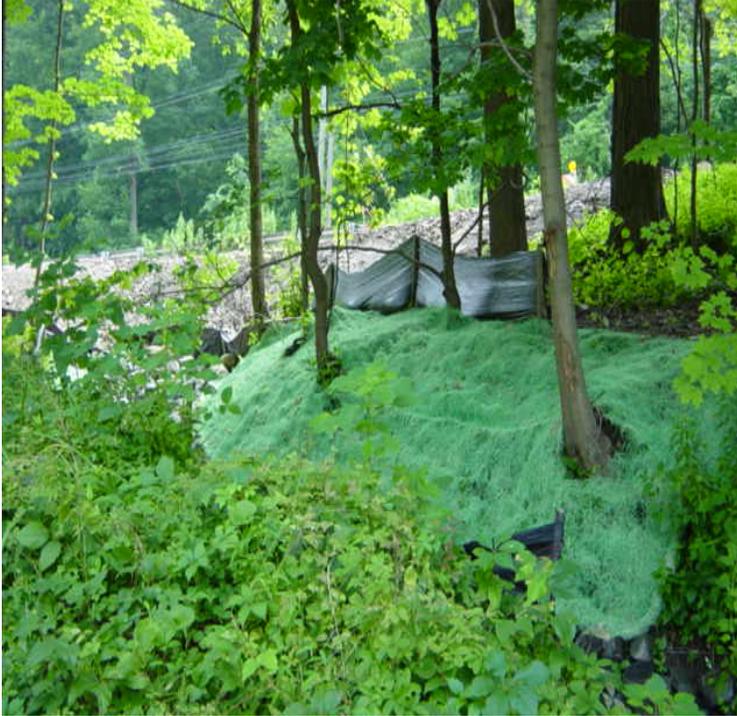
345kV (Old Danbury Rd) Photo on the left shows the erosion control mats in good shape along the slope above the swale. Photo on the right shows where the recent rain washed sediment over the silt fence. The fence should be repaired and the sediment pulled back. 6/29/06

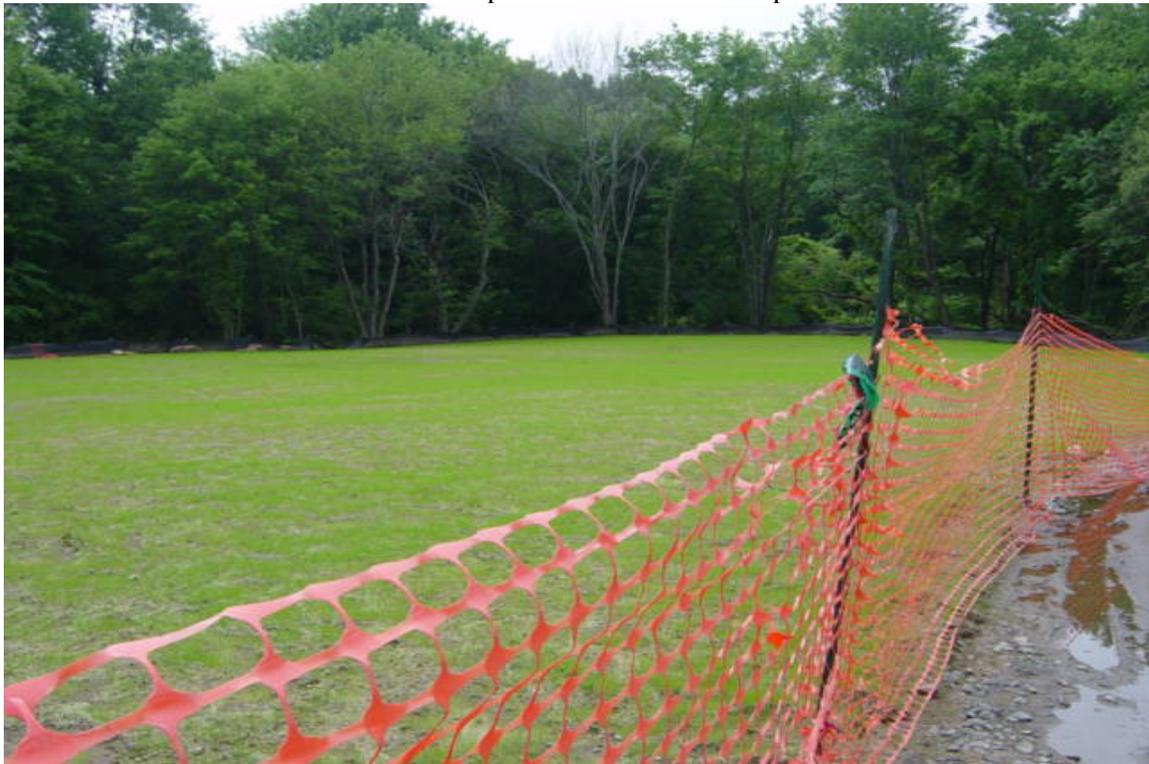
(School Rd HDD): Photo shows the restored HDD School Rd site with grass growing and construction fence in place. 6/29/06

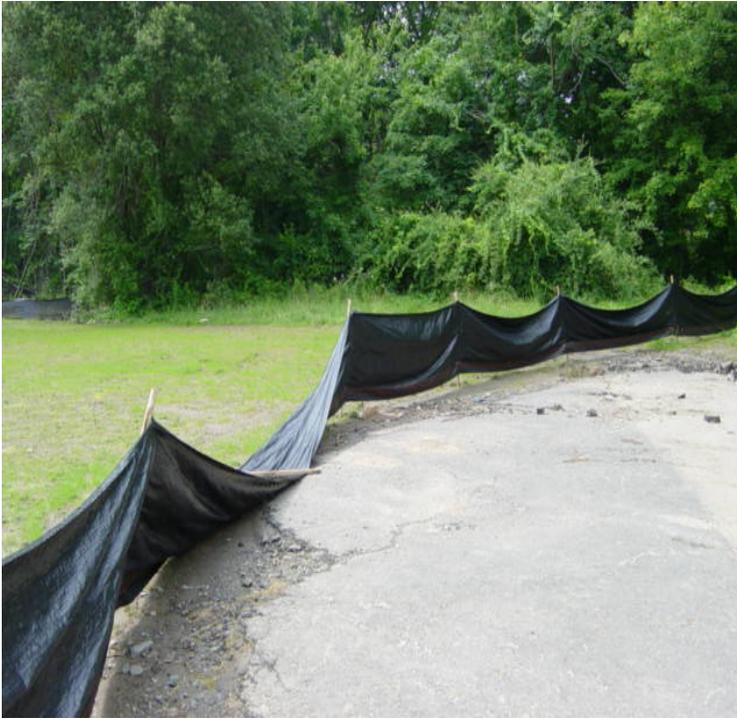
Photo on the left shows silt fence along the driveway at the School Rd site. If this is meant to reduce run-off to the restored area, it should be toed in. If it is serving as construction fence, it doesn't need to be. Photo on the right shows the culvert near Wilton HS with good veg cover.

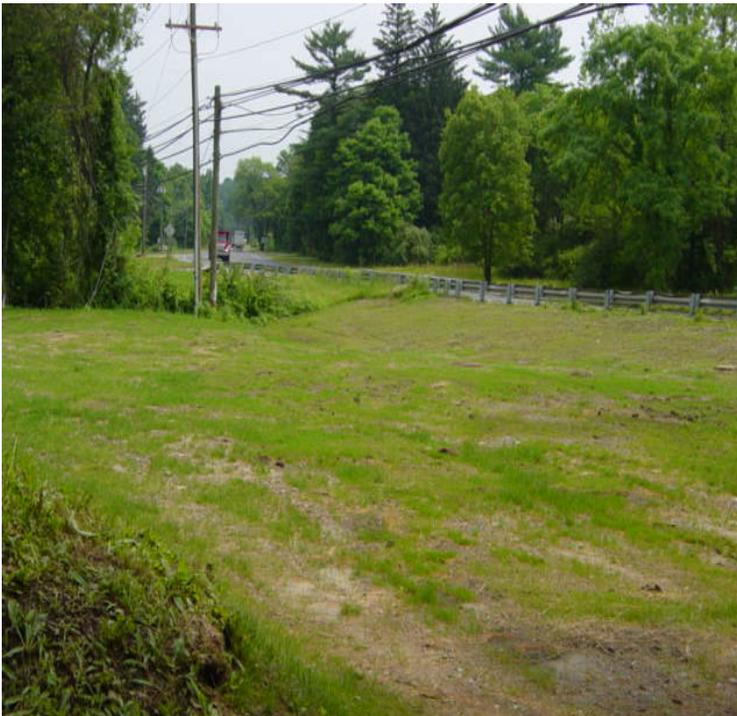
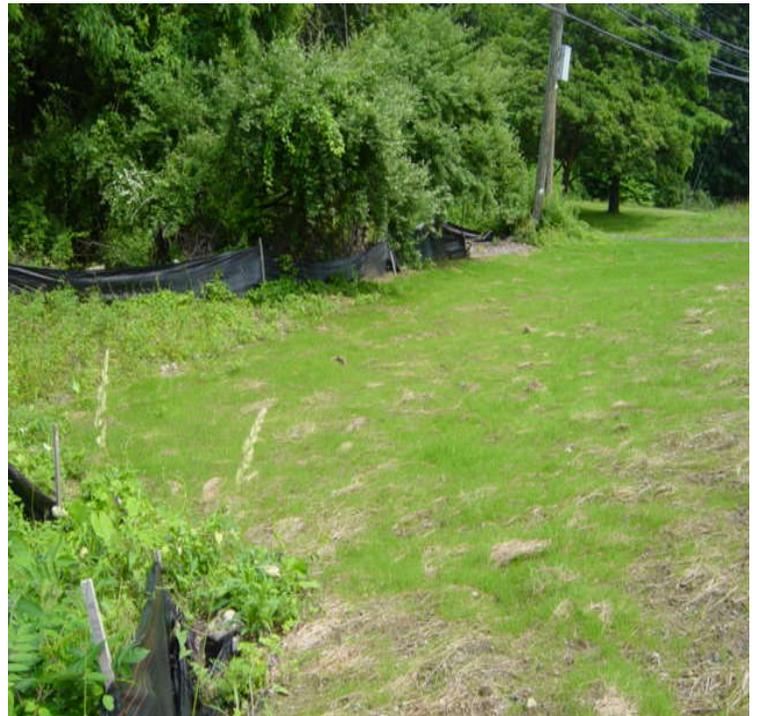
Both photos show the restored areas to the north and south of the stream at Wilton HS. Grass cover is increasing and the areas are stabilizing well. 6/29/06

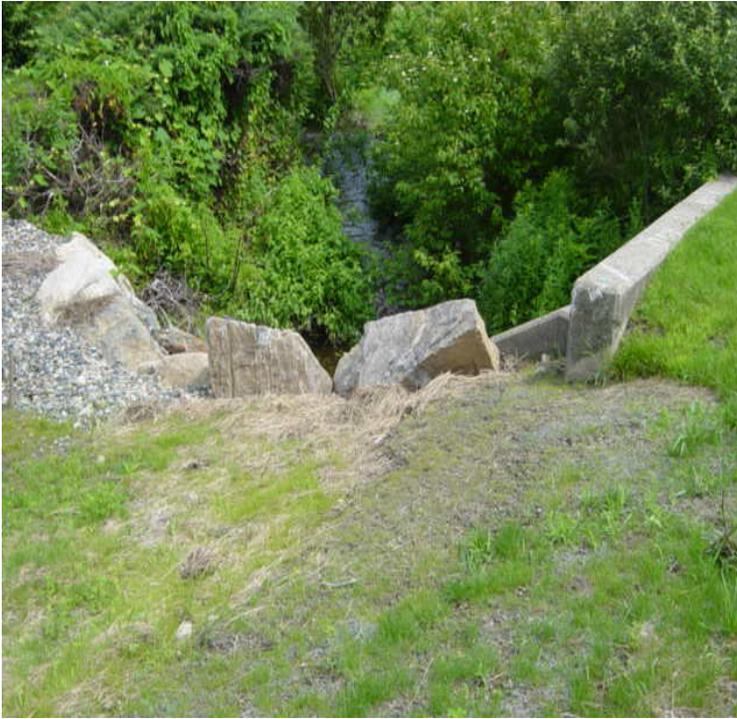
(Georgetown Deli) Photo on the left shows the restored area south of the stream. Photo on the right shows the streambank with the boulders in place. Both areas are beginning to re-vegetate. 6/29/06

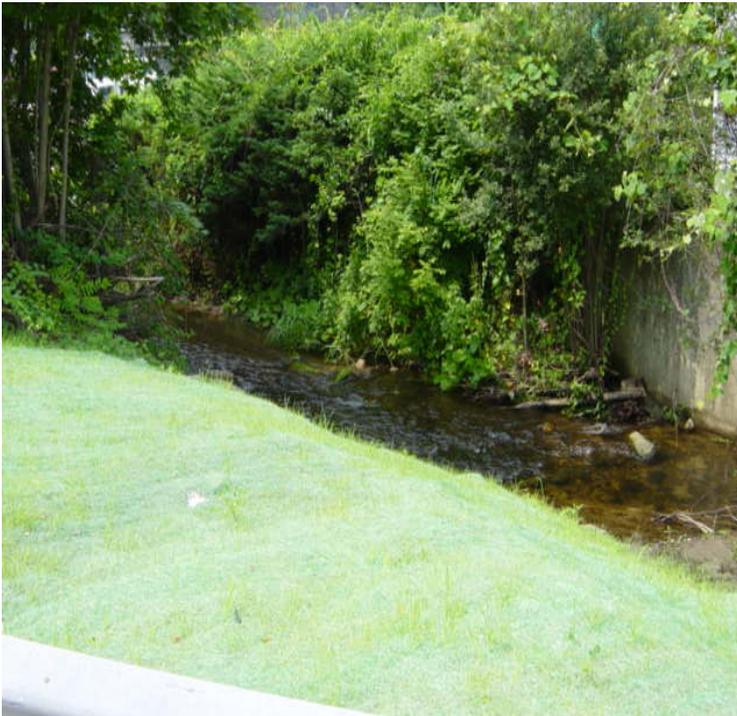
Photo on the left shows the streambank slope at the Georgetown Deli which is beginning to re-vegetate with the erosion control mat. Photo on the right shows the well restored slope leading to the new HDD site. 6/29/06
