Docket No. 217 – Development and Management Plan Inspection

Northeast Utilities Service Company Certificate of Environmental Compatibility and Public Need for the construction of a 345-kV electric transmission line and reconstruction of an existing 115-kV electric transmission line between Connecticut Light and Power Company's Plumtree Substation in Bethel, through the towns of Redding, Weston, and Wilton, and to the Norwalk Substation in Norwalk, Connecticut.

Date: July 14, 2005

Location: 345 kV Underground Route

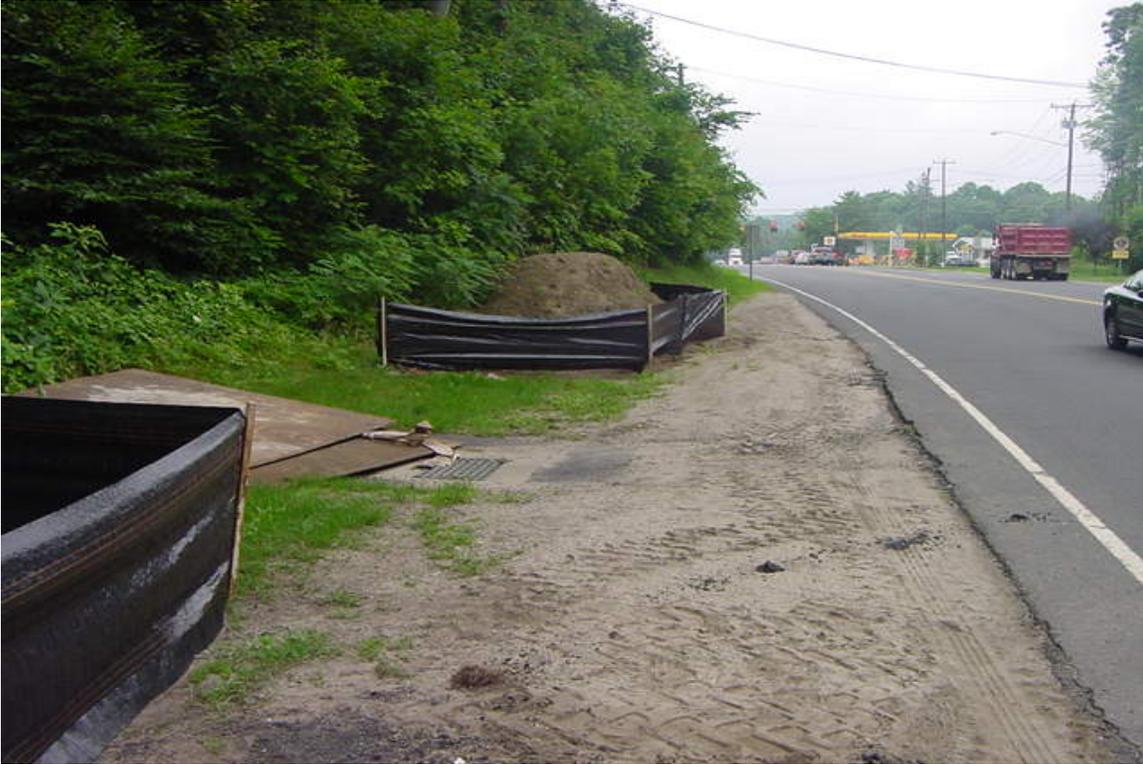
Silt fence has been placed at the base of the small stockpiles near the Rt. 7 and Rt. 107 intersection.
(7/14/05)

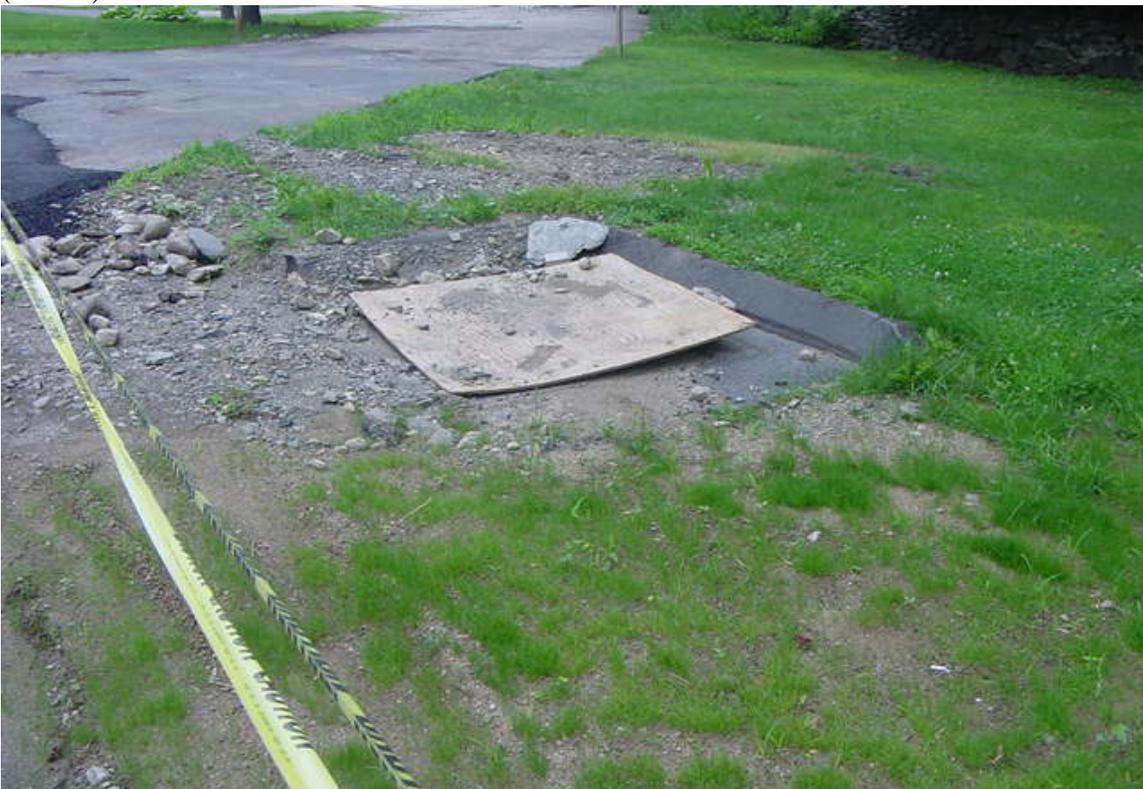
One of the catch basin that may require erosion controls along Route 7 just past the Route 107 intersection.
(7/14/05)

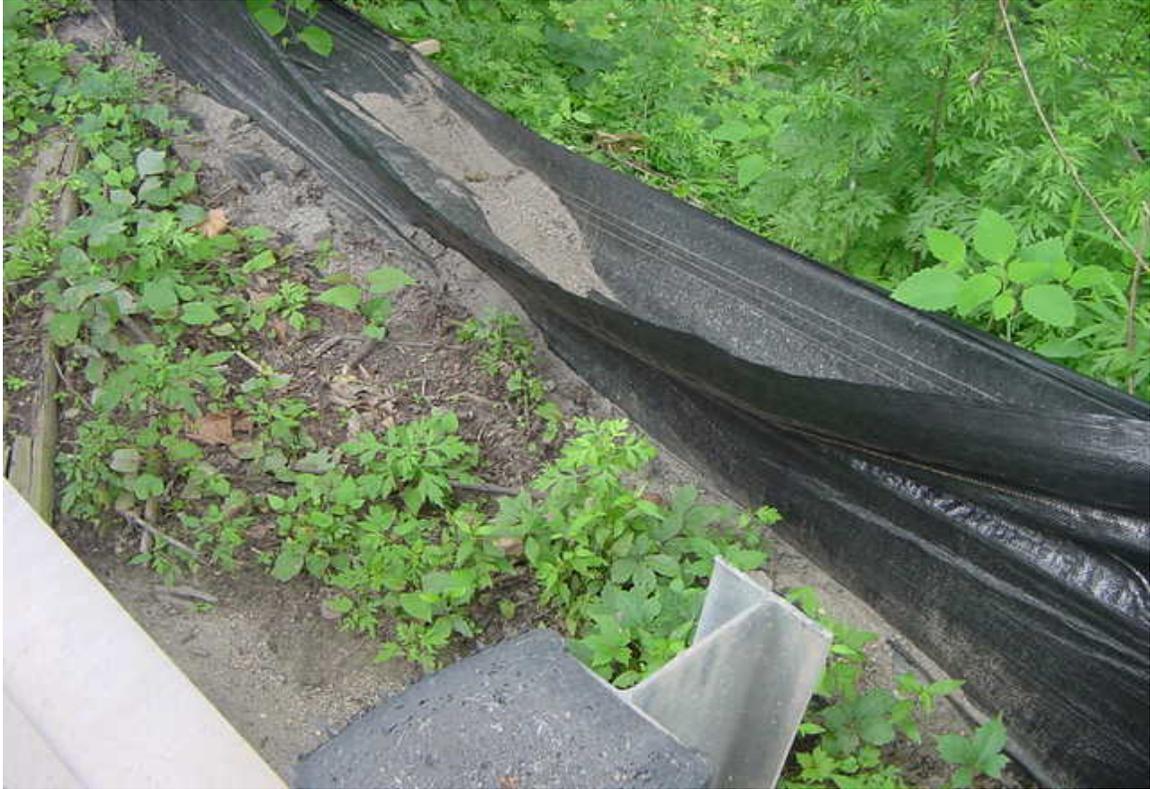
View of silt fence increasingly in need of repair along Route 7 in Wilton. (7/14/05)

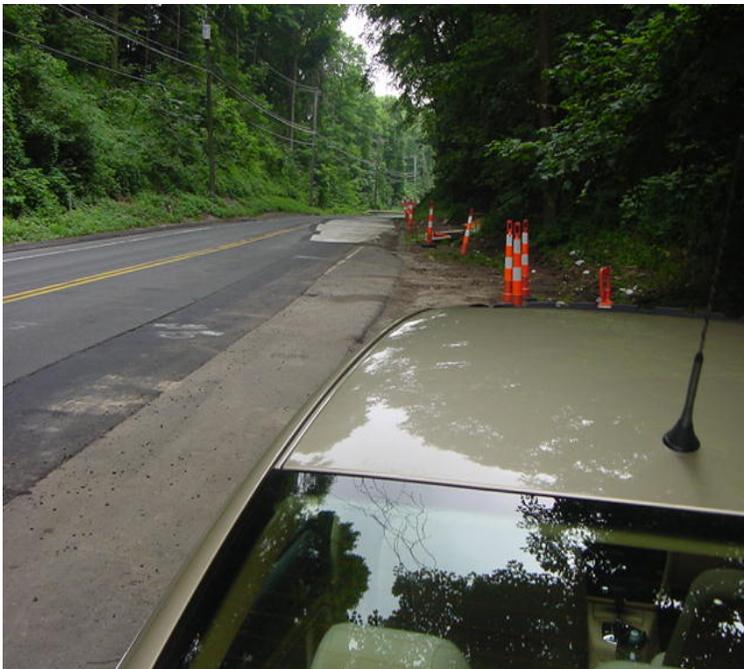
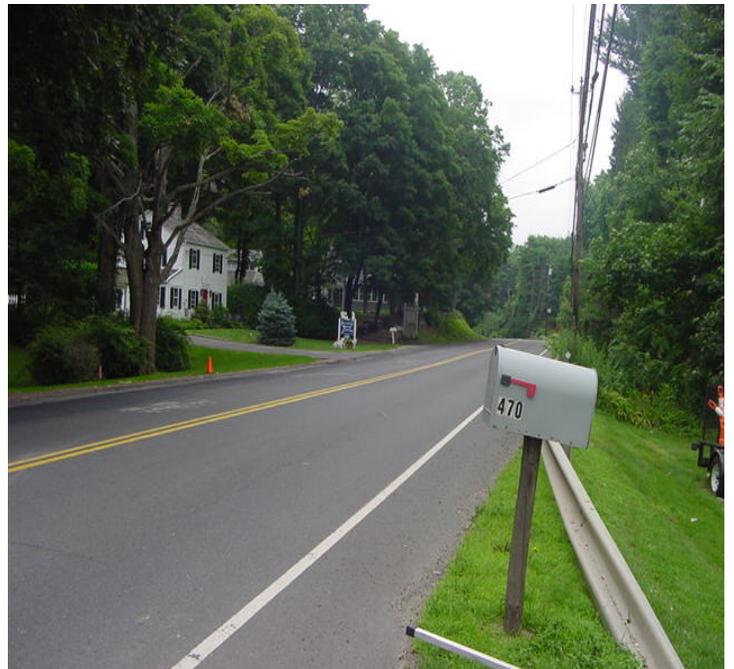
Trenching and vault installation along Route 7 south of the intersection and in the vicinity of the Methodist Church equipment yard respectively. (7/14/05)
