Docket No. 217 – Development and Management Plan Inspection

Date: July 19, 2006

Location: 345kV Underground Route

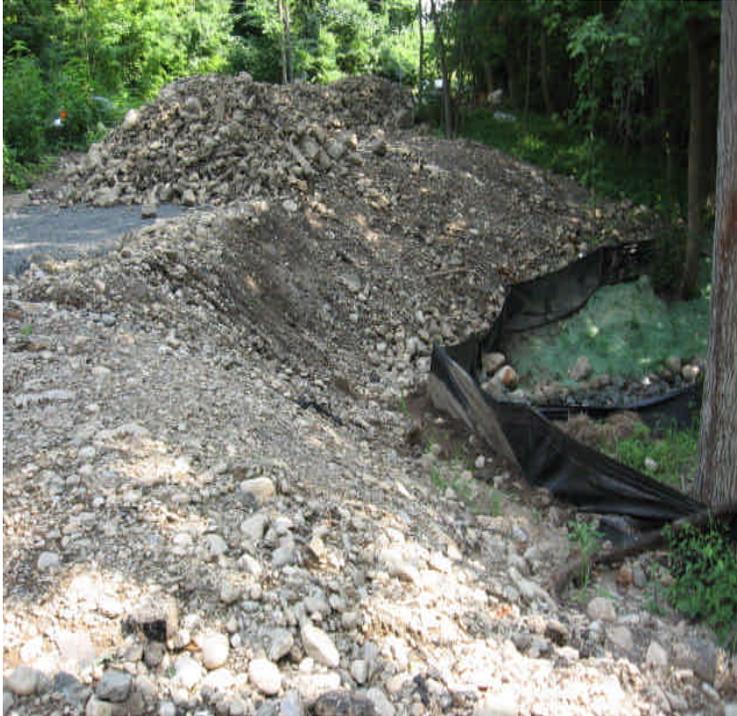
345kV (Old Danbury Rd) Photo on the left shows where the silt fence was repaired. Large stockpiles had been placed here as well. Grade and restore as soon as possible to remove potential for erosion. Photo on the right shows a stone dust past into the area. 7/19/06

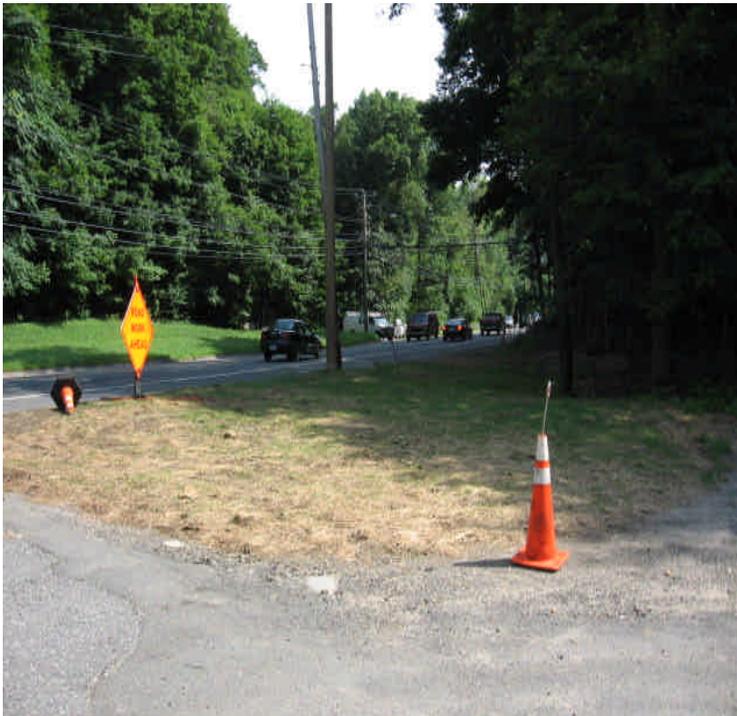
(HDD Exit) Photo shows a view of the area along the road at the limo service parking lot that has been restored with seed and mulch. Photo on the right shows the restored slope looking towards the bore exit. The landowner here has some requests. 7/19/06

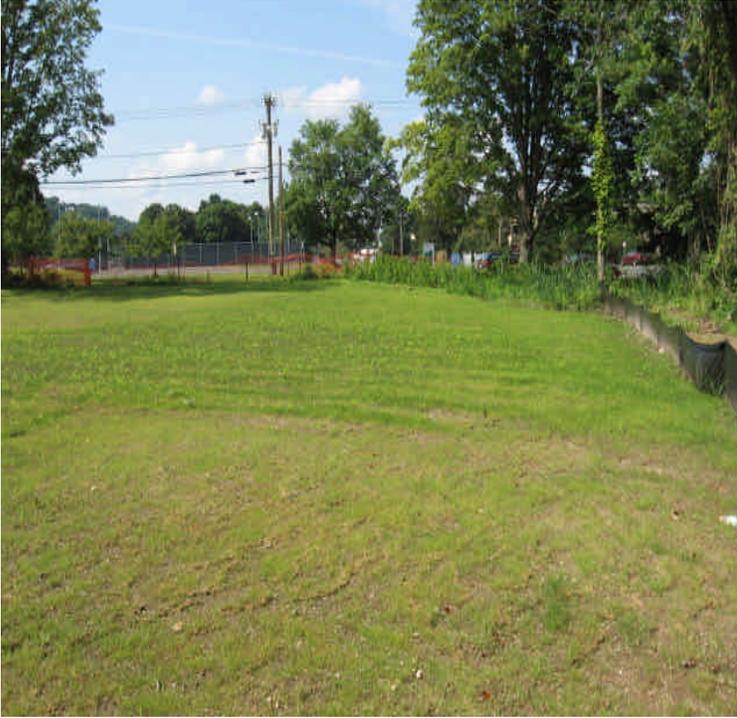
(School Rd HDD) Photo on the left shows the grass growth continuing within the restored HDD site. Photo on the right shows well -established vegetation in the area adjacent to the wetland. 7/19/06

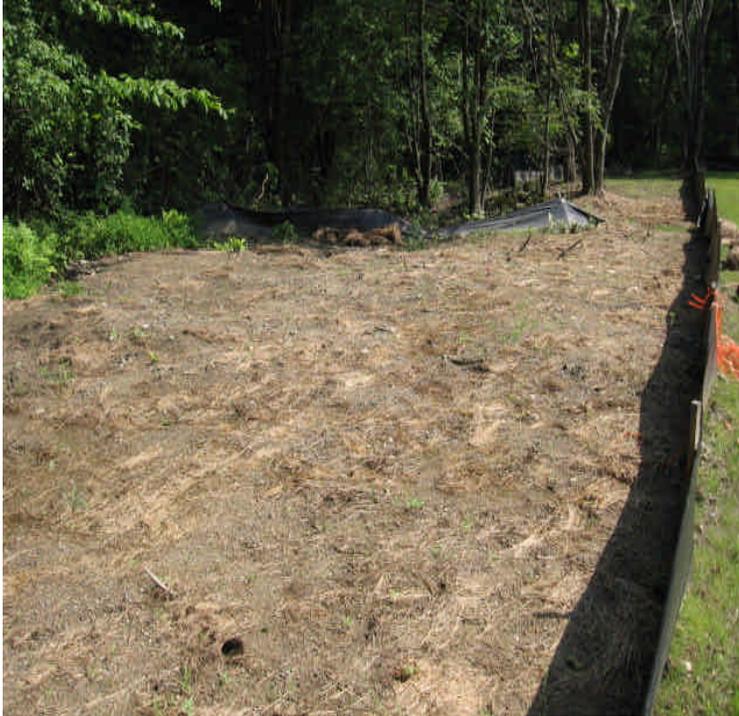
Photo on the left shows the mulched area on the eastern side of the site. Vegetative cover is taking a while to establish here in the expectation that wetland species would return. Photo on the right shows the controls in place to filter run-off before it enters the channel. Silt fence is beginning to wash down here. Reinforce when feasible. 7/19/06

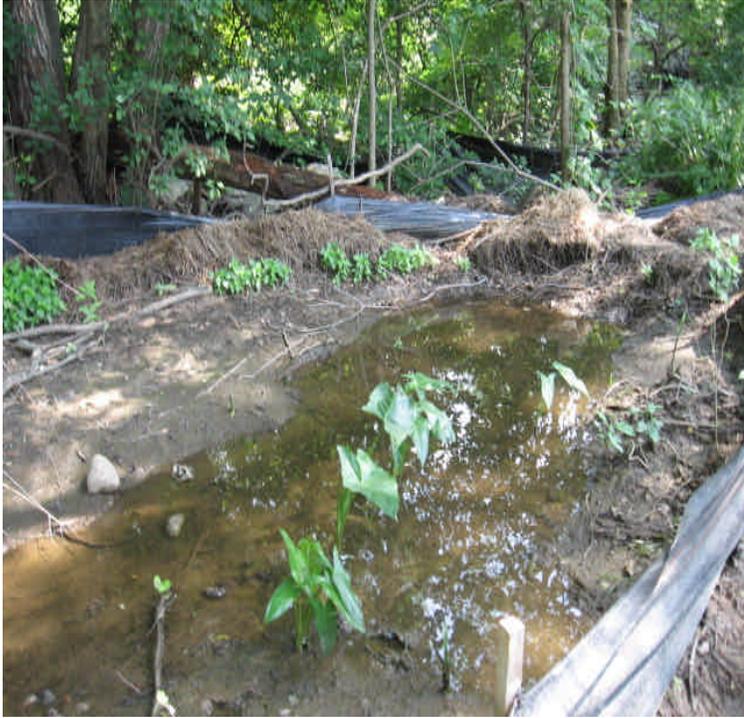
Photo on the left shows the channel along the eastern side of the site with fairly clear standing water and aquatic vegetation returning. (Georgetown HDD) Photo on the right shows a view of the asphalt pad with no run-off issues to the adjacent river 7/19/06

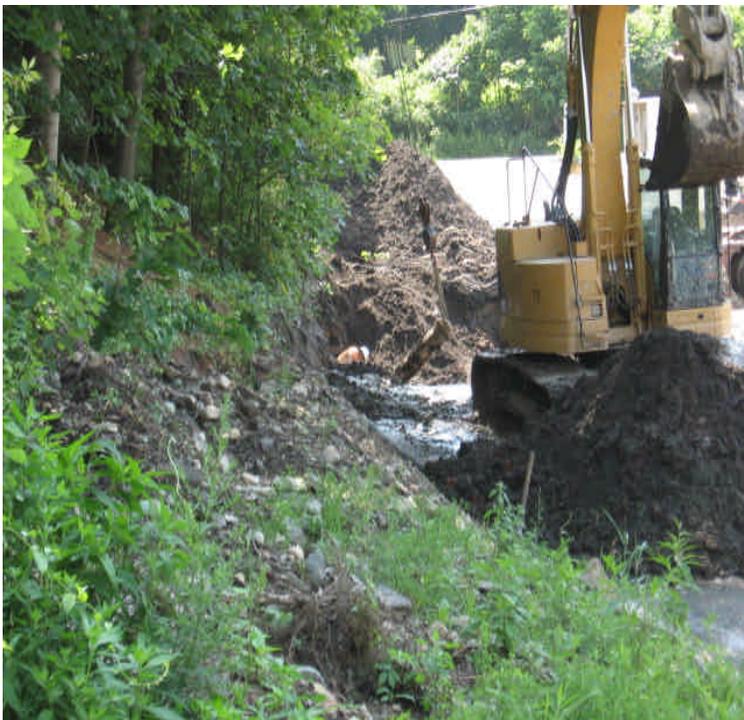
Photo on the left shows a view of the operations and equipment at the HDD site with resulting stockpiles. (Umpawaug Rd): Photo on the right shows a topsoil stockpile along the roadway. This vault area remains to be restored. 7/19/06
