Docket No. 217 – Development and Management Plan Inspection

Northeast Utilities Service Company Certificate of Environmental Compatibility and Public Need for the construction of a 345-kV electric transmission line and reconstruction of an existing 115-kV electric transmission line between Connecticut Light and Power Company's Plumtree Substation in Bethel, through the towns of Redding, Weston, and Wilton, and to the Norwalk Substation in Norwalk, Connecticut.

Date: July 21-22, 2005

Location: 345 kV Underground Route

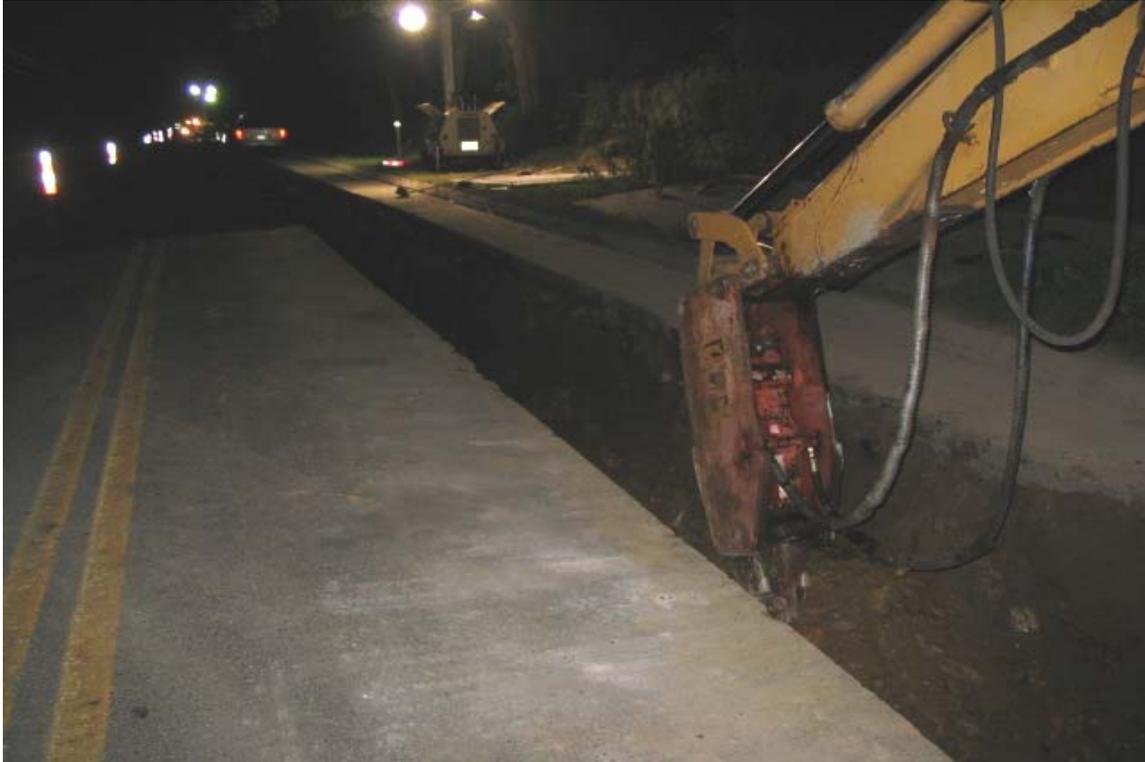
345kV (Rt. 7 Wilton) View of the nightwork trenching in the roadway of Rt. 7 to place pipe. (7/22/05)

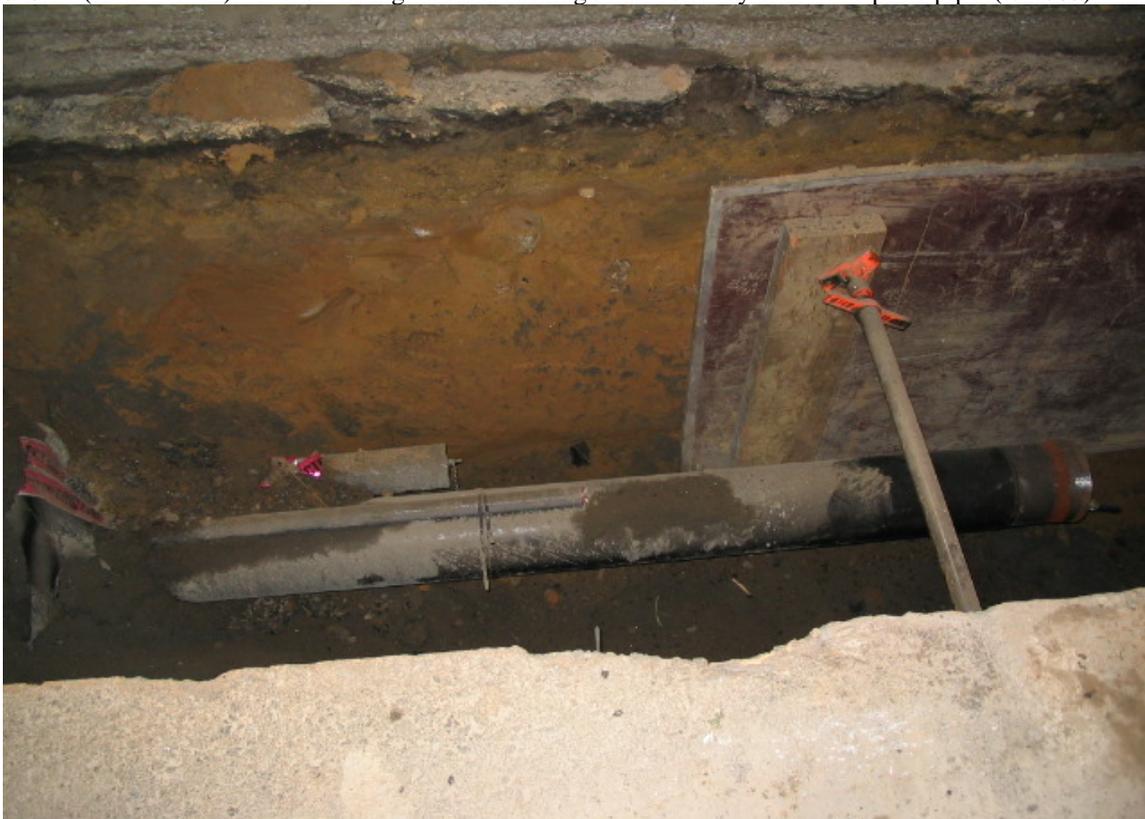
View of the pipe installed in the trench along Rt. 7. (7/21/05)

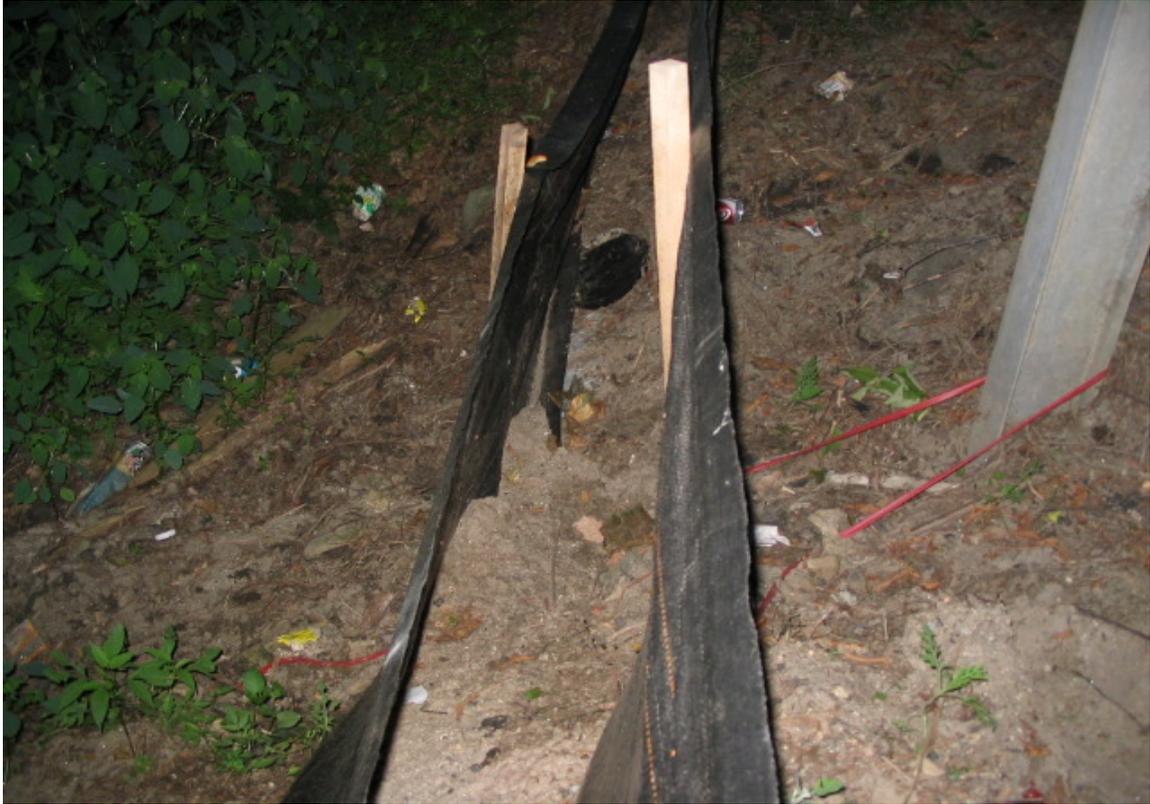
The silt fence which had been signaled for repair in recent reports has been reinforced with a second piece of fence. (7/22/05)

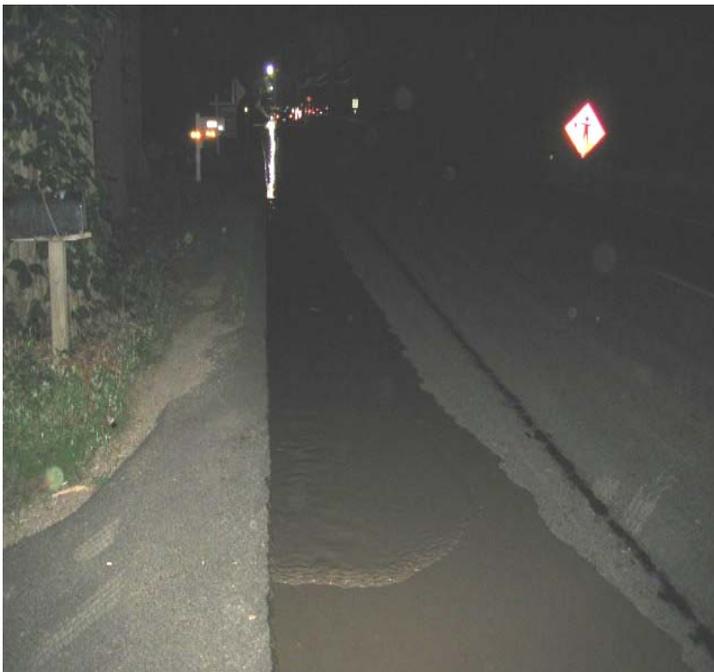
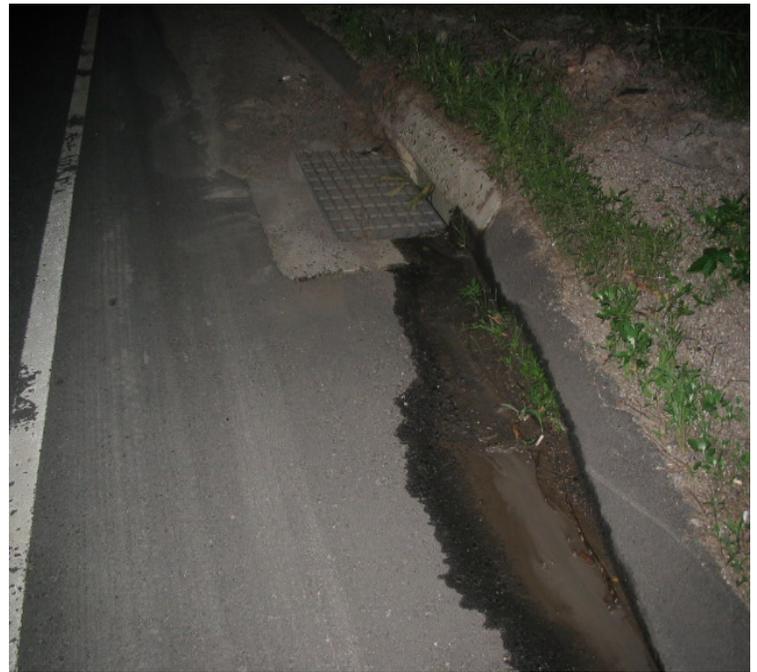
Slurry muds from sawcutting operations on Rt. 7 had traveled hundreds of feet from the construction down a hill to an unprotected catch basin. (7/22/05)

Areas of Inspection	Observation	Recommended Action
Vault Openings and Trench Construction	<ul style="list-style-type: none"> - Trenching, pipe installation, and sawcutting operations were ongoing along Rt. 7 in Wilton during the night and BSC was available to view the active work. 7/22/05 - Trenching and pipe installation continued in several locations along Rt. 107 south of the Umpawaug Rd. area. 7/22/05 - Correction: Actual vault installation has not yet occurred near the Rt. 107 and Rt. 7 intersection. 7/22/05 	<ul style="list-style-type: none"> -All work has been in the roadway and seems well contained for the most part. See erosion control sections for specific recommendations. 7/22/05
Erosion and Sediment Controls (includes inspection within 24 hours of a storm event)	<ul style="list-style-type: none"> - Most areas of silt fence remain installed in the areas of active work along Rt. 7 and Rt. 107. 7/22/05 - The spot which has been signaled in previous reports, located to the south of the equipment storage yard (along Rt. 7) has been repaired by placing a second row of silt fence behind the first in the area of the drain. This had been repaired previously but was difficult to see. 7/22/05 	<ul style="list-style-type: none"> - Continue to monitor and maintain and repair the fence when necessary. 6/09-7/22/05 - Continue to monitor and repair fence when necessary in this spot since this area includes a curb cut where slurry muds or sediment could reach the wetlands. 7/22/05
