**Docket No. 217 – Development and Management Plan Inspection**

Northeast Utilities Service Company Certificate of Environmental Compatibility and Public Need for the construction of a 345-kV electric transmission line and reconstruction of an existing 115-kV electric transmission line between Connecticut Light and Power Company’s Plumtree Substation in Bethel, through the towns of Redding, Weston, and Wilton, and to the Norwalk Substation in Norwalk, Connecticut.

**Date:** July 26, 2006

**Location:** 345kV Underground Route

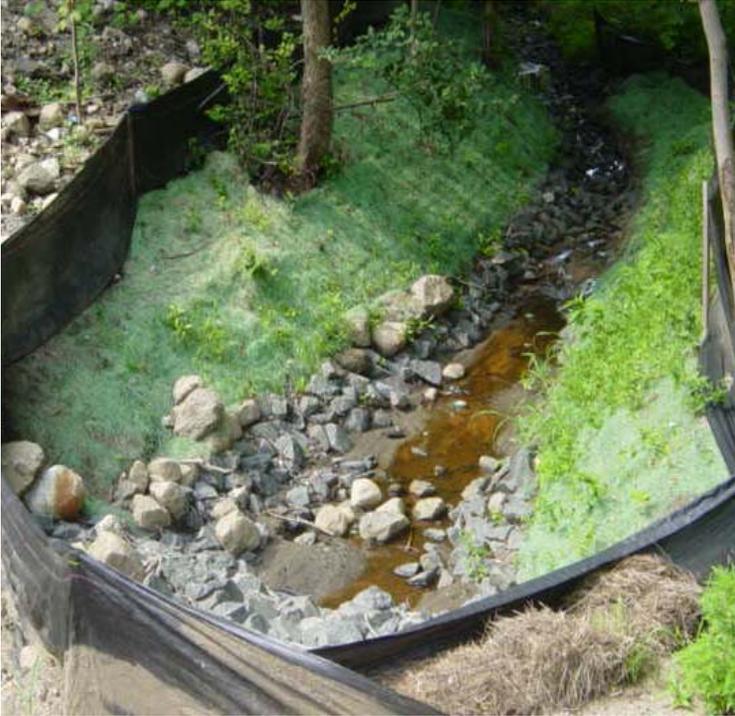
345kV (Old Danbury Rd) Photo on the left shows the silt fence remaining in place at the swale here. Photo on the right shows the erosion control mats in place. Stockpiles remain upgradient of the controls. 7/26/06

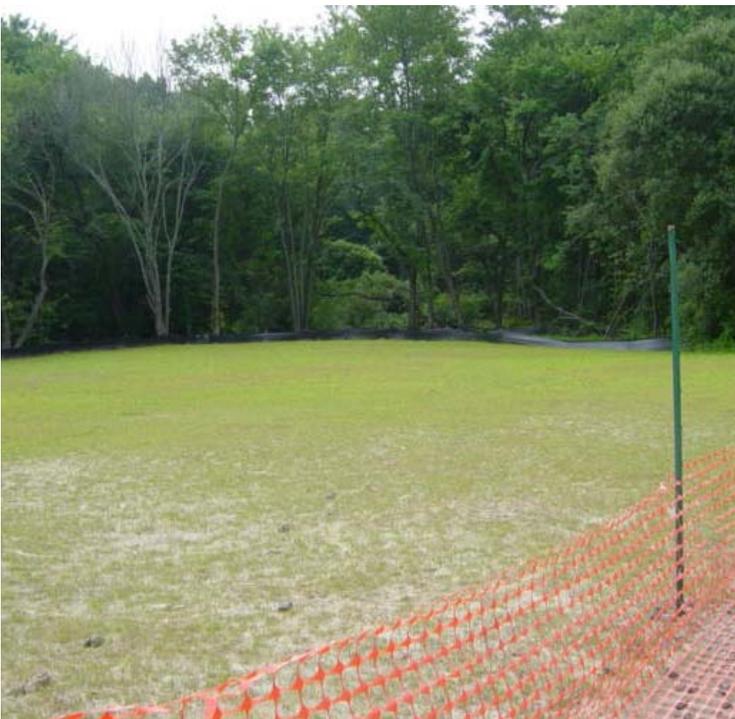
(School Rd HDD) Photo on the left shows the grass growth continuing within the restored HDD site. Photo on the right shows where the fencing should be repaired in order to keep any vehicles off the grass. 7/26/06

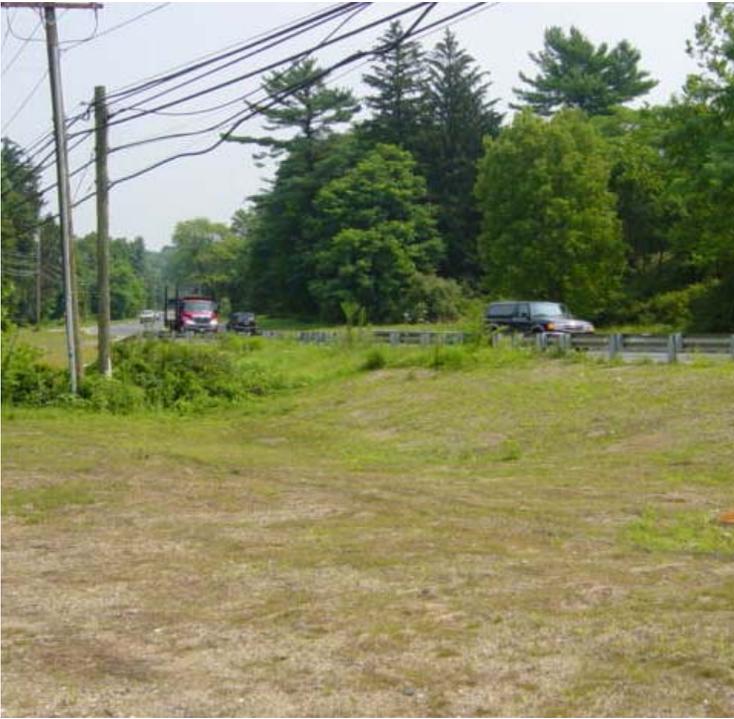
(Route 7) Photo on the left shows an overview of the restored Wilton HS J&B. This area is mostly stabilized but the weather may have affected continued grass growth. Photo on the right shows the storage area near the Rt 7/107 intersection. 7/26/06

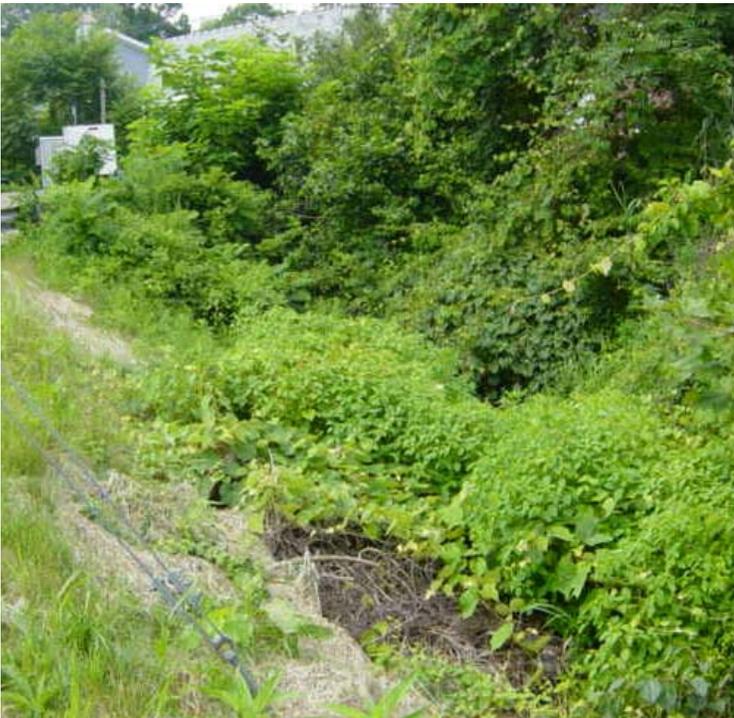
(Georgetown Deli): Photo on the left shows successful vegetation along the restored streambank. Photo on the right shows the trenchwork to connect the system at the Georgetown HDD site. 7/26/06

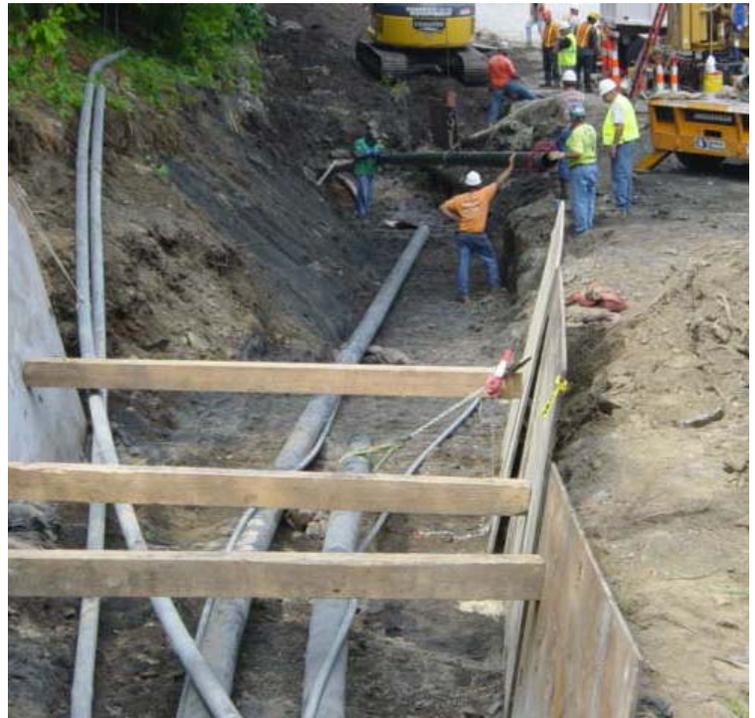
- Trenching and pipe installation was occurring at the new HDD site in Georgetown to connect the system. Large stockpiles remain here. 7/26/06	- Continue to monitor the area and see erosion control section for more information. 7/26/06	- N/A
