Docket No. 217 – Development and Management Plan Inspection

Date: August 10, 2005

Location: 345kV Underground Route

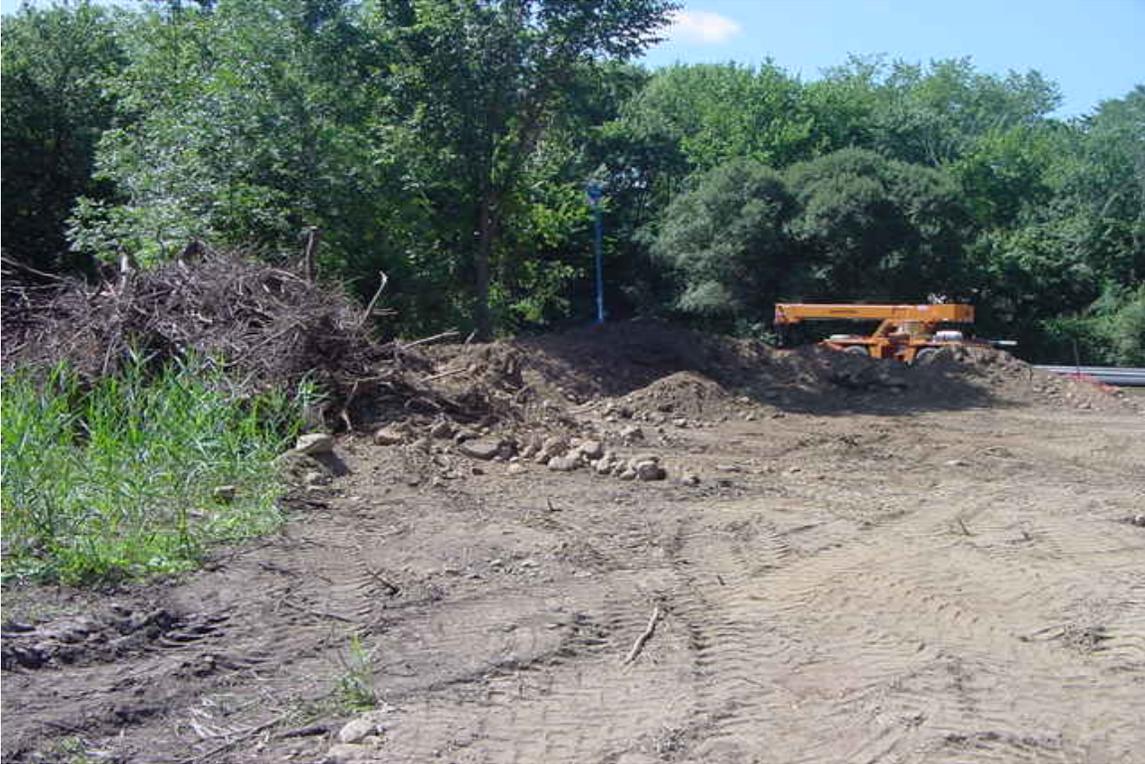
345kV (Rt. 7) View of the storage area at School Rd. The brush pile will be moved from the edge of the wetland. (8/10/05)

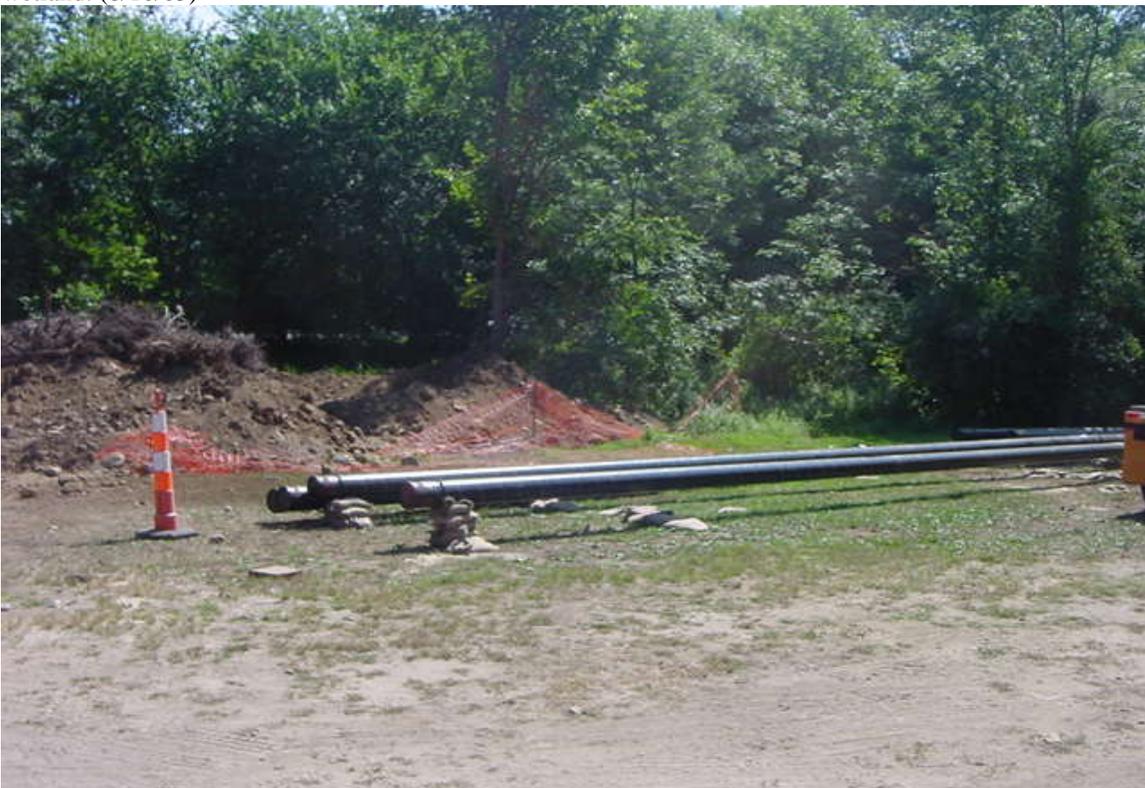
Some of the soil here had been removed but the remaining soil associated with the brush pile should also be disposed of. (8/10/05)

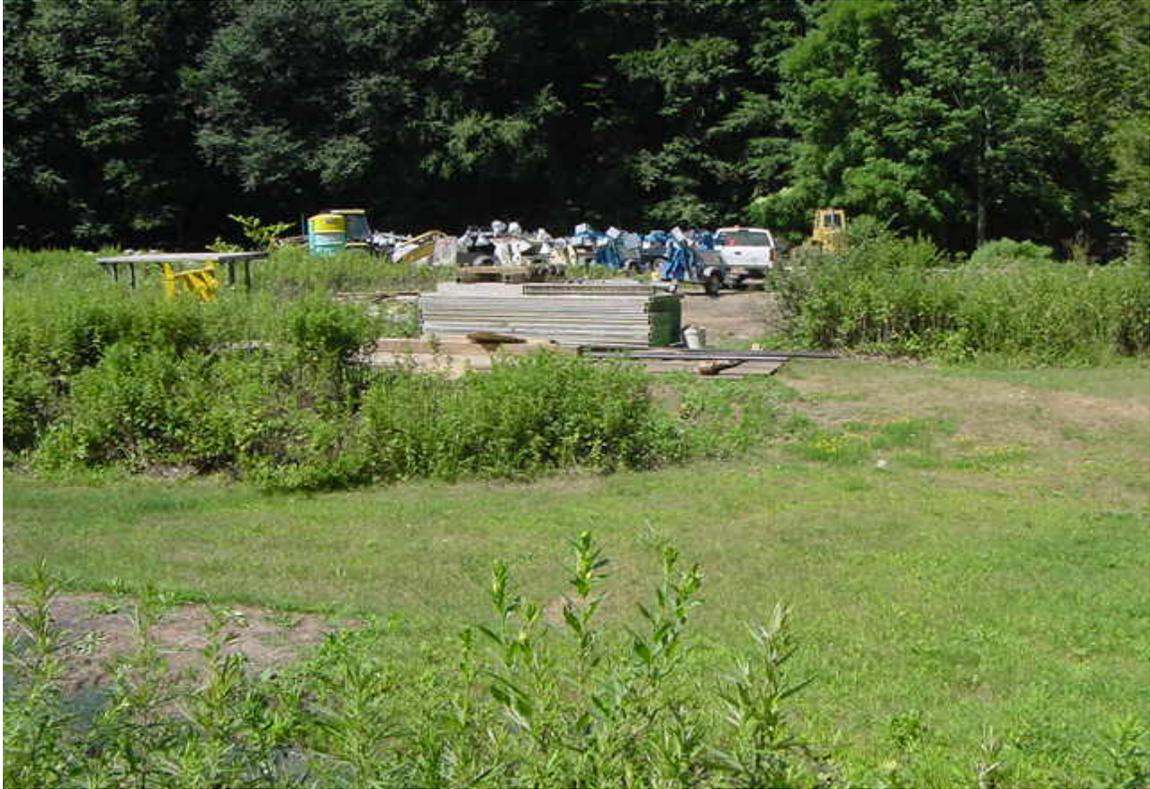
View of the original storage yard off Rt. 7. Materials are appropriately placed back from the wetland swale. (8/10/05)
