Docket No. 217 – Development and Management Plan Inspection

Northeast Utilities Service Company Certificate of Environmental Compatibility and Public Need for the construction of a 345-kV electric transmission line and reconstruction of an existing 115-kV electric transmission line between Connecticut Light and Power Company’s Plumtree Substation in Bethel, through the towns of Redding, Weston, and Wilton, and to the Norwalk Substation in Norwalk, Connecticut.

Date: August 18 and 19, 2005

Location: 345kV Underground Route

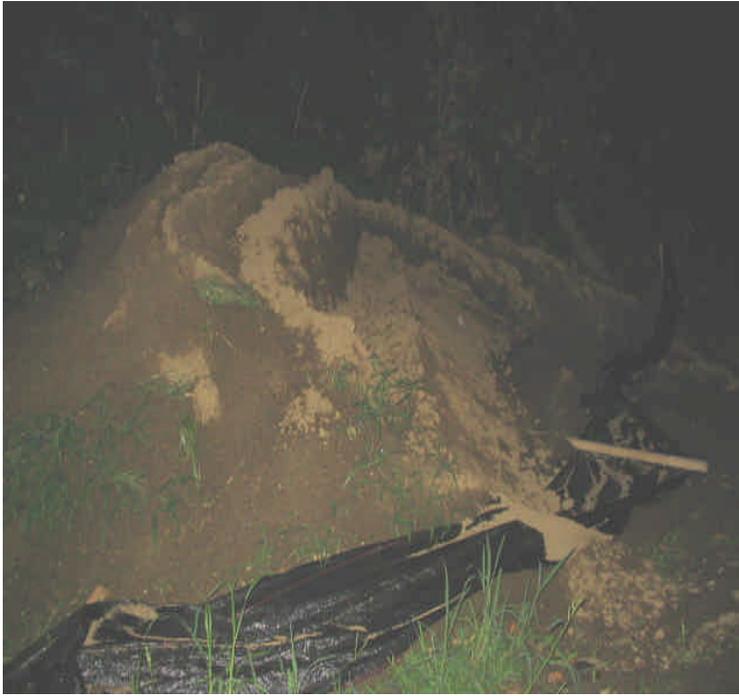
345kV (Rt. 7 Nightwork) Photo on the left: The silt fence at the small stockpile near the Rt. 7/107 intersection has fallen down. Photo on the right: The catch basin here is well protected and has prevented noticeable sediment from entering the inlet. (8/19/05)

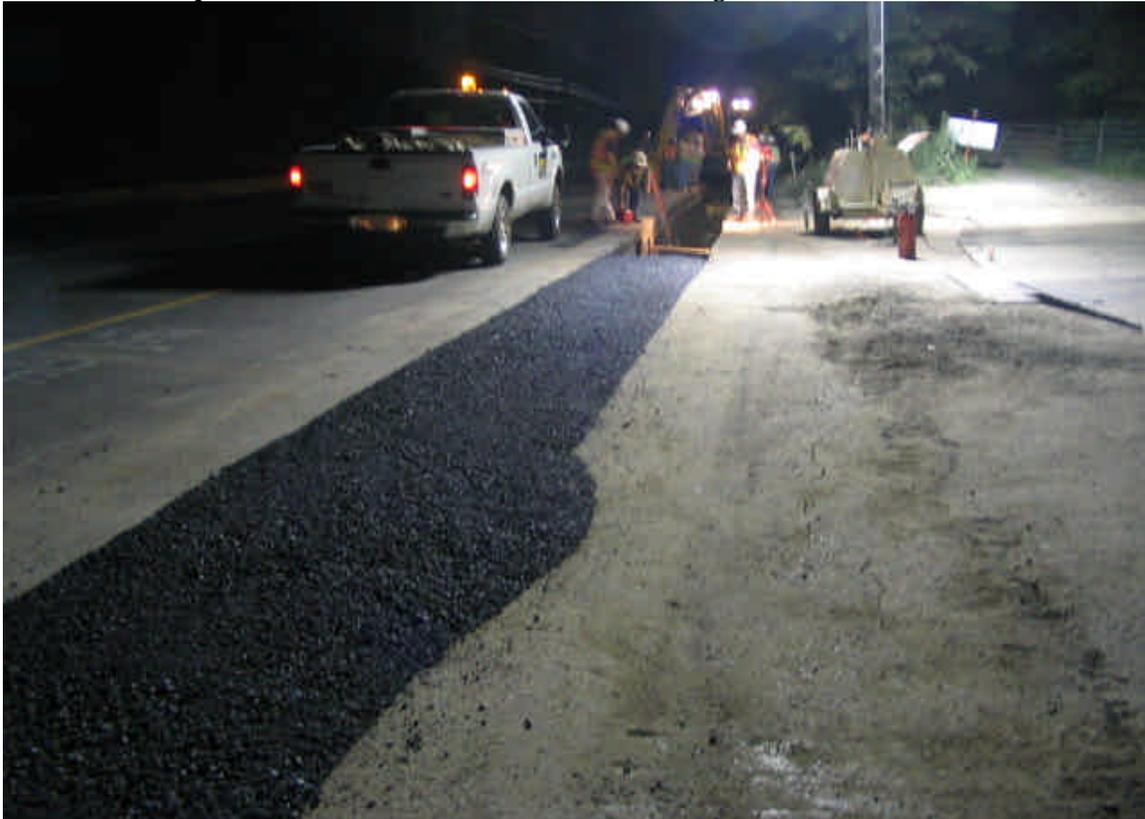
Overall view of the trenchwork and repaving out along Rt. 7 and in the vicinity of Marvin Gardens nursery. (8/19/05)

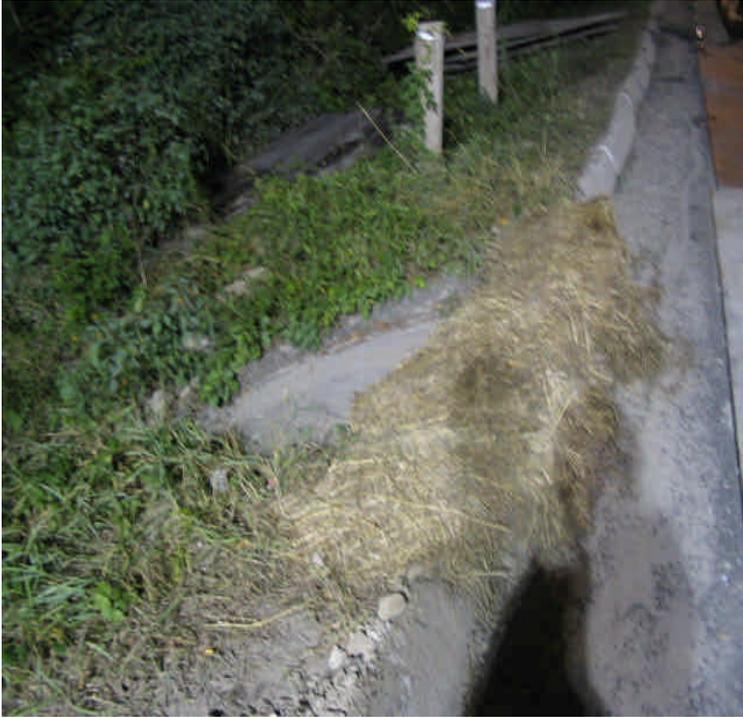
Photo on the left: Near Seeley Rd., the inlet swale is well protected with haybales as recommended. Photo on the right: View of the area in front of the Wilton fields recently disturbed and to be at least temporarily restored when work is complete here. (8/19/05)

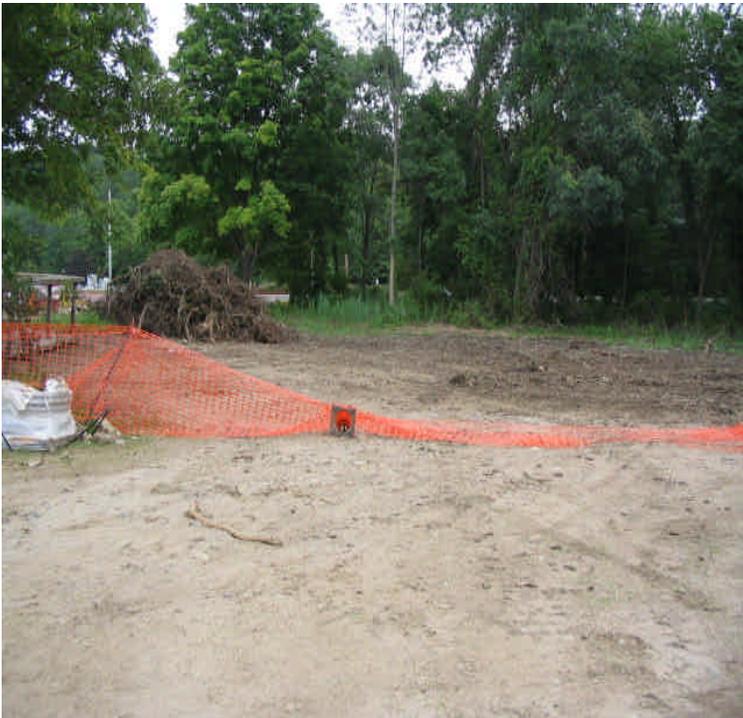
Photo on the left: The brush pile has been moved back to the wetland edge and the dirt piles are completely removed. Photo on the right: The silt fence has been knocked over at the original storage yard due to landowner activities. It should be repaired. (8/19/05)

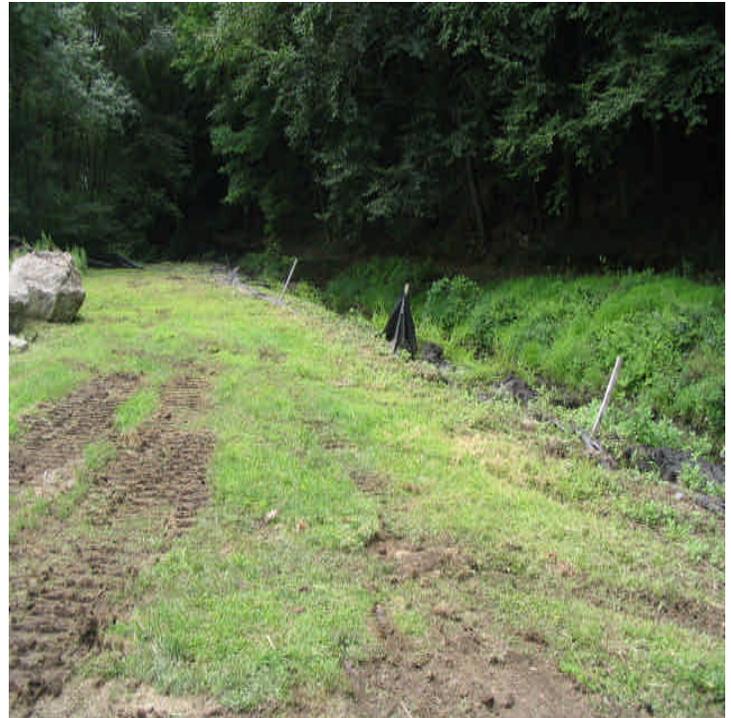
Areas of Inspection	Observation	Recommended Action
<p>Erosion and Sediment Controls (continued)</p>	<ul style="list-style-type: none"> - The silt fence located at the edge of the original storage yard near the Rt. 107 and 7 intersection has been pushed over completely due to separate landowner activities. 8/19/05 - The silt fence at the base of the soil stockpile near the Rts 107/7 intersection has been pushed over completely and needs repair. 8/19/05 -The curb cut across from Seeley Rd has been protected with haybales as recommended. 8/19/05 - The haybales on some of the catch basins previously protected on Rt. 7 have become degraded or were moved by equipment traffic. Slurry muds were noted along the roadway, even during the following day.8/19/05 - Catch basins in the vicinity of the vault installation were not protected and some sediment was present on the roadway. 8/19/05 - Some catch basins in the vicinity of Rt. 107 daywork were protected as recommended but several were not. 8/19/05 - Slurry mud was tracked down the road from the Rt.107 work where it turned off the roadway and caused some erosion under a wooden fence. 8/19/05 	<ul style="list-style-type: none"> - This fence needs repair as wetlands are immediately beyond the yard. 8/19/05 -In general, practice appropriate “housekeeping” and be sure to remove any left over debris from work areas. - The silt fence should be repaired as long as soil is piled here. 8/19/05 - Continue to maintain and be consistent with catch basin and inlet protection measures when work is in the vicinity, including areas steeply downgradient from sawcutting. Filter fabric is also an accepted measure if haybales are difficult to maintain. 8/19/05 - In general, catch basins should also be cleaned regularly and roadways swept of sediment attributed to the project. 8/19/05 - Contain all muds and monitor where water is flowing even when catch basins are not the receivers. The erosive gully may need to be repaired, especially as it is off the roadway. 8/19/05

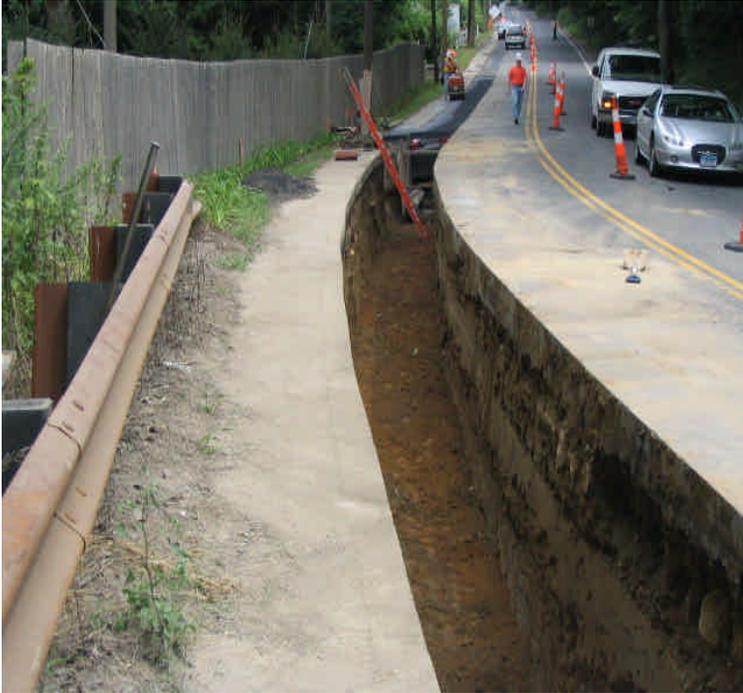
345kV (Rt. 107, Daywork) Photo on the left: General view of the trench work. Photo on the right: a recently completed vault installation. The landowner's property was regraded and seeded appropriately. More mulch is being added. (8/19/05)

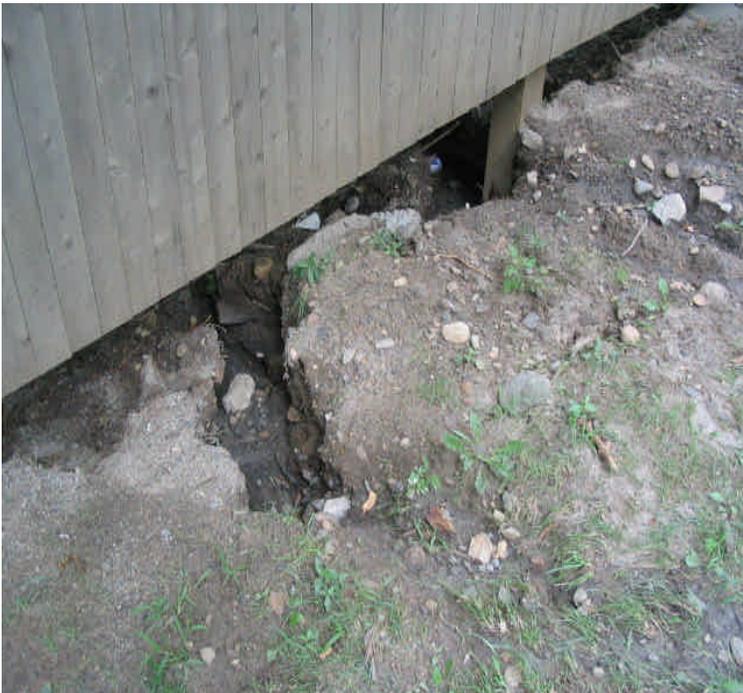
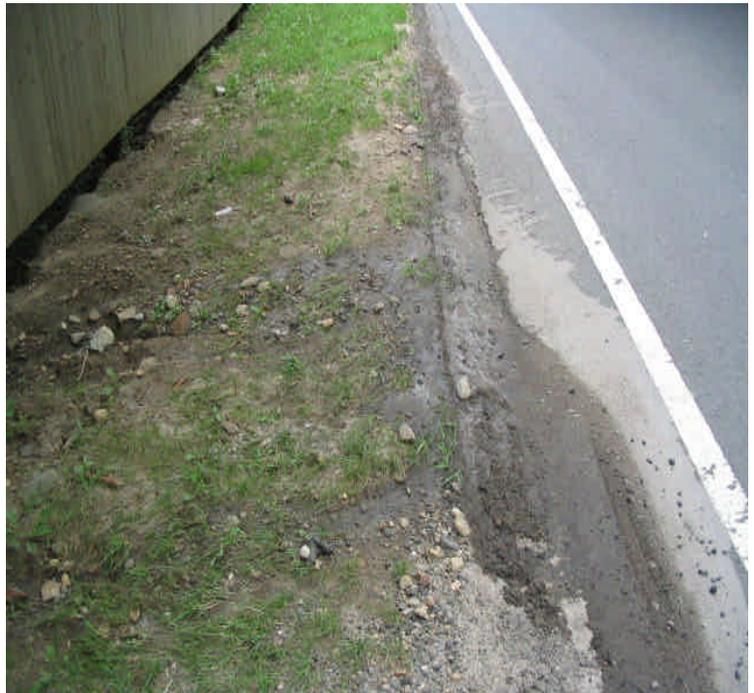
As a result of the trenching, slurry mud has run down the road and headed off site to private property causing some erosion under a fence. Muds should be controlled, even when there are no catch basins in the vicinity and the erosion should be repaired. (8/19/05)
