Docket No. 217 – Development and Management Plan Inspection

Northeast Utilities Service Company Certificate of Environmental Compatibility and Public Need for the construction of a 345-kV electric transmission line and reconstruction of an existing 115-kV electric transmission line between Connecticut Light and Power Company’s Plumtree Substation in Bethel, through the towns of Redding, Weston, and Wilton, and to the Norwalk Substation in Norwalk, Connecticut.

Date: August 24, 2006

Location: 345kV Underground Route

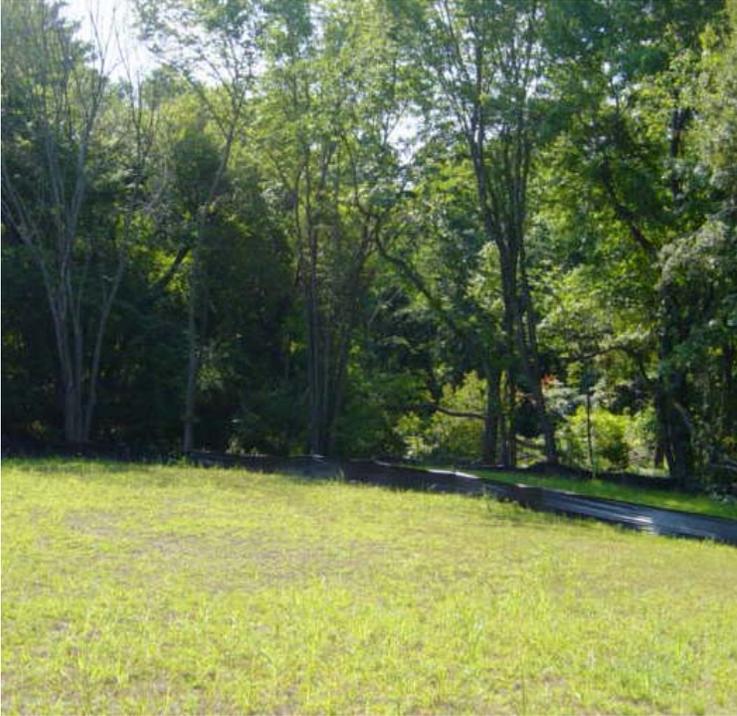
345kV: Photo on the left shows the School Rd site. Vegetative growth has slowed due to the recent drier weather but the surface is fairly stable. Photo on the right shows the previously disturbed area of wetlands to the south of the site with vegetation returning. 8/24/06

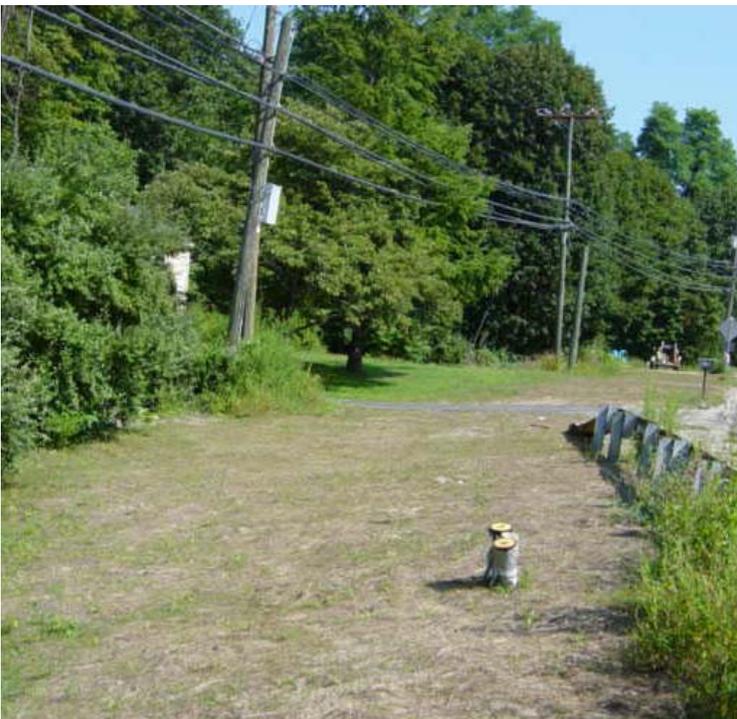
Photo on the left shows the previously restored area near Allens Meadow Park. Vegetative growth has also slowed here due to the recent drier weather. Photo on the right shows a view of the storage area near the Rt 7/107 intersection. The area continues to be cleaned up. 8/24/06

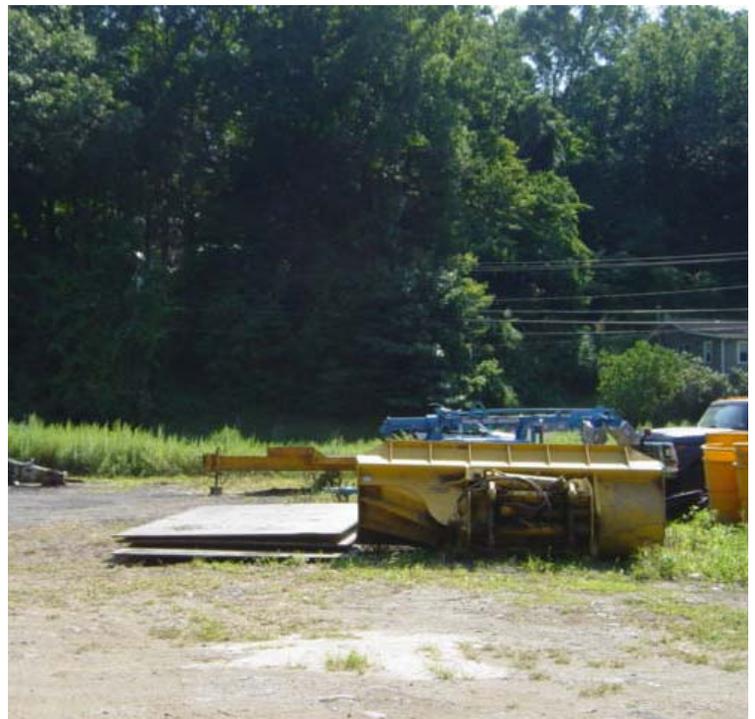
| Areas of Inspection | Observation | Recommended Action | Corrective Action |
|---|--|---|---|
| Staging, Storage, and Parking Areas | <p>- The equipment storage yard on the property south of the Rt. 7 &107 intersection was mostly contained. 1/26-8/24/06</p> <p>- Disturbance is mostly due to landowner activities. 3/15-8/24/06</p> <p>- A possible spill remains here in the gravel. 8/3-8/24/06</p> <p>- The storage area along Rt 7 across from Old Highway Rd is still in use. 8/24/06</p> <p>- The racquet club storage yard has a pile of sandbags and other equipment stored here. Stormwater had been</p> | <p>- In general, materials should be placed appropriately in storage areas or immediately adjacent to work each night. No potentially spillable materials should be left behind. Equipment should not be placed near resource areas.</p> <p>-Determine if this is project related and remove affected soil and stone. 8/3-8/24/06</p> <p>- The area is fairly well contained but control disturbed soil if necessary. Continue good housekeeping here. 8/24/06</p> <p>- Install haybales at the culvert within the swale in an attempt to filter run-</p> | <p>-N/A at this time</p> <p>- Needs attention</p> <p>-May need attention</p> <p>- Needs attention</p> |

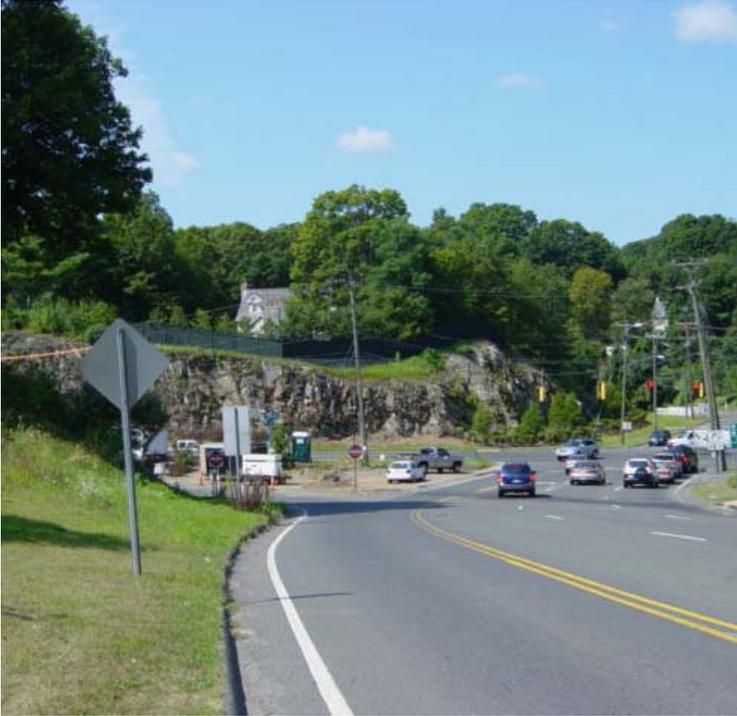
| Areas of Inspection | Observation | Recommended Action | Corrective Action |
|--|---|--|--|
| | - Active work continues at the Rt 7/107 intersection. Catch basins in the area do not have controls and there are adjacent stockpiles and disturbed soil. 8/24/06 | - See erosion control section. 8/16/06 | - Needs attention. |

Photo on the left shows a view of the work at the Rt 107/7 intersection. Catch basins here are not covered and protected and there are adjacent stockpiles and disturbed soil. Photo on the right shows restoration at recent work areas along Rt 107. 8/24/06

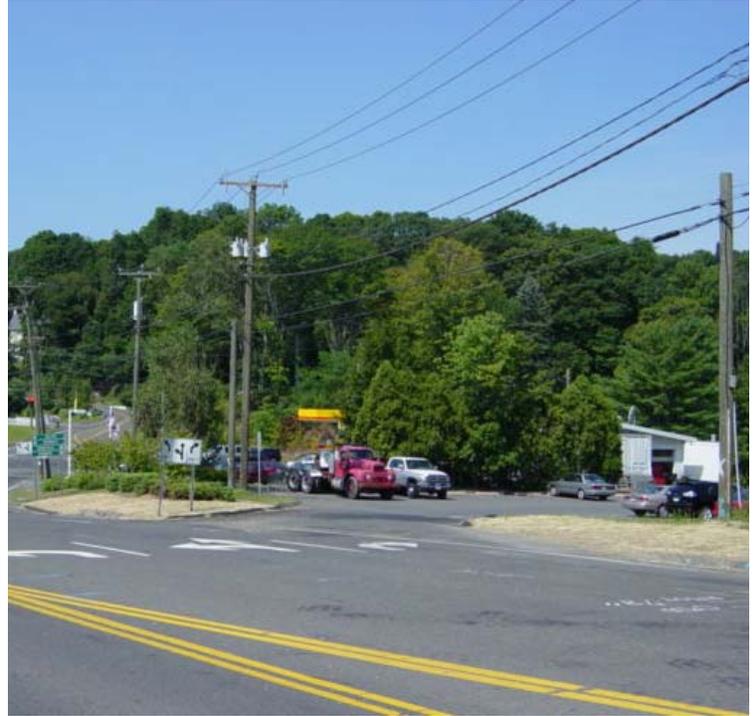
| Areas of Inspection | Observation | Recommended Action | Corrective Action |
|--|---|--|--|
| | - Work areas along Rt 107 were restored and seeded. Asphalt curbing was mostly replaced. 8/24/06 | - None at this time 8/24/06 | - Areas were restored |

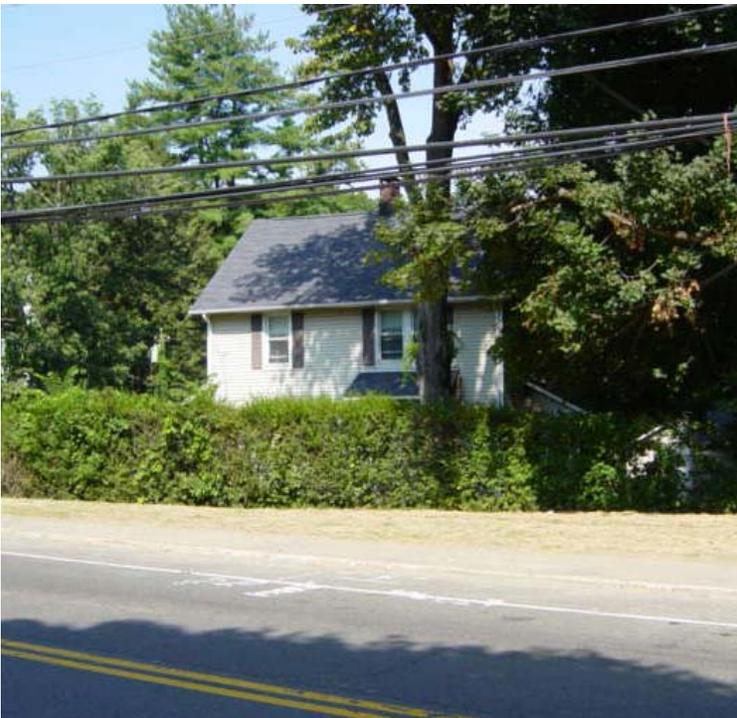
(Georgetown): Photo on the left shows where the work at Church St is complete and the area was restored. Photo on the right shows a view of the completed HDD site in the Gilbert & Bennett lot. Seed and mulch are still needed here along the slope. 8/24/06

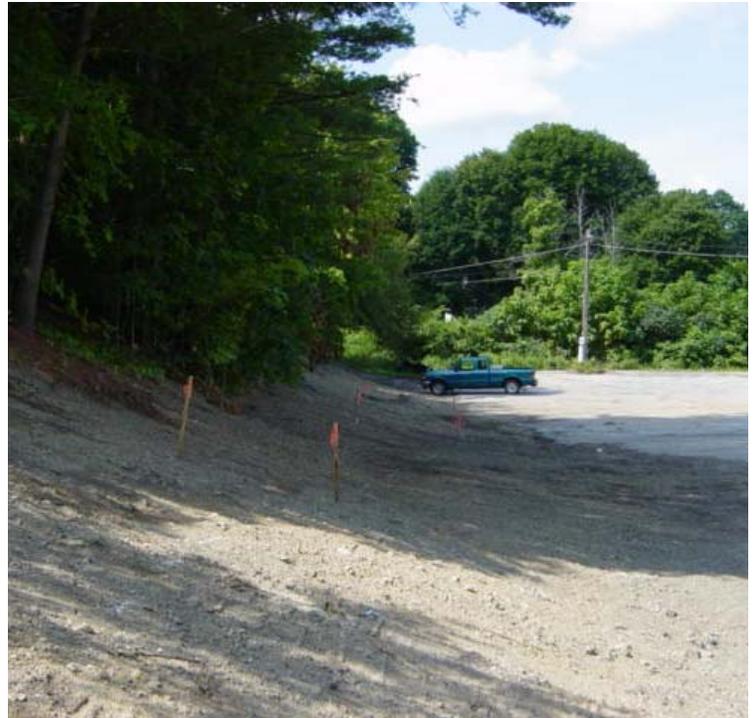
| Areas of Inspection | Observation | Recommended Action | Corrective Action |
|---|--|---|---|
| Erosion and Sediment (E&S) Controls continued | <p>restored areas and the boulders are holding up well. 8/24/06</p> <p>- At the Georgetown HDD site (Gilbert & Bennett lot), the slope where the trenching had occurred was graded but did not appear to have been seeded yet. 8/9-8/24/06</p> <p>- Church St and several areas along Rt 107 were restored with seed and mulch. 8/24/06</p> | <p>to promote stabilization. Continue to monitor 5/31-8/24/06</p> <p>- Seeding and mulching needs to occur. Determine whether the slope will require mats for stabilization as this area may erode. 8/3-8/24/06</p> <p>- Continue to monitor for stabilization. 8/24/06</p> | <p>-Needs restoration.</p> <p>- N/A</p> |

| Areas of Inspection | Observation | Recommended Action | Corrective Action |
|--|--|---|--|
| Vegetative clearing limits (including trees to save or danger trees noted) | <p>-The restoration efforts (seeding and mulching) in several locations along Rt 7 including HDD resulted in grass cover but growth is slowing due to the weather 7/26-8/24/06</p> <p>- The slope along the Gilbert & Bennett lot where the HDD occurred still needs to be seeded and mulched. 8/9-8/24/06</p> | <p>-Continue restoration: and monitor areas for suitable growth. 8/24/06.</p> <p>- Restore and stabilize the slope. 8/9-8/24/06</p> | <p>N/A at this time</p> <p>- Needs attention</p> |
