Docket No. 217 – Development and Management Plan Inspection

Northeast Utilities Service Company Certificate of Environmental Compatibility and Public Need for the construction of a 345-kV electric transmission line and reconstruction of an existing 115-kV electric transmission line between Connecticut Light and Power Company’s Plumtree Substation in Bethel, through the towns of Redding, Weston, and Wilton, and to the Norwalk Substation in Norwalk, Connecticut.

Date: August 25, 2005

Location: 345kV Underground Route

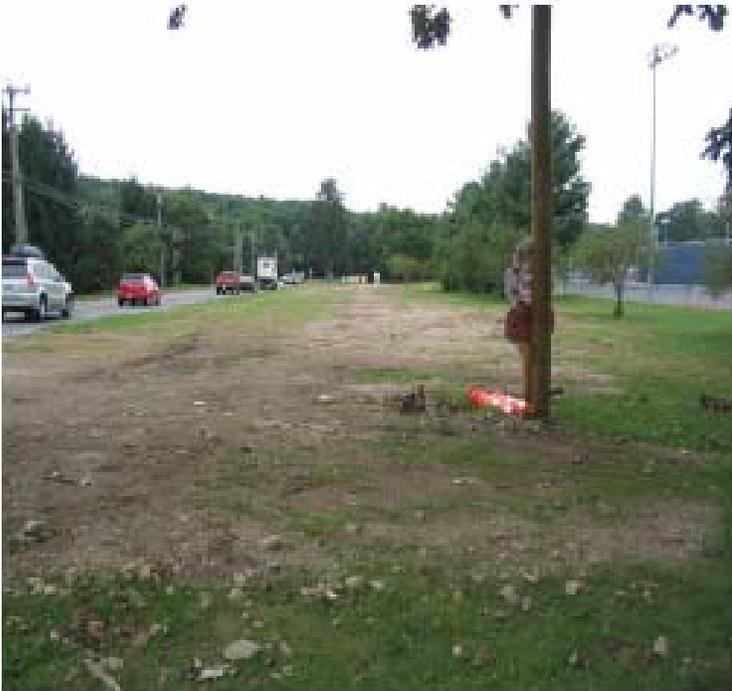
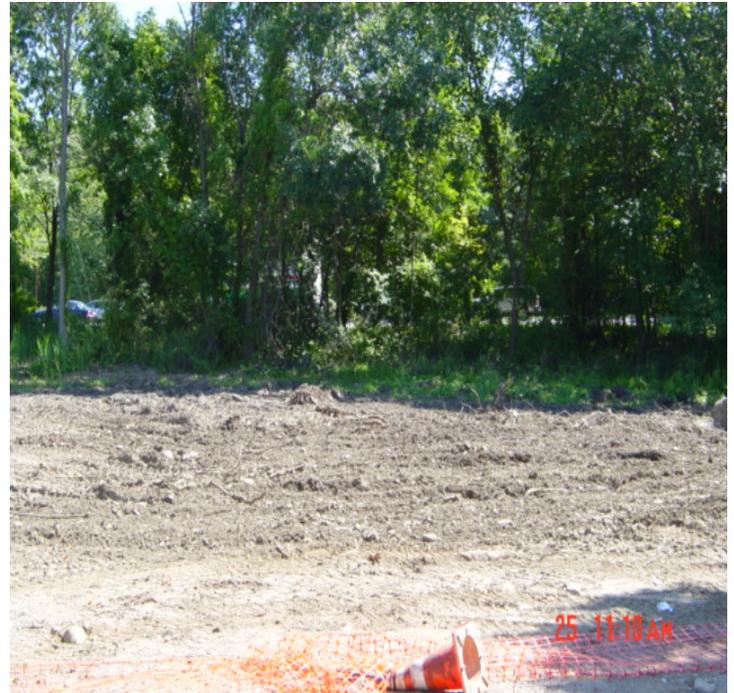
345kV (Route 7 Wilton): The photo on the left shows areas along the athletic fields which need to be restored. The photo on the right shows the School Rd. area where disturbed soil should also be temporarily stabilized unless the staging work occurs here soon. (8/25/05)

Areas of Inspection	Observation	Recommended Action
State species of concern, threatened and endangered species	- No species of concern are located in this area of construction.	- N/A
Vegetative clearing limits (including trees to save or danger trees noted)	<p>-Several areas of bare soil where trenching and vault installation occurred off roadway are still present, including near the athletic fields. The area has rocks left on the surface and should be regraded and restored to lawn. 8/25/05</p> <p>- The vault/manhole area in front of a single family home on Rt. 107 is well restored. 8/25/05</p>	<p>- When ground cover removal is necessary along the sides of the roadway, the areas should be restored and reseeded following the work. 8/25/05</p> <p>- According to the D&M plan, areas that are disturbed but will not be worked in for over 21 days should be temporarily stabilized/reseeded after 7-14 days. Restoration crews should be attending these areas prior to the deadline.</p>

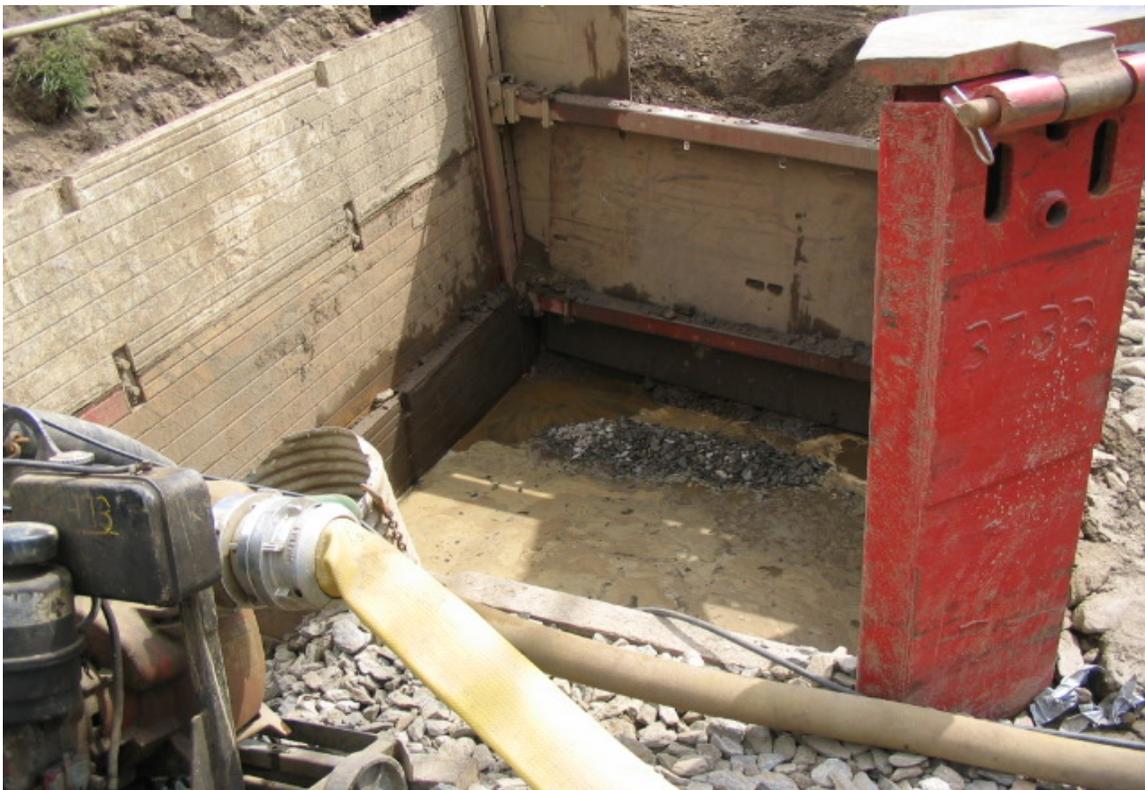
View of the jacking pit near Allens Meadow Park and north of the high school to jack and bore an adjacent stream. Dewatering is required and work has been slowed by other utilities. (8/25/05)

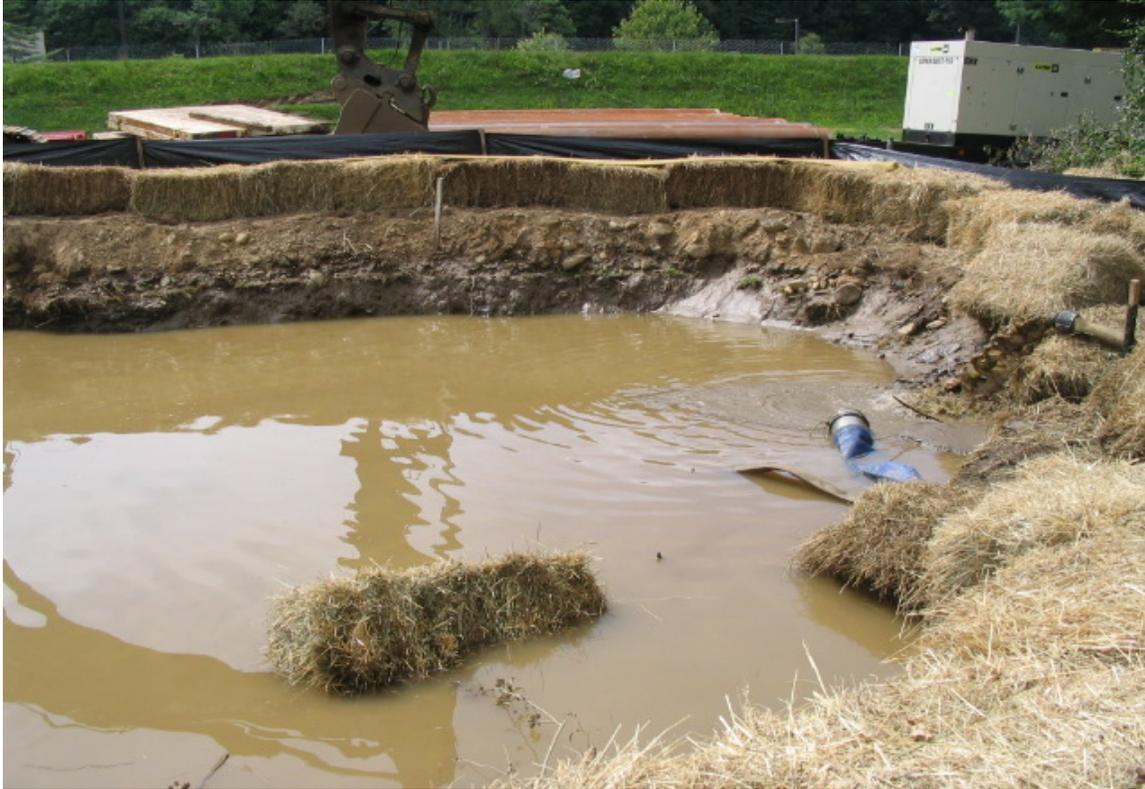
Areas of Inspection	Observation	Recommended Action
	<p>from the jacking pit was placed improperly leading to water discharging to the stream. This was rectified but turbid water is still entering the stream after it moves through all of the controls in place at the settling basin. 8/25/05</p>	<p>controls. Some recommendations are more haybales and silt fence staked at the outer edge of the spillway. Silt fence could also be placed to line the basin near the spillway before it percs out. The discharge hose should be placed at the far side of the basin from the stream to allow more settling time. 8/25/05</p> <p>- In general, keep slurry muds in control as catch basins may outlet to wetlands.</p>
<p>Staging, Storage, and Parking Areas</p>	<p>- The silt fence at the equipment storage yard located on property off Rt. 7, south of the Rt 107 and 7 intersection has been completely pushed over by separate landowner activities. 8/19-8/25/05</p> <p>- The additional storage and staging yards for equipment and constructing trench materials along Rt. 7, appears to be in good repair. 8/19/05</p> <p>-At the School Rd. storage area, the soil surface is disturbed where the stockpiles had been. If bore staging work is not scheduled here soon, it should be temporarily stabilized. 8/25/05</p>	<p>- It needs to be confirmed whether the fence was repaired but it doesn't appear to be. Wetlands are located immediately adjacent. 8/25/05</p> <p>- In general, equipment should not be left above or adjacent to wetlands during inactive hours.</p> <p>- Continue to keep the area contained. Keep materials and equipment to a condensed area where possible. 8/25/05</p>

View of the settling basin set up to receive the water from the jacking pit (8/25/05)

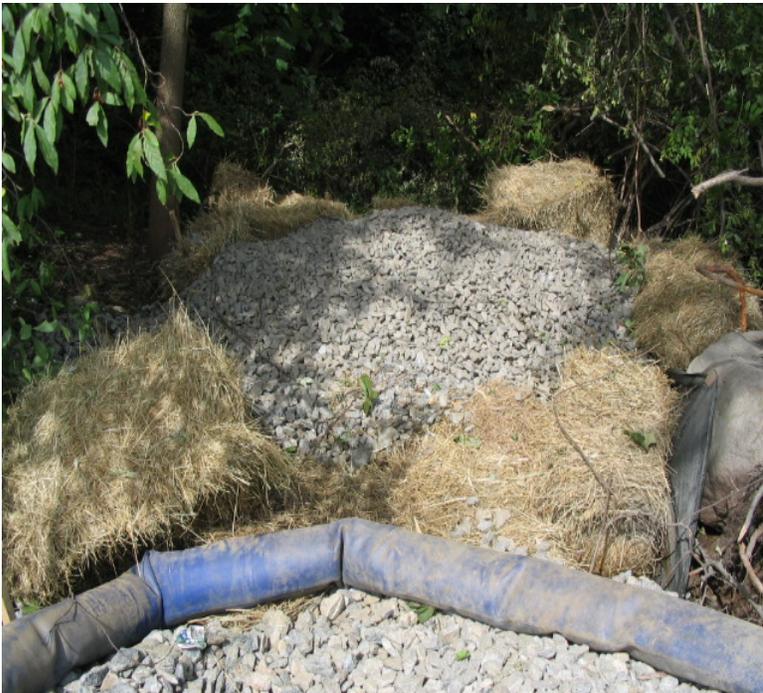
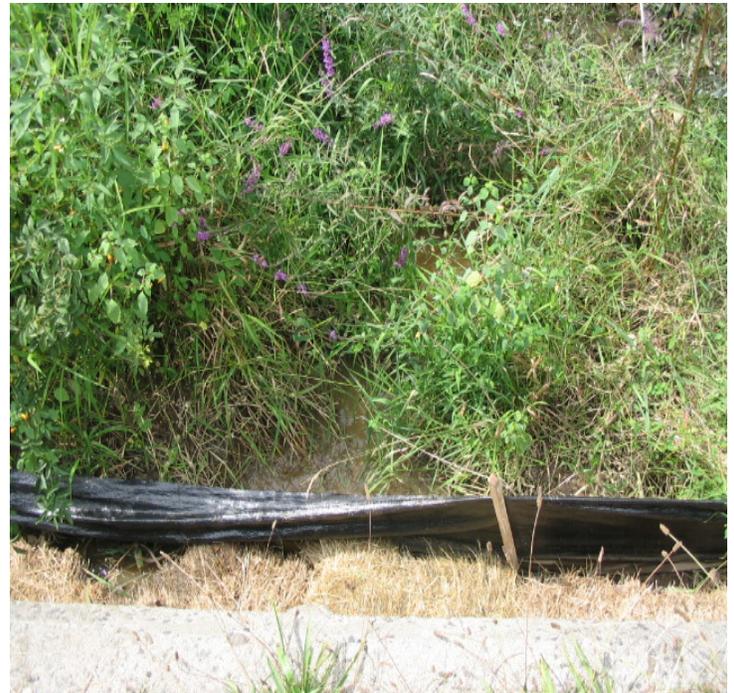
The photo on the left shows the spillway and controls set up to filter the water leaving the settling basin. The photo on the right shows that turbid water is still entering the stream and getting through to the final sediment barrier staked within the stream itself. (8/25/05)

Areas of Inspection	Observation	Recommended Action
Vault Openings and Trench Construction	<ul style="list-style-type: none"> - Trenching, pipe installation, and sawcutting operations continue along Rt. 7 in Wilton during the night. 8/25/05 - Trenching, pipe installation, and saw cutting continued along Rt. 107 during the day in the vicinity of #145. 8/25/05 - The vault/manhole contractor is working at a location across from Zion Hill Church off roadway. 8/25/05 -Active work for a jack and bore of a stream near Allens Meadows Park is occurring. The jacking pit is under construction and the bore is not underway yet. 8/25/05 	<ul style="list-style-type: none"> -The majority of the work has been in the roadway and seems contained for the most part. Some work is also located off the road shoulder and disturbed areas need some attention. See erosion control and material storage sections for specific recommendations. 8/25/05 - Despite efforts to control the dewatering here, turbid water is still reaching the stream. Alternatives are needed. 8/25/05

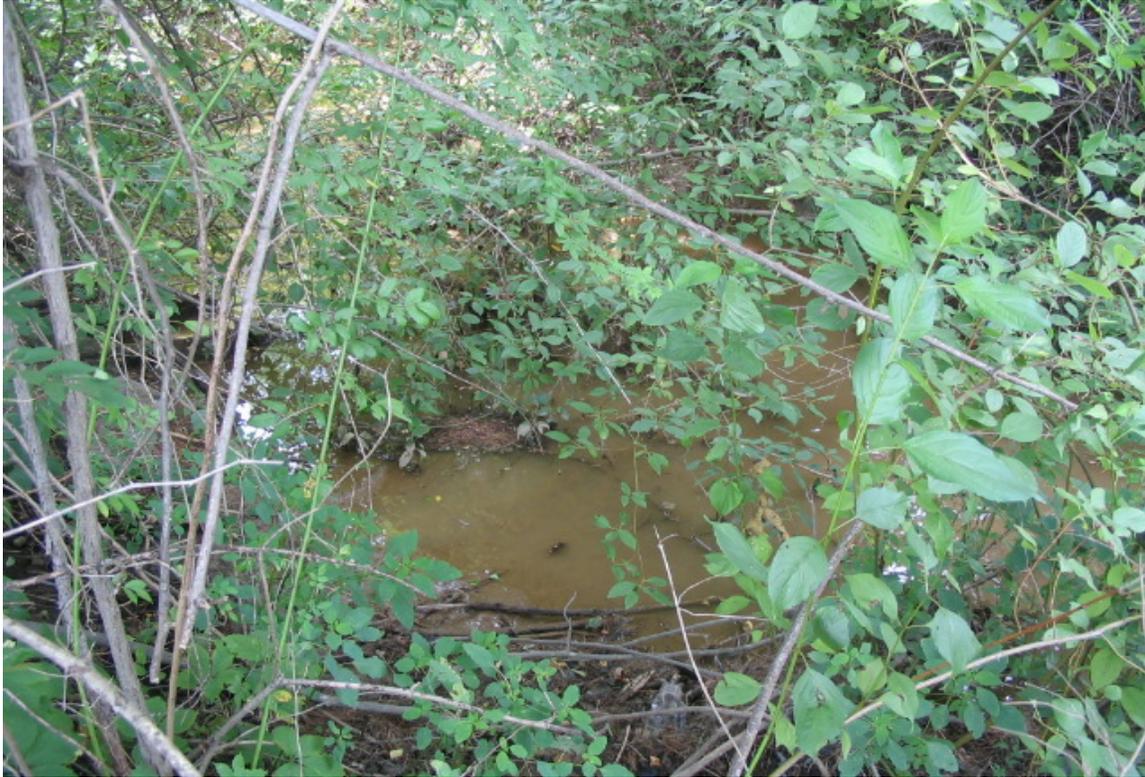
View of the stream below the spillway from the basin. Despite the controls and efforts made, turbid water is still making it to the stream. (8/25/05)

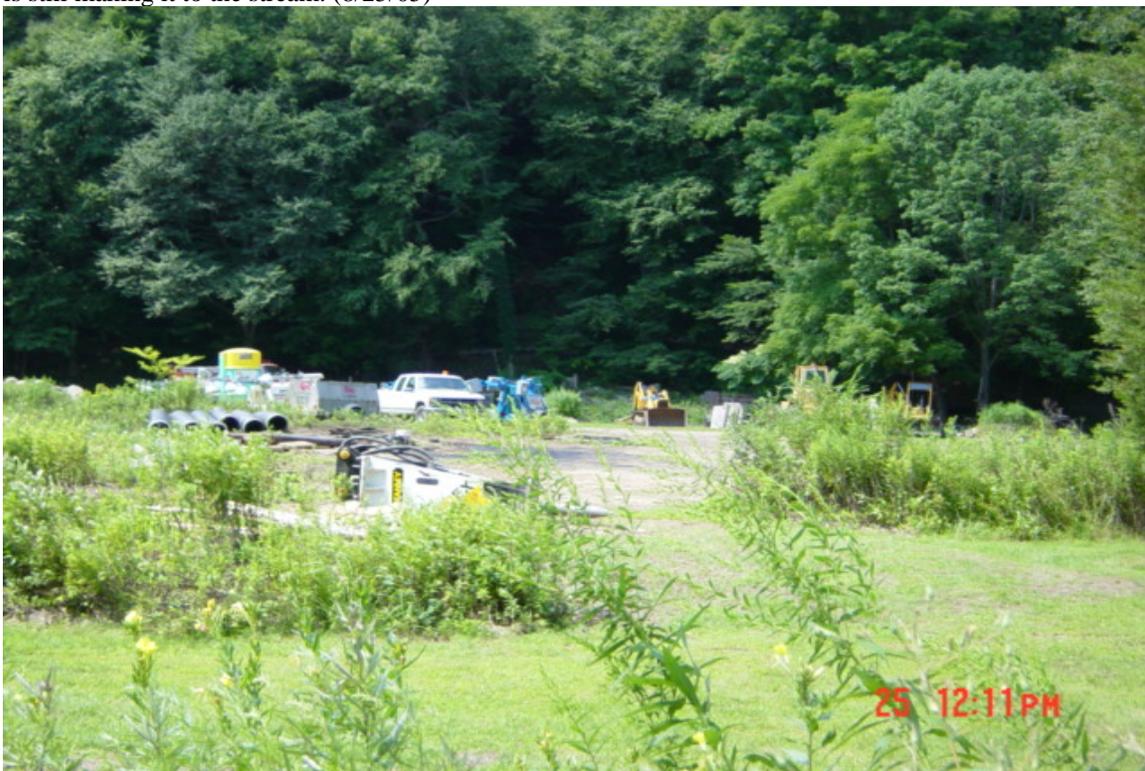
View of the storage yard near the Rt. 107/7 intersection. It needs to be confirmed whether silt fence was restored following the landowner's activities. (8/25/05)

Erosion and Sediment Controls (includes inspection within 24 hours of a storm event)	<ul style="list-style-type: none"> - It appears areas of silt fence remain installed in the areas of active work along Rt. 7 and Rt. 107 where needed but several areas of silt fence are down. 8/25/05 	<ul style="list-style-type: none"> - Continue to monitor and maintain and repair the fence in the vicinity of active work. If work returns to the areas where the silt fence is down, it must be repaired before active work begins. 8/25/05
