Docket No. 217 – Development and Management Plan Inspection

Northeast Utilities Service Company Certificate of Environmental Compatibility and Public Need for the construction of a 345-kV electric transmission line and reconstruction of an existing 115-kV electric transmission line between Connecticut Light and Power Company’s Plumtree Substation in Bethel, through the towns of Redding, Weston, and Wilton, and to the Norwalk Substation in Norwalk, Connecticut.

Date: September 15, 2005

Location: 345kV Underground Route

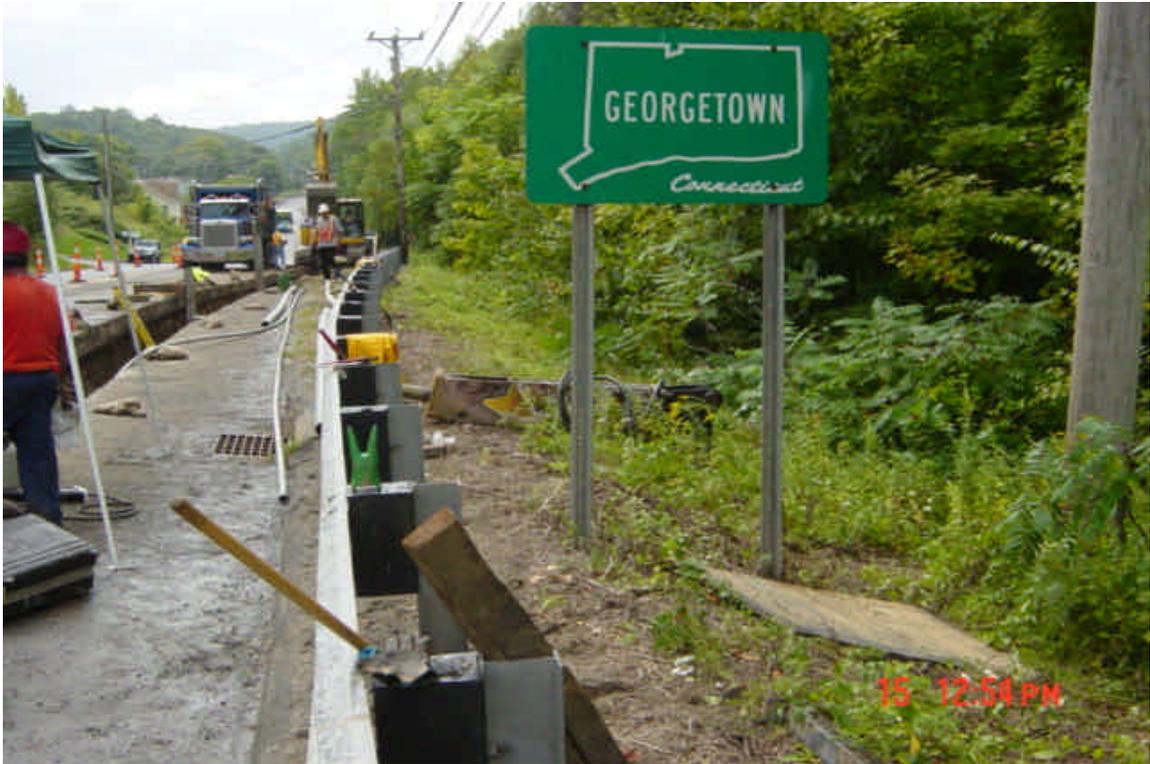
345kV (Route 107 Daywork North of Georgetown Deli): View of the trench work and associated materials. Good “housekeeping” should be performed at the end of each day. (9/15/05)

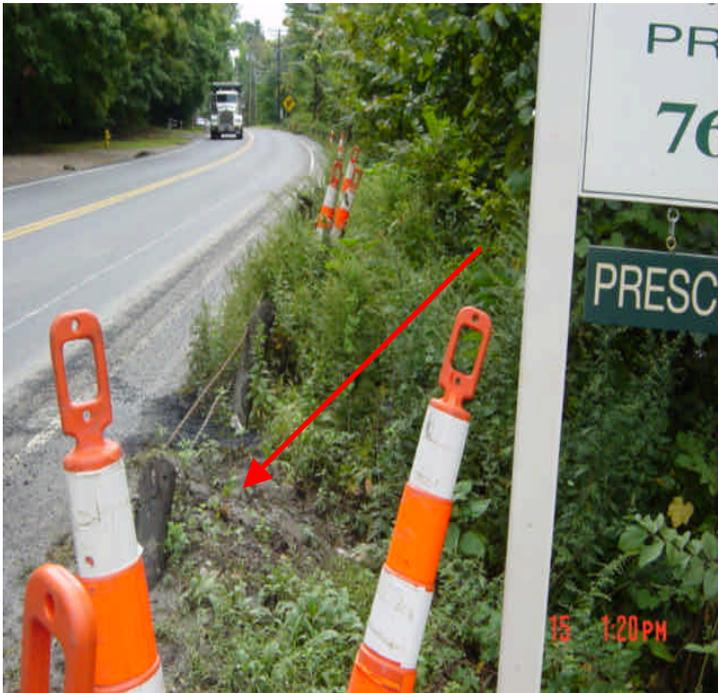
345kV (Rt 7): Photo on the left shows some runoff from the roadway appeared to cause some erosion in the vicinity of #465 (Dr Rosen’s office). Erosion controls should be installed at swales/drainways near active work. Photo on the right shows some damage to adjacent guardrail. Store materials appropriately and make necessary repairs to existing infrastructure. (9/15/05)

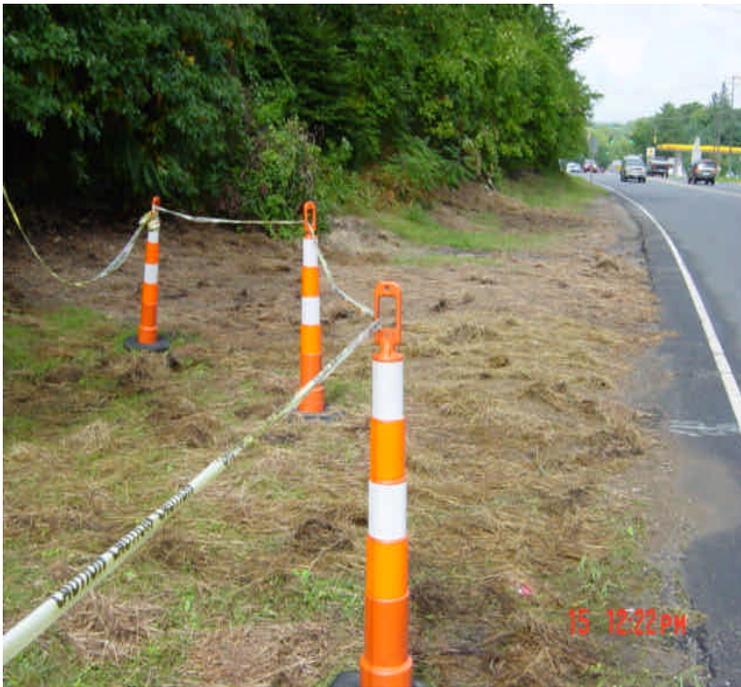
(345kV: Rt. 7) Photo on the left shows where stockpiles had been removed and the area reseeded and mulched. Photo on the right shows some materials being stored beyond the brush line near the Wilton Racquet Club. Storage areas should have a limit of work line. (9/15/05)

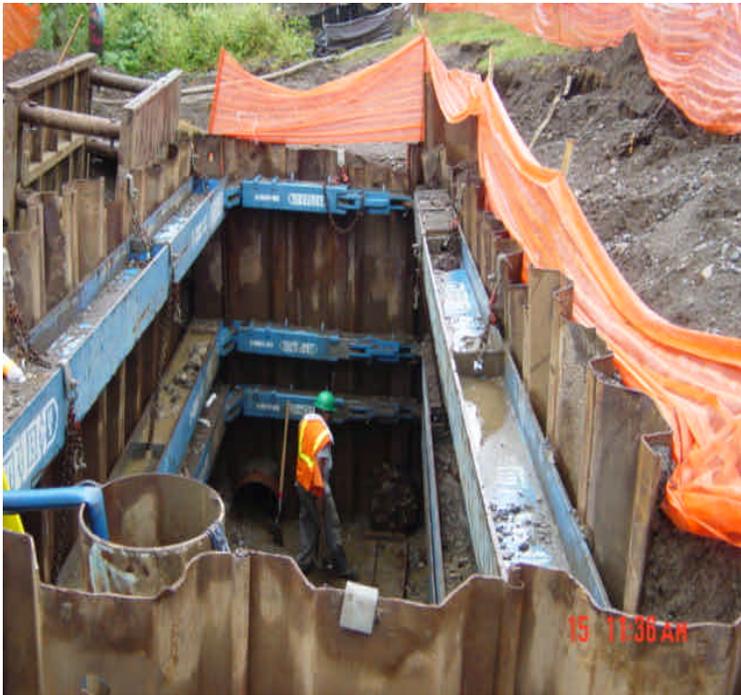
(345kV: Rt. 7) Wilton High School: Photo on the left shows the progress of the trench where the jack and bore is occurring. Photo on the right shows some mud tracking into the roadway from the site. (9/15/05)

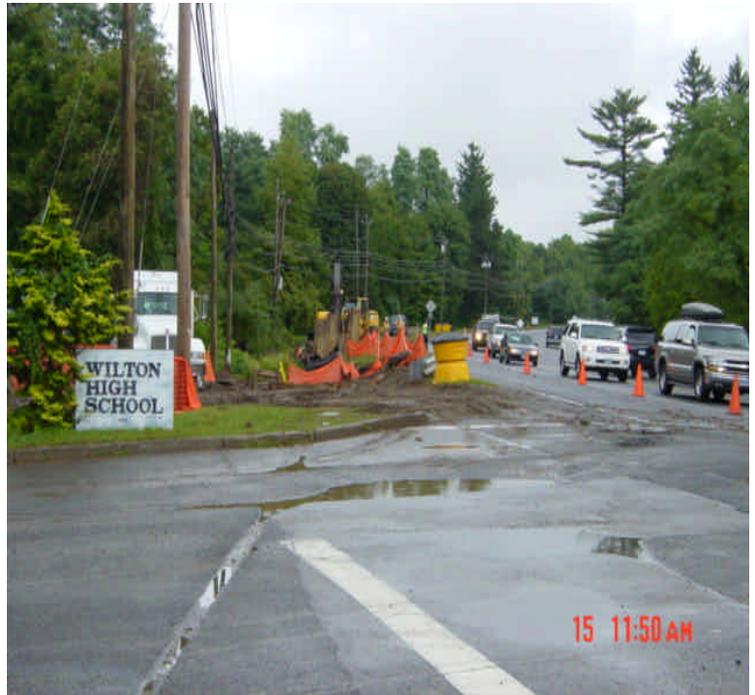
Additional Observations	<p>- Some sediment tracking to the roadway was noted near the jack and bore due to muddy conditions. 9/15/05</p>

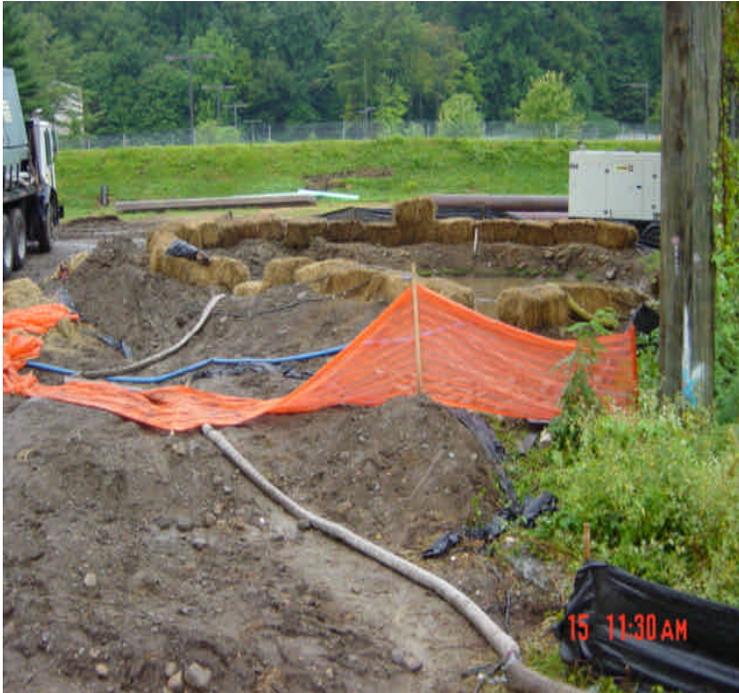
Photo on the left shows the jacking pit side where erosion control had been down on the day of the inspection. The photo on the right shows the repairs made the following day. (9/15-16/05)

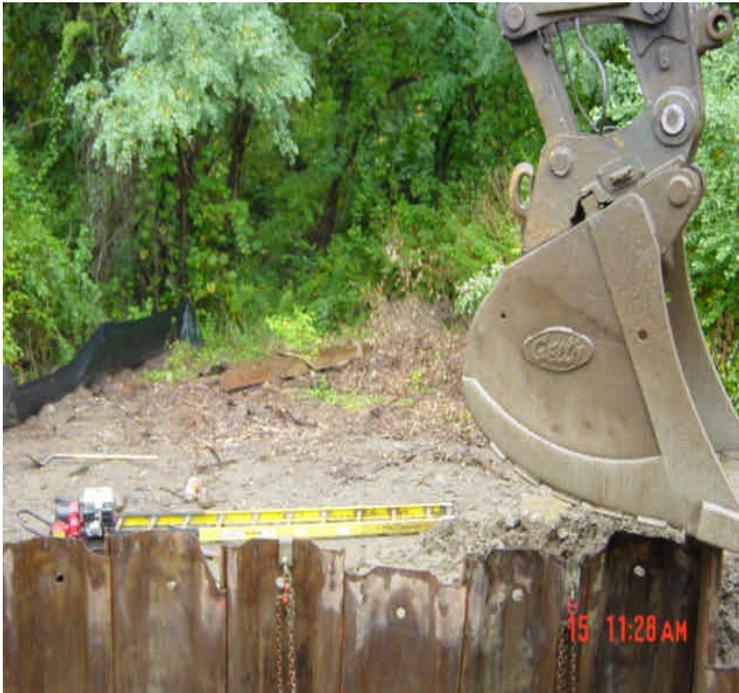
Photo on the left shows a view of the receiving pit side of the stream which is now dug. Photo on the right shows some of the excavate which was not encompassed by silt fence on the day of the inspection. This was rectified the day following the inspection. (9/15/05)

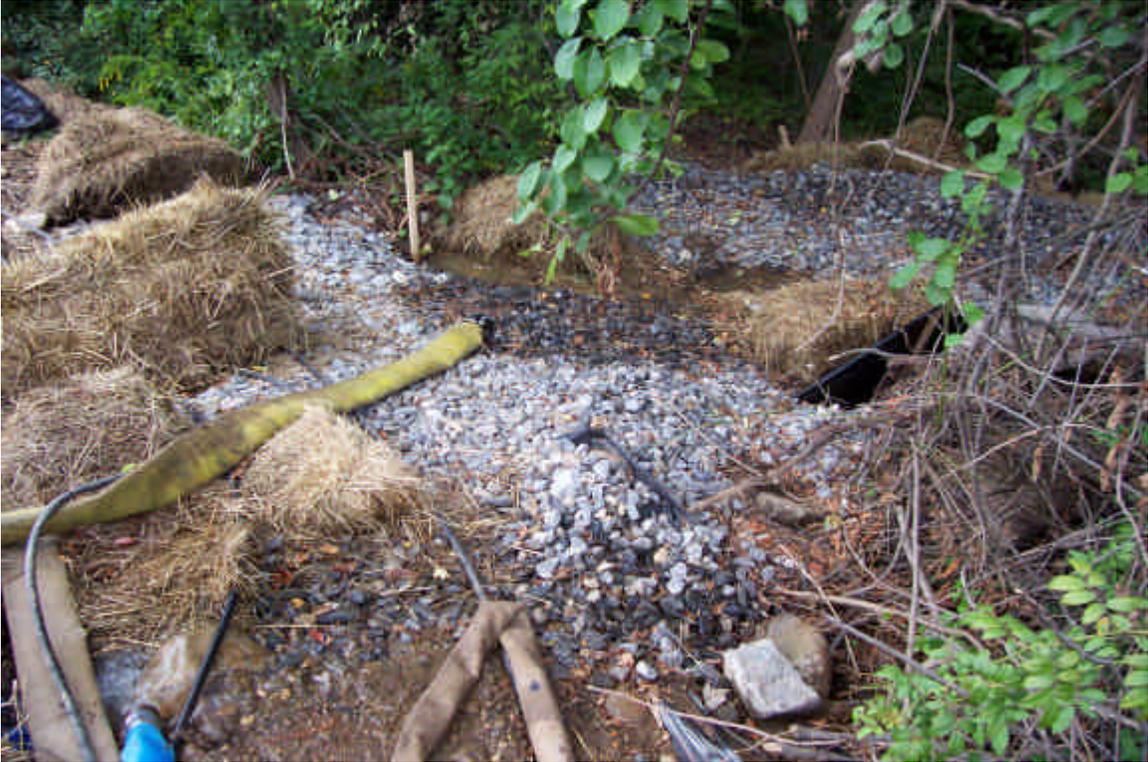
Due to difficulty keeping discharge to the stream clear, the hoses from the jacking pit were placed directly on the stone outlet pad while the dirtier water from the receiving pit remains in the settling basin. (9/16/05)

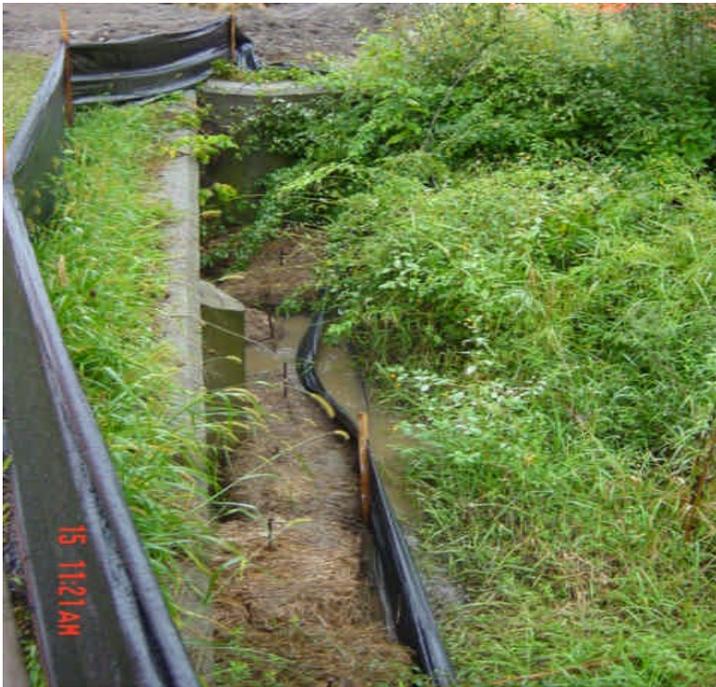
Photo on the left shows the turbid water in the stream on the day of inspection following the rains. Photo on the right shows the better quality of the water on the day following inspection after some repairs were made. (9/16/05)
