**Docket No. 217 – Development and Management Plan Inspection**

**Date:** September 21, 2005

**Location:** 345kV Underground Route

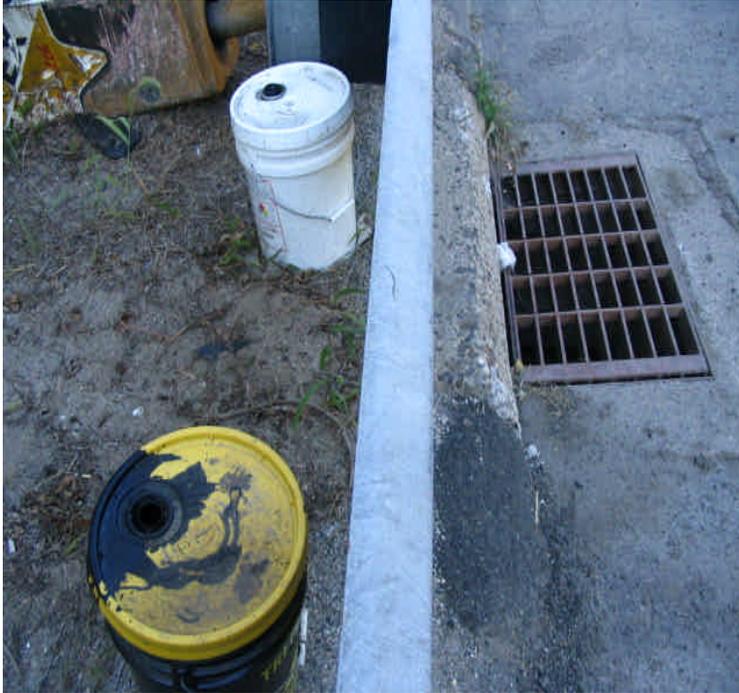
**345kV (Route 107 Daywork): The photo on the left shows some materials left uncovered and not immediately adjacent to the active work. Catch basins in this work area were also not protected. The photo on the right shows an area where an excavator had been parked, resulting in disturbed soil without erosion controls. (9/21/05)**

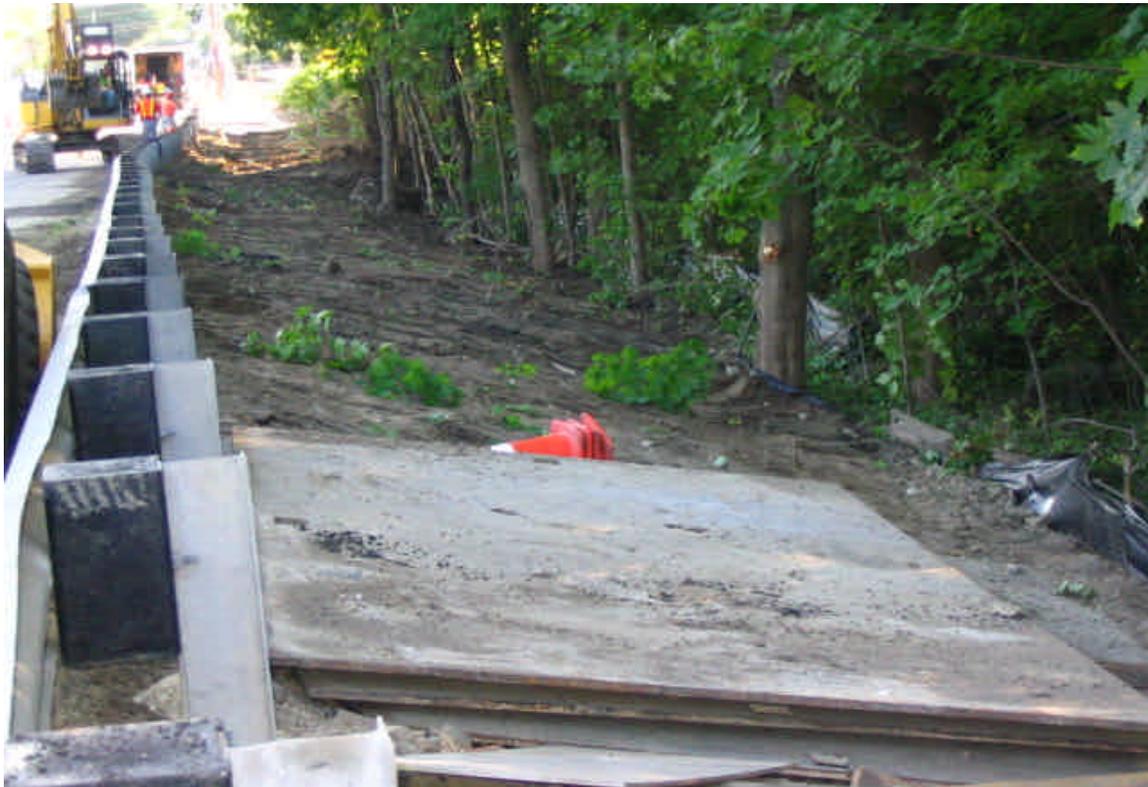
**View of work north of the Georgetown Deli. A section of silt fence is down here and needs repair as a wetland is located downgradient. (9/21/05)**

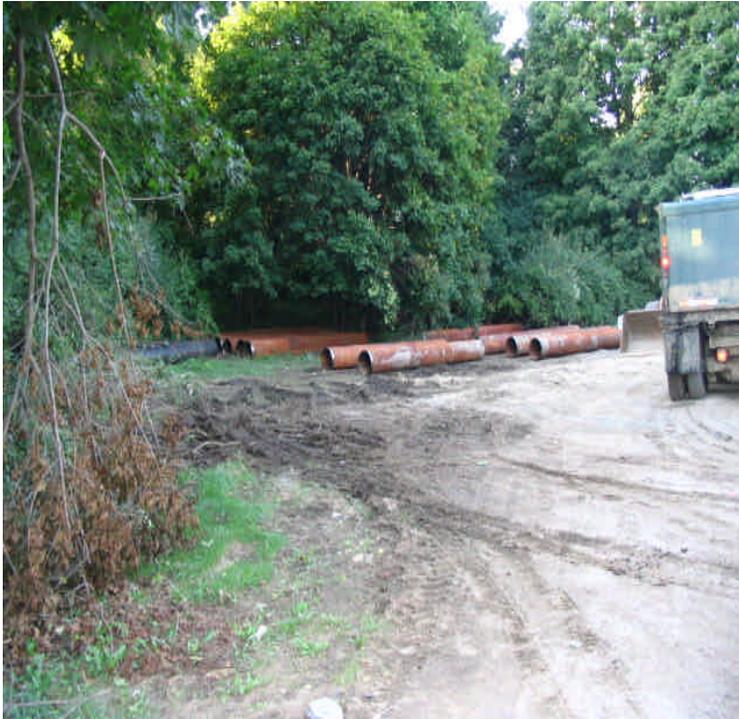
**345kV (Route 7):** Photo on the left shows one of several storage areas have materials placed beyond previously cleared areas and have no clear limit of work. Keep materials as contained as possible. Photo on the right is of the receiving pit constructed on the north side of the stream. A second excavation not seen in the photo is present to repair a potential leak in a sanitary sewer line.

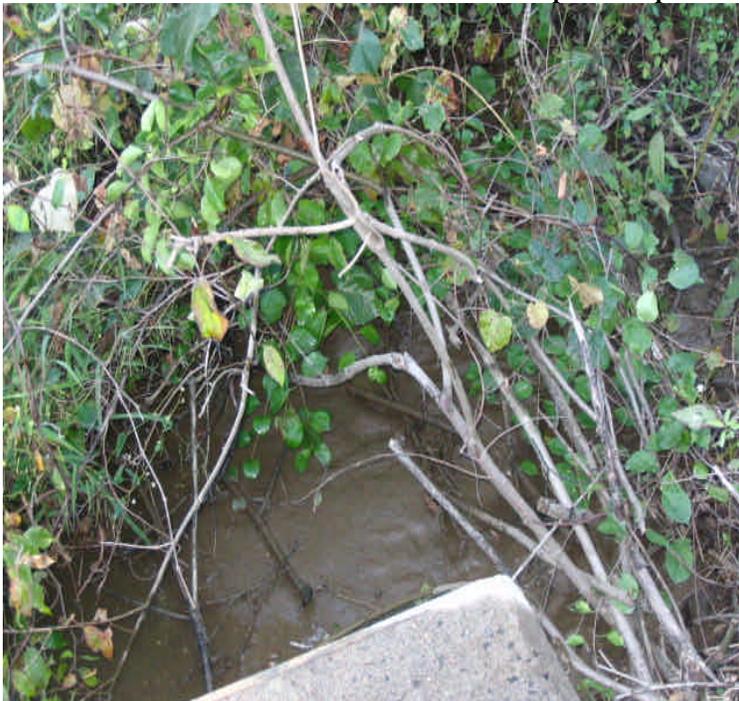
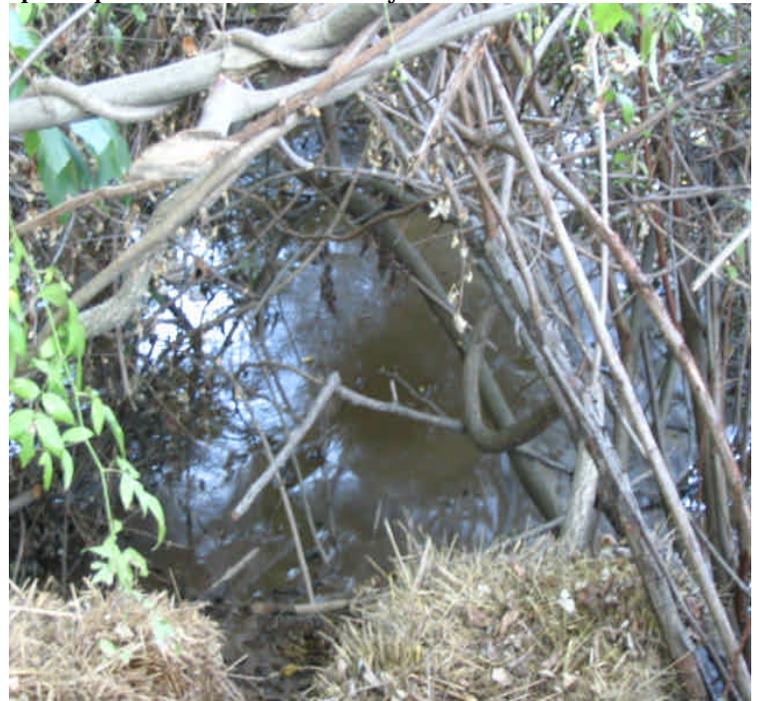
Several views of areas of sedimentation to the stream and area adjacent to the settling basin at the jack and bore. These areas formed even with the use of multiple controls and should be removed carefully by hand/shovel. (9/21/05)

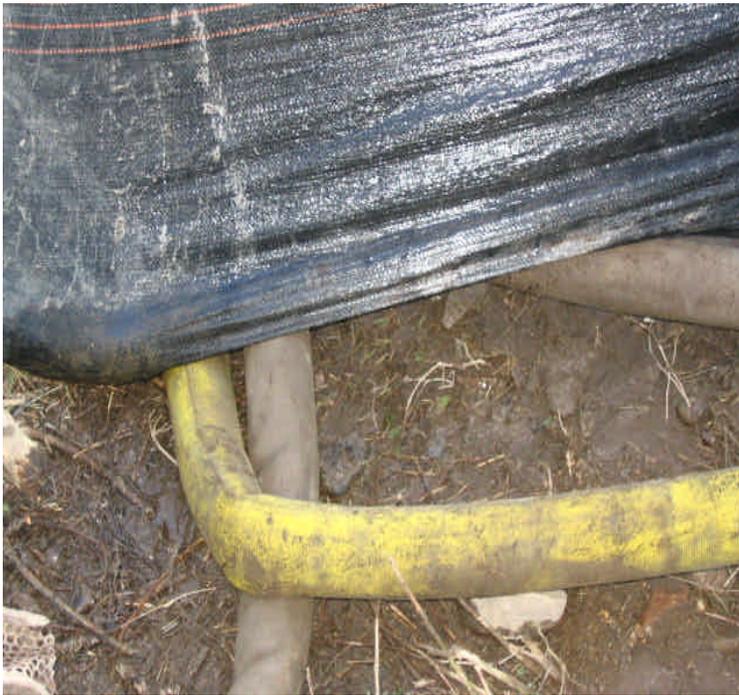
Photo on the left shows dewatering hoses placed under the silt fence. This will undermine the purpose of the fence so the hoses were removed and placed over it. The photo on the right shows where a small leak was noted and placed with absorbent pads and pellets. (9/21/05)

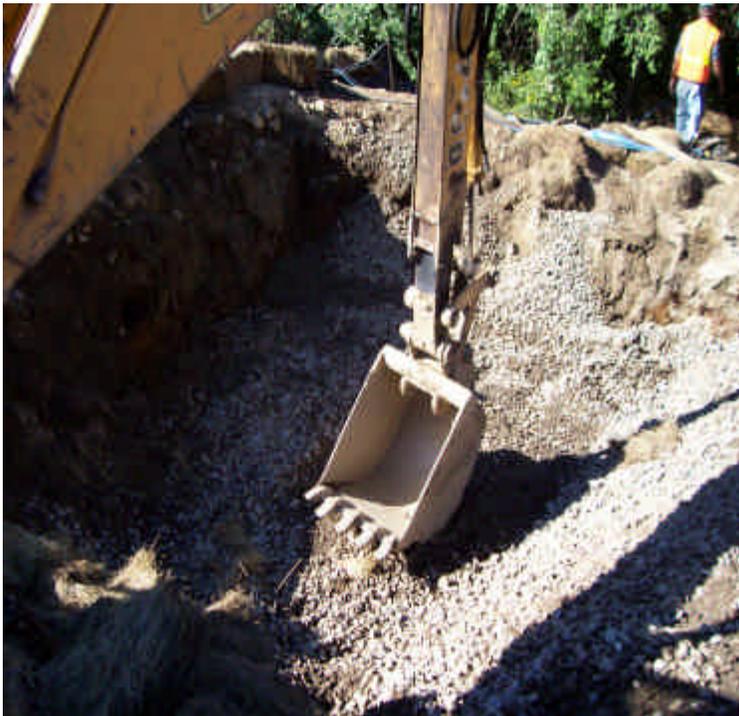
Repairs were made immediately following the inspection and conditions were significantly improved. Photo on the left shows the settling basin having been drained and lined with clean trap rock to better contain and filter discharge water. The photo on the right shows an overview of the area following the repairs. (9/21-9/22/05)
