**Docket No. 217 – Development and Management Plan Inspection**

Northeast Utilities Service Company Certificate of Environmental Compatibility and Public Need for the construction of a 345-kV electric transmission line and reconstruction of an existing 115-kV electric transmission line between Connecticut Light and Power Company's Plumtree Substation in Bethel, through the towns of Redding, Weston, and Wilton, and to the Norwalk Substation in Norwalk, Connecticut.

**Date:** September 29, 2006

**Location:** 345kV Underground Route

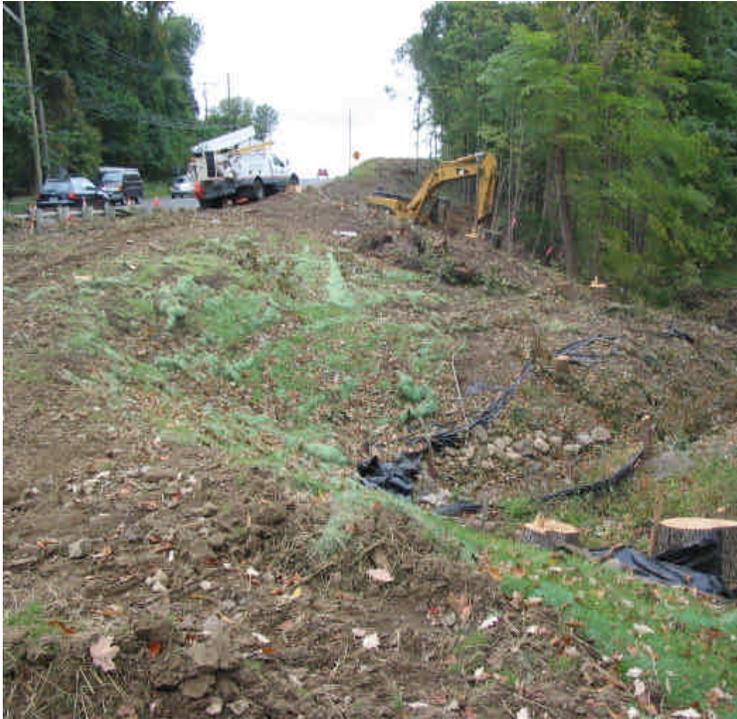
345kV: Photo on the left shows the clearing occurring near the Old Danbury Rd area. This is part of the work on Rt 7 and unrelated to the 345kV project. Photo on the right shows a view of the swale and erosion controls in this area. The controls in this area are no longer the responsibility of 345kV contractors. 9/29/06

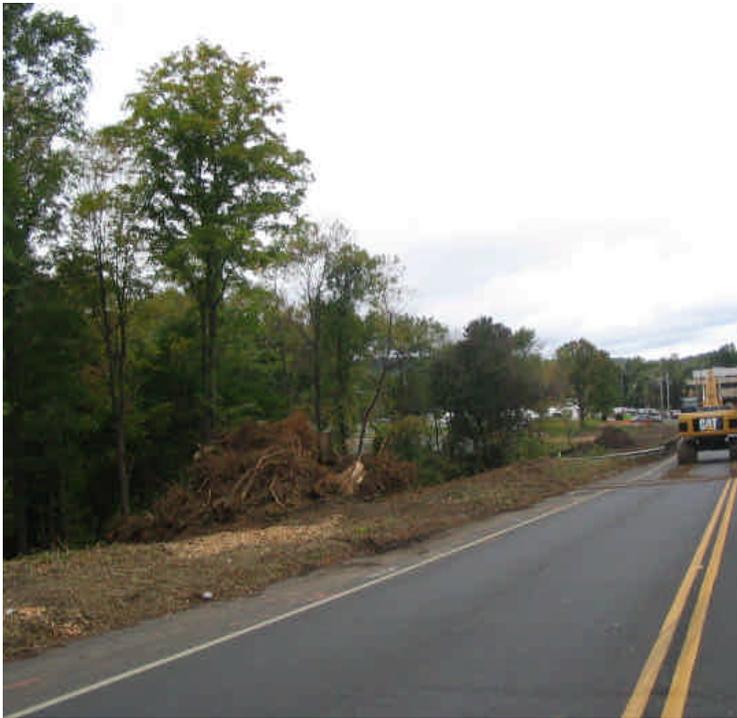
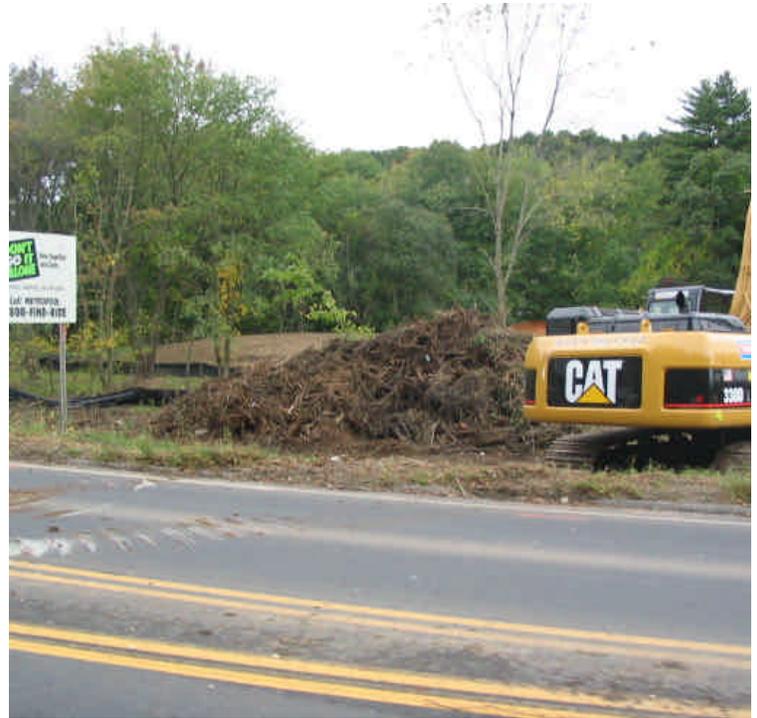
Both photos show clearing and disturbance related to the work on Rt 7. This is unrelated to the 345kV project and is adjacent to the old HDD site off School Rd. 9/29/06

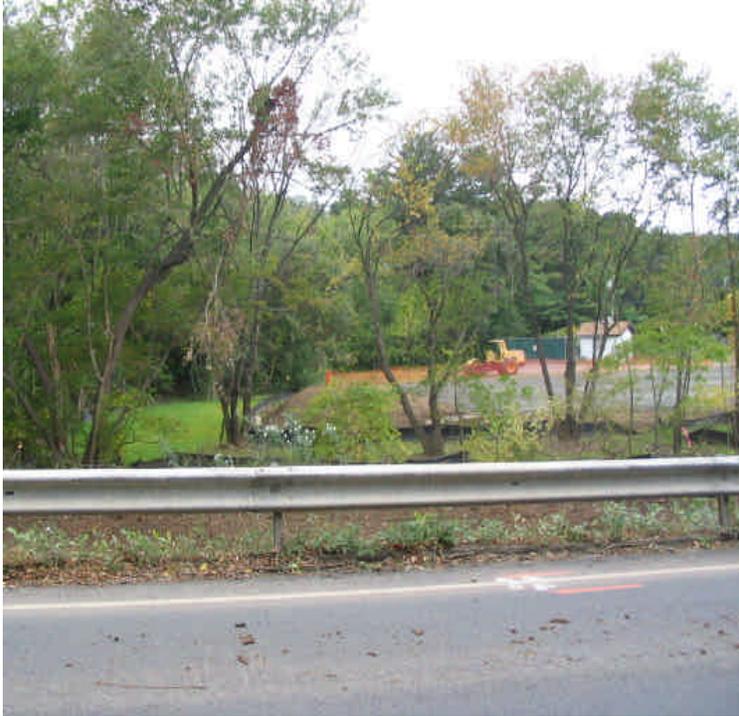
Photo on the left shows a view of the old HDD where a parking lot for the Rt 7 construction project is in place. It will be the responsibility of that project to keep erosion controls secure in the future. Photo on the right shows the contractor storage area near Four Seasons racquet club. This area is still heavily utilized. 9/29/06

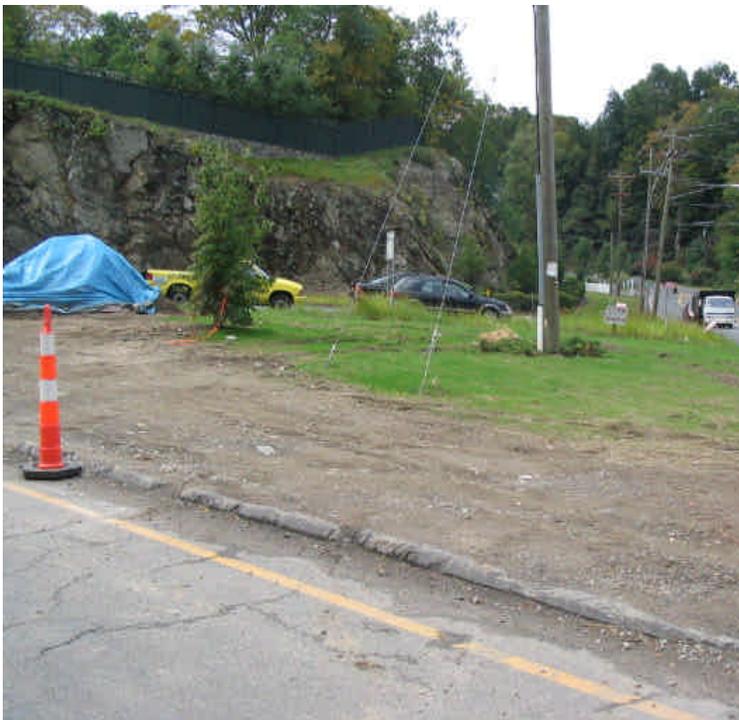
<p><b>Rt. 107</b></p>	<p>- Restored areas at the storage area near #848 (Rt.7) continue to show grass growth. 9/29/06</p> <p>- Catch basins near the Rt. 107 &amp; 7 intersection do not have filters/ controls in place. Some disturbed soil is present although portions have been restored. 7/12-9/29/06</p> <p>- At the Georgetown Deli J&amp;B, all restored streambanks appear stabilized. 9/29/06</p> <p>- At the Georgetown HDD site (Gilbert &amp; Bennett lot), the slope where the trenching had occurred was graded but did not appear to have been seeded yet. Good controls are in place. 8/9-9/29/06</p> <p>-A recently loamed and</p>	<p>-Area appears to be stabilized and returned to the landowner. 9/22-9/29/06</p> <p>- Finalize restoration of the island when access is complete. 4/6-9/29/06</p> <p>-None. This area can be removed from the inspection. 9/29/06</p> <p>- Seeding and mulching needs to occur. 8/9-9/29/06 Generally, guidelines state that fall seeding should be completed by Oct 15<sup>th</sup>.</p> <p>- None at this time.</p>	<p>-Area is stable</p> <p>- Needs attention when feasible unless the Rt 7 project will affect this location.</p> <p>-Banks appear stable</p> <p>- Needs to be seeded.</p> <p>- N/A</p>

Photo on the left shows the Rt 107/7 intersection. Some areas have been seeded/mulched but final restoration is still required. Photo on the right shows a view of the silt fence installed at the Gilbert & Bennett lot. Seed and mulch are still needed here along the slope. 9/29/06

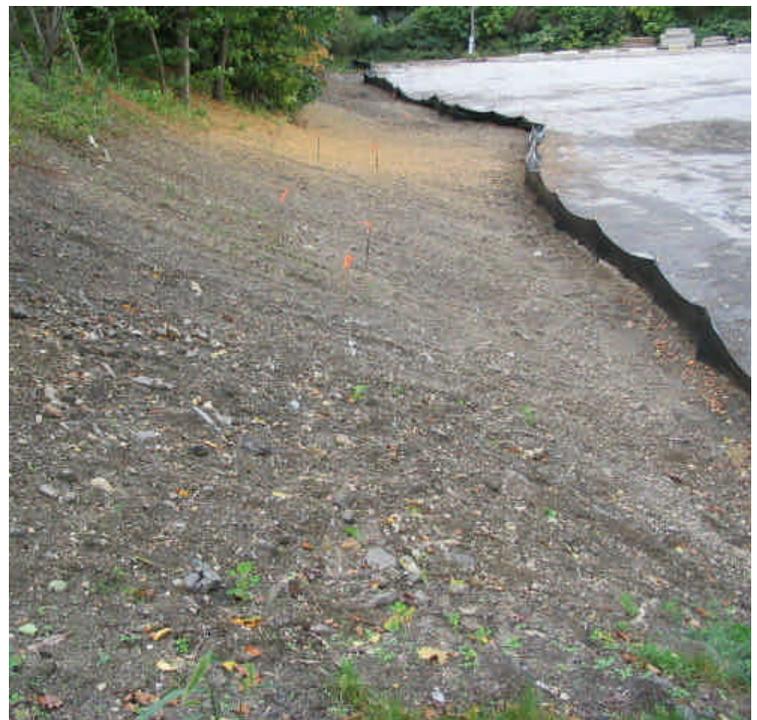
Areas of Inspection	Observation	Recommended Action	Corrective Action
	9/29/06 - The slope along the Gilbert & Bennett lot where the HDD occurred still needs to be seeded and mulched. 8/9-9/29/06	9/29/06 - Restore and stabilize the slope. 8/9-9/29/06 Generally, guidelines state that fall seeding should be completed by Oct 15 <sup>th</sup> .	- Needs attention
Dewatering	- No dewatering was noted at this time. 9/29/06	-None at this time. 9/29/06	- N/A
Blasting	- No blasting is occurring on site at this time.	- None at this time.	N/A
Spills and Material Storage	-No spills or drips were noted along the project route. Equipment is limited. 9/29/06	- The contractors should remain vigilant about securing and handling fuel containers. - Continue to keep all vehicles maintained well (i.e. no apparent fluid leaks) if they will be used or stored on site. - Check equipment status on a regular basis and keep spill kits on hand. - Report spills immediately, even if they are being controlled.	- Good proactive controls were used.
