**Docket No. 217 – Development and Management Plan Inspection**

Northeast Utilities Service Company Certificate of Environmental Compatibility and Public Need for the construction of a 345-kV electric transmission line and reconstruction of an existing 115-kV electric transmission line between Connecticut Light and Power Company’s Plumtree Substation in Bethel, through the towns of Redding, Weston, and Wilton, and to the Norwalk Substation in Norwalk, Connecticut.

**Date:** October 5, 2005

**Location:** 345kV Underground Route

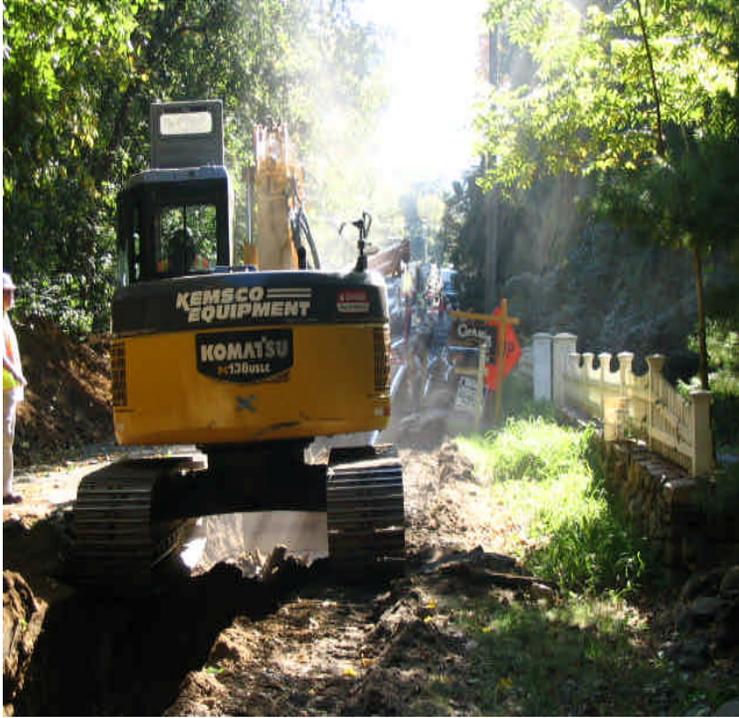
**345kV (Route 107 Daywork):** The photo on the left shows the active trenching on Umpawaug Road with soil from the day's excavation stockpiled. If soil is stockpiled longer than the day, silt fence will be needed. The photo on the right shows a stockpile area left over on Umpawaug Rd. The area should be restored if work here is done. (10/5/05)

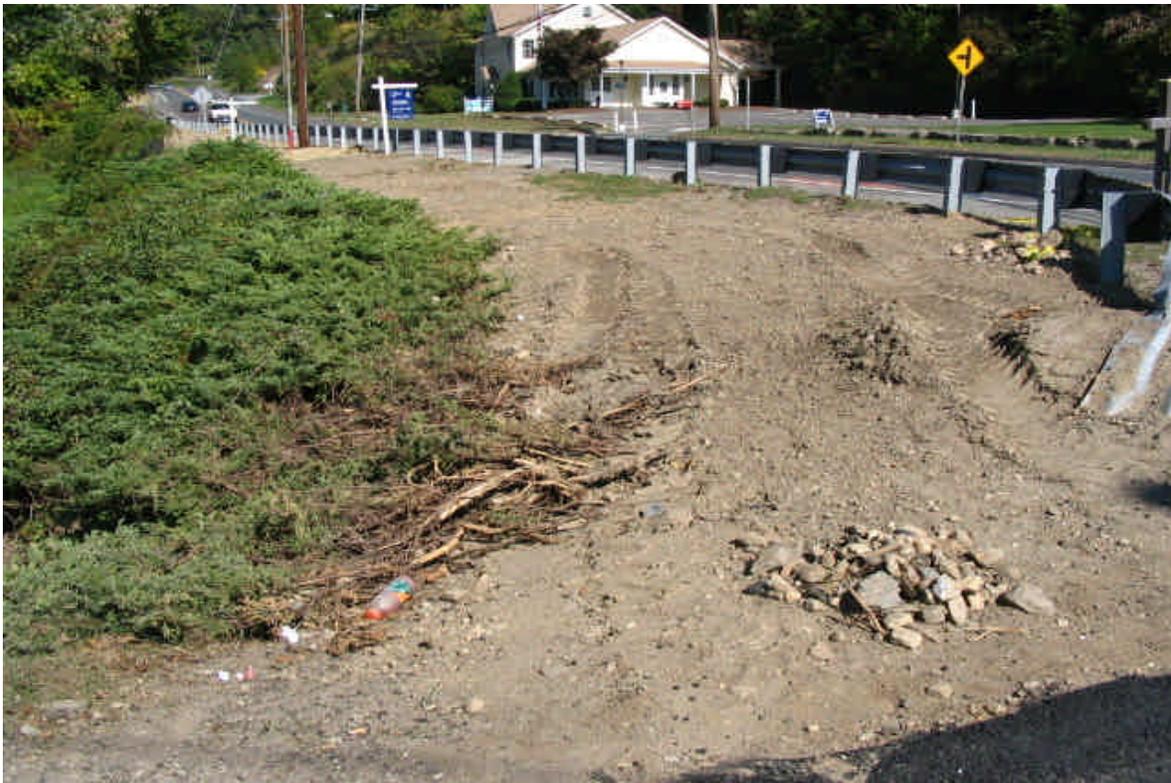
**345kV (Daywork Route 107):** View just north of Georgetown Deli. Restoration measures have been implemented up to a point but should continue. Silt fence was pulled prematurely here. (10/5/05)

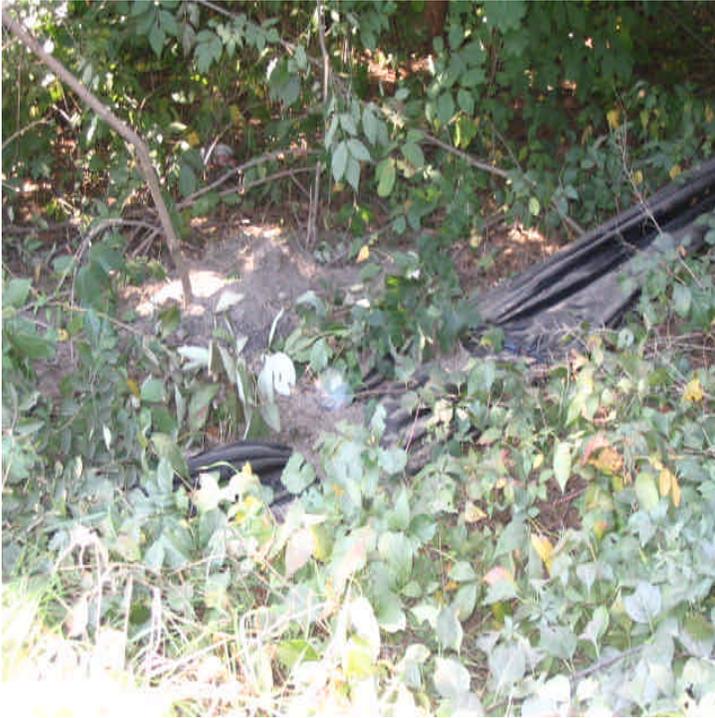
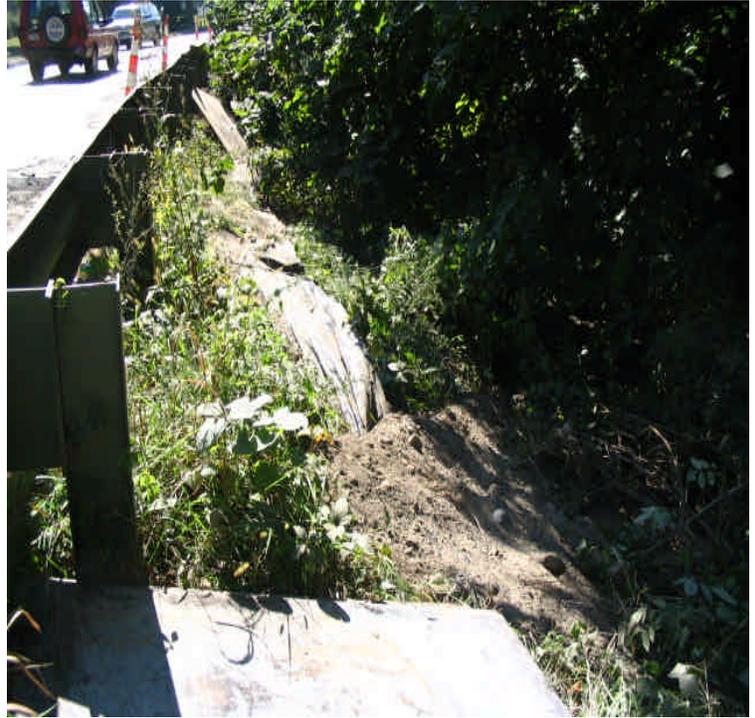
**345kV (Route 7): Both photos show a spot near #475 Rt. 7 by Olmstead Hill Rd. where the silt fence has come down and some small soil piles were left behind. 10/5/05**

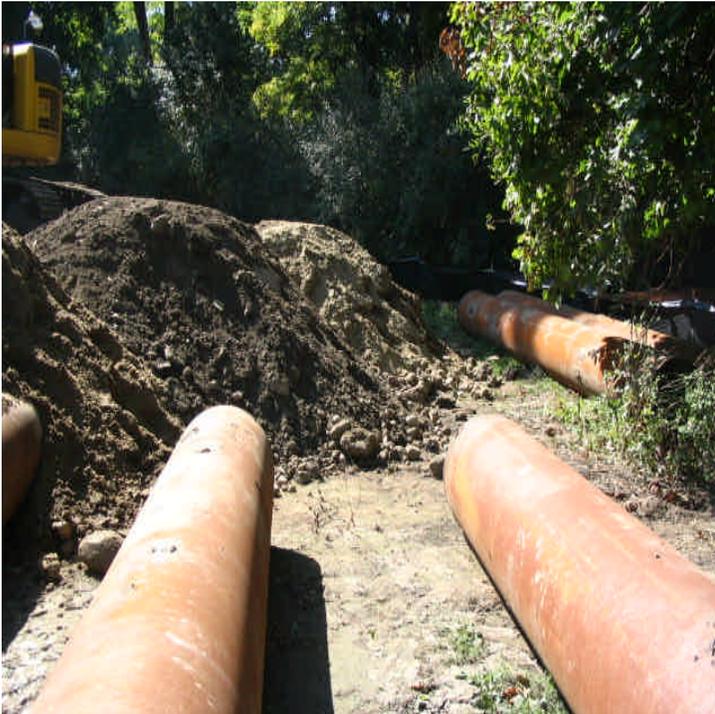
**Photo on the left shows the backfill pile at the Wilton HS jack and bore with silt fence well installed. Photo on the right shows the receiving pit side of the work. (10/5/05)**

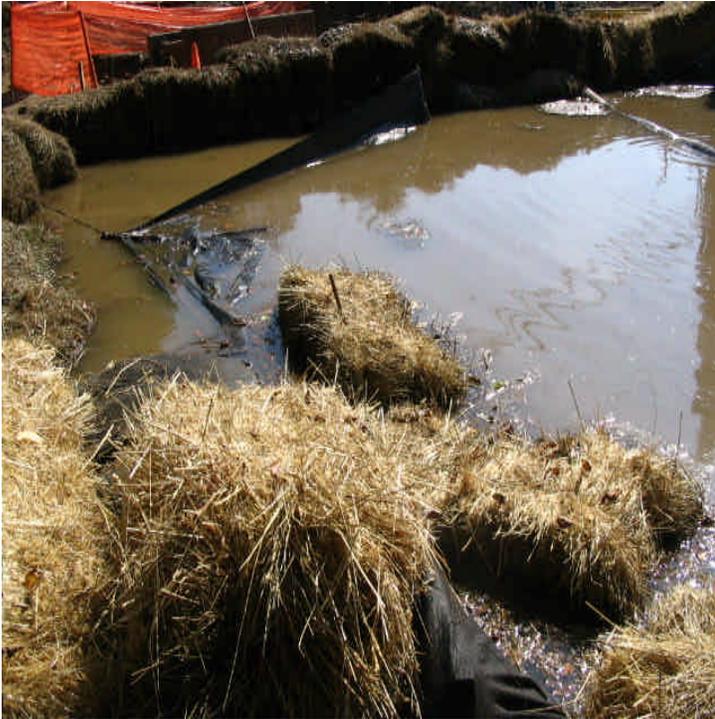
Photo on the left shows how the settling basin which once again has become turbid. The photo on the right shows all of the controls in place with some slightly turbid water still getting through. (10/5/05)

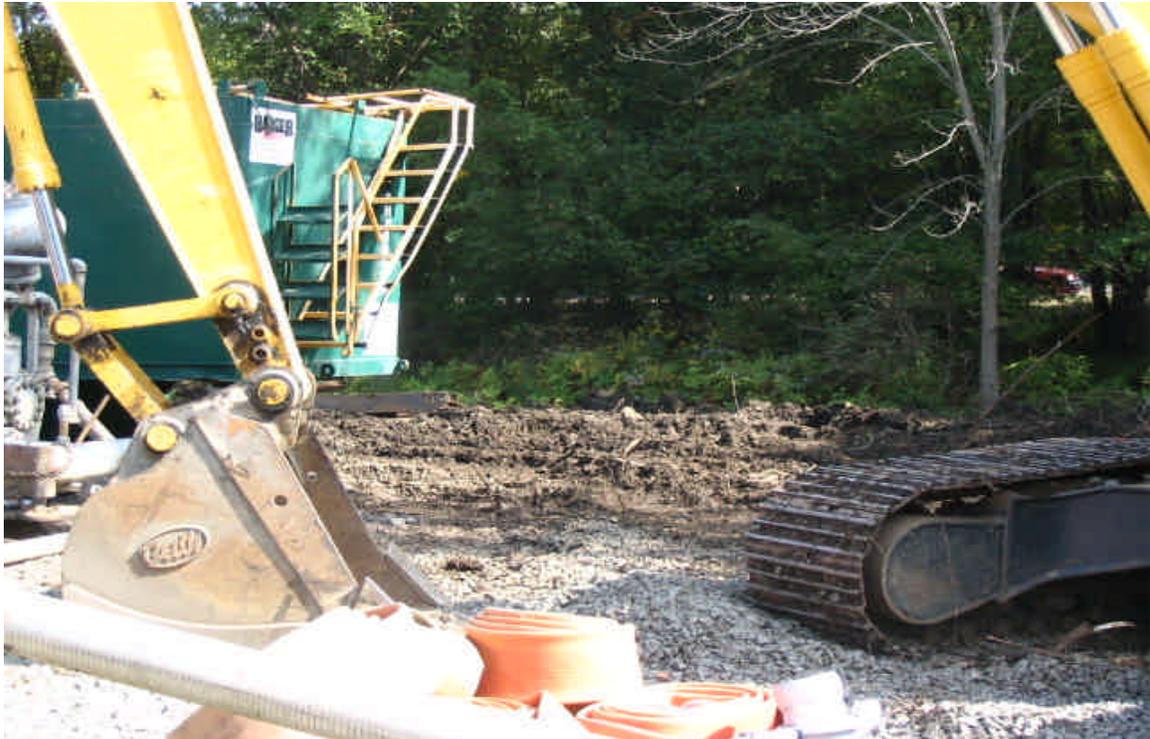
In preparation for the drill, the adjacent area was disturbed and will require silt fence. Contractors were scheduled to install the fence once the area of disturbance needed was identified. (10/5/05)
