Docket No. 217 – Development and Management Plan Inspection

Northeast Utilities Service Company Certificate of Environmental Compatibility and Public Need for the construction of a 345-kV electric transmission line and reconstruction of an existing 115-kV electric transmission line between Connecticut Light and Power Company’s Plumtree Substation in Bethel, through the towns of Redding, Weston, and Wilton, and to the Norwalk Substation in Norwalk, Connecticut.

Date: October 13, 2005

Location: 345kV Underground Route

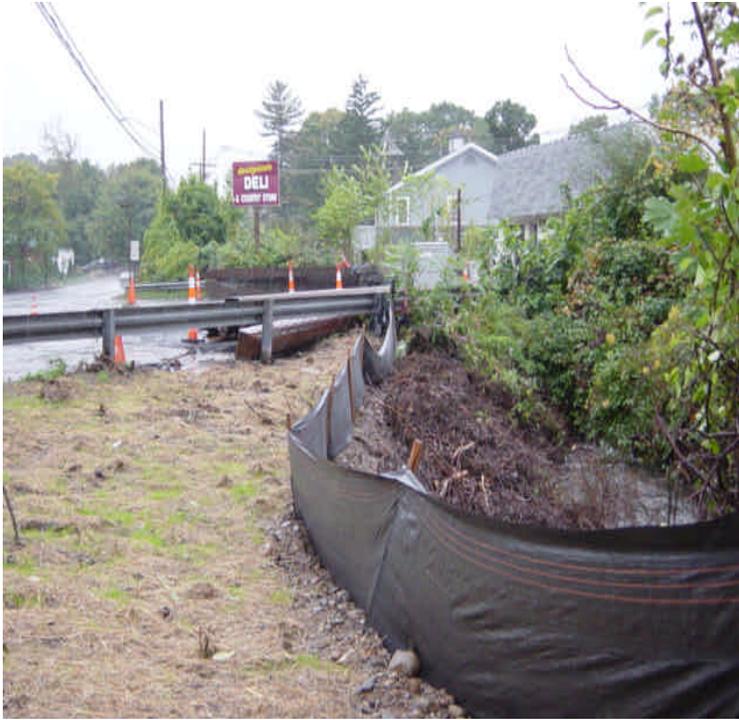
345kV (Daywork Rt. 107 and Umpawaug Rd.): The photo on the left shows the restored areas north of Georgetown Deli with silt fence reinstalled. The photo on the right shows erosion controls installed along the work area on Umpawaug Rd. (10/13/05)

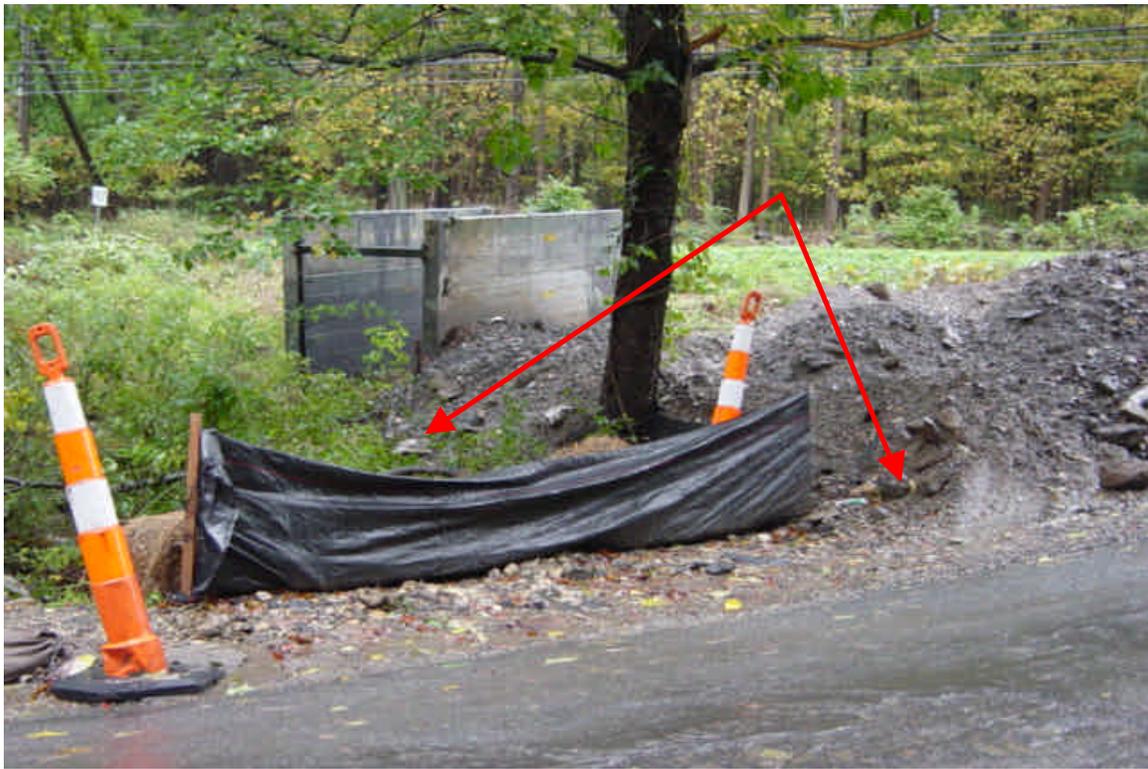
345kV (Daywork Umpawaug Rd.): A storage area near the intersection of Umpawaug and Rt. 107 needs additional silt fence to encompass this stockpile. (10/13/05)

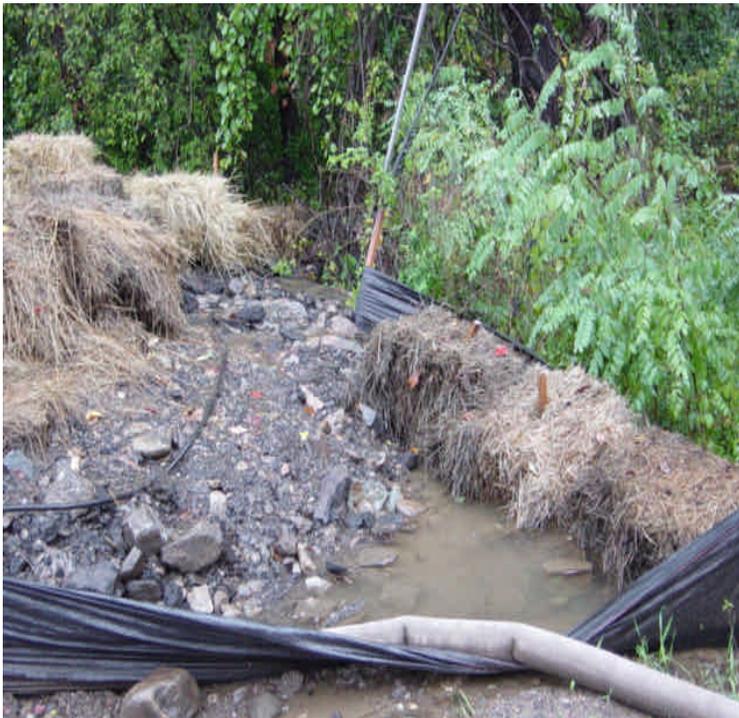
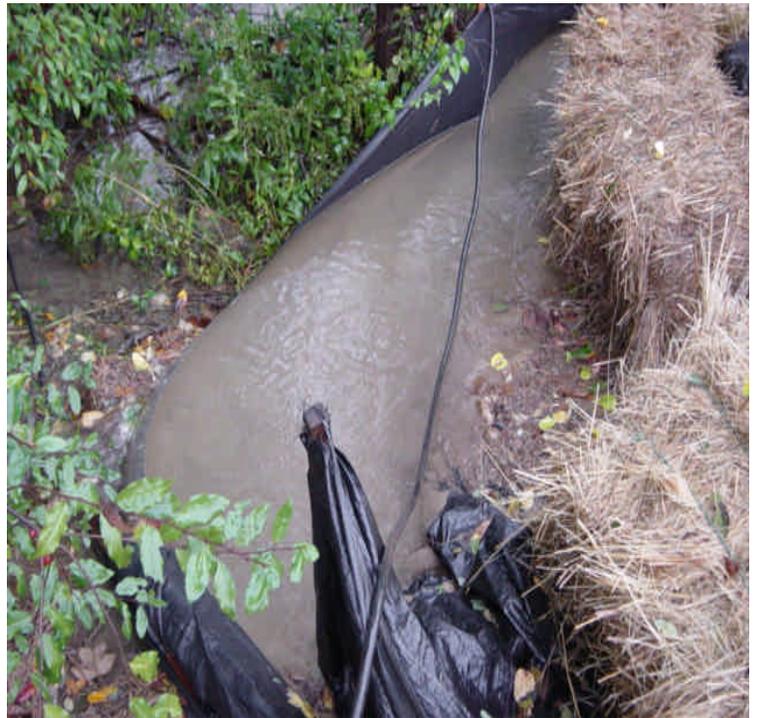
345kV (Route 7 Wilton HS Jack and Bore): The photos shows area along the settling basin where the erosion controls were overwhelmed by the increased volumes of water. Upgrades/repairs are needed. 10/13/05

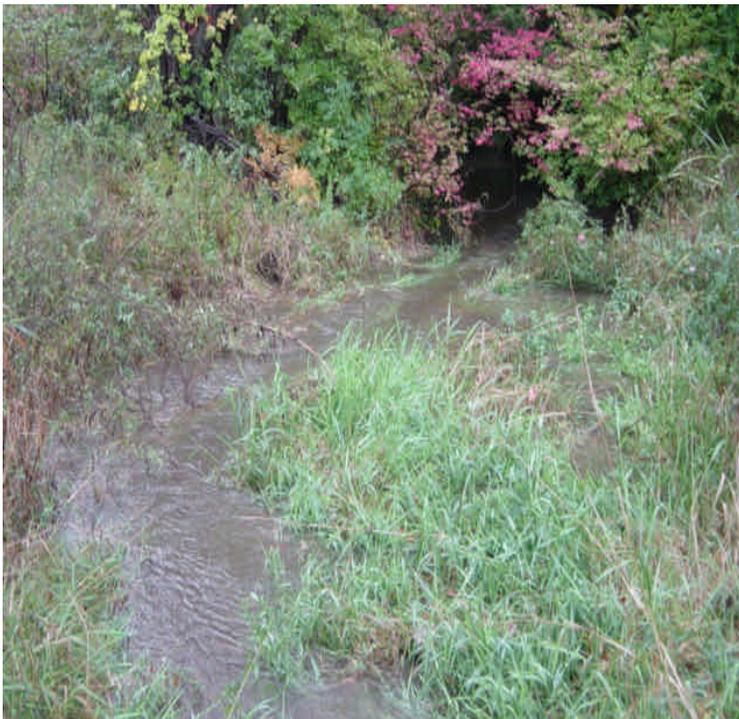
<p>Adjacent Wetlands and Waterways</p>	<ul style="list-style-type: none"> -At the jack and bore near Allens Meadow Park, the stream has very high volume due to the rain. The water is still turbid due to the use of the settling basin. When the water recedes, it will have to be determined whether the accumulated sediment has been washed away. 10/13/05 	<ul style="list-style-type: none"> -If the sediment was washed away, this is not the best thing for the stream but nothing can be done at this point. BSC will determine the extent/if any of the remaining accumulated sediment. Hand shoveling is likely the best solution but we will look into a vac truck option. 10/13/05

Photo on the left shows the downstream portion of the stream which is somewhat flooded due to the rains. Conditions are still somewhat turbid. Photo on the right shows the jacking pit which has been partially backfilled. (10/13/05)

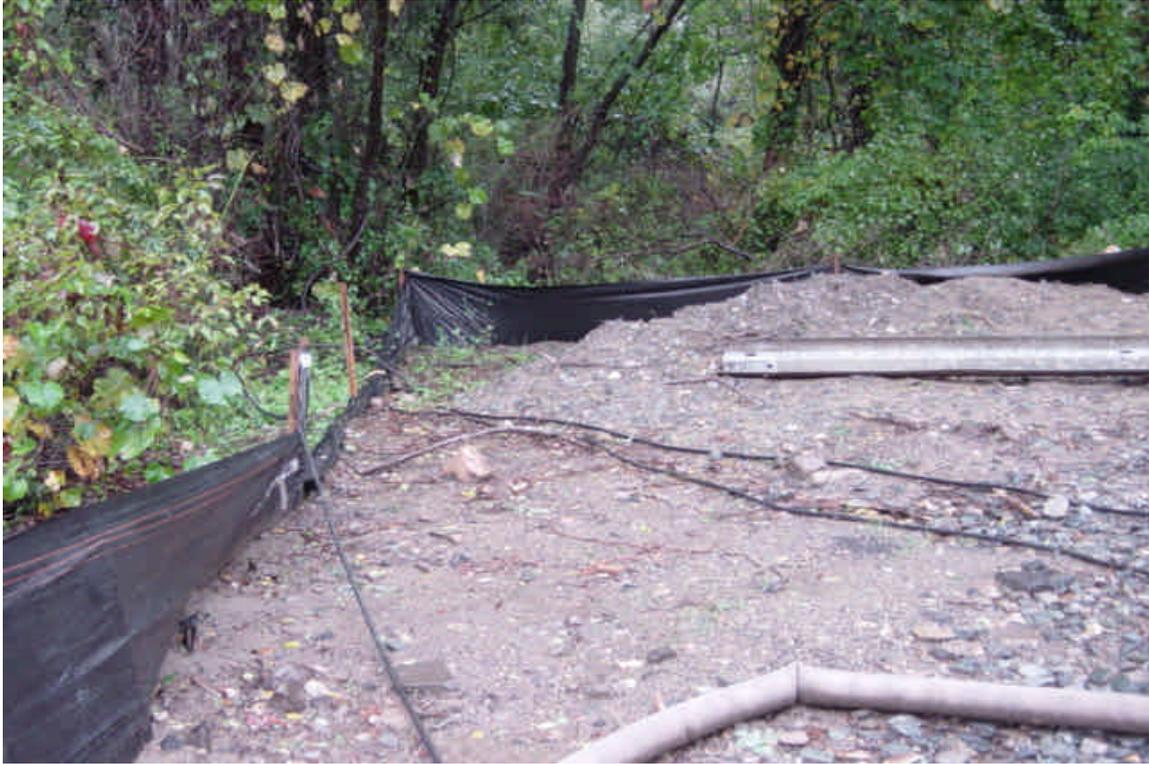
View of a section of silt fence on the northern/receiving side of the stream which needs repair. (10/13/05)

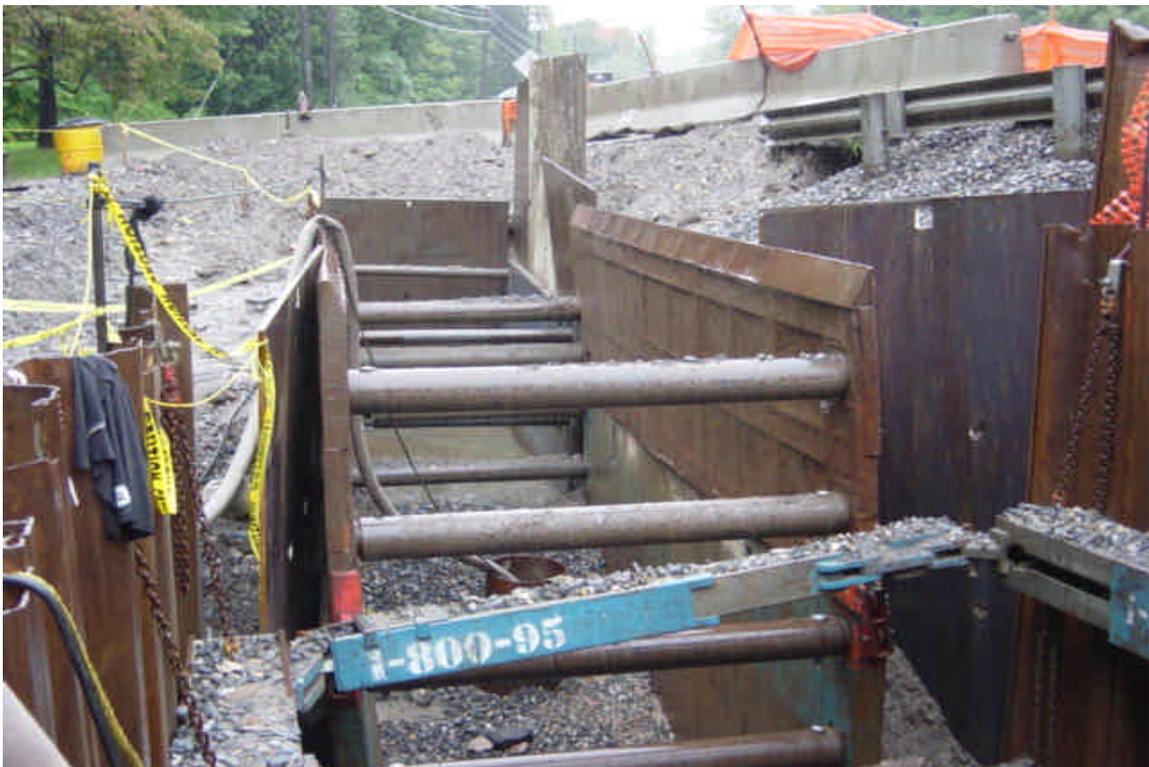
General view of the receiving pit on the northern side of the stream. (10/13/05)

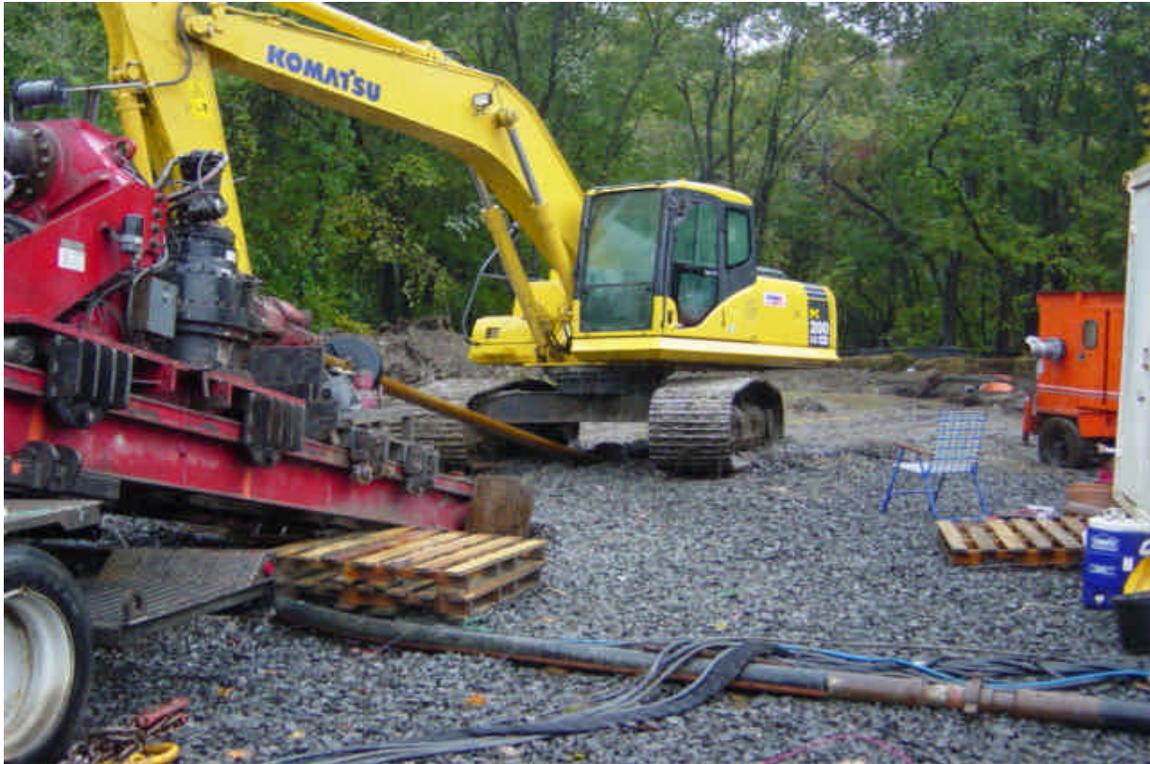
345kV: (Horizontal Direction Drill) View of the work area with the beginning of the bore activities taking place. (10/13/05)

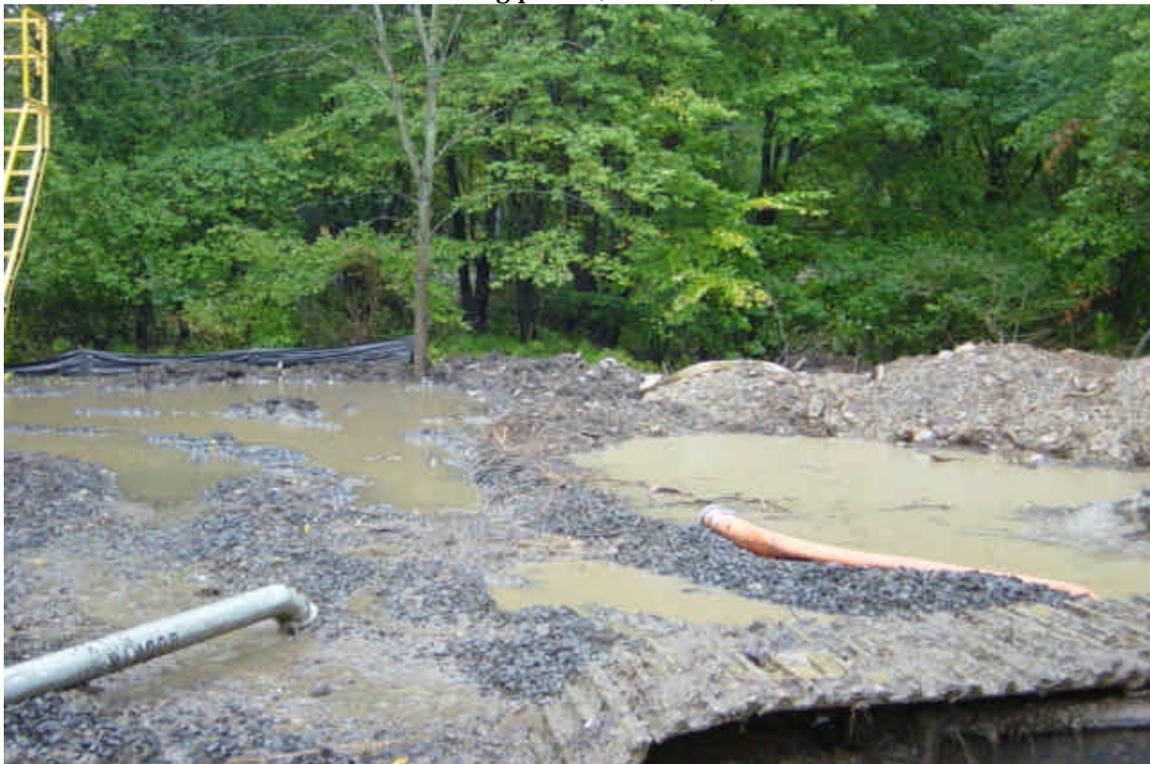
Erosion controls have been installed but additional fence is necessary to encompass all of the disturbance and the stockpiles. These controls should be installed ASAP. (10/13/05)
