Docket No. 217 – Development and Management Plan Inspection

Northeast Utilities Service Company Certificate of Environmental Compatibility and Public Need for the construction of a 345-kV electric transmission line and reconstruction of an existing 115-kV electric transmission line between Connecticut Light and Power Company’s Plumtree Substation in Bethel, through the towns of Redding, Weston, and Wilton, and to the Norwalk Substation in Norwalk, Connecticut.

Date: October 19, 2005

Location: 345kV Underground Route

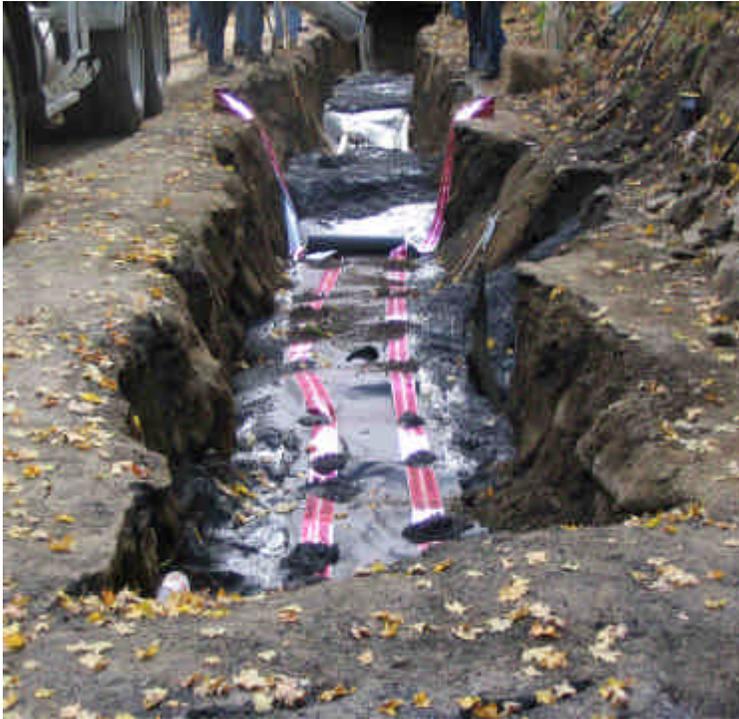
345kV (Umpawaug Rd Daywork): The photo on the left shows the active trenching on Umpawaug Road. The photo on the right shows a stockpile area left over at a vault installation near #134. Some silt fence or haybales should be placed downgradient as a swale is in the vicinity. 10/19/05

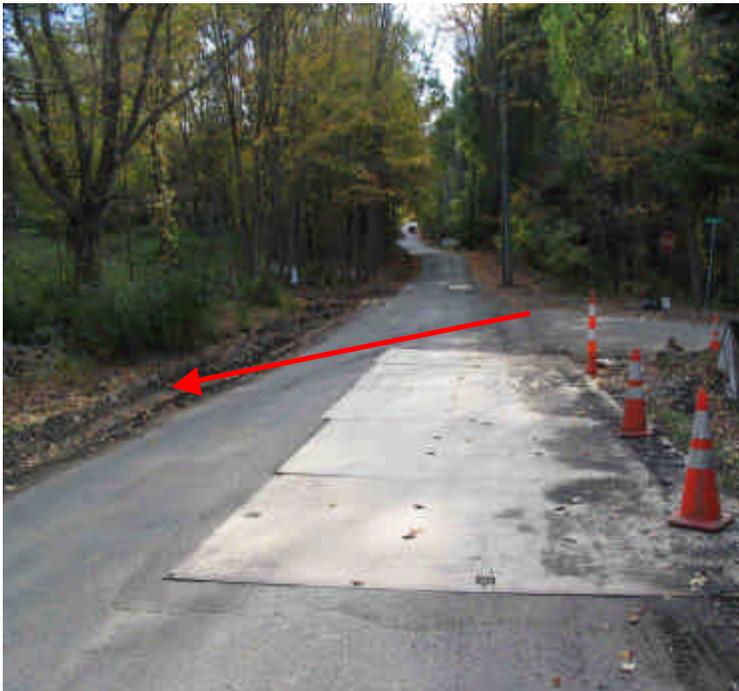
Photo on the left shows where pipe has been installed with a rutted area at the edge of the roadway. A wet swale runs through here so the area should be smoothed out and restored. A haybale is in place at the end. Photo on the right shows the storage area at the Rt 107 intersection. Controls are installed better here. (10/19/05)

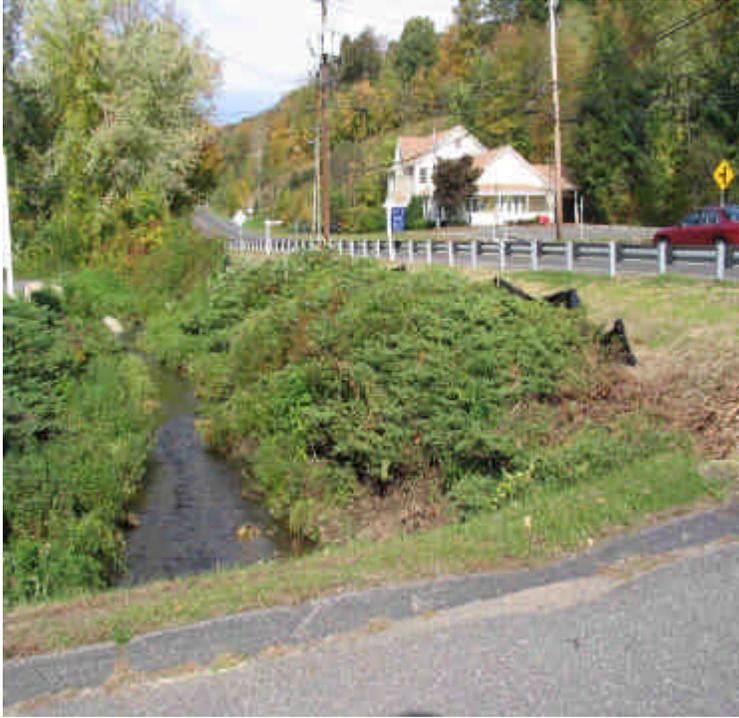
345kV (Route 107 and 7): The photo on the left shows good restoration and regrowth by Georgetown Deli with the previously dry channel flowing following the rains. Photo on the right shows pipe being installed at the north side of the jack and bore. 10/19/05

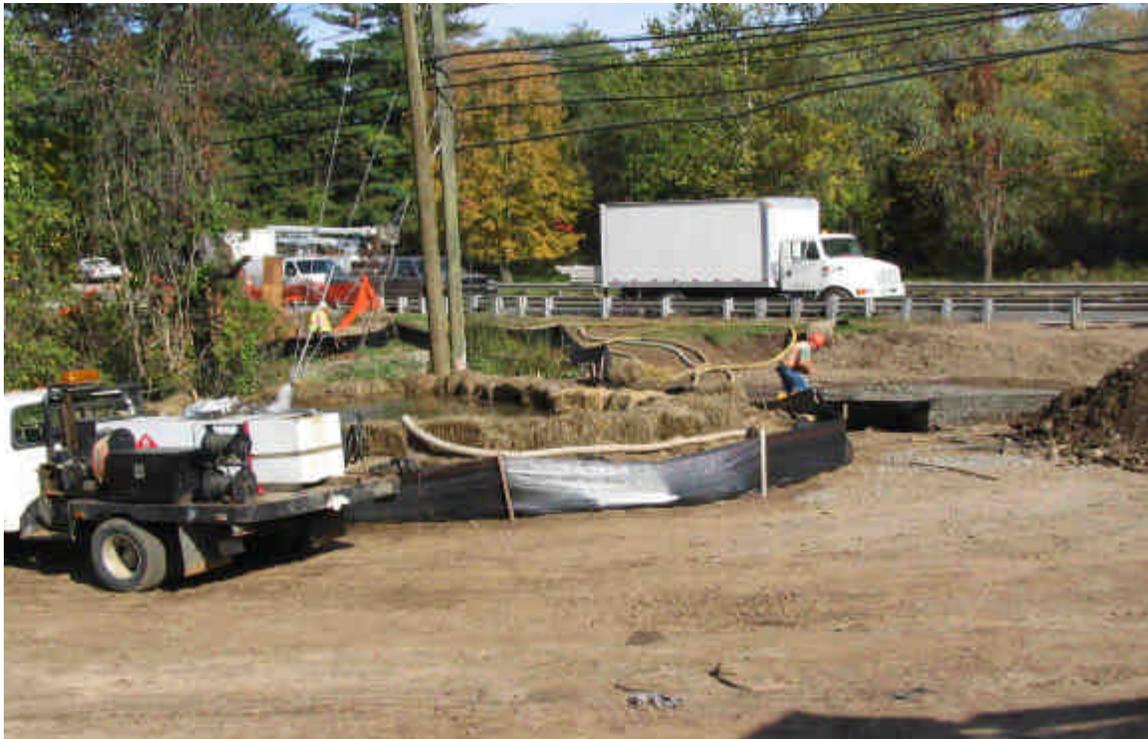
345kV (Wilton HS): General view of the jack and bore on the southern side. The pit on this end has been completely closed up and backfilled. (10/19/05)

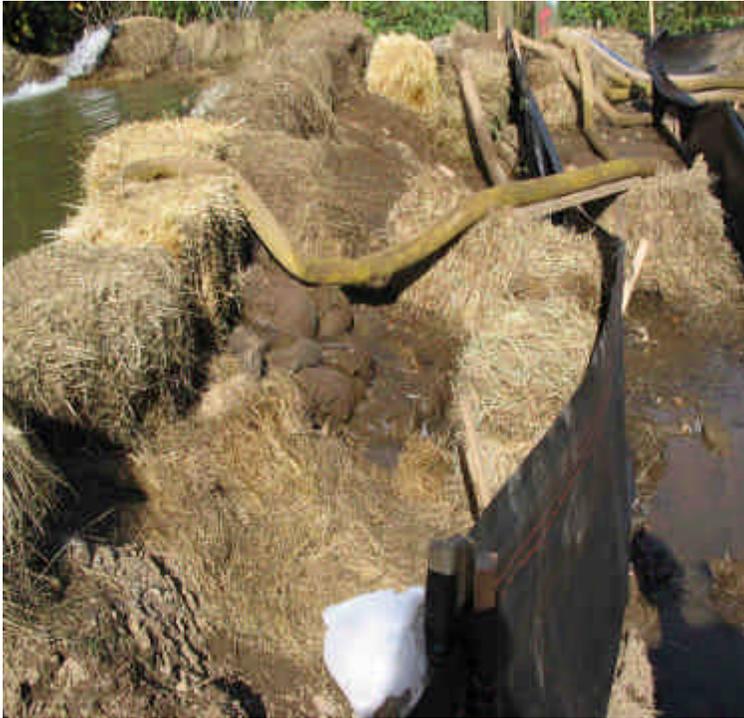
Photo on the left shows where several breakout flows are leaving the settling basin. During the inspection, additional controls were installed to filter the water before it reached the stream. Photo on the right shows the stream with mostly clear flow but some turbidity. (10/19/05)

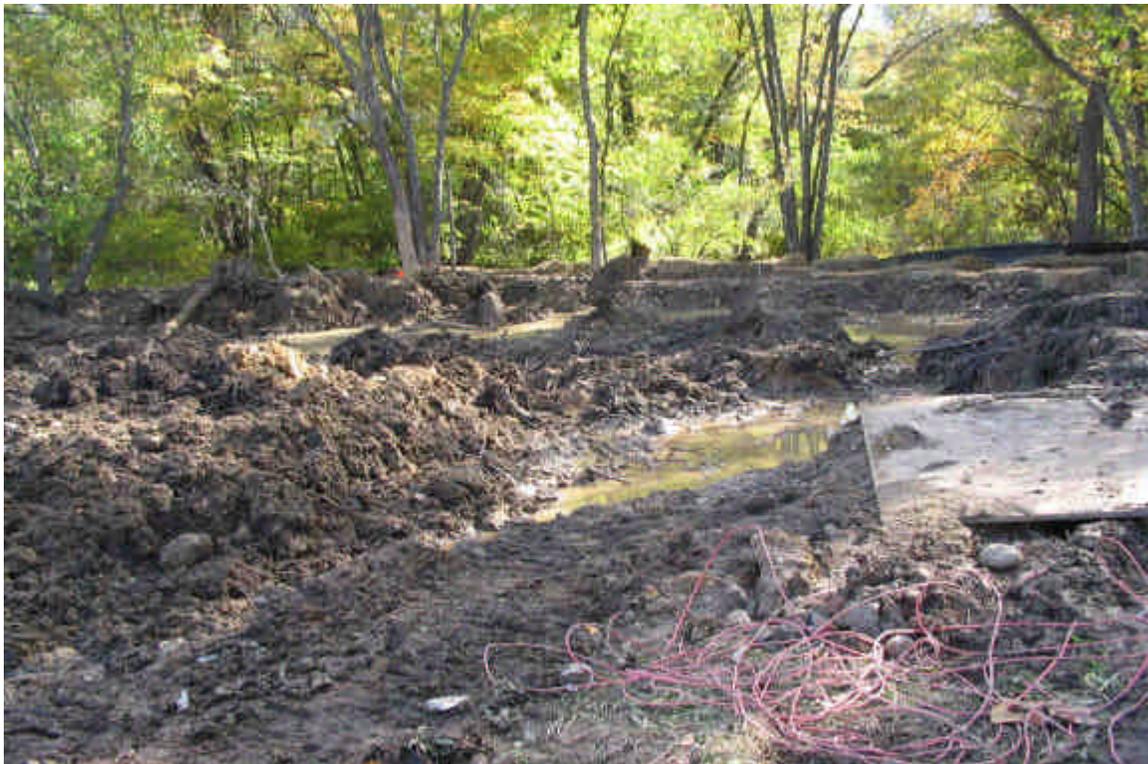
345kV Horizontal Directional Drill: The drill head separated as it was being removed from the bore, resulting in the excavation of this area to recover it. The rains created a muddy pit. (10/19/05)

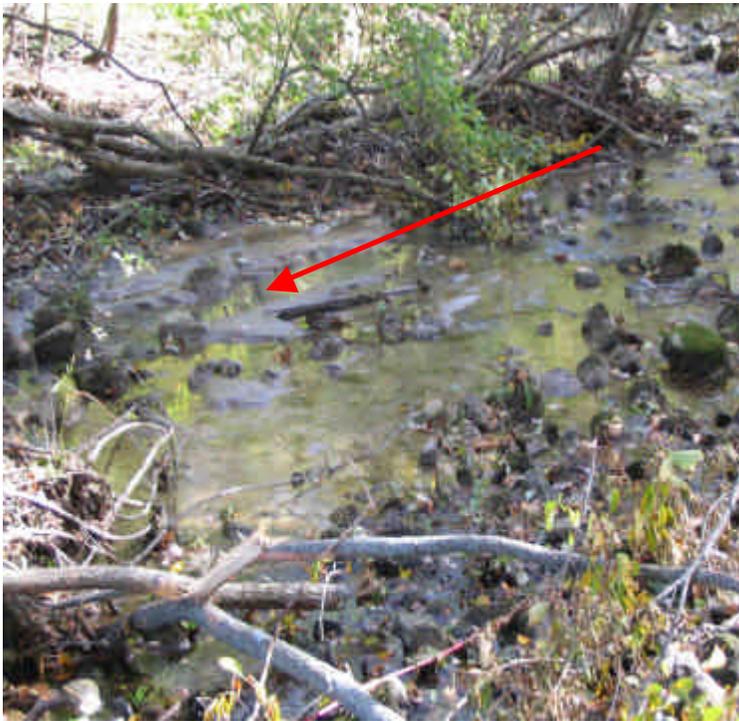
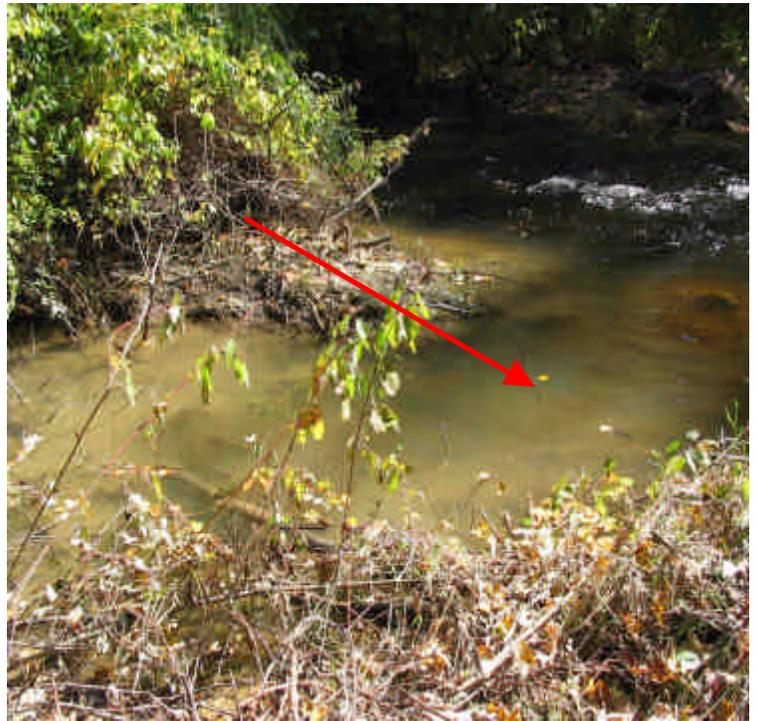
Areas of Inspection	Observation	Recommended Action
	<p>still noted here. 10/19/05</p> <p>- The work at the HDD site caused a noticeable amount of sediment to build up in the stone channels and adjacent wetlands. Accumulated sediment was also noted in a side channel up to the Norwalk River. 10/19/05</p>	<p>- At the inspection we decided sediment will be removed by hand when conditions dry out a little. Most was removed by the end of the week. 10/19/05</p>
<p>Staging, Storage, and Parking Areas</p>	<p>- The silt fence at the equipment storage yard located on property south of the Rt. 7 & 107 intersection is in place. 10/19/05</p> <p>- Additional silt fence is required at the School Rd. HDD area along the eastern side to encompass the disturbed area and brush piles. 10/19/05</p>	<p>- Continue to maintain. 10/19/05</p> <p>- In general, materials should be placed appropriately in storage areas or immediately adjacent to work each night. No potentially spillable materials should be left behind or out overnight. 10/19/05</p> <p>- Install the additional fence as soon as possible. 10/19/05</p>

Due to rain run-off through the excavation area, sediment build up was noted in the wetlands beyond despite the controls in place. Photo on the left shows the noticeable sediment immediately beyond the drill and photo on the right shows the intersection of this channel with the Norwalk River. The line where sediment had accumulated could be distinguished. (10/19/05)

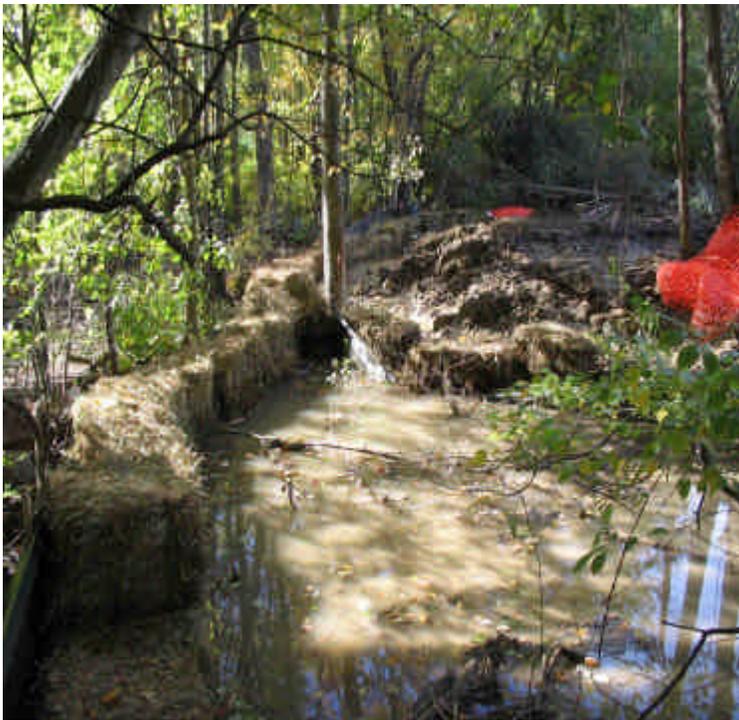
Photo on the left shows where turbid water had pooled up on the drill side of the controls but was still entering the wetlands. Photo on the right shows where brush and bare soil were piled at the edge of work. Silt fence should be extended here to help reduce turbidity. (10/19/05)

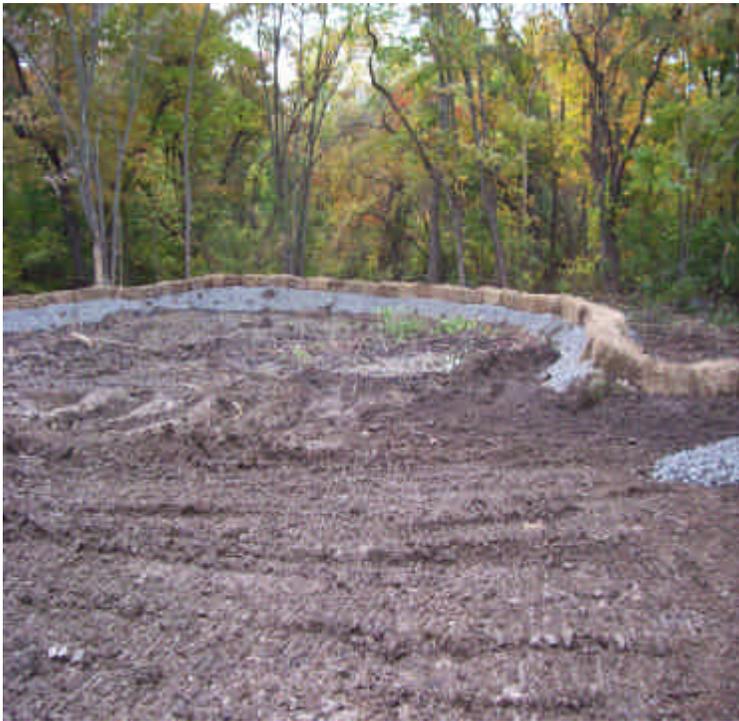
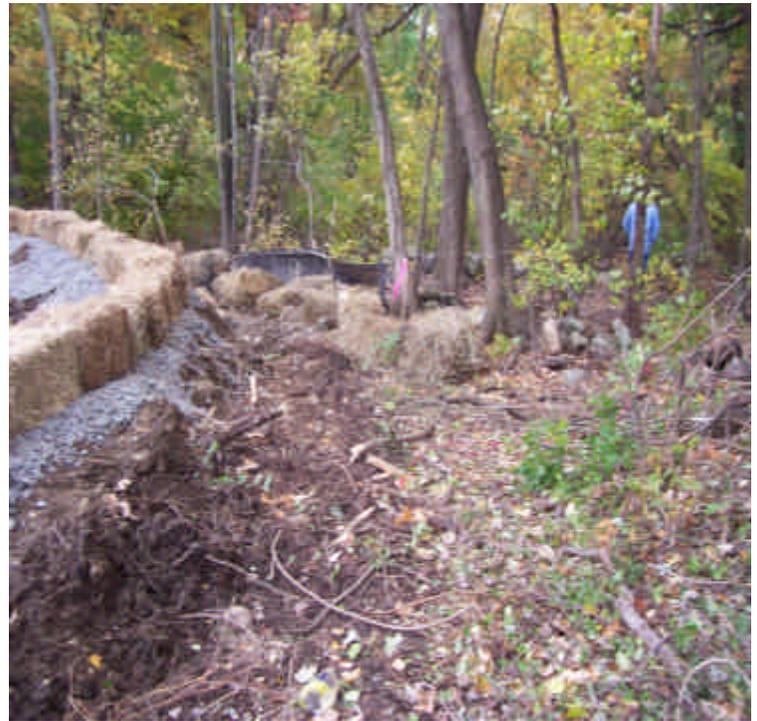
(HDD) Within a few days of the inspection, the disturbed area was regraded and excavated in an attempt to prevent runoff to the adjacent wetlands during the predicted rains this weekend and early next week. Controls were also repaired and reinforced and work was done to removed built up sediment.

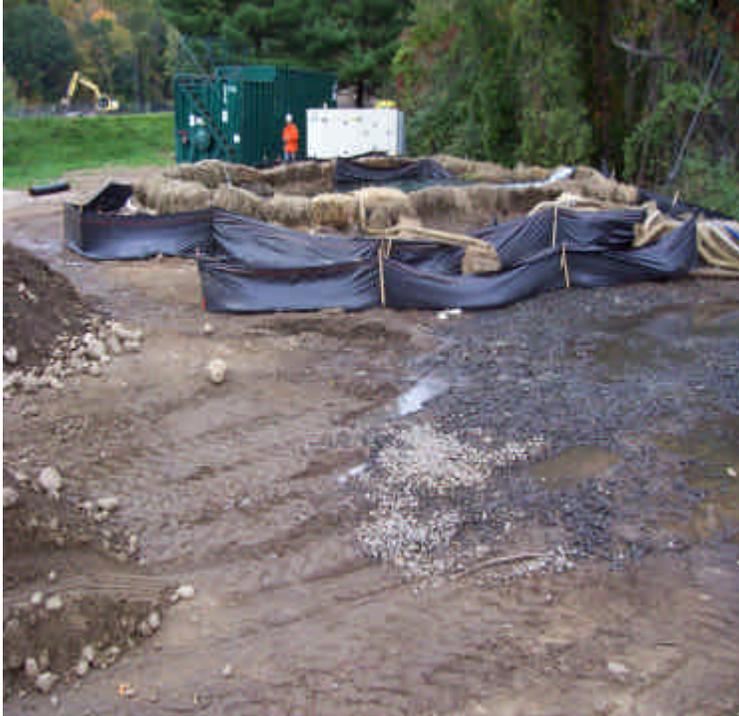
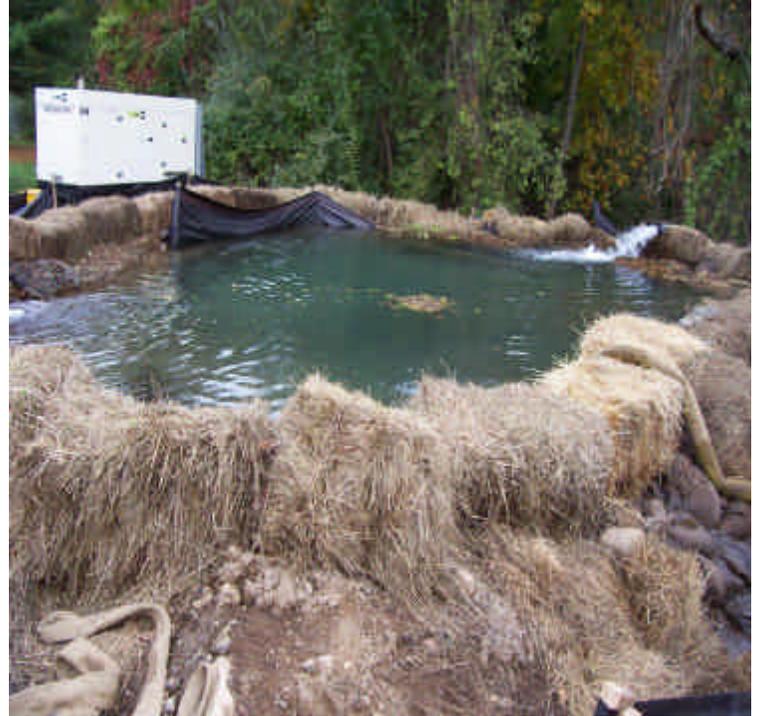
(Jack and Bore) The jack and bore area was also cleaned up prior to the predicted rains with much cleaner water in the basin and a number of additional controls and stone to help filter breakout flows.
